MINERALS PROGRAM INSPECTION REPORT

MINE NAME: Deakins Pit	MINE/PROSPECTING ID#: M-2001-060	MINERAL: Sand and gravel	COUNTY: Moffat
INSPECTION TYPE: Monitoring	WEATHER: Windy	INSP. DATE: May 12, 2022	INSP. TIME: 10:00
OPERATOR: 3B Enterprises, LLC	OPERATOR REPRESENTATIVE: None	TYPE OF OPERATION: 112c - Construction Regular Operation	
REASON FOR INSPECTION: Normal I&E Program	BOND CALCULATION TYPE: Complete Bond	BOND AMOUNT: \$71,160.00	
DATE OF COMPLAINT: NA	POST INSP. CONTACTS: None	JOINT INSP. AGENCY: None	
INSPECTOR(S): Hunter Ridley	INSPECTOR'S SIGNATURE:

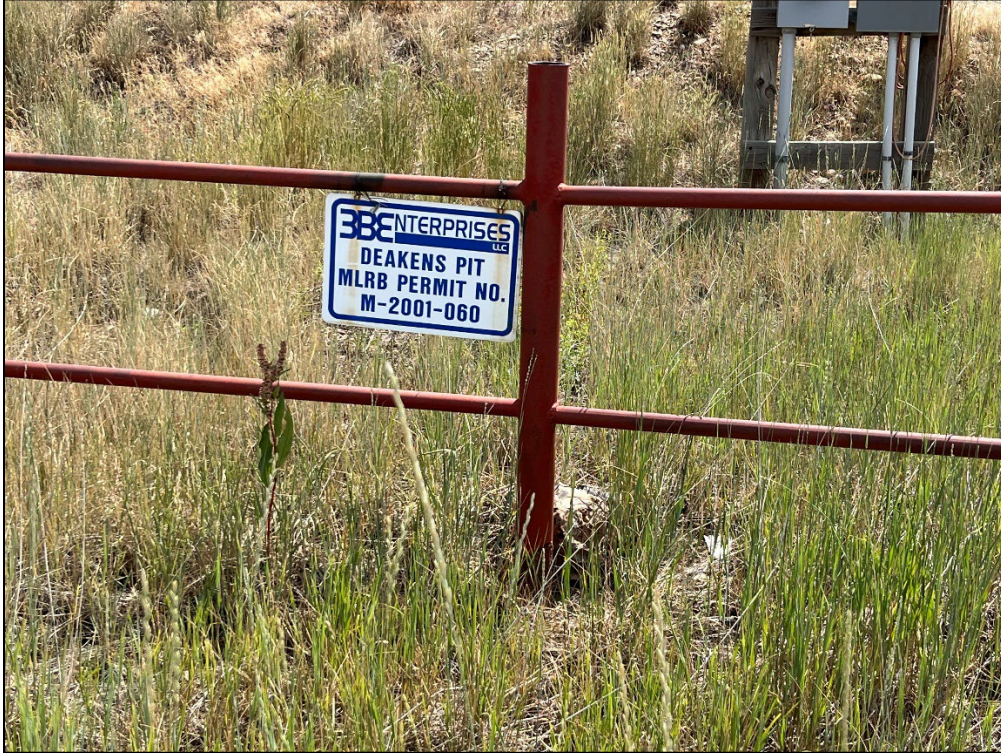
Signs and Markers: The mine identification sign and affected area boundary markers are in place and in compliance with Rule 3.1.12. The sign is located at the entrance of the permit boundary on the east side and includes all information necessary for compliance (Photo 1).

Photo 1: Mine sign located at the eastern permit boundary entrance.

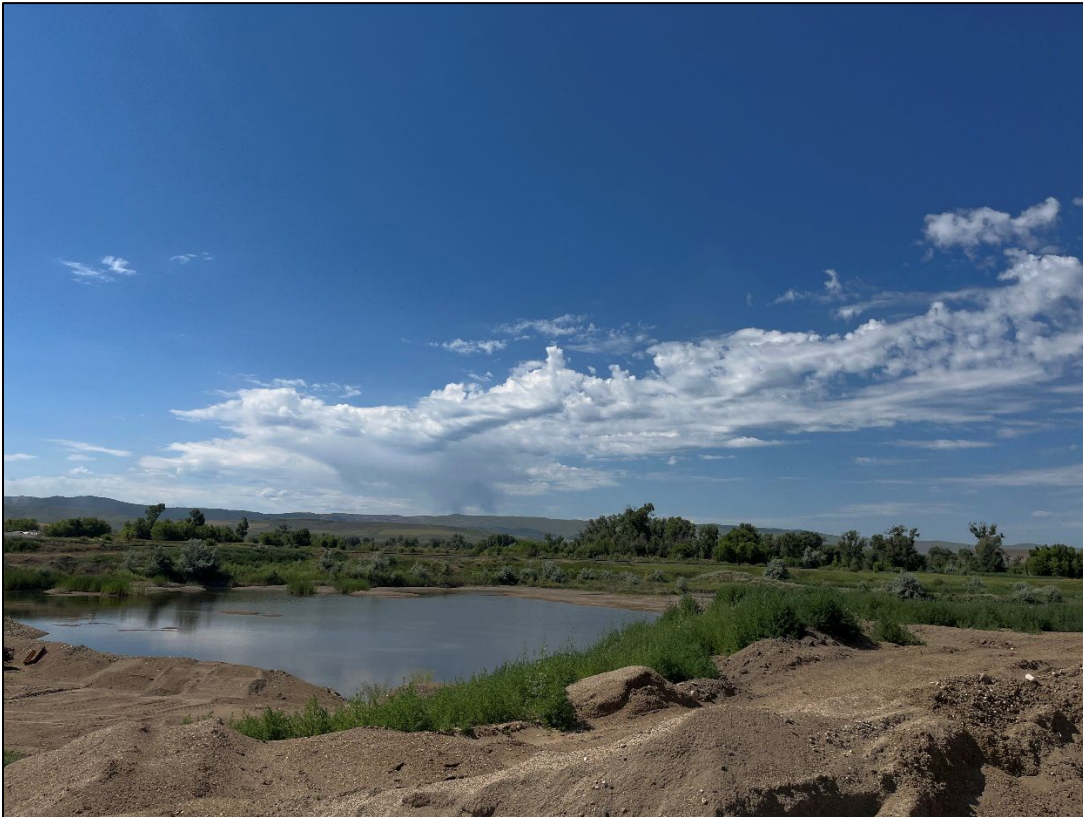
Backfilling and Grading: Backfilling for final reclamation has occurred in limited areas throughout the site. While the post mining land uses for the permit includes industrial use, the predominant use in final reclamation for the site will be a set of recreational ponds. Therefore, much of the excavated areas of the site will be left to fill in with groundwater and minimal backfill will need to occur. Technical Revision 2 (TR-2) was approved in 2017 and allows for the importation of inert fill for backfill material. Partially reclaimed slopes were observed to be in compliance with the requirements of 2:1 to 3:1 grade (Photos 2 and 5).

Photo 2: View south of a partially reclaimed pond ion the East Pit.

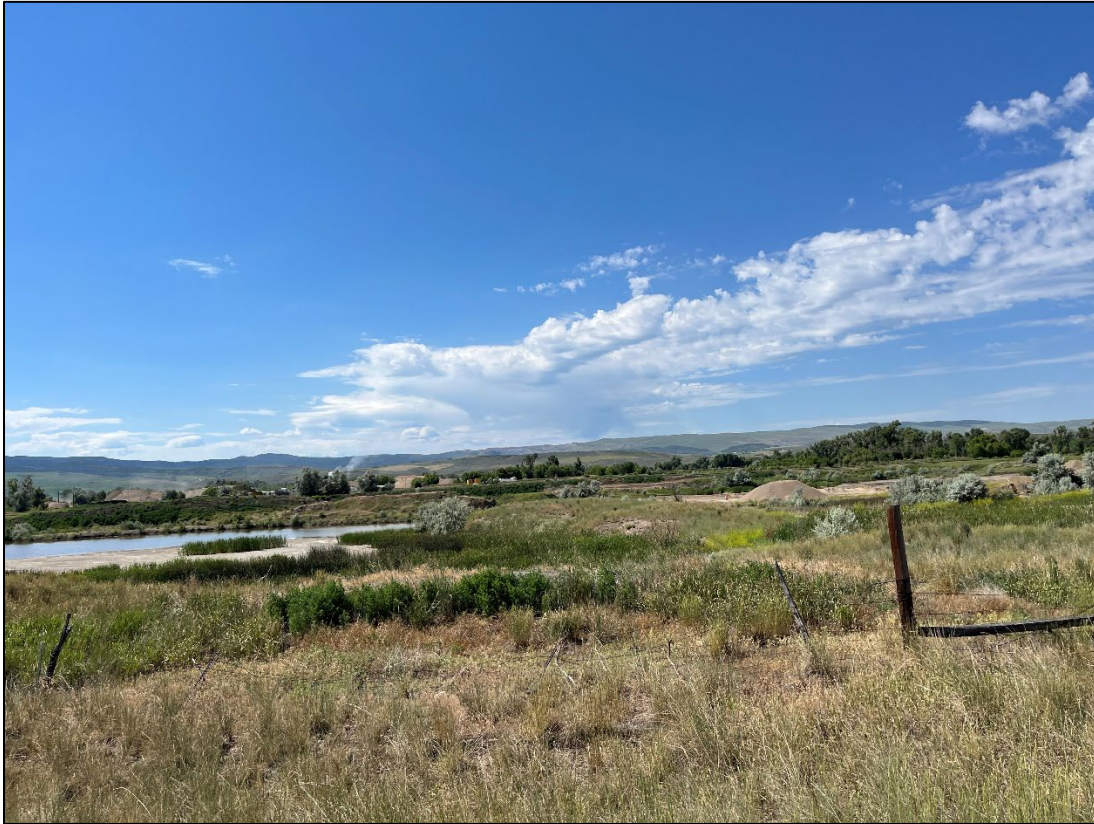
General Mine Plan Compliance: The permit is divided into two pits, the East and West Pit. The two pits are divided by 1st Street. The site was operating at the time of the inspection in the West Pit (Photos 6 and 8) with crushers and screeners. The east pit had no active mining occurring, but multiple stockpiles are located within the pit area (Photo 3). The East Pit still holds material reserves to be mined.

Photo 3: View northwest from the southeast corner of East Pit, stockpiles and a partially reclaimed pond are visible.

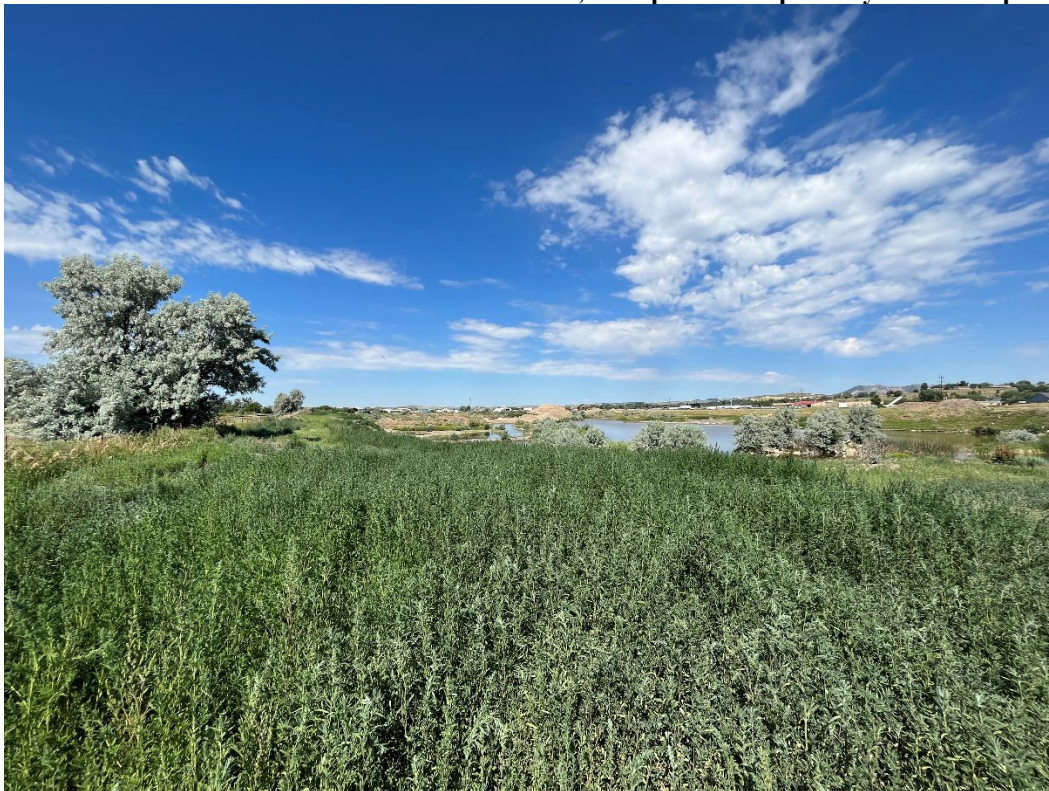
Permit Stipulations: The permit contains one active stipulation which states the following: "Operator will not perform any mining within 200 feet of the railroad prior to obtaining a notarize compensation agreement with the railroad or submitting an engineering evaluation demonstrating that the structure will not be affected, reference 6.3.12." The Operator was found to be in compliance with this stipulation (Photo 4).

Photo 4: View west within the east pit, the railroad line is the to south.

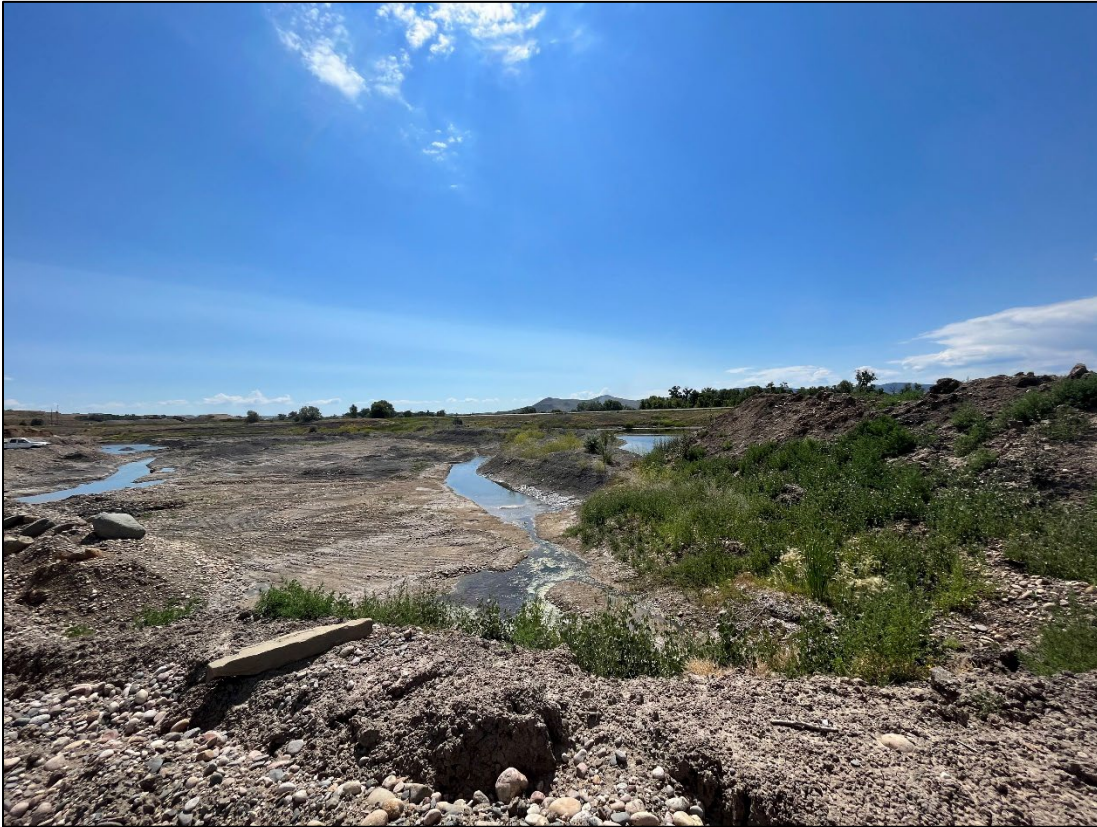
Photo 5: View south of partial reclamation in the West Pit.

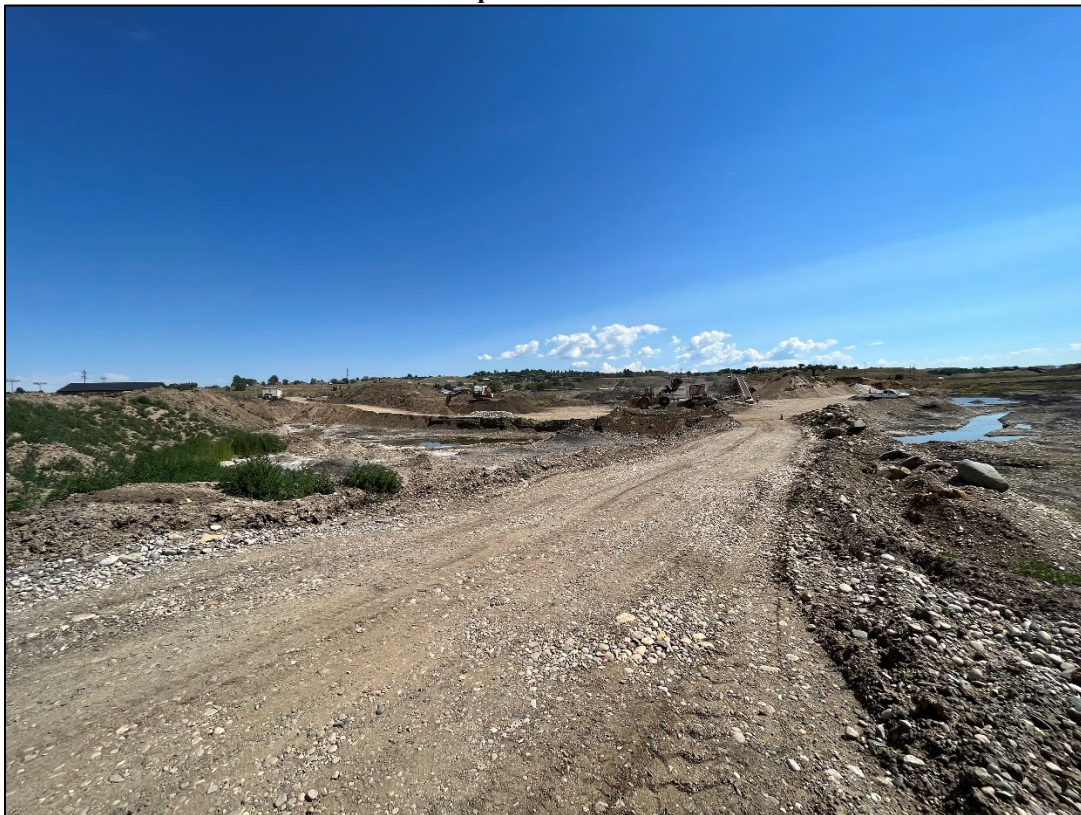
Topsoil: Topsoil piles were observed in both pits adjacent to 1st Street and along the western edge of West Pit (Photos 6 and 7). Piles were vegetated and no issues observed.

Photo 6: View east into the West Pit, vegetated topsoil is to the west.

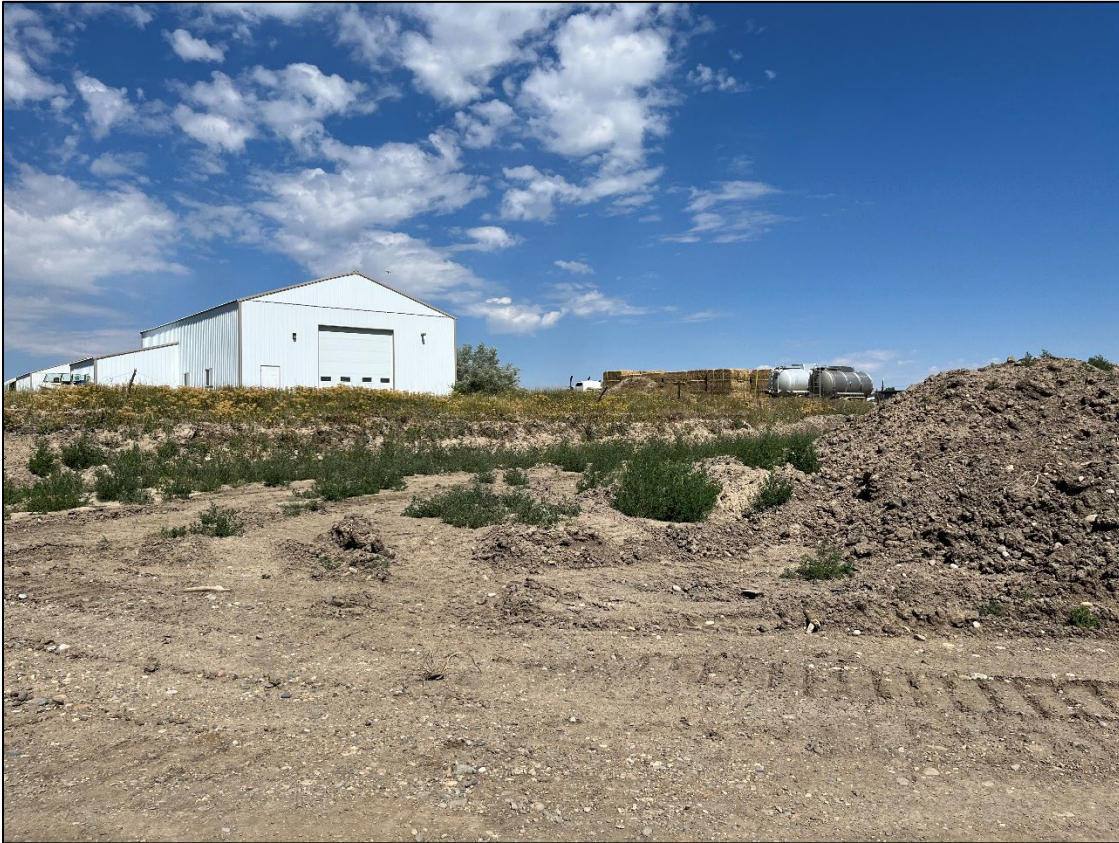
Photo 7: Vegetated topsoil is located along western edge of West pit.

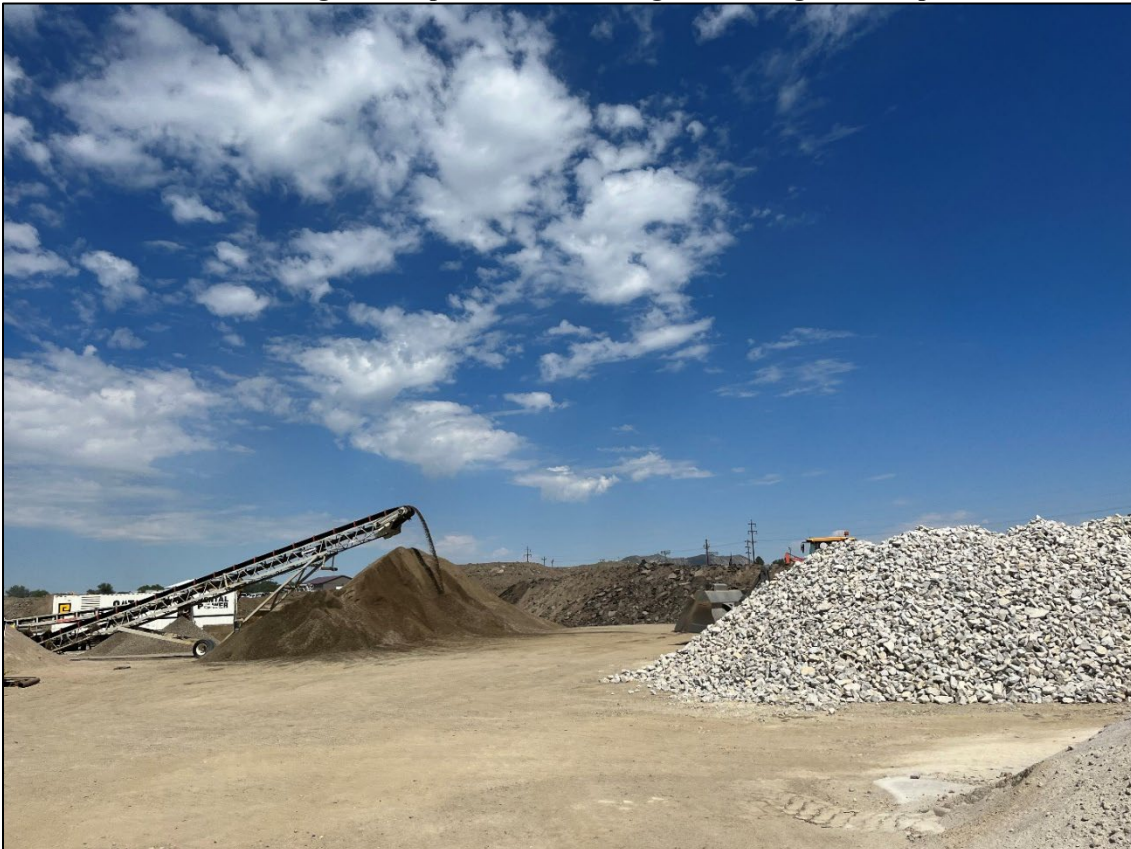
Photo 8: View north of stockpiled materials, active crushing and sorting was occurring at the time of inspection.
