To: Jerald Schnabel  
Castle Aggregate  
File: June 2024 Monitoring Summary

**Reference: June 2024 Geotechnical Monitoring Summary Pikeview Quarry**

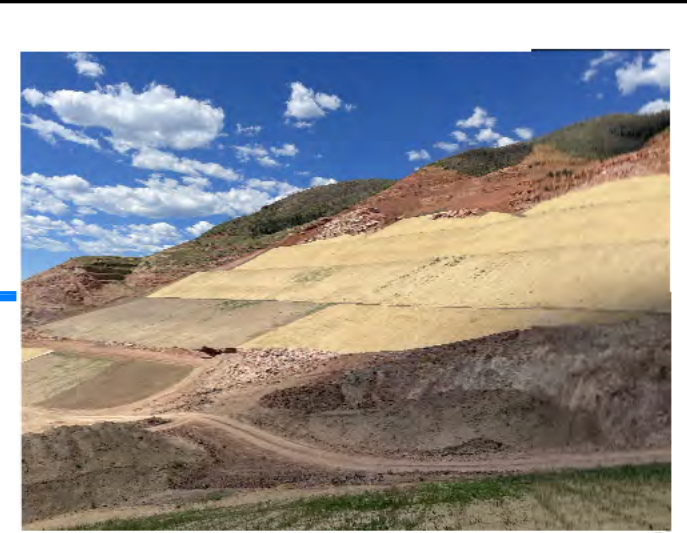
- Cracking was previously observed on the graded slopes near the upper extents of the fill slope. These tension cracks were inspected in June and observed to be similar in nature and extent from previous inspections.

4. CRACKS ON SLOPE THAT ARE HEALING.

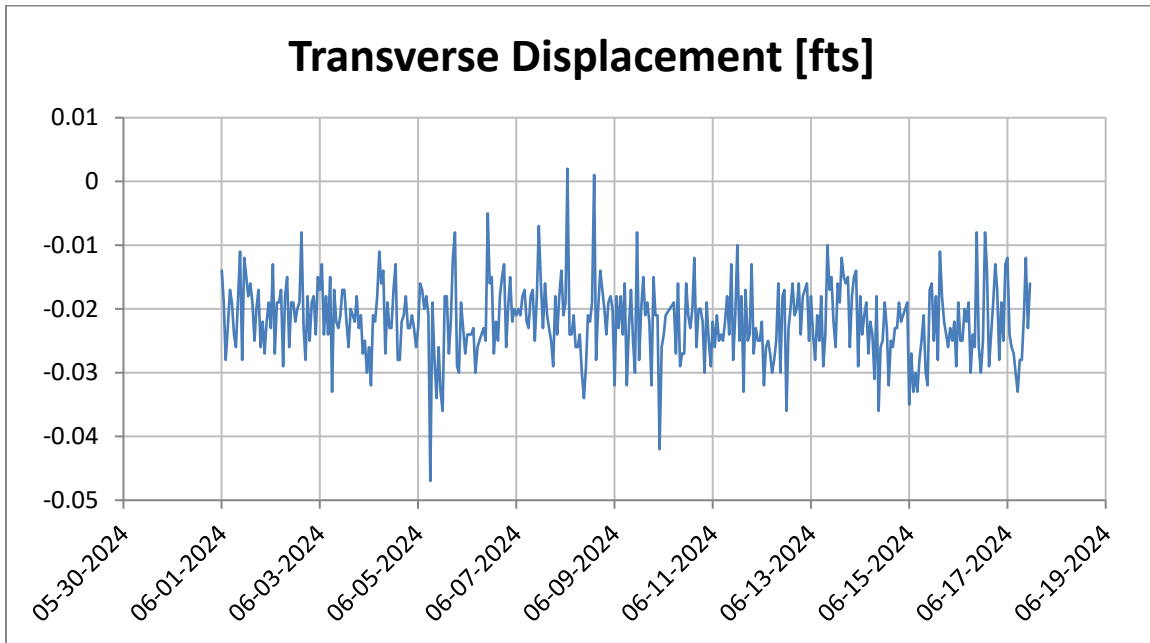
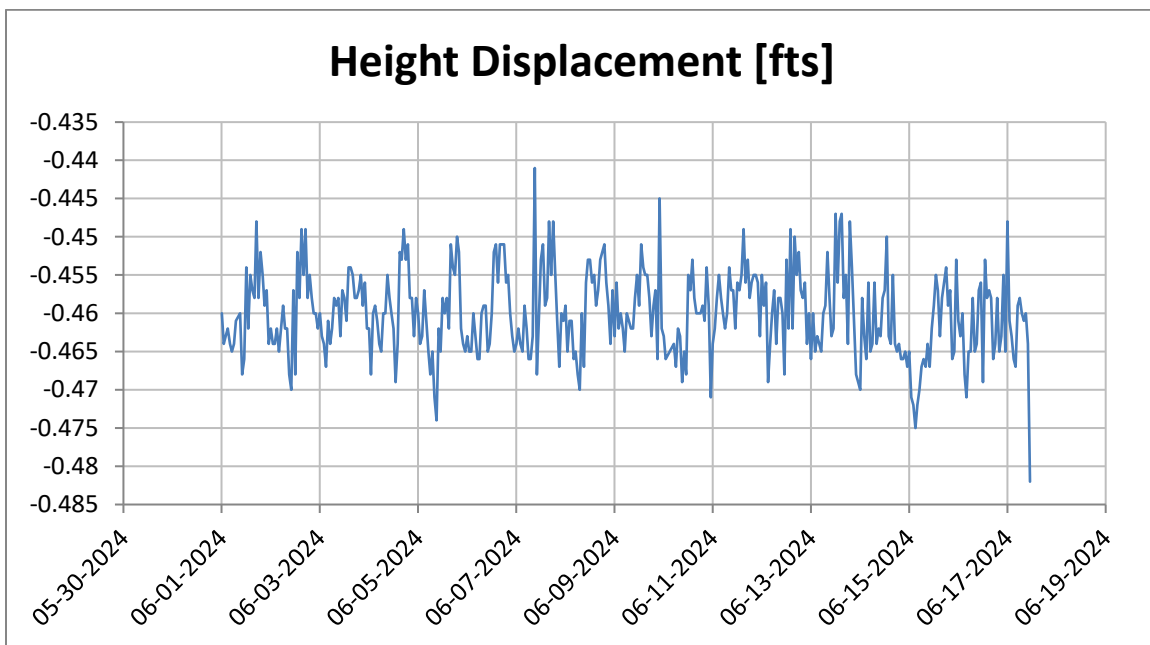
## Prism BR1

| Date(s) | Alert | Cause/Actions taken | Resolved |
|---|--|--|---|
| 17-Jun to 18-Jun | BR1 not found | Prism removed during grading activities | 17-Jun |

1. Survey accuracy is  $\pm 0.016$  feet.
2. Alert threshold is  $\pm 0.35$  feet.
3. Transverse displacement is in the horizontal direction. Positive direction means closer to the robotic total station.
4. Height displacement is in the vertical direction. Positive direction means higher in elevation.
5. Prism previously recorded slope creep movements.
6. Prism replaced by BR4 and was removed on June 17.

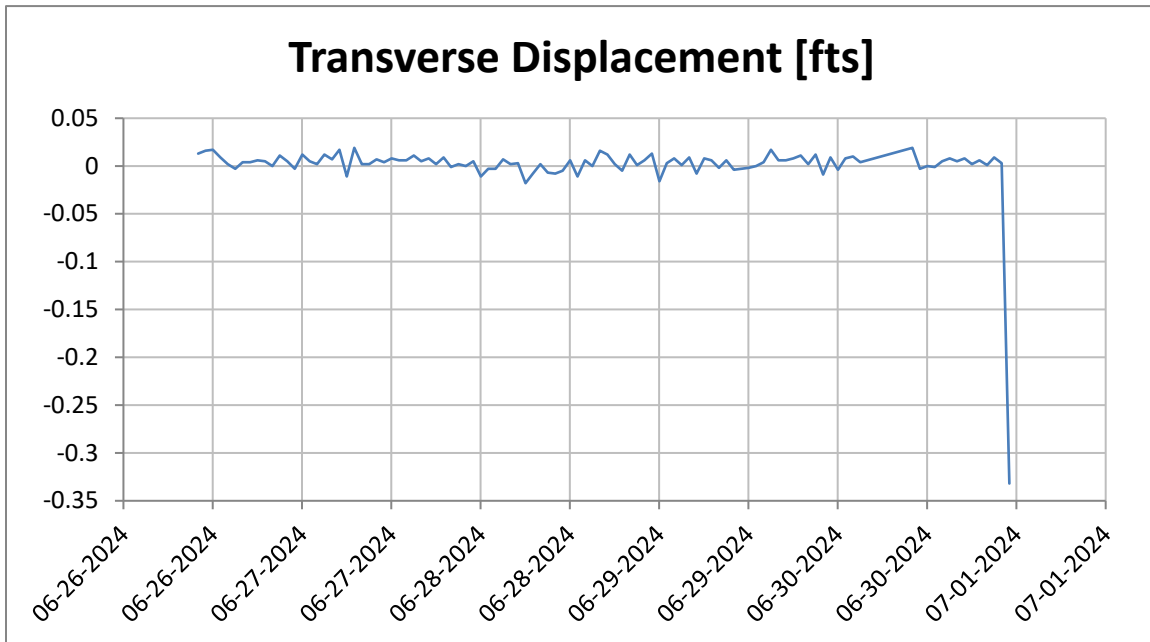
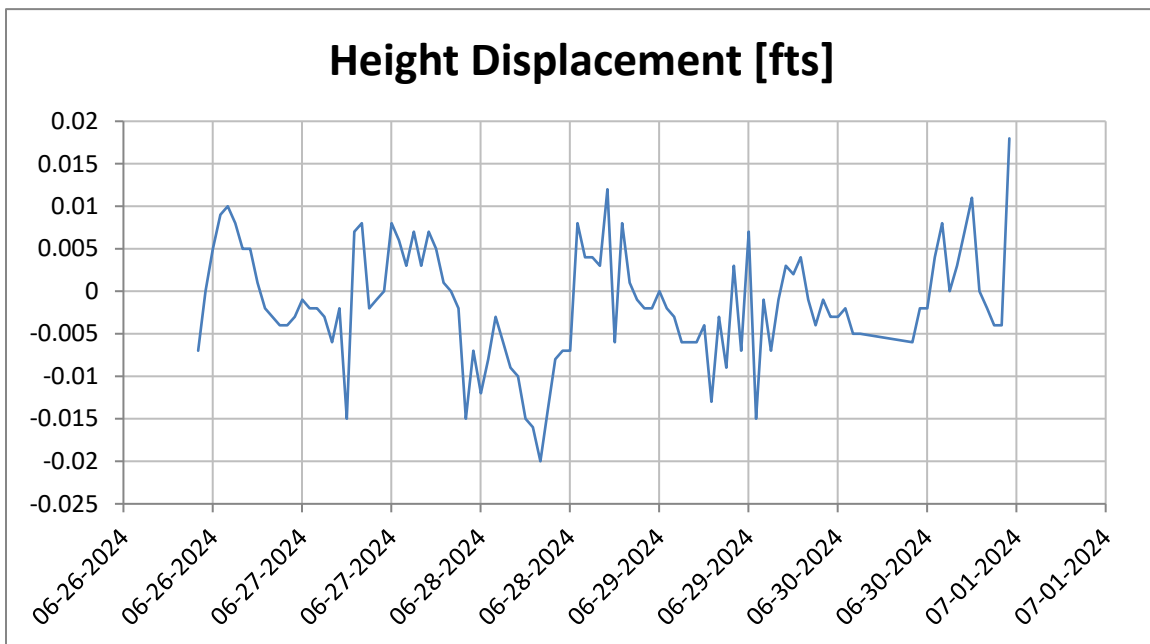
## Prism BR4

1. Survey accuracy is +/-0.016 feet.
2. Alert threshold is +/-0.35 feet.
3. Transverse displacement is in the horizontal direction. Positive direction means closer to the robotic total station.
4. Height displacement is in the vertical direction. Positive direction means higher in elevation.
5. Prism replaced BR1 and was installed on June 26.
6. Rain and fog at end of month caused erroneous readings.

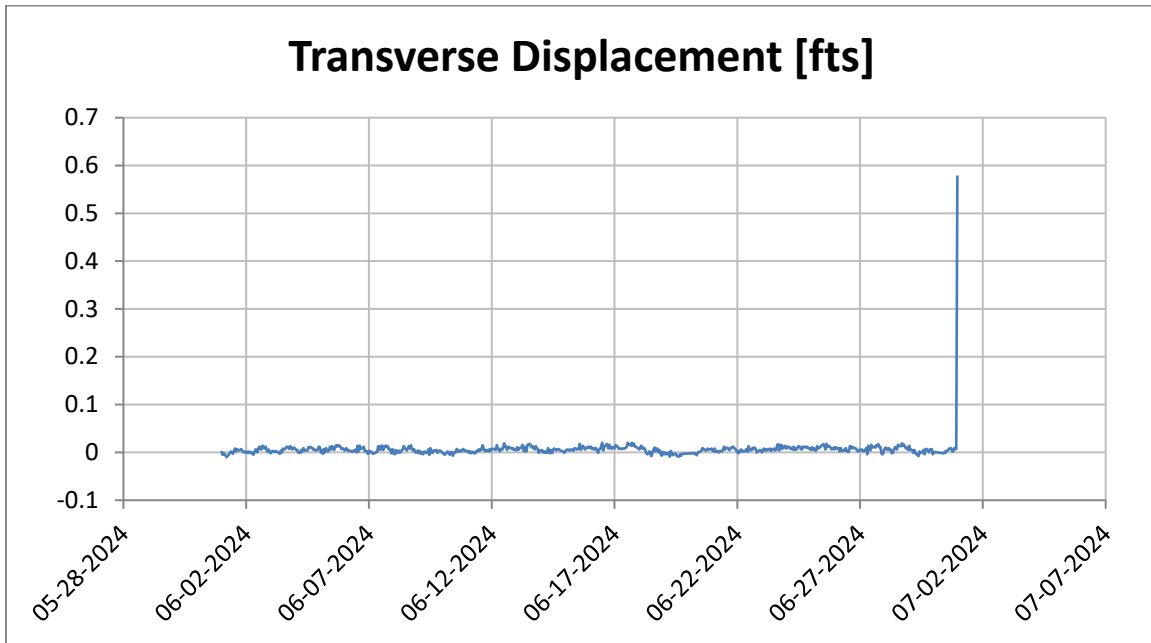
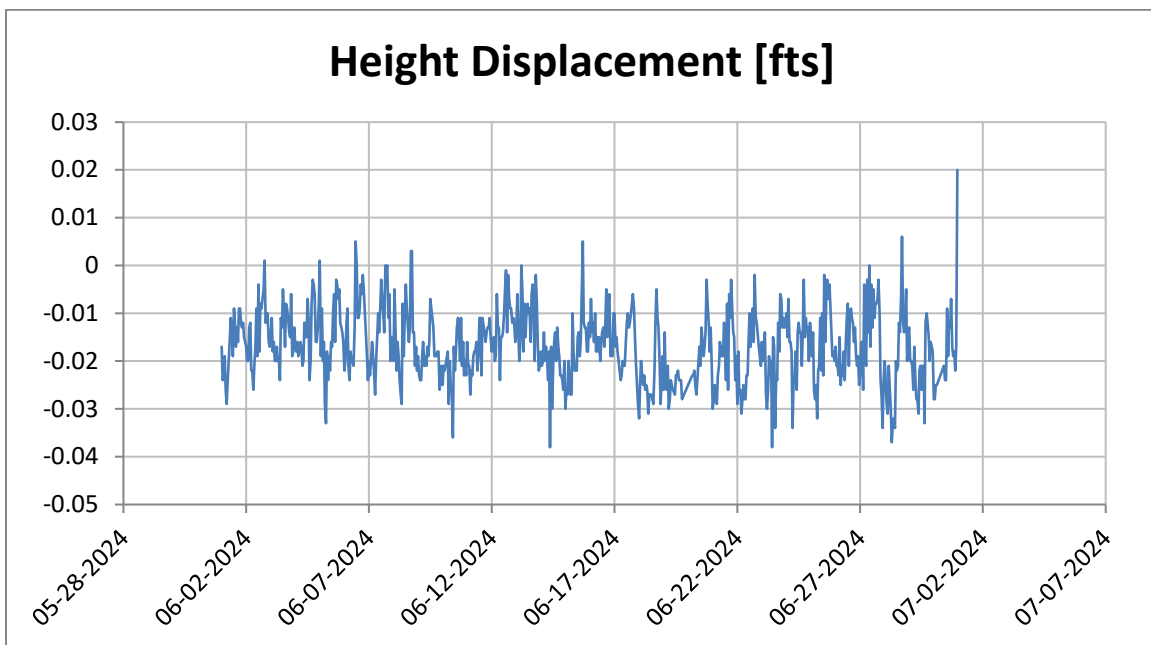
## Prism P5

| Date(s) | Alert | Cause/Actions taken | Resolved |
|---|--|--|---|
| 30-Jun to 1-Jul | P5 regression limits | Rain and fog. No work being performed at time of alerts. Readings in positive and negative directions. | 1-Jul |

1. Survey accuracy is  $\pm 0.016$  feet.
2. Alert threshold is  $\pm 0.35$  feet.
3. Transverse displacement is in the horizontal direction. Positive direction means closer to the robotic total station.
4. Height displacement is in the vertical direction. Positive direction means higher in elevation.
5. Rain and fog at end of month caused erroneous readings and regression limit alerts.

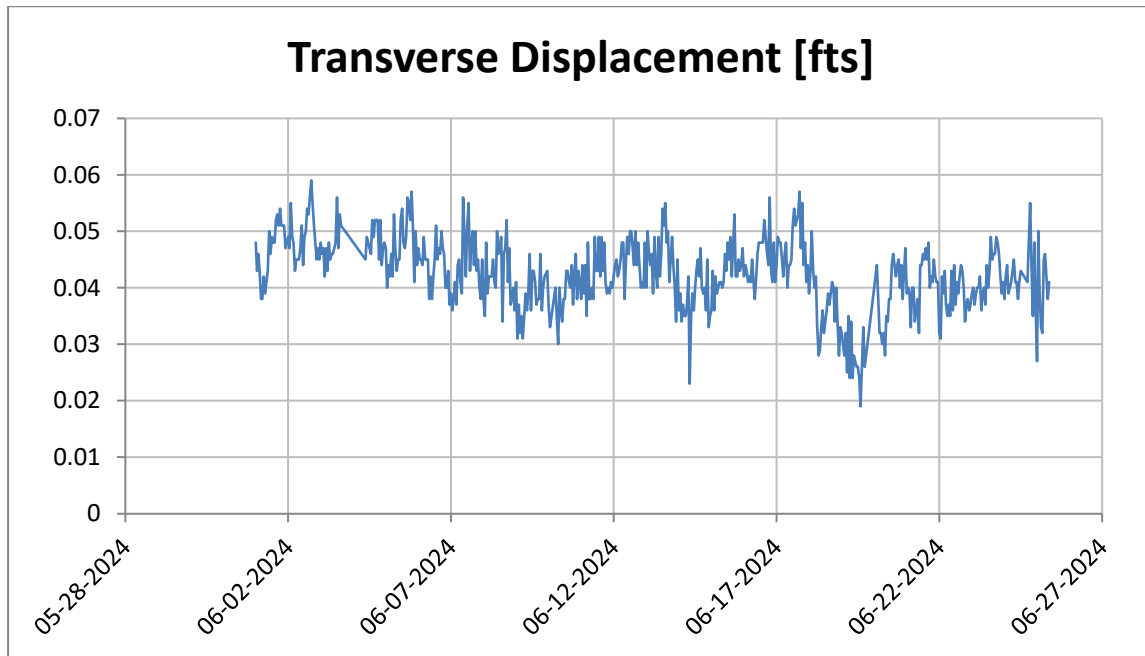
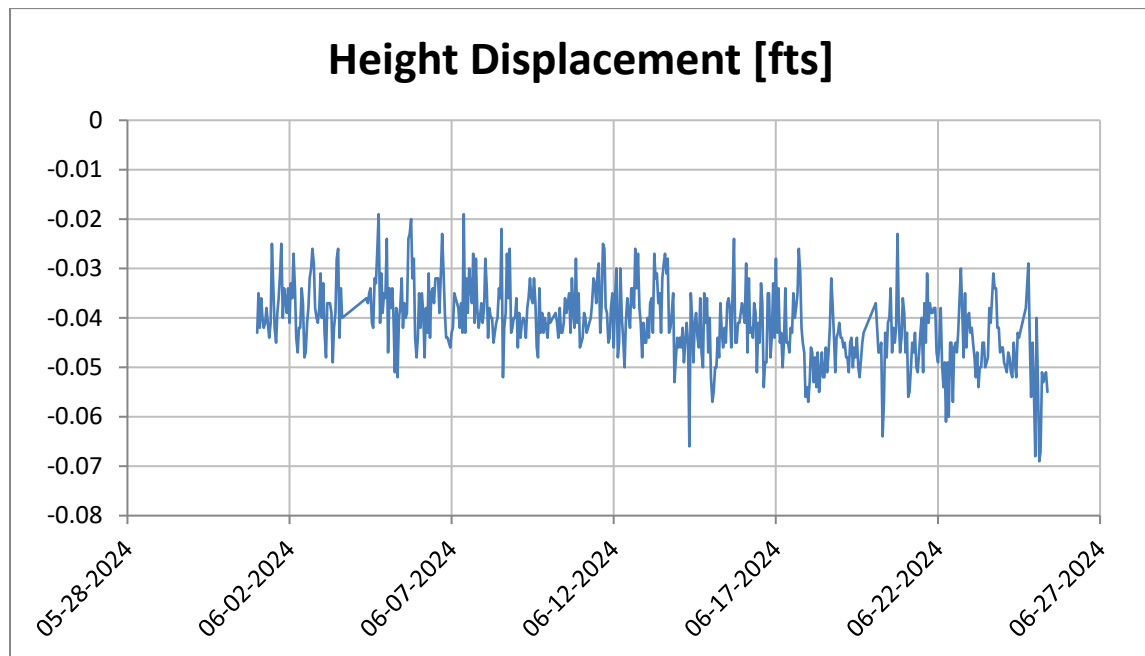
## Prism P70

| Date(s) | Alert | Cause/Actions taken | Resolved |
|---|--|--|---|
| 25-Jun to 26-Jun | P70 communication errors and point not found | Equipment operations in area. Fill being moved down to buttress. | 26-Jun |

1. Survey accuracy is  $\pm 0.016$  feet.
2. Alert threshold is  $\pm 0.35$  feet.
3. Transverse displacement is in the horizontal direction. Positive direction means closer to the robotic total station.
4. Height displacement is in the vertical direction. Positive direction means higher in elevation.
5. Prism removed on June 25.
