MINERALS PROGRAM INSPECTION REPORT
PHONE: (303) 866-3567

MINE NAME: Pikeview Quarry	MINE/PROSPECTING ID#: M-1977-211	MINERAL: Limestone (general), granite gneiss and do	COUNTY: El Paso
INSPECTION TYPE: Monitoring	WEATHER: Clear	INSP. DATE: June 25, 2024	INSP. TIME: 10:00
OPERATOR: Riverbend Industries Inc.	OPERATOR REPRESENTATIVE: Jerry Schnabel	TYPE OF OPERATION: 112c - Construction Regular Operation	
REASON FOR INSPECTION: Normal I&E Program	BOND CALCULATION TYPE: None	BOND AMOUNT: \$13,389,784.00	
DATE OF COMPLAINT: NA	POST INSP. CONTACTS: None	JOINT INSP. AGENCY: None	
INSPECTOR(S): Hunter Ridley	INSPECTOR'S SIGNATURE:

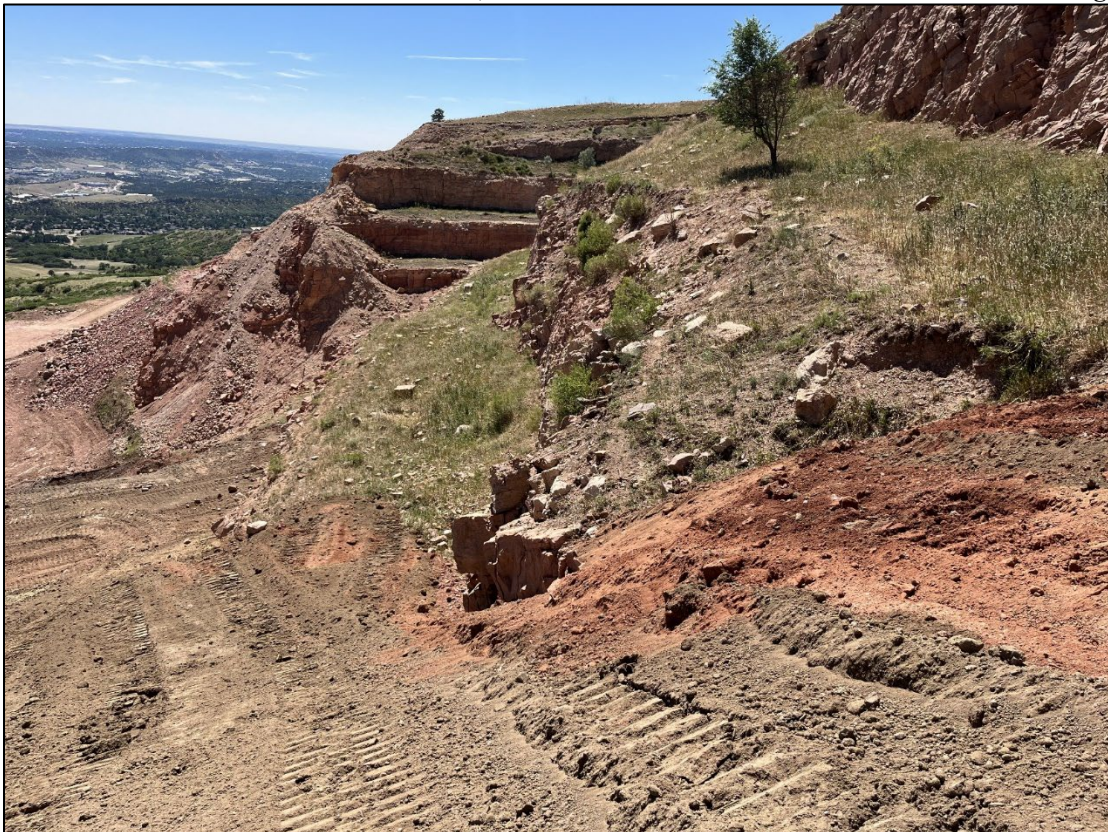
All major earthwork is complete at the site. All placed backfill continues to be tested for compaction in accordance with the approved specifications. All equipment associated with the earthwork contractor has been removed from the site. Only a few, smaller pieces of equipment remain onsite for use in revegetation and minimal earth and material moving work. These activities include topsoiling slopes (Photo 3 and 7), buttressing the BFR area using material excavated from drainage channels (Photo 8), placing rip rap (Photos 11 and 12), and regrading tie-in areas on the completed slopes (Photo 9). Material has been removed from the BFR to reduce weight on the slope. This material was then transferred to the bottom of the BFR and used as an additional buttress for the rock feature (Photo 8). The 2H:1V slope along and under the BFR area has been adjusted slightly for field conditions. The southern tie-in area will require minor scaling of looser rock material to ensure stability of this area before topsoiling and matting can occur (Photo 9).

Photo 9: Area of new slope tie-in to old reclamation benches, minimal scaling will be done to improve structural integrity at the edges of this tie in.

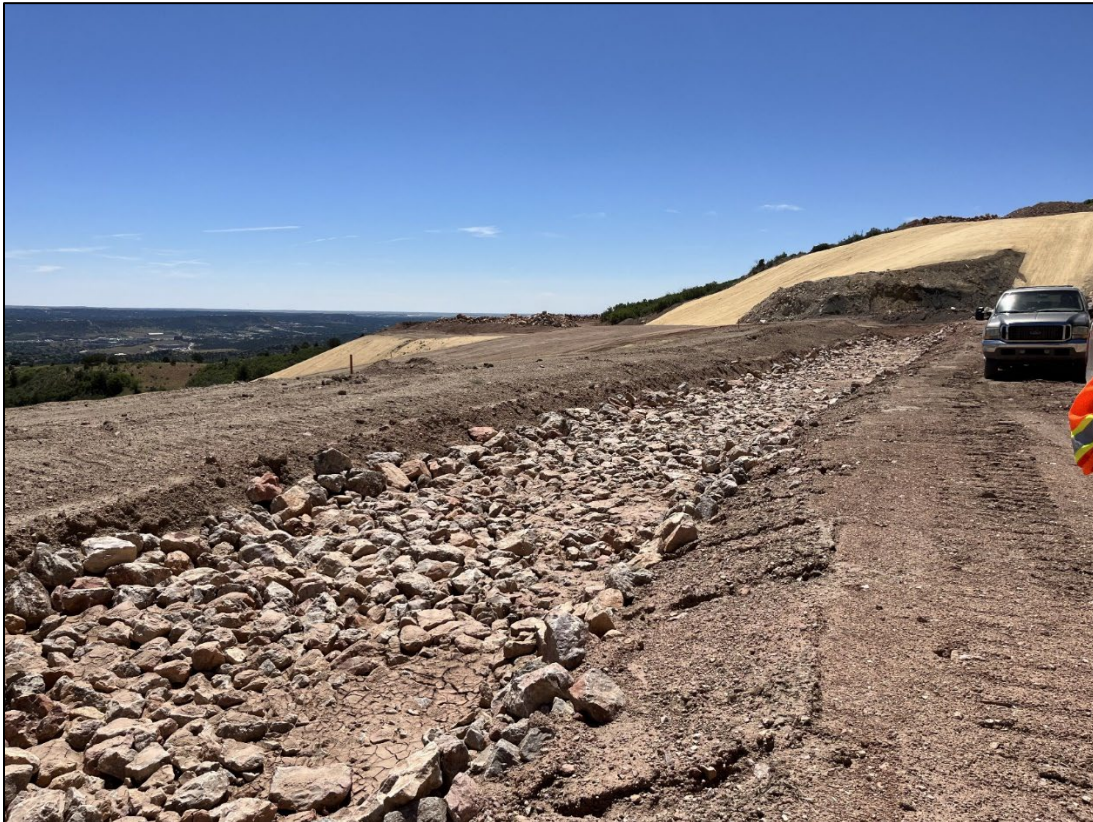
Photo 11: Rip rapping of channels has begun on the lower bench.
