C-1981-035 July Partial Inspection Report

PERMIT INFORMATION

Permit Number: C-1981-035 Mine Name: King Coal Mine Operator: GCC Energy, LLC Operator Address: Mr Jordan McCourt 6473 County Road 120 Hesperus, CO 81326	County: La Plata Operation Type: Underground Permit Status: Active Ownership: Private
	Operator Representative Present: Jordan McCourt
Operator Representative Signature: (Field Issuance Only)

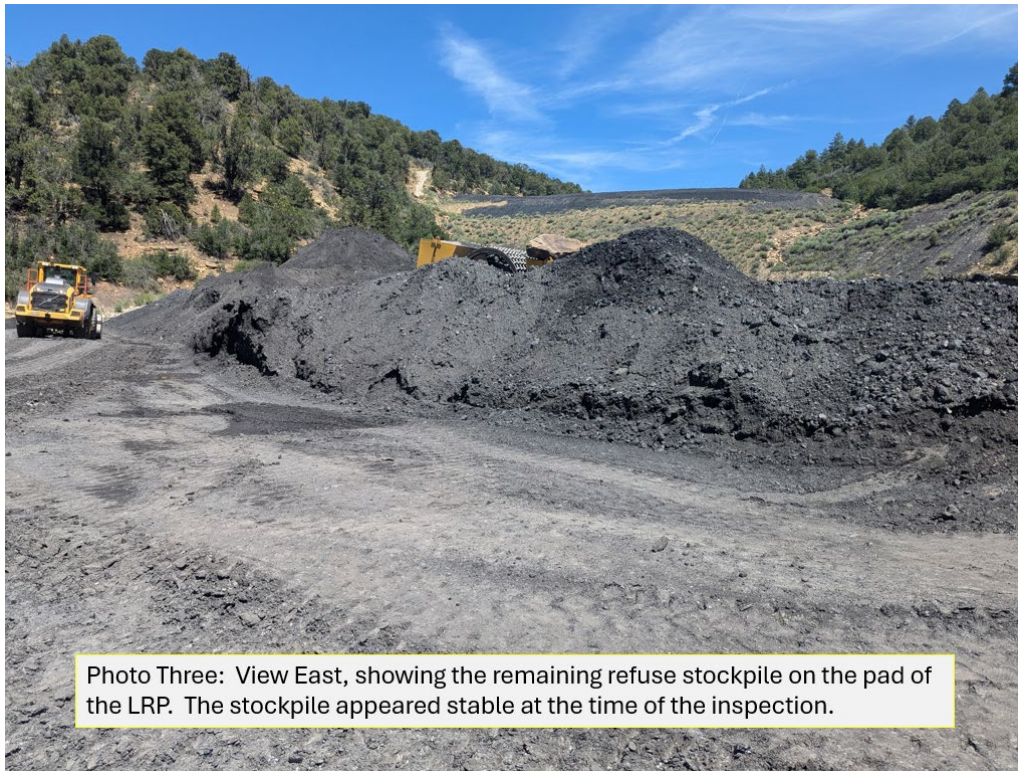
Photo Three: View East, showing the remaining refuse stockpile on the pad of the LRP. The stockpile appeared stable at the time of the inspection.

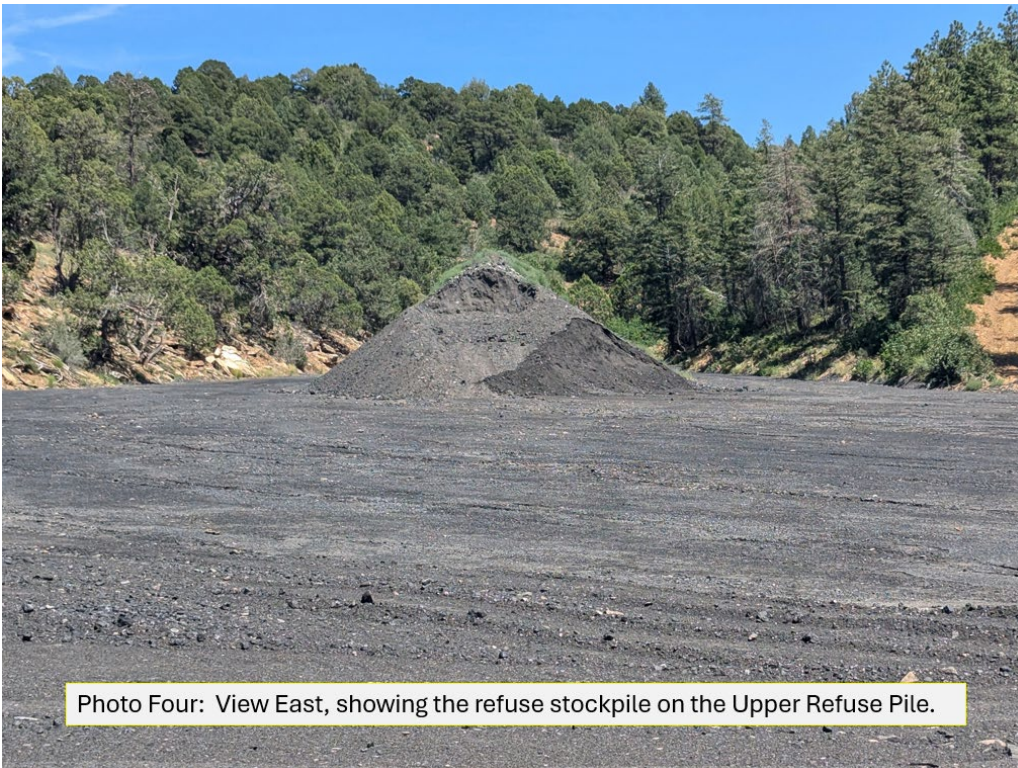
material near the top of the pad was observed and in good condition. No evidence of erosion or material transport was noted. The stockpile can be seen in Photo Four. The pad is also in good condition, appears to be properly compacted and exhibits positive drainage. The pad can be seen in Photo Five. During the Division's previous inspection, some small erosional features were noted near the Southwest shoulder of the URP and the Operator was advised to monitor the features. The Operator elected to go ahead and grade them out and repair the area, and no new erosion was noted. The repairs are in excellent condition and can be seen in Photo Six.

Photo Four: View East, showing the refuse stockpile on the Upper Refuse Pile.

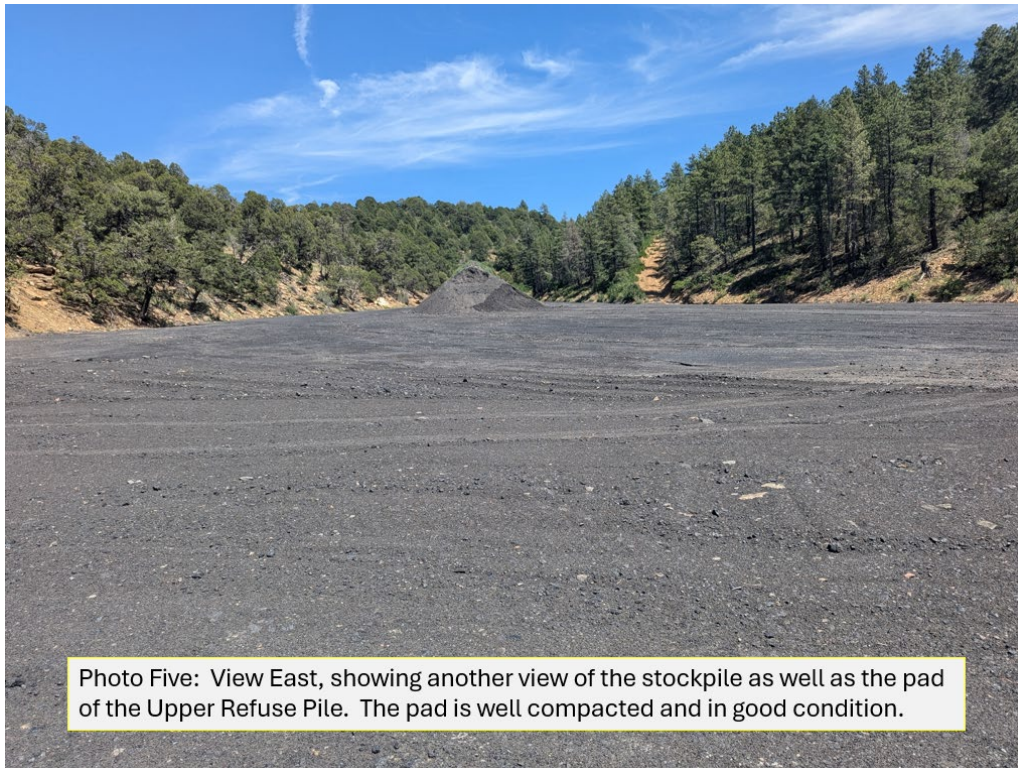
Photo Five: View East, showing another view of the stockpile as well as the pad of the Upper Refuse Pile. The pad is well compacted and in good condition.

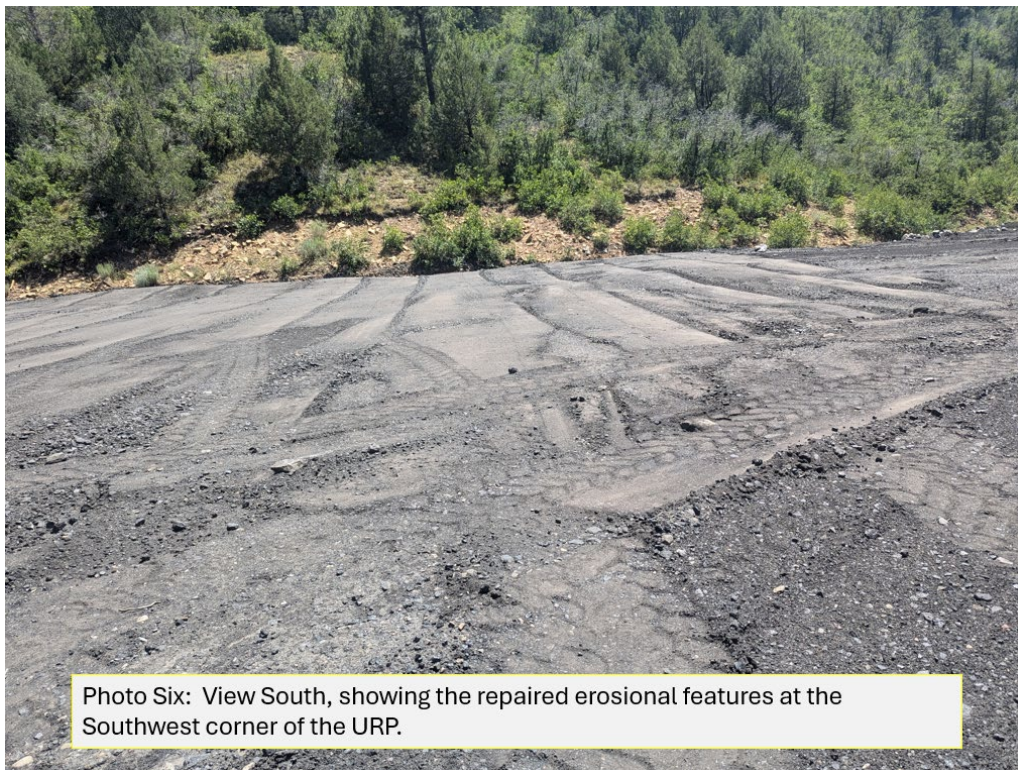
Photo Six: View South, showing the repaired erosional features at the Southwest corner of the URP.

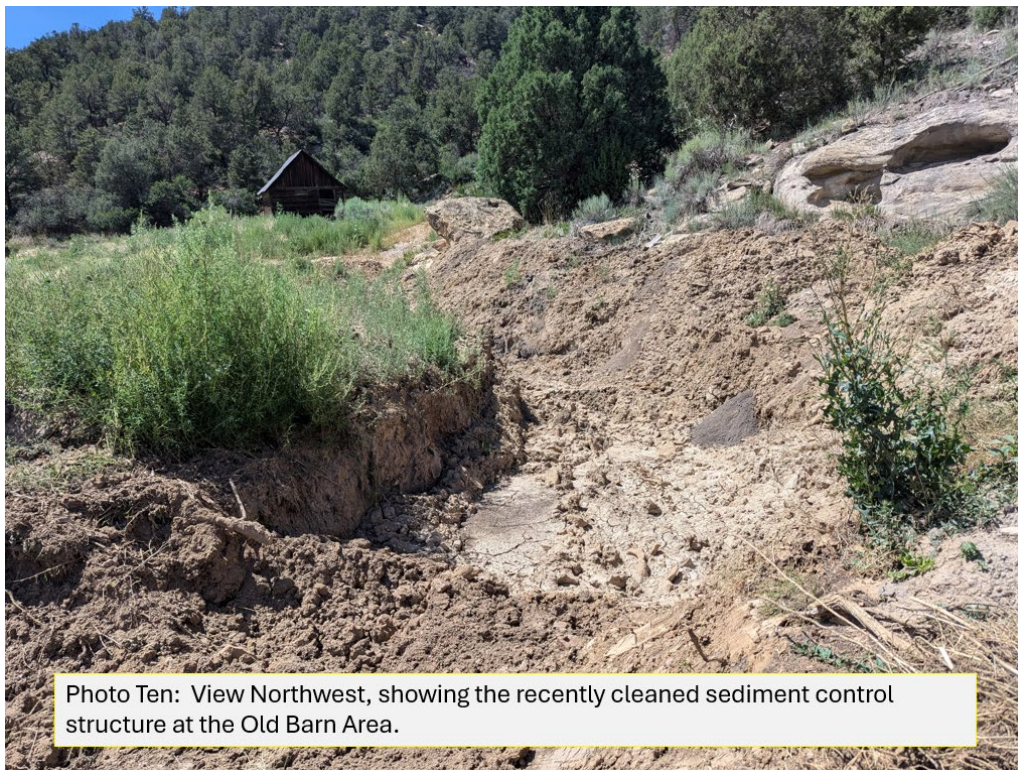
Recently, the area has seen significant localized rain events. The result of one such event caused significant flows and sedimentation to impact the sediment control structure at the Old Barn Area. Evidence of high flow and sedimentation was observed, that overwhelmed the structure, topping the silt fence and spreading across the road. In the time since the rain event, the operator has repaired the sediment control structure and re-installed the silt fence on the downstream side. All material that made its way to the road has been cleaned up and removed. The sediment control structure, silt fence and road can be seen in Photos Ten through Twelve. The Operator has done an exemplary job of conducting the repairs and this is not considered a problem at this time.

Photo Ten: View Northwest, showing the recently cleaned sediment control structure at the Old Barn Area.
