## QUARTERLY SEDIMENTATION POND INSPECTION REPORT

Mine: Lorencito

Inspection Period: Second Quarter 2024

Inspection Date: 06/13/24

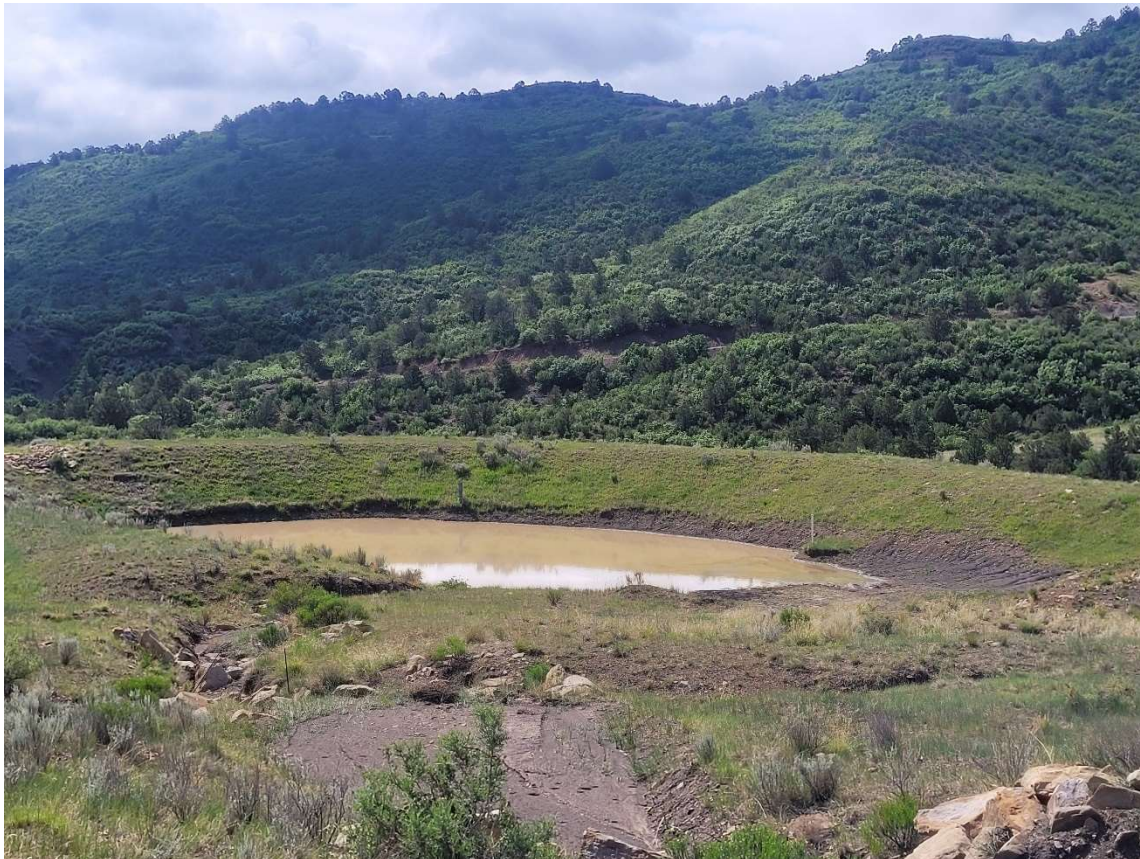
NPDES ID. No.: Pond #6

Pond was holding water at time of inspection, not near the bottom of the decant. Bank was stable during inspection.
