**MINERALS PROGRAM INSPECTION REPORT**  
**PHONE: (303) 866-3567**

<b>MINE NAME:</b> Pikeview Quarry	<b>MINE/PROSPECTING ID#:</b> M-1977-211	<b>MINERAL:</b> Limestone (general), granite gneiss and do	<b>COUNTY:</b> El Paso
<b>INSPECTION TYPE:</b> Monitoring	<b>WEATHER:</b> Clear	<b>INSP. DATE:</b> July 30, 2024	<b>INSP. TIME:</b> 10:00
<b>OPERATOR:</b> Riverbend Industries Inc.	<b>OPERATOR REPRESENTATIVE:</b> Jerry Schnabel	<b>TYPE OF OPERATION:</b> 112c - Construction Regular Operation	
<b>REASON FOR INSPECTION:</b> Normal I&E Program	<b>BOND CALCULATION TYPE:</b> None	<b>BOND AMOUNT:</b> \$6,805,607.00	
<b>DATE OF COMPLAINT:</b> NA	<b>POST INSP. CONTACTS:</b> None	<b>JOINT INSP. AGENCY:</b> None	
<b>INSPECTOR(S):</b> Hunter Ridley	<b>INSPECTOR'S SIGNATURE:</b>

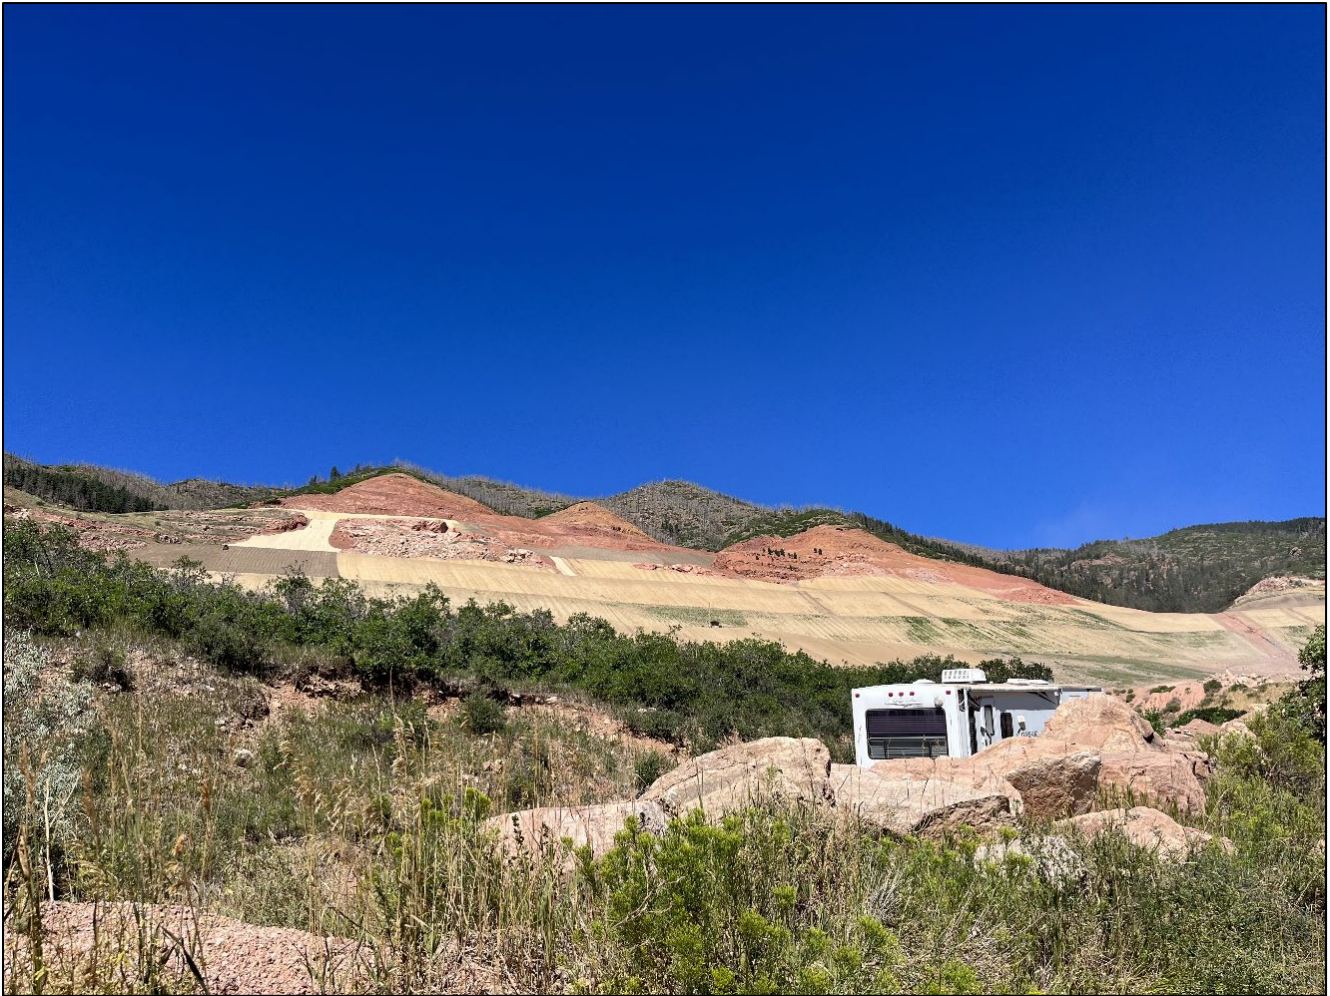
Slopes at final grade are being topsoiled, seeded, and matted and revegetation efforts are being closely monitored by staff on site (Photos 1, 2 and 12). This includes the tension crack area noted in previous inspections and in geotechnical reports (Photo 3).

Recent vegetation growth was observed across the main buttress portion of the site (Photos 1 and 12). Growth in this area appeared to be supporting multiple species of grasses and transplanted shrubs. Vegetation in the northern portion of the property continues to green, though may require additional seeding as stated above (Photos 2 and 3). Weeds currently being treated at the site include a List A noxious weed species, Myrtle spurge along with common knapweed, thistle, toadflax, and mullein.

**Photo 1: Overview of progress on main, east facing slope.**

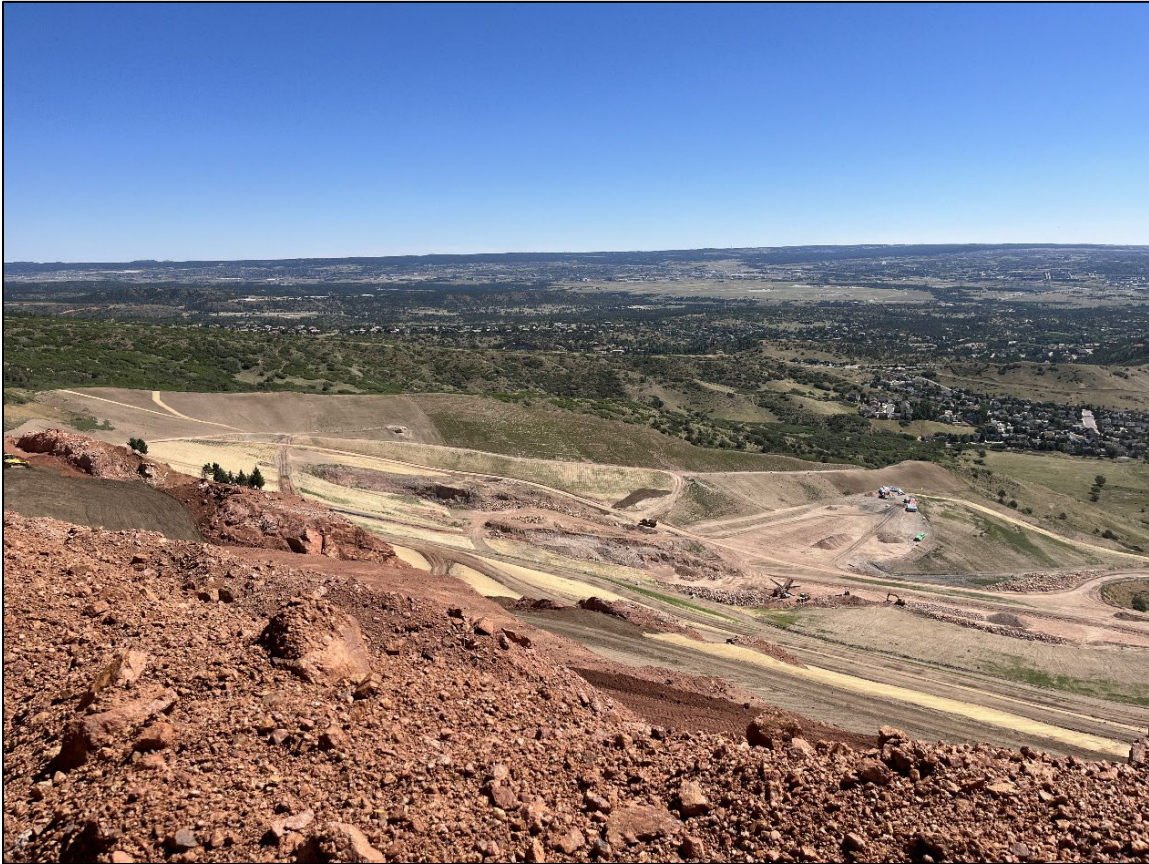
**Photo 2: View northeast of shop area, Colorado Springs owned property, and Dragons Back area.**

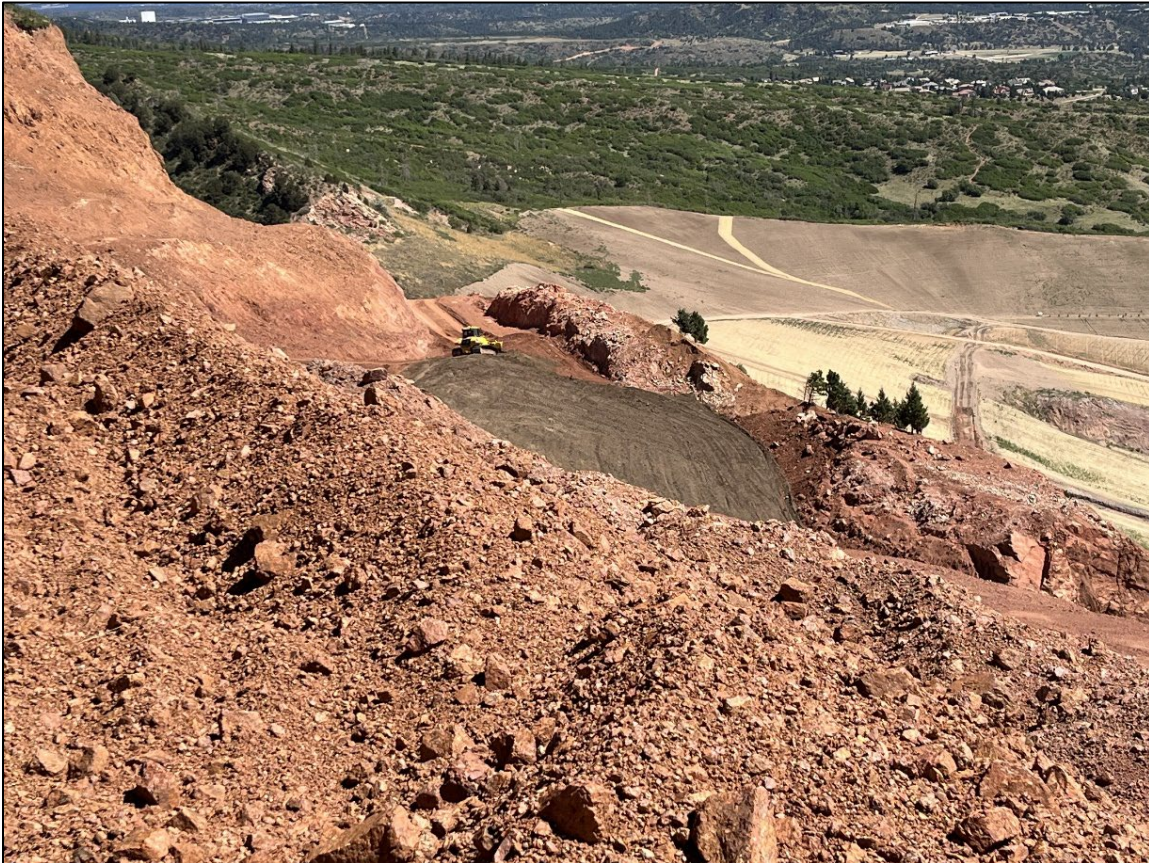
**Photo 3: View of tension crack area, recently topsoiled.**

The previously removed BFR prisms (BR1 and BR3) have been reinstalled. Several prisms are planned to be added to the site. Two additional prisms will be installed in the tension crack area (Photo 3), perpendicular to the cracks and located above and below the crack area to monitor movement during final reclamation. No visual movement of these cracks was observed before topsoiling occurred. Should the movement of these prisms continue to be minimal in over time, the Division has no major concern for slope stability. Another rock bolted prism is planned to be added to the middle peak to monitor potential movement in final reclamation (Photo 4). Site representatives are set to meet with City officials in early August to discuss the permanency of both the prisms and the office area at the site after full and final release from the Division's jurisdiction.

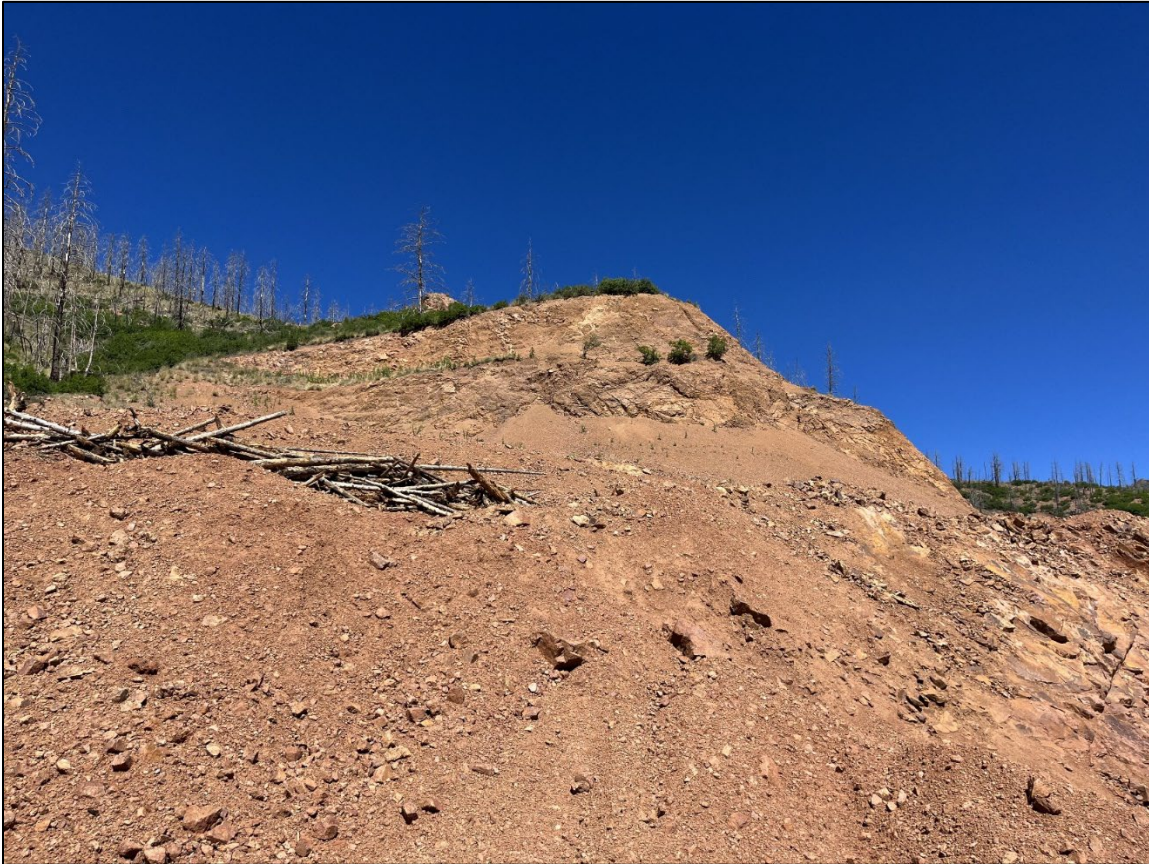
**Photo 4: View west of the upper middle peak area, trees will be used as erosion control.**

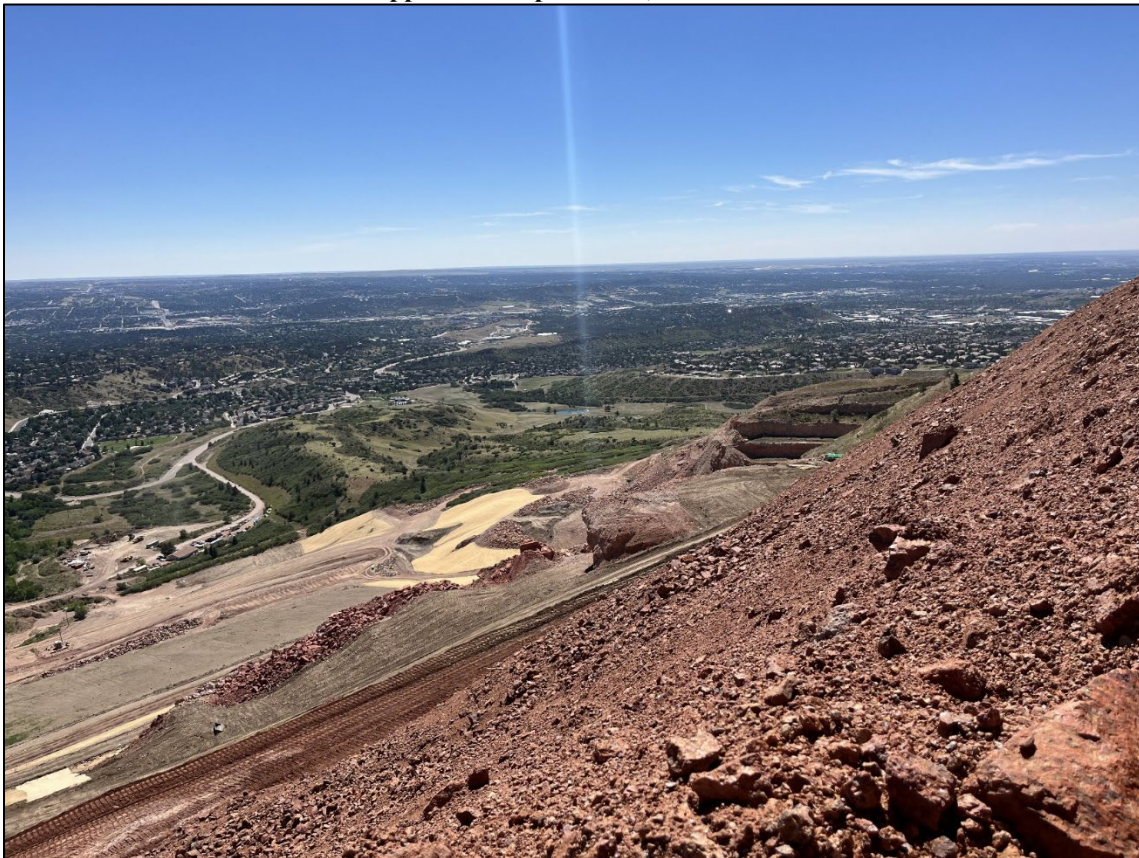
**Photo 5: View southeast of backfilled BFR area.**

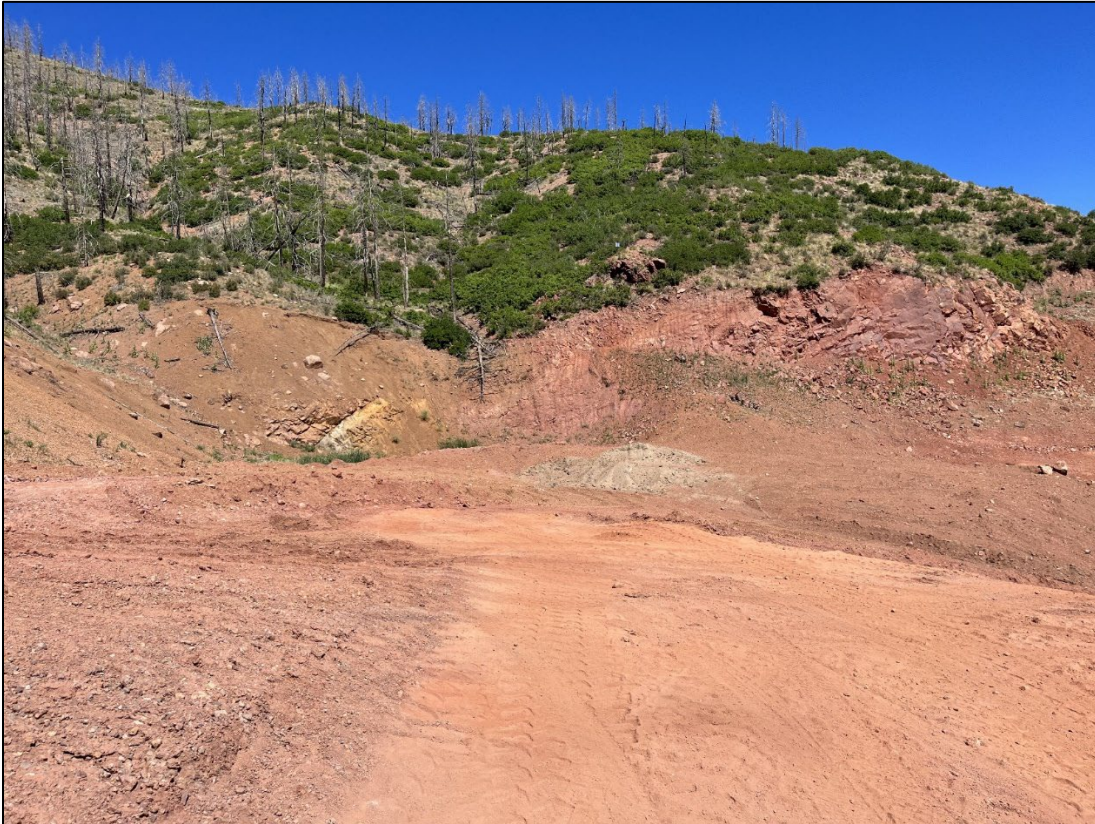
**Photo 6: View north of the 'sheep pond' area, if this feature remains it will be moved off Forest Service property.**

- Action will need to be taken to address the small impoundment of water near the western peaks

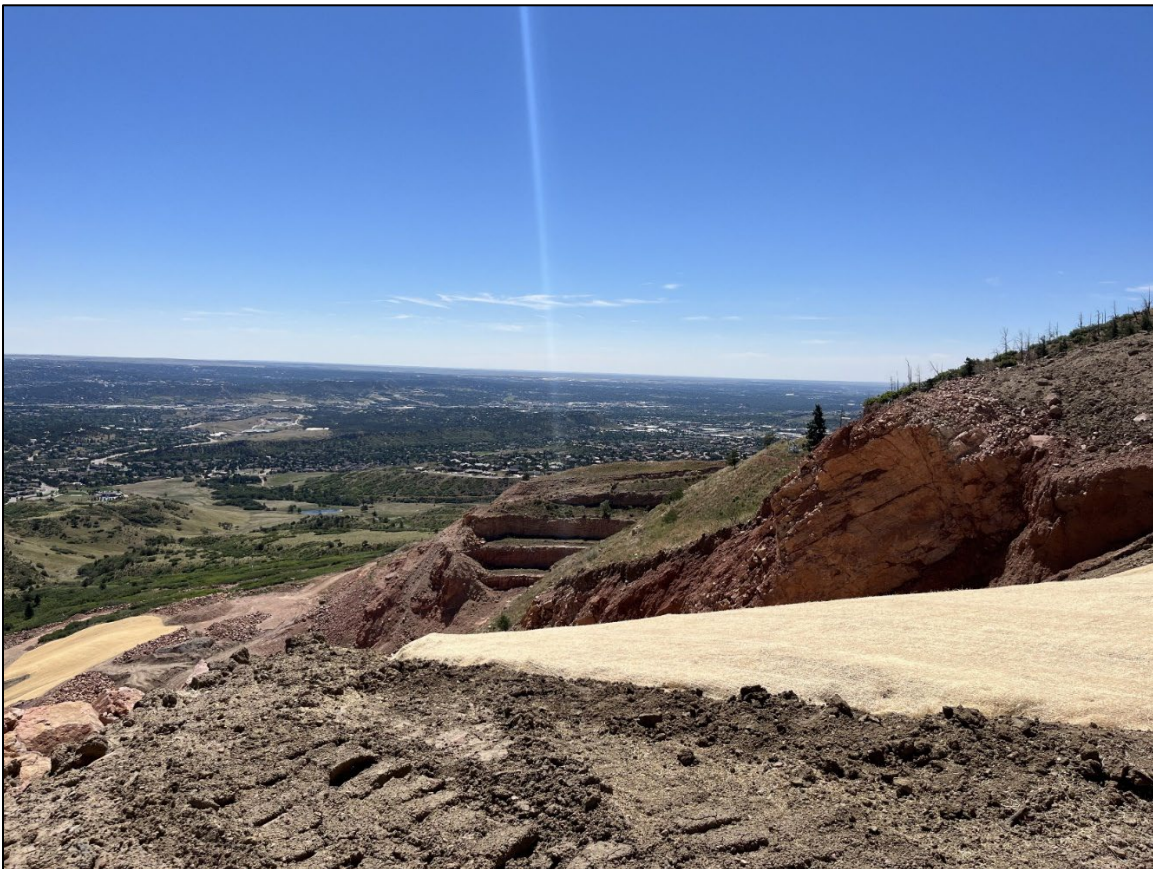
**Photo 7: BFR tie-in area and 2H:1V slope above the 7500 prism series.**

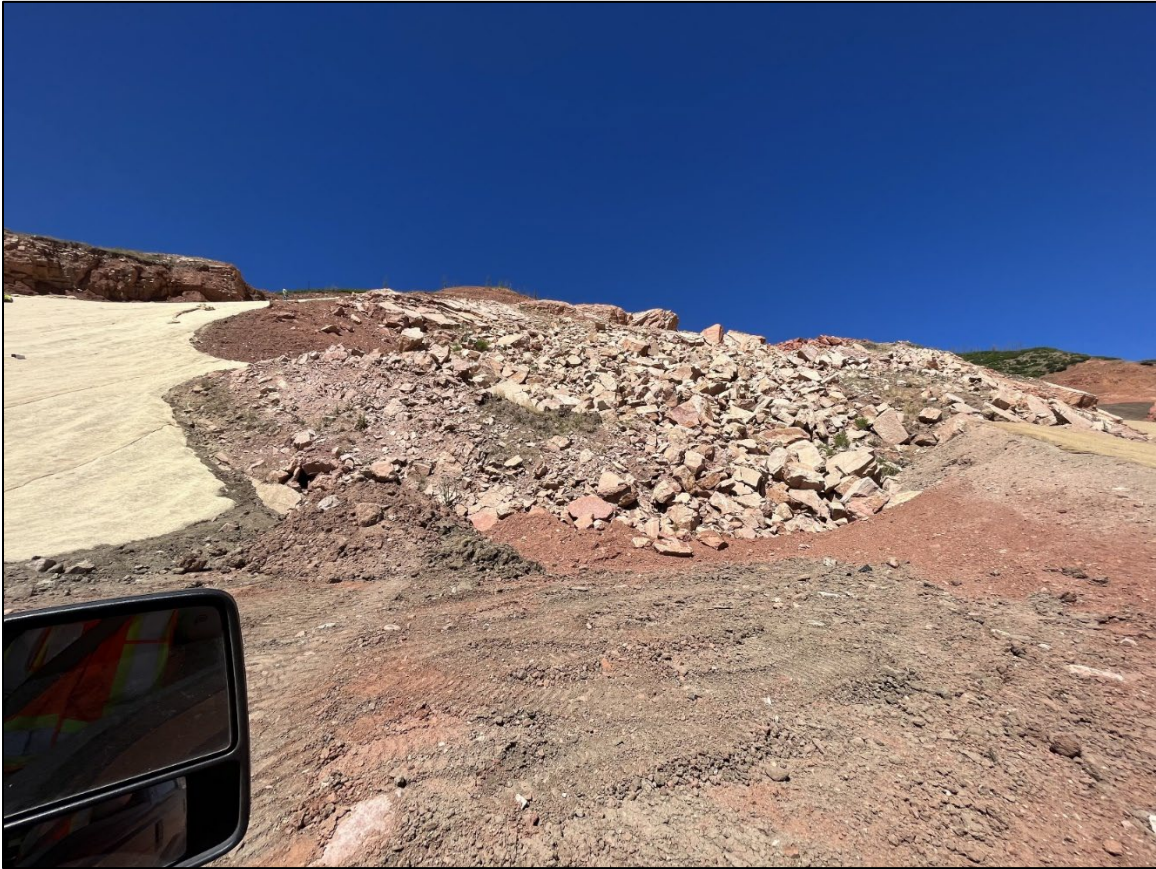
**Photo 8: View of the bottom buttress for the BFR area, material will continue to be added to buttress this large rock feature.**

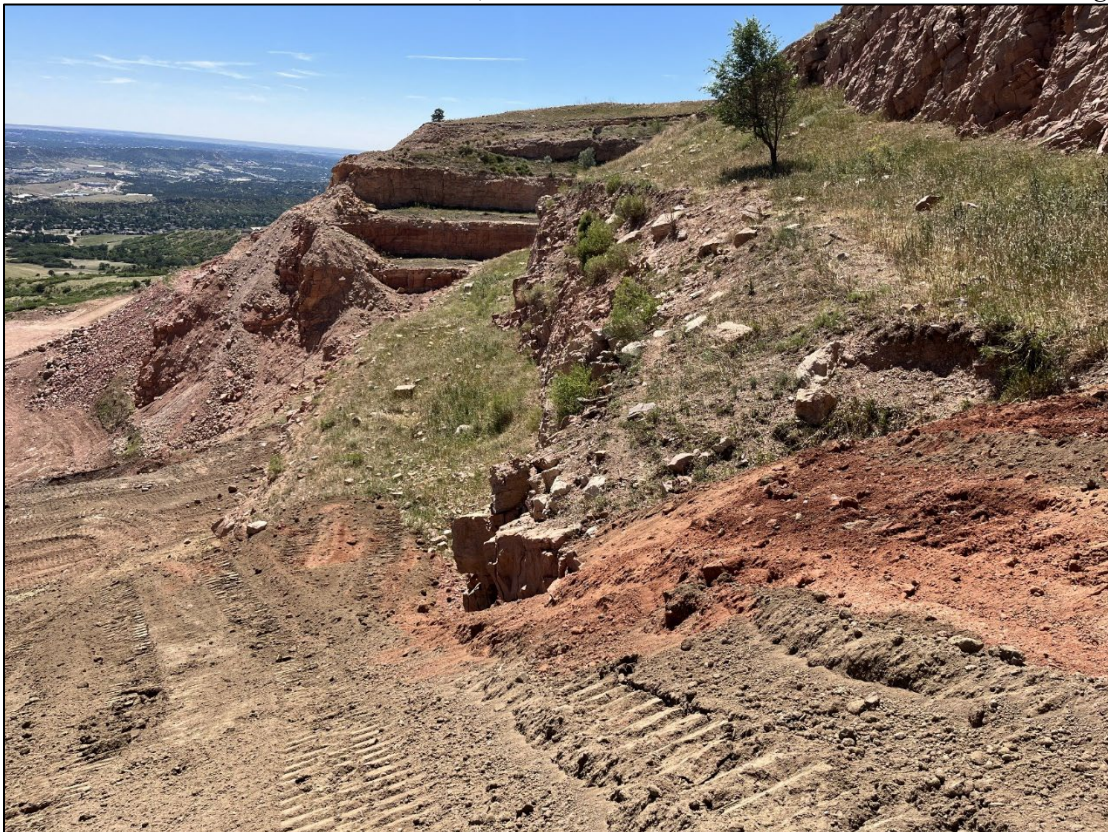
All major earthwork is complete at the site. All placed backfill continues to be tested for compaction in accordance with the approved specifications. All equipment associated with the earthwork contractor has been removed from the site. Only a few, smaller pieces of equipment remain onsite for use in revegetation and minimal earth and material moving work. These activities include topsoiling slopes (Photo 3 and 7), buttressing the BFR area using material excavated from drainage channels (Photo 8), placing rip rap (Photos 11 and 12), and regrading tie-in areas on the completed slopes (Photo 9). Material has been removed from the BFR to reduce weight on the slope. This material was then transferred to the bottom of the BFR and used as an additional buttress for the rock feature (Photo 8). The 2H:1V slope along and under the BFR area has been adjusted slightly for field conditions. The southern tie-in area will require minor scaling of looser rock material to ensure stability of this area before topsoiling and matting can occur (Photo 9).

**Photo 9: Area of new slope tie-in to old reclamation benches, minimal scaling will be done to improve structural integrity at the edges of this tie in.**

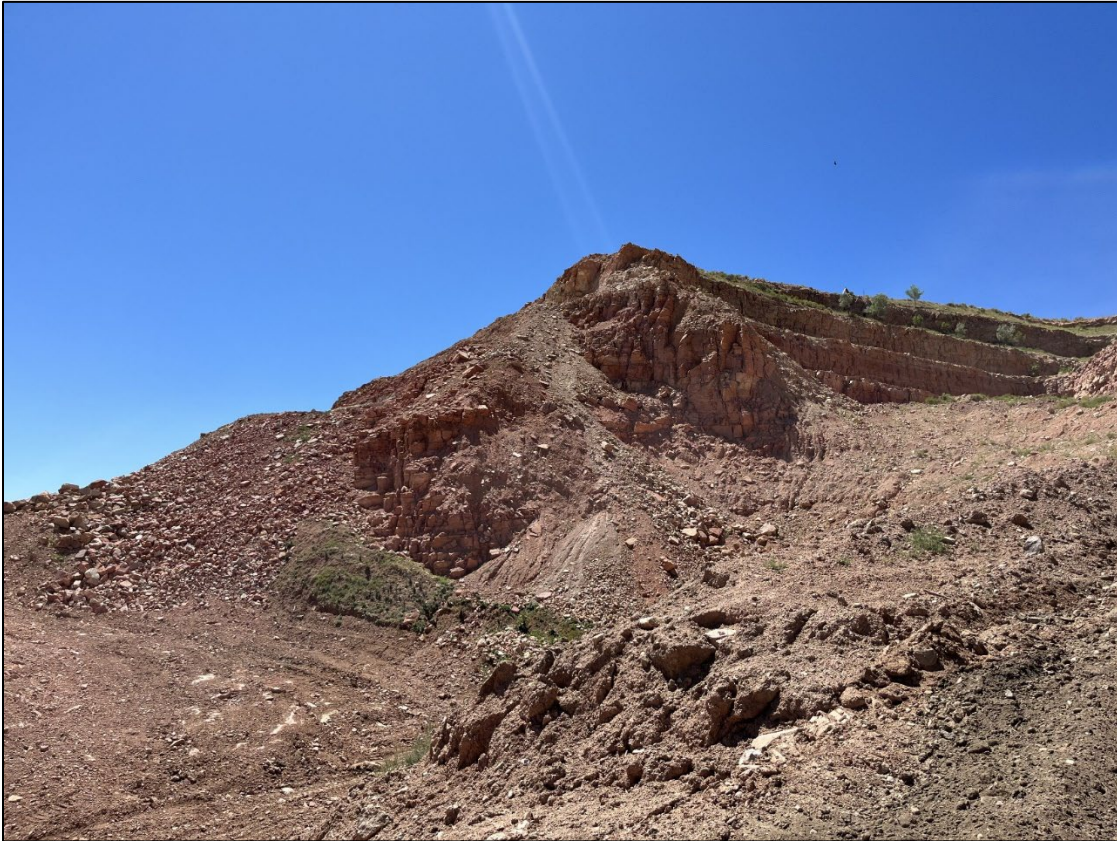
**Photo 10: View south of a peak located at the southern end of the permit boundary, this peak will remain and carry a natural drainage channel to a designed plunge pool.**

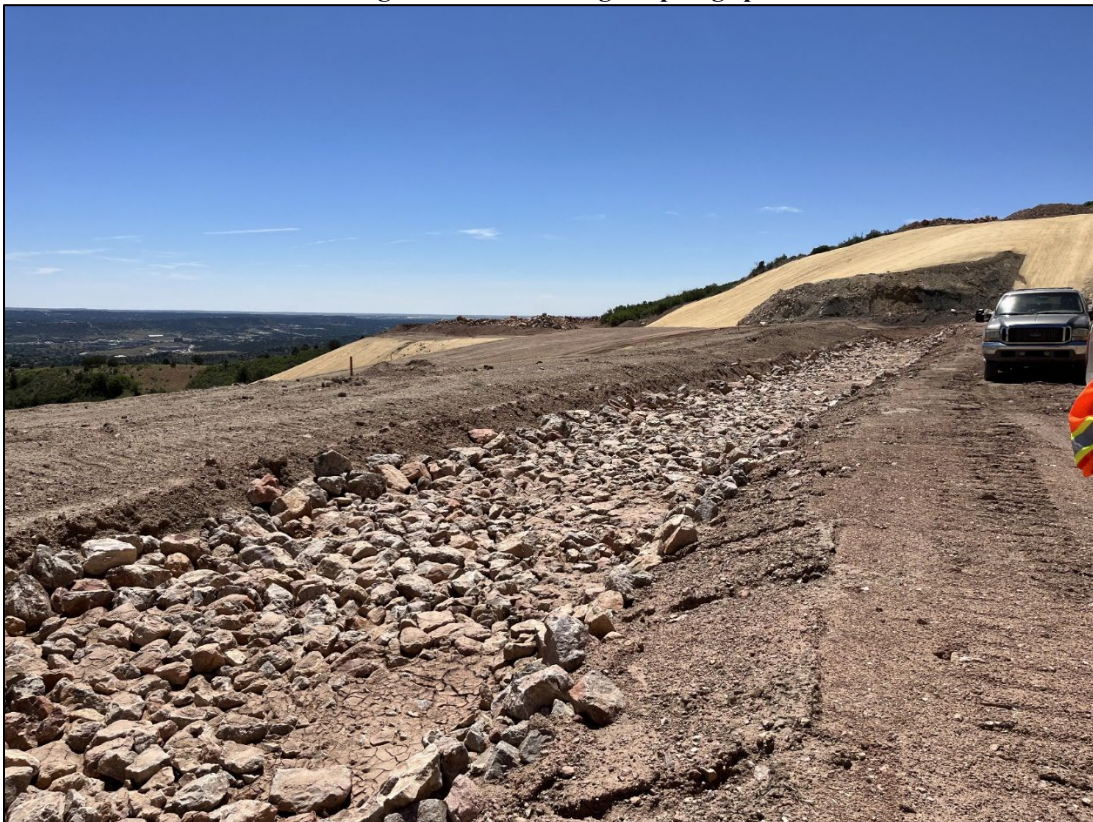
**Photo 11: Rip rapping of channels has begun on the lower bench.**

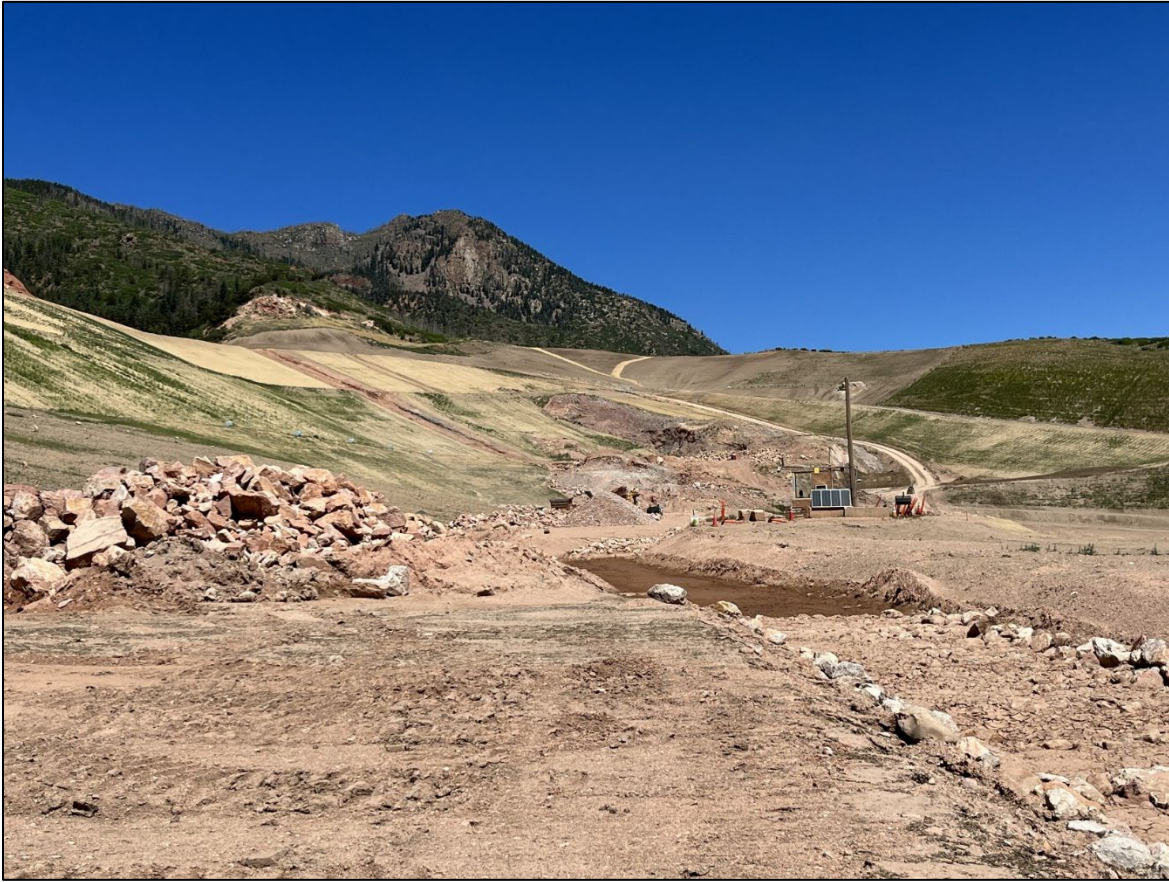
**Photo 12: View north of new growth on matted slopes on both City and private property.**
