**Climax Mine**  
Highway 91 - Fremont Pass  
Climax, CO 80429  
Phone (719) 486-7718  
Fax (719) 486-2251

July 24, 2024

**Re: Mayflower Pump Station EPF Failure – Climax Mine Permit No. M-1977-493**

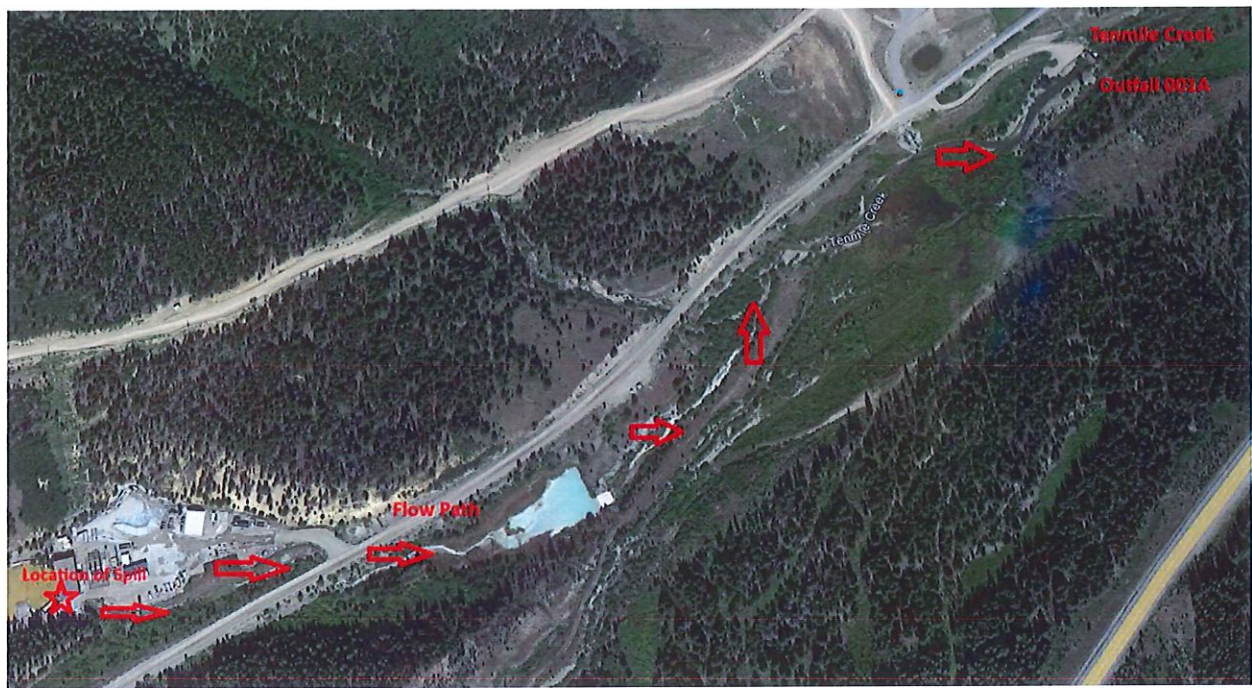
## Attachment 1 – Location and Flow Map

Incident occurred at the Climax Mine located at Fremont Pass – Highway 91, Climax, CO 80429. At approximately 2:45 pm on July 18, 2024, a routine pipe jetting job was completed and the Mayflower Pump Station was going to be brought back online. The pumps were turned on in auto sequence-auto control mode. The line was filling with the variable frequency drive (VFD) – pumps 2 and 3 started at the same time, this made pumps trip/power out. A trip occurred and operator was able to clear alarm – hit auto start again – observed that the line pressure dropped to zero and turned the pumps off. Water hammer occurred and caused the blind flange at the end of a pipeline junction at the Pump Station to fail and caused process water to drain into a Climax Mine drainage that eventually leads to Climax's Colorado Discharge Permit System (CDPS) permit (No. CO0000248) Outfall 001A that represents the beginning of Tenmile Creek.

Upon repair of the flange, the pumps were brought online in a staggered manner and normal operations resumed. Attachment 1 shows the release location and path of flow.

*Climax Response: Climax does not interpret this event as an emergency situation due to the duration of the release and repair. Climax is currently constructing a pumpback system in this area that will prevent situations like this from occurring in the future. Climax will be installing control/delay programming into the startup sequence of the pumps at this pump station; so that pumps start with appropriate intervals in between, and Climax will be updating the pump startup process SOP as well.*
