MINERALS PROGRAM INSPECTION REPORT
PHONE: (303) 866-3567

| MINE NAME: Snyder Quarry | MINE/PROSPECTING ID#: M-1977-210 | MINERAL: Limestone (general) | COUNTY: El Paso |
| INSPECTION TYPE: Monitoring | WEATHER: Raining | INSP. DATE: July 17, 2024 | INSP. TIME: 11:15 |
| OPERATOR: City of Colorado Springs | OPERATOR REPRESENTATIVE: David Deitemeyer | TYPE OF OPERATION: 112c - Construction Regular Operation | |

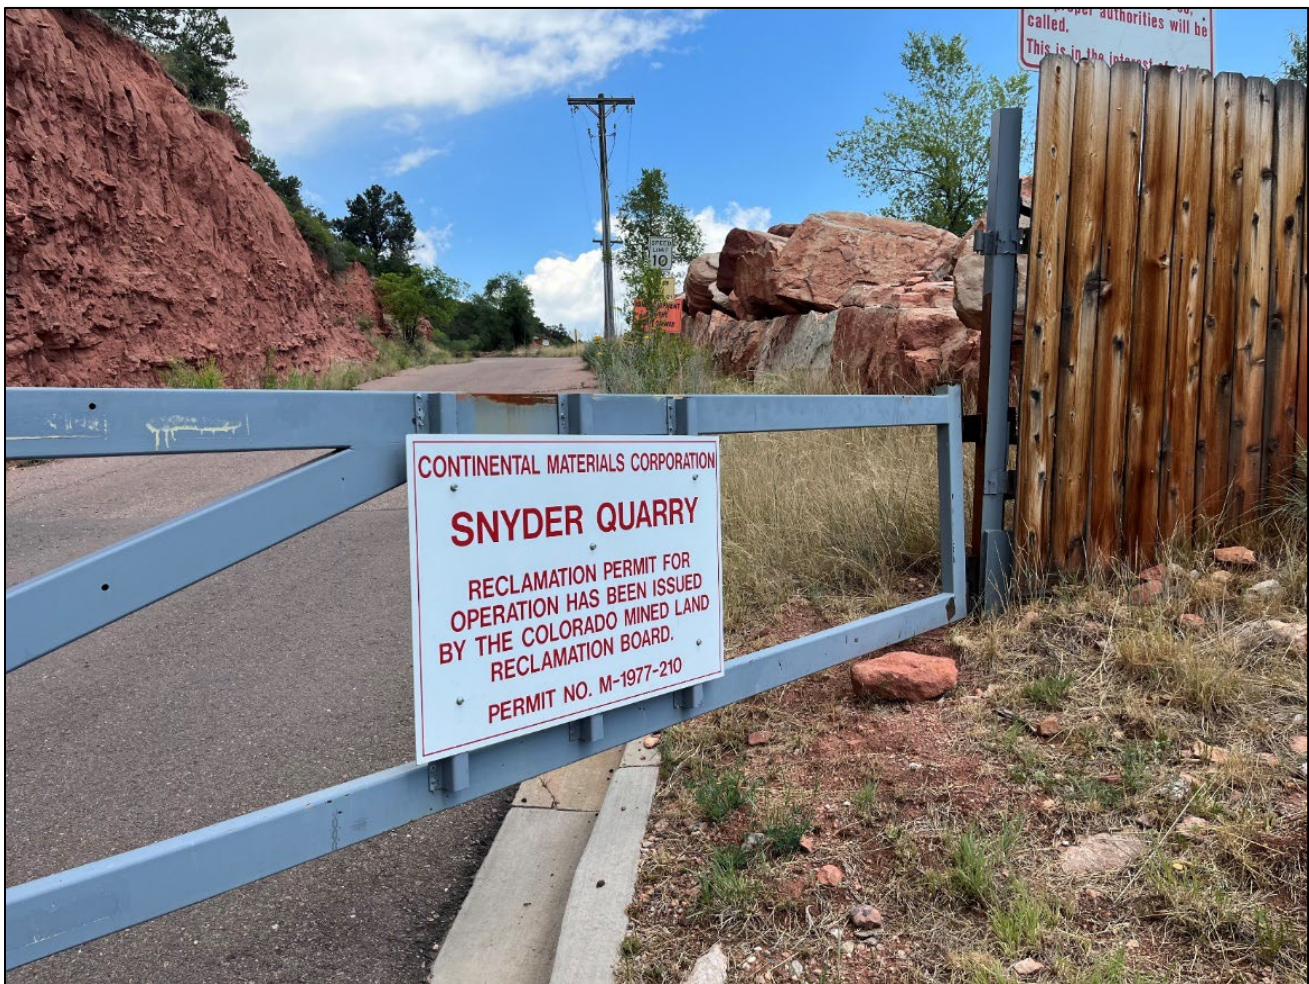
PROBLEM/POSSIBLE VIOLATION: Problem: An appropriate mine identification sign was not posted at the entrance of the mine site. This is a problem for failure to post a mine identification sign as required by Section 3.1.12(1) of the rule. The Operator shall, at the entrance of the mine site post a sign, which shall be clearly visible from the access road, with a minimum size equaling one hundred and eighty-seven (187) square inches, such as eleven (11) inches in height and seventeen (17) inches in width, with appropriate font size, with the following: the name of the Operator, a statement that a reclamation permit for the operation has been issued by the Colorado Mined Land Reclamation Board; and the permit number.

Signs and Markers: The permit sign was properly posted (Photo 1), but the Permittee name needs to be changed from Continental Materials Corporation to Colorado Springs. **This has been cited as a problem for failure to post a mine identification sign as required by Section 3.1.12(1) of the rule. Please provide the Division with proof of corrective action by the above given corrective action due date.** Boundary markers in the form of white stakes delineate the permit boundary.

Photo 1: Mine sign at the access road entrance. Information is out of date.

CORRECTIVE ACTIONS: The operator shall, at the entrance of the mine site, post a sign which shall be clearly visible from the access road with the following: the name of the operator, a statement that a reclamation permit for the operation has been issued by the Colorado Mined Land Reclamation Board; and the permit number. The operator shall submit photo documentation that a proper sign has been posted by the corrective action date.

CORRECTIVE ACTION DUE DATE: 10/22/24

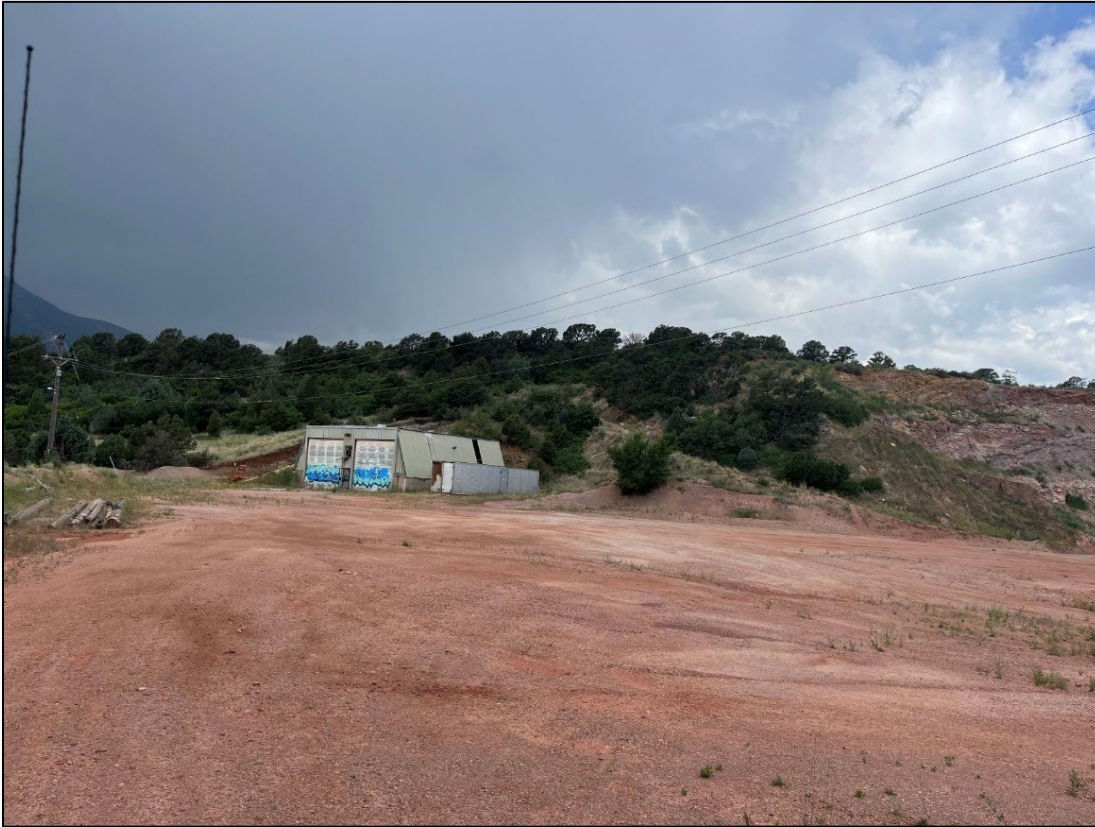
Reclamation Success: The City has not initiated any new reclamation since the permit was transferred from the previous Permittee in 2021. The highwalls west and north (Photo 5) of the north pit appeared to have been adequately reclaimed. The hillsides above the two pits to be backfilled were reclaimed before city took over permit (Photos 3 and 5). The office building located in the south will remain in final reclamation, as clarified under Technical Revision 3 (TR-3) (Photo 2).

Photo 2: View west of the currently abandoned office building to remain in final reclamation, located at the southern permit boundary.

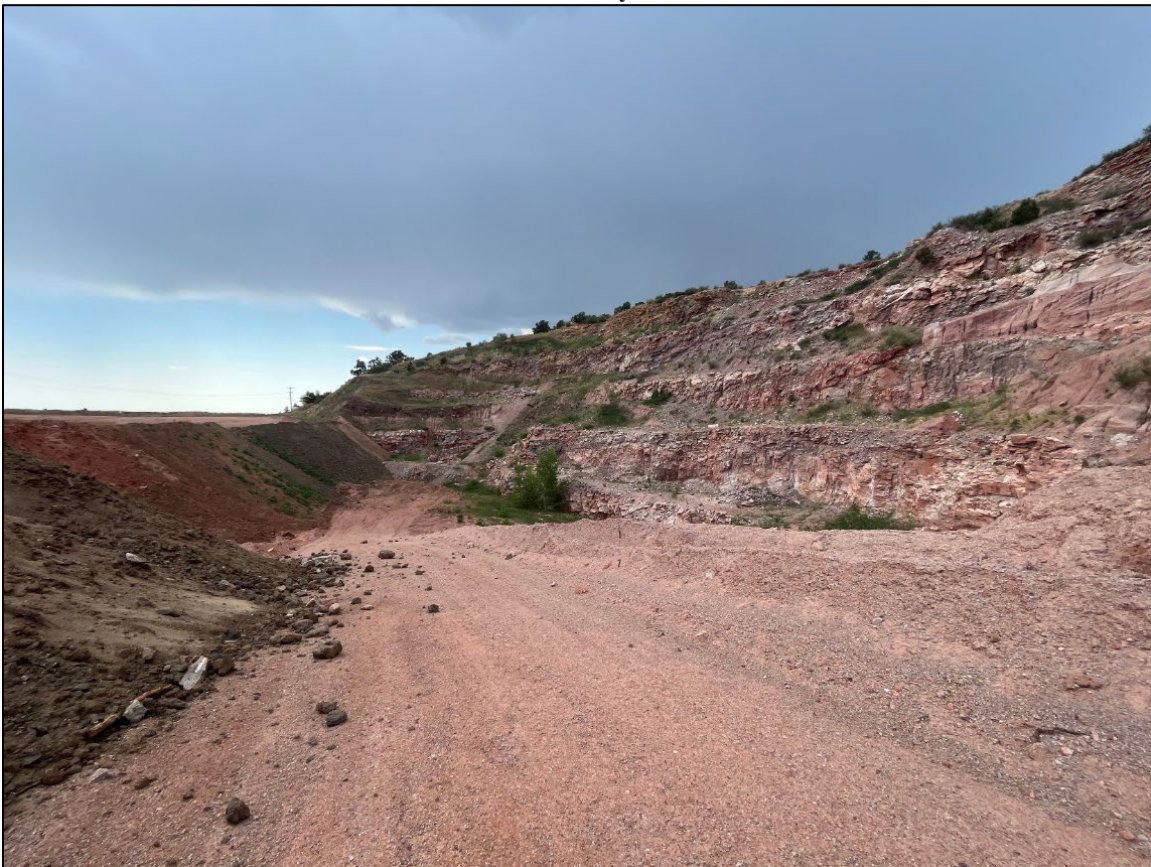
Backfilling and Grading: Both pits on site (Photos 3 and 7) are approved to be backfilled in final reclamation as discussed in Amendment 4 (AM-4). Several unreclaimed highwalls throughout the site will require scaling to reduce rockfall and increase safety (Photos 4 and 6). The approved plan allows for multiple highwall configurations. The northern most portion of the permit has slopes that will be regraded but will remain in the overall 'basin' or 'bowl' shape that it now mimics (Photo 9). The steeper slopes in this area will be regraded mainly with material pushed down from above (Photo 10). Some outcrops of the historical step and bench configuration will remain in final reclamation. Sufficient backfill material may or may not be available onsite for backfilling of the two pits and for general regrading of the rest of the site. Mr. Deitemeyer was informed that should any extra fill need to be imported to the site, a TR for an inert fill notice (Pursuant to Rule 3.1.5(9)) will need to be filed with the Division.

Photo 3: View south into the western pit to be backfilled, previously reclaimed benches are visible to the west.

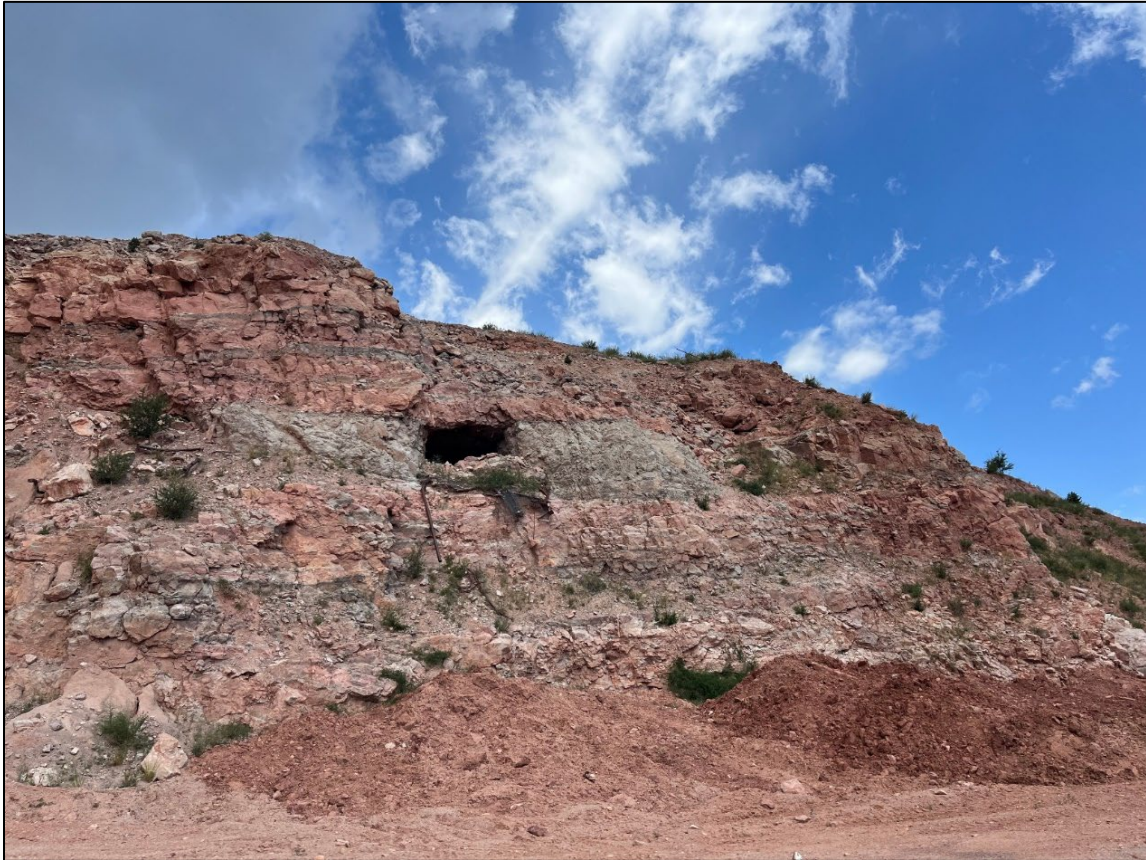
Fish and Wildlife: No impact to wildlife was observed. A small opening is located on the western side of the site in the historic highwall (Photo 4). Mr. Deitemeyer stated that CPW had discussed that this opening should possibly be left as-is in final reclamation for use as bat habitat.

Photo 4: Opening to possibly be left for wildlife habitat.

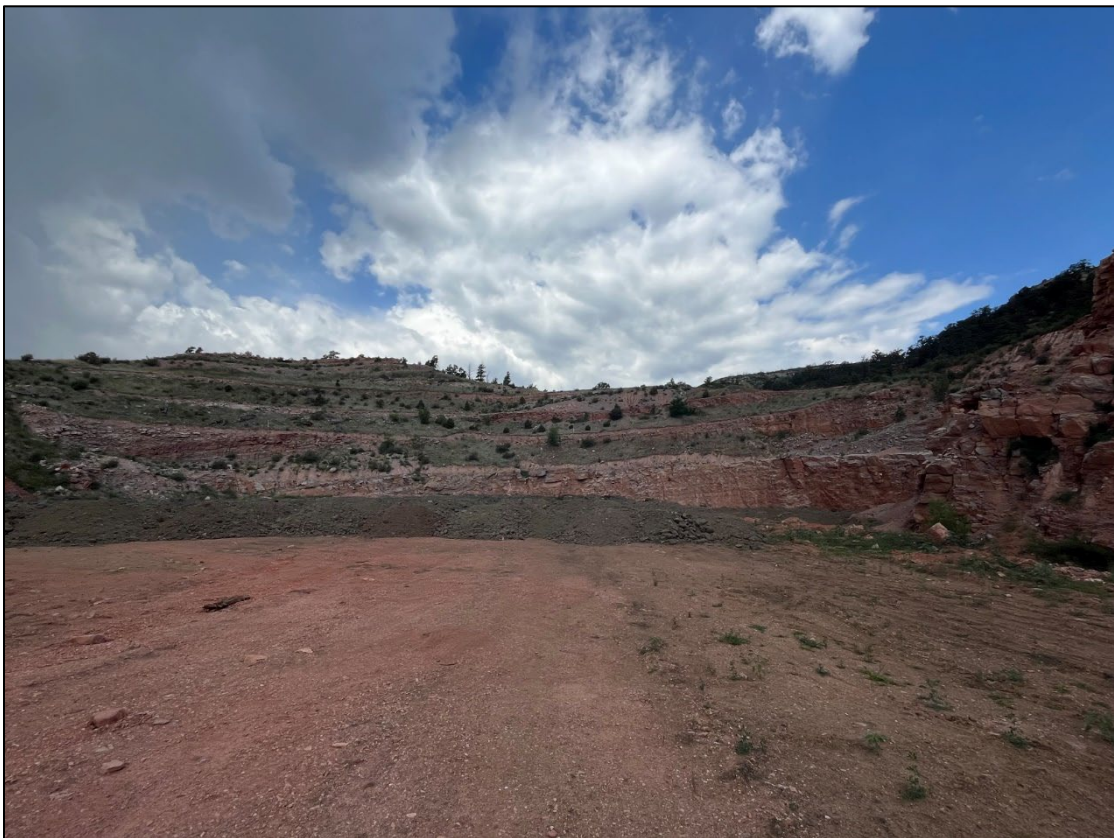
Photo 5: View north of the previously reclaimed highwalls at the northern permit boundary.

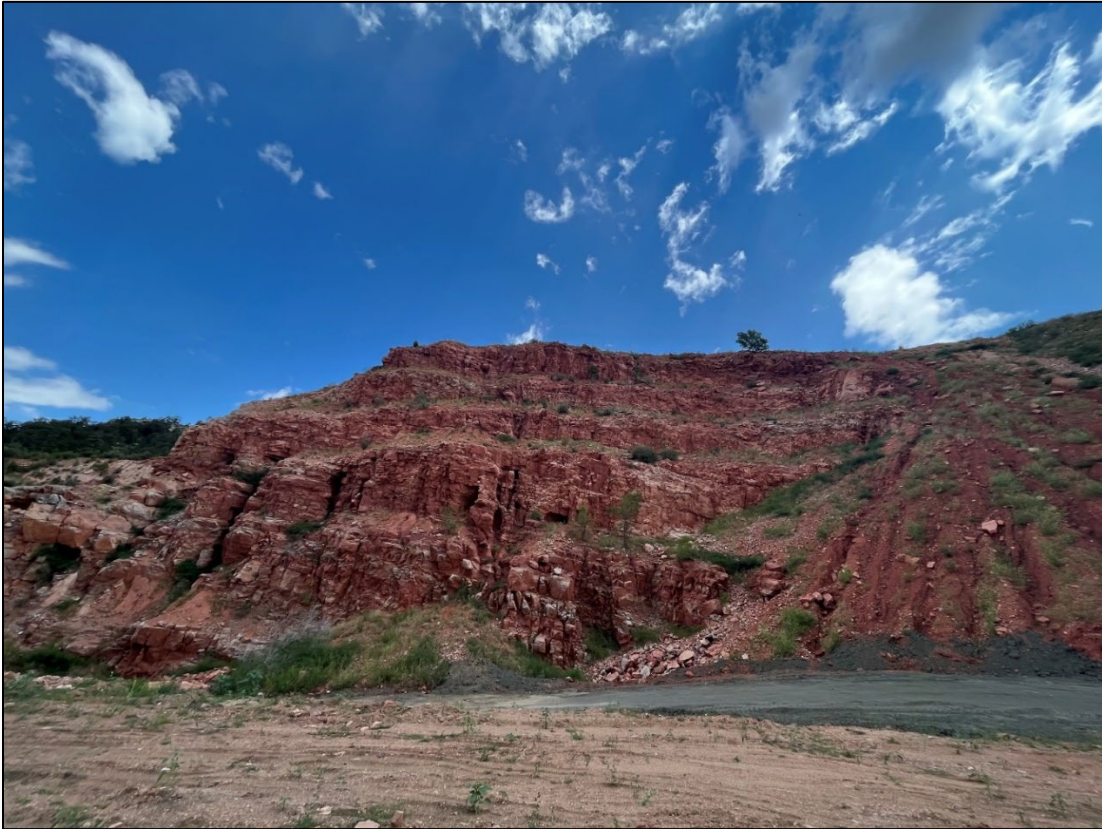
Photo 6: Highwall to the east of Photo 7, still in need of reclamation.

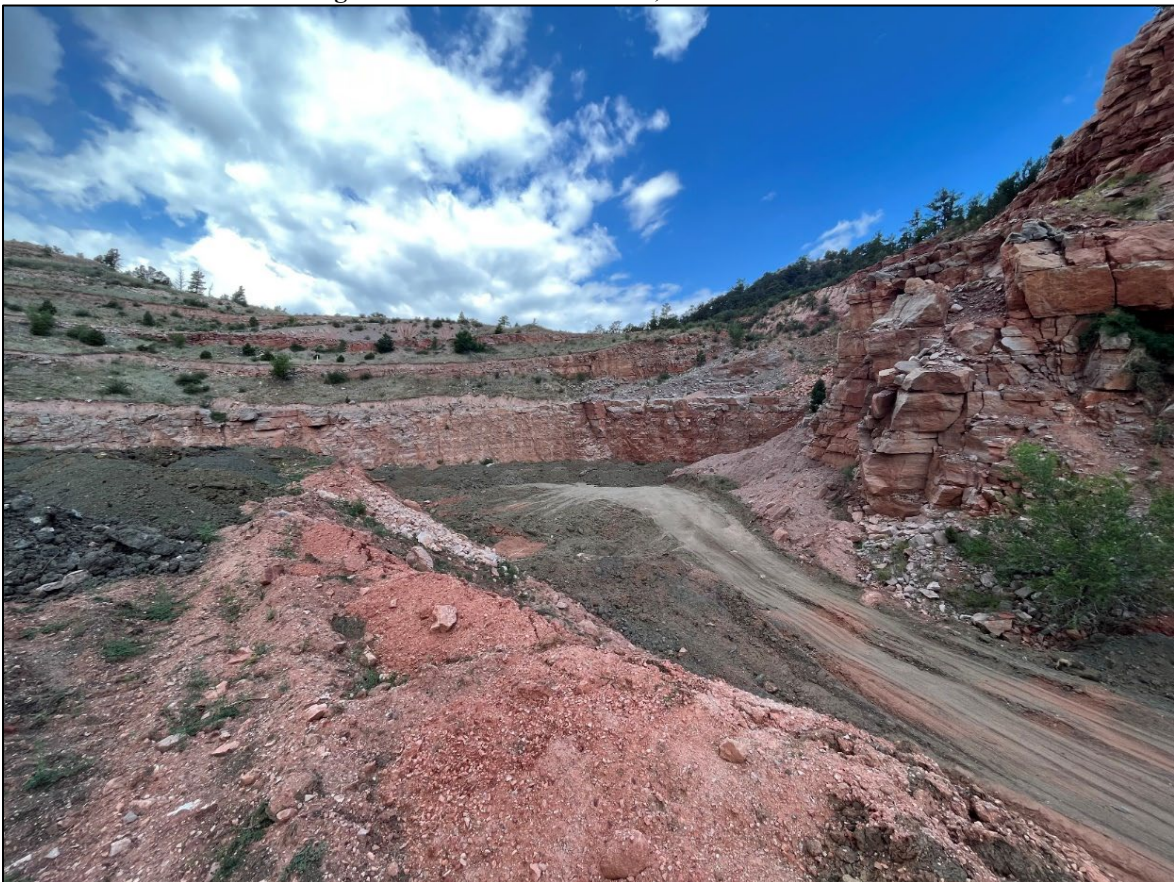
Photo 7: View north into the second pit which will be backfilled in final reclamation.

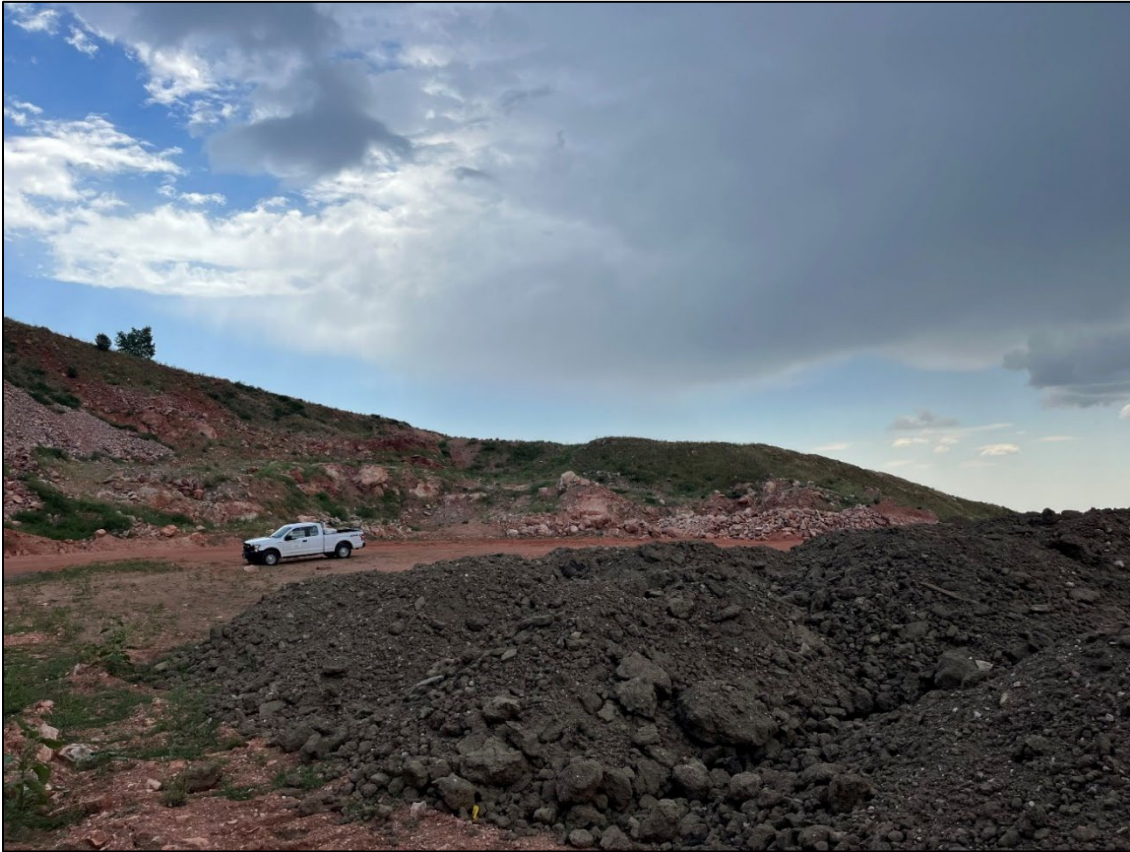
Revegetation: There has been no new revegetation effort since the previous inspection. Knapweed continues to be a minor problem on site. The Division advises the City to implement the TR-2 approved weed control plan to upkeep with the presence of weeds. Topsoil piles to be used in final reclamation were observed onsite (Photo 8).

Photo 8: View southeast of topsoil which will be used in final reclamation.

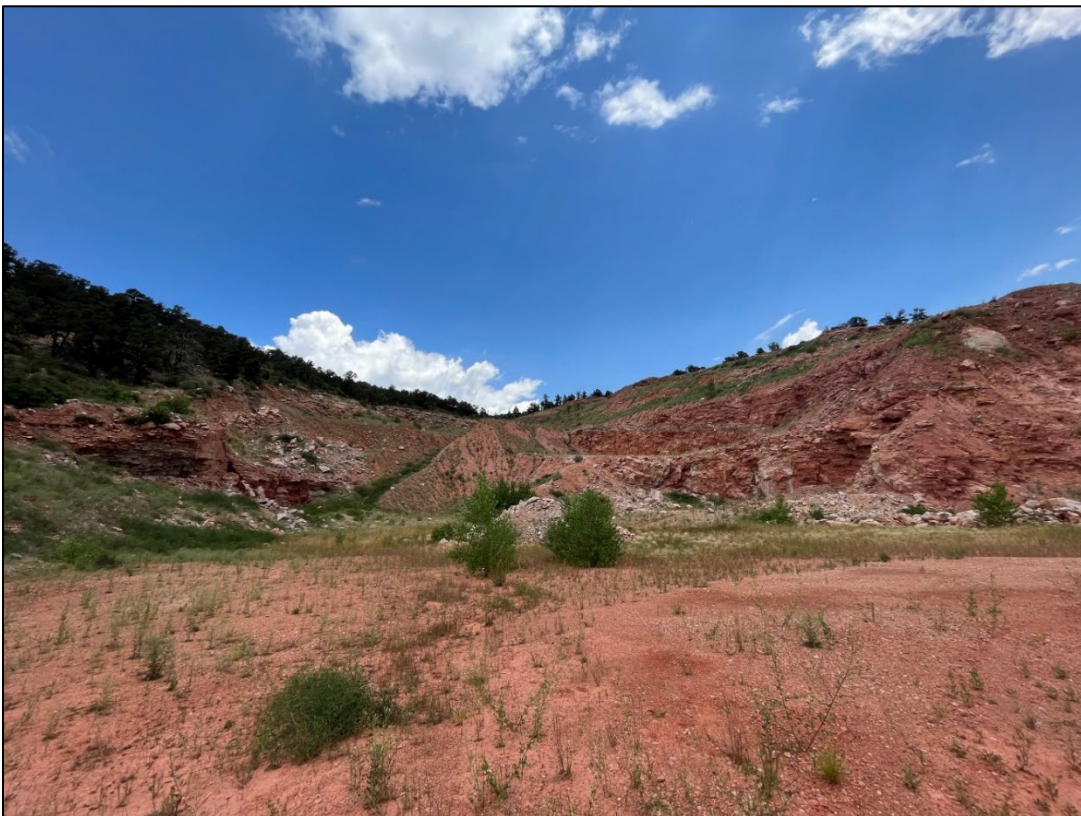
Photo 9: View east of the basin-shaped area in the northeast of the permit boundary, features in this area are yet to be fully reclaimed.

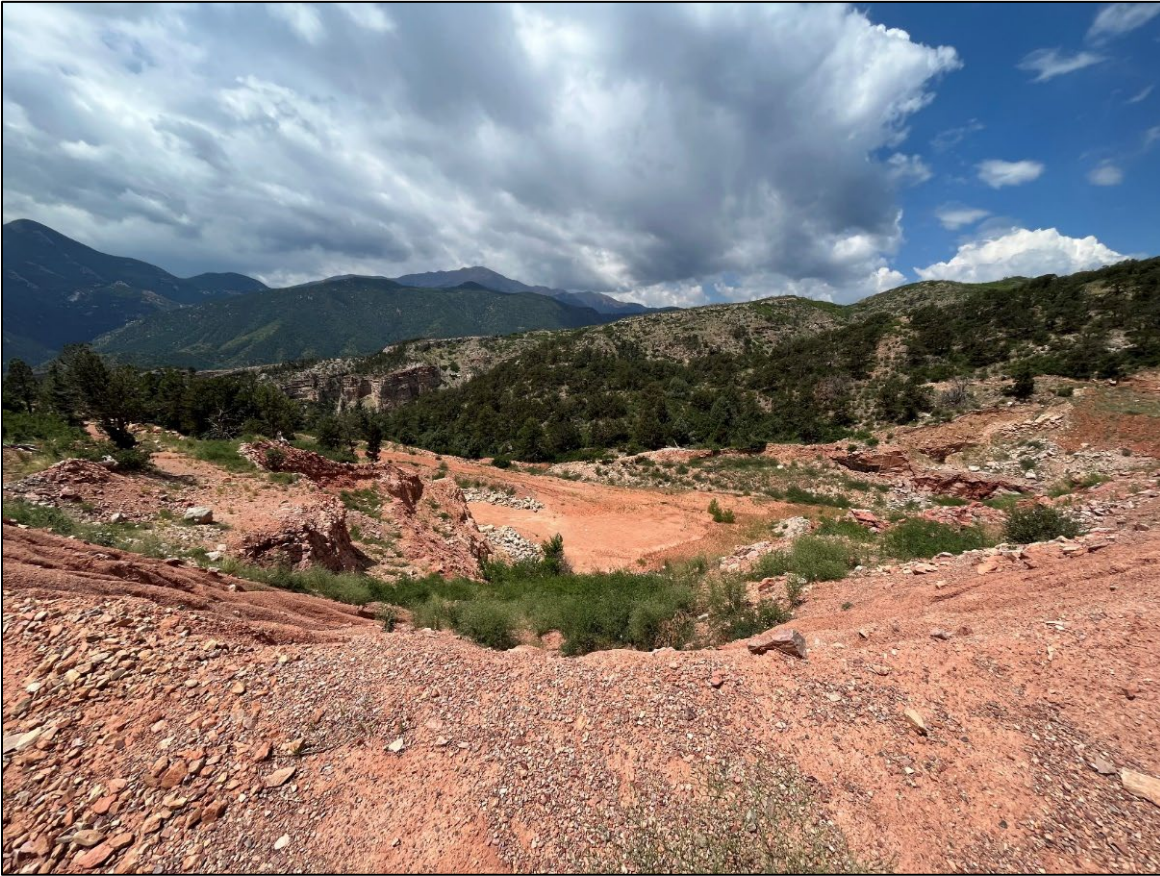
Photo 10: View west down into the northern most pit. Material from above will be pushed down to regrade slopes below.

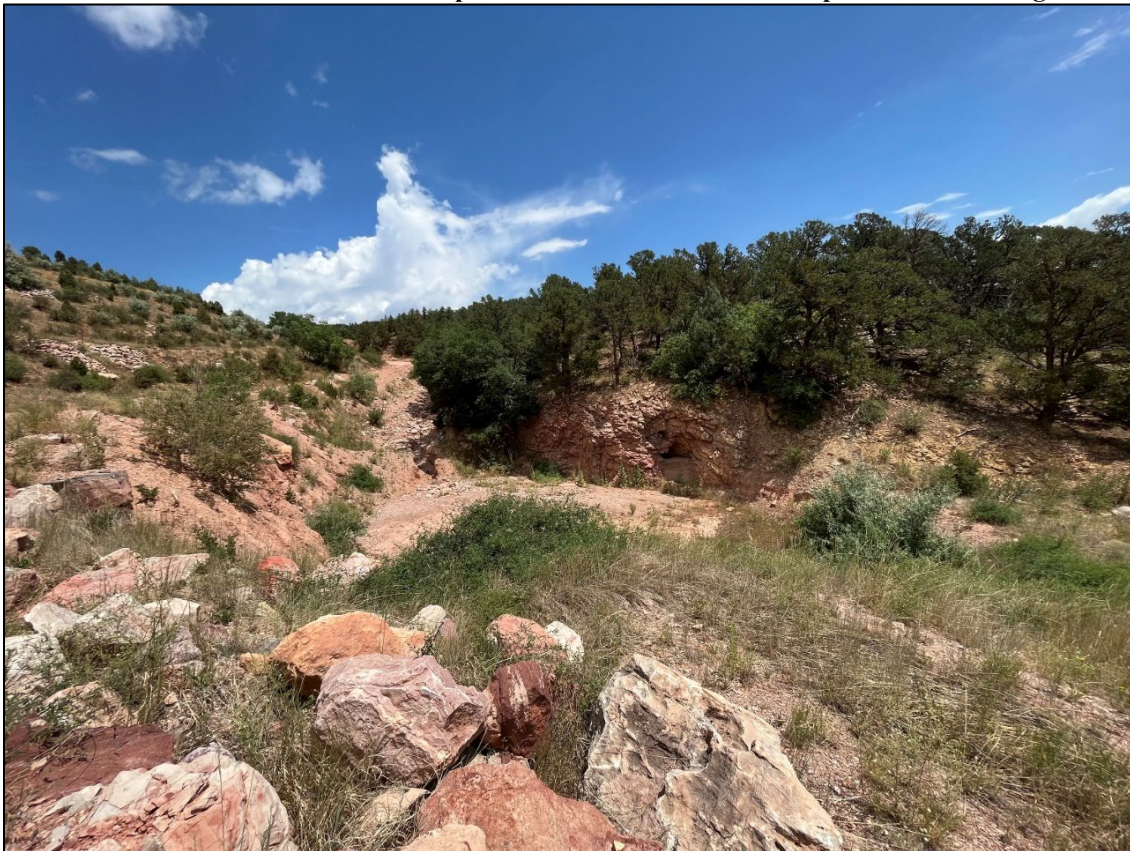
Hydrologic Balance: No standing water was observed in the pit and no exposed groundwater was observed. The large storage pond to the east will be removed in final reclamation. Material will be regraded, ripped, and redesigned to reestablish the low point of natural drainage in the area. This area drains to Williams Canyon and into two small sediment traps located along the access road. These traps will remain in final reclamation and be ripped (Photo 11). All other stormwater from the site drains down into the access road to Black Canyon.

Photo 11: View northeast of the sediment basins along the access road to remain in final reclamation.
