**MINERALS PROGRAM INSPECTION REPORT**  
**PHONE: (303) 866-3567**

<b>MINE NAME:</b> Henderson Development	<b>MINE/PROSPECTING ID#:</b> M-1980-110	<b>MINERAL:</b> Sand and gravel	<b>COUNTY:</b> Adams
<b>INSPECTION TYPE:</b> Monitoring	<b>WEATHER:</b> Clear	<b>INSP. DATE:</b> September 27, 2023	<b>INSP. TIME:</b> 09:30
<b>OPERATOR:</b> E-470 Public Highway Authority	<b>OPERATOR REPRESENTATIVE:</b> Derek Slack	<b>TYPE OF OPERATION:</b> 112c - Construction Regular Operation	
<b>REASON FOR INSPECTION:</b> Normal I&E Program	<b>BOND CALCULATION TYPE:</b> None	<b>BOND AMOUNT:</b> \$0.00	
<b>DATE OF COMPLAINT:</b> NA	<b>POST INSP. CONTACTS:</b> None	<b>JOINT INSP. AGENCY:</b> None	
<b>INSPECTOR(S):</b> Nikie Gagnon Amy Eschberger	<b>INSPECTOR'S SIGNATURE:</b>

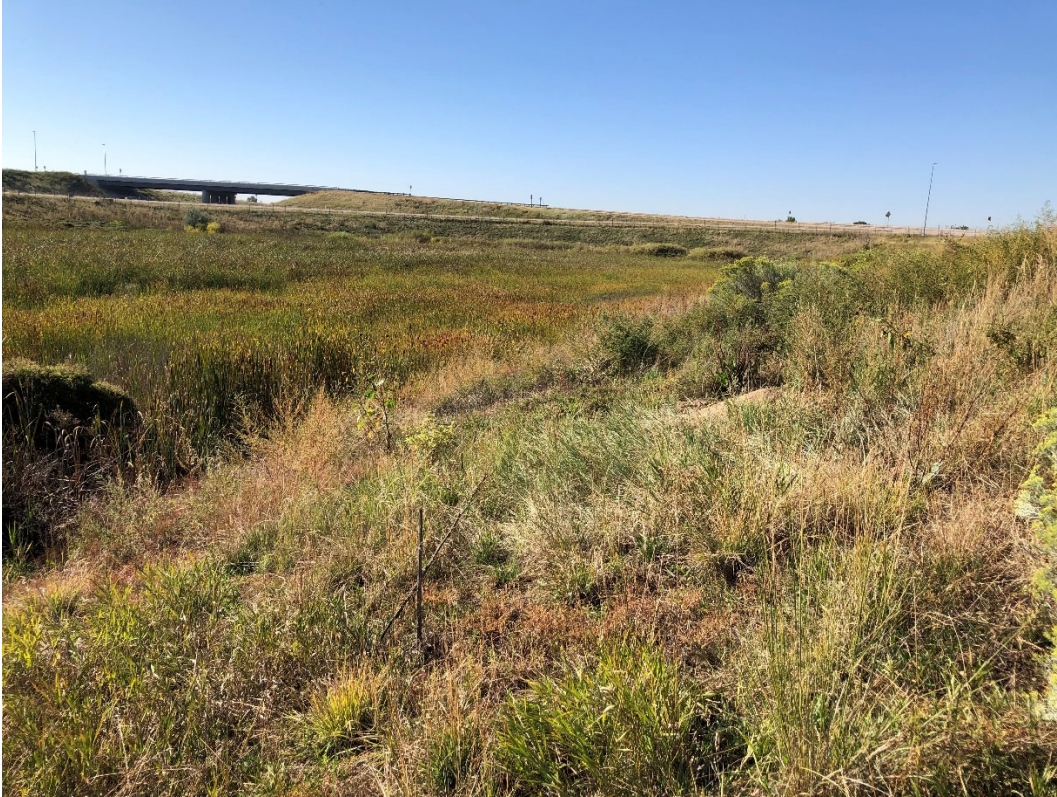
Photo 1: View looking at the south end of the pit.

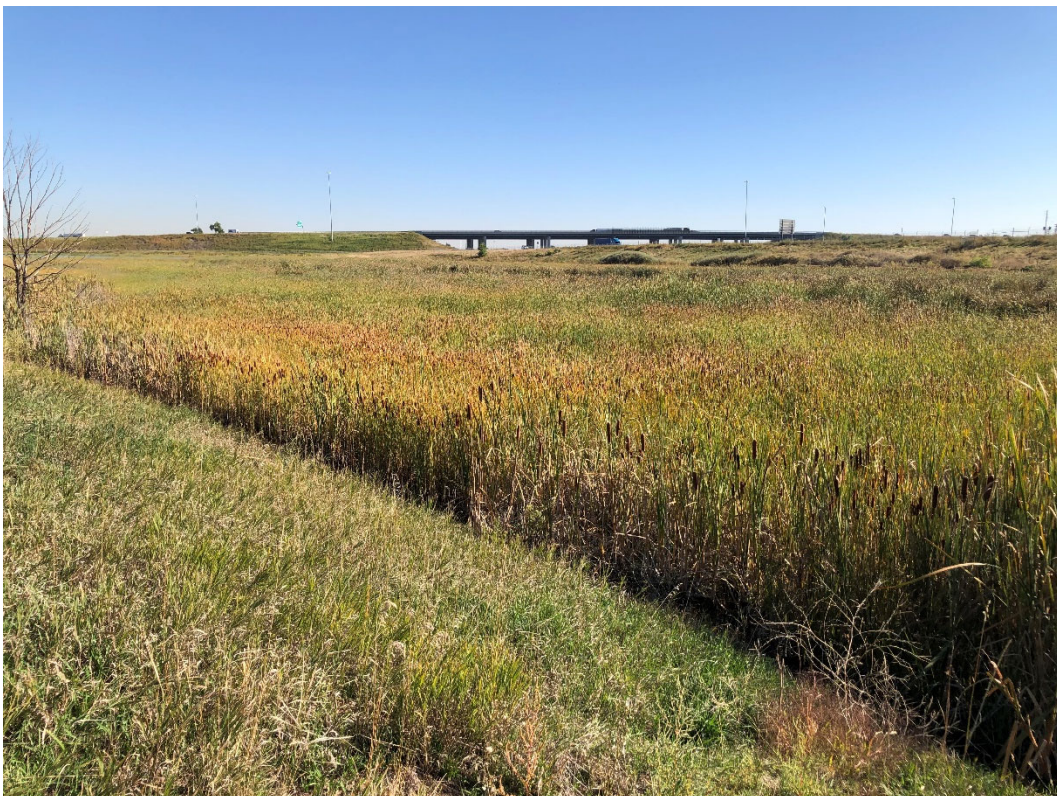
Photo 2: View looking northeast across the pit from the south end of the permit area.

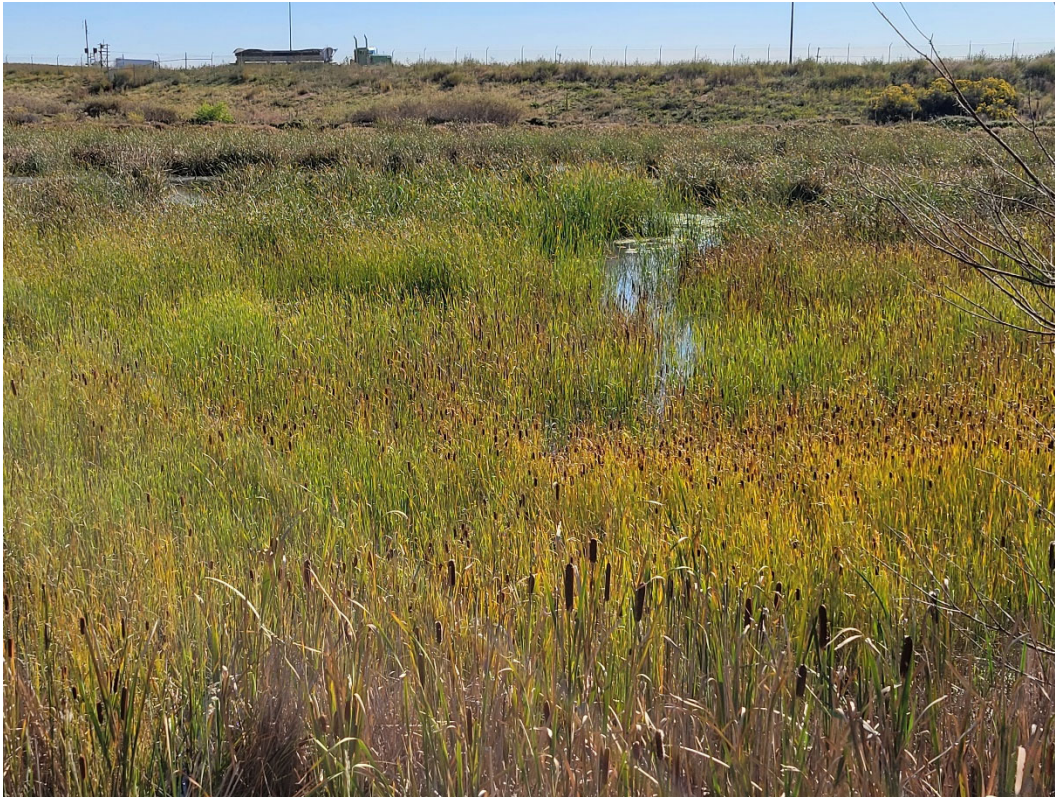
During this inspection, the Division observed exposed groundwater in the former pit. The water depth was estimated to be 2-3 feet in the bottom of the pit, which runs north/south across the site. Wetland vegetation (primarily cattails) was observed growing in the bottom of the pit. Ponded water has been an ongoing concern at this site. The Operator has taken steps to address the ponding issue, including installing six monitoring wells in 2020, within and around the property, to investigate the groundwater system. Most recently, in January 2022, the Division approved Technical Revision 5 for the installation of a perimeter passive subsurface drainage system to transport groundwater around the site. The initial test drainage system consisted of a trench on the north end of the permit area and 1000 feet of perforated pipe and rock to direct flow into undisturbed alluvium. During this inspection, the Operator stated that the passive drainage system is not adequately draining water from the site and they continue to make adjustments to the system, including digging the trench deeper and extending the inlet pipes to keep them from clogging up with algae. The Operator and the Division discussed the possibility that the low permeability fill material may be contributing to the perched groundwater, and the potential for groundwater mounding associated with slurry walls around adjacent pits.

Based on observations during this inspection, the Operator is not in compliance with Section 34-32.5-116(4)(h) of the Colorado Revised Statutes and 3.1.6(1)(a) of the Construction Materials Rules and Regulations governing injury to existing water rights. The Division recommended that the Operator hire a consultant to help determine the source of the exposed groundwater and submit the groundwater report to the Division for review.

Photo 3: Looking down into the pit at the south end of the permit area. Cattails observed growing in the pit.

Additionally, since the proposed passive drainage system is not adequately working, the Operator will need to submit a Technical Revision with a new mitigation plan to address the exposed groundwater on site.

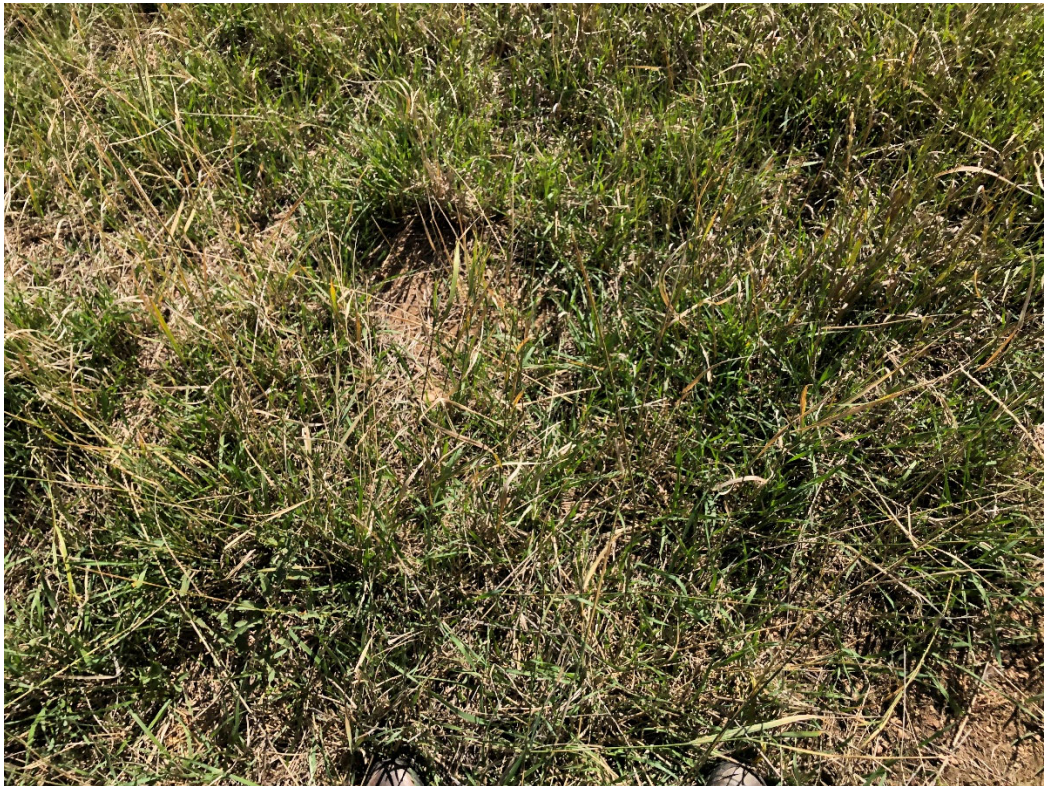
Photo 4: Close up of vegetation density on the side slopes of the pit.

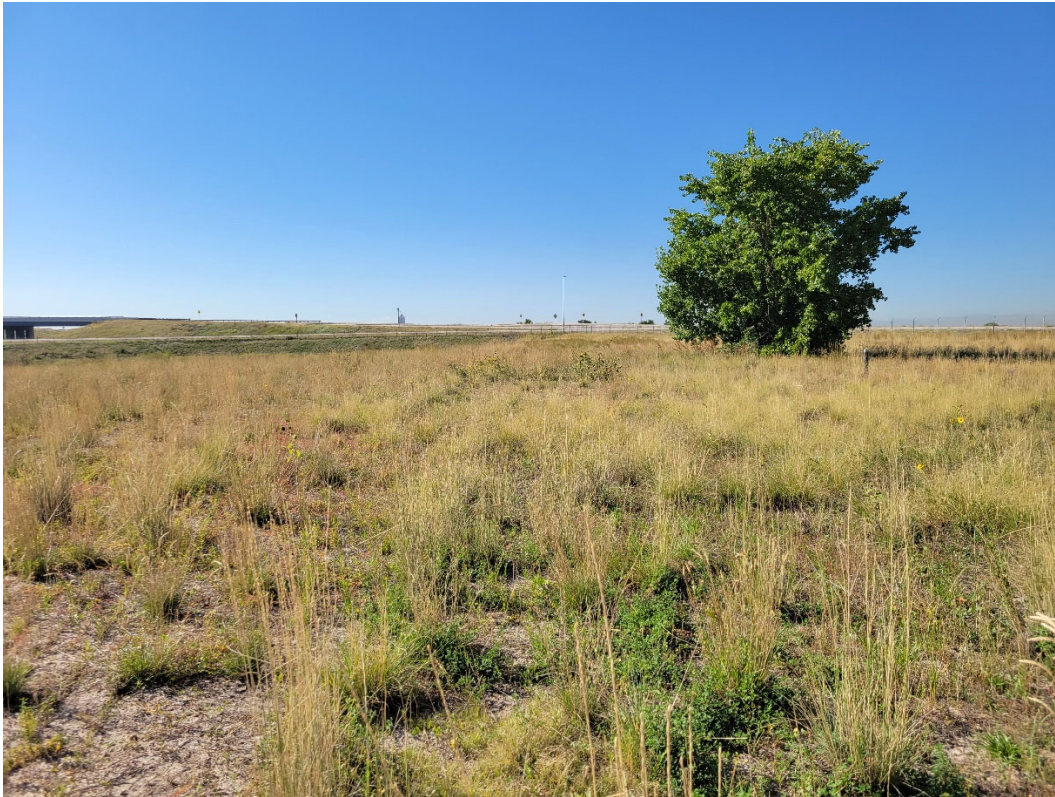
Photo 5: View looking towards the south end of the permit area from the entrance. Desirable grasses and forbs observed growing in this area.

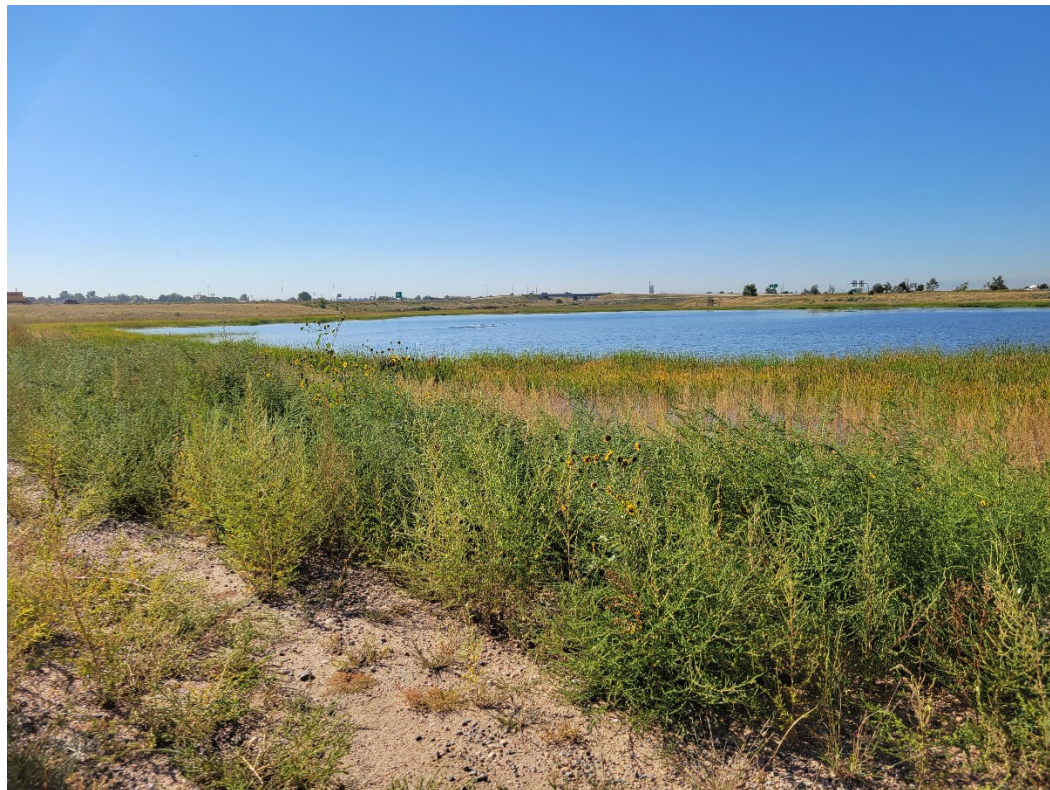
According to Division records, the entire site was reseeded in the fall of 2017. The Division observed desirable species of grass on the southern end of the permit area, including wheatgrass, sideoats grama, and switchgrass, consistent with the seed mix modification approved in Technical Revision 4 (2019). Some bare patches of ground were noted near the entrance. On the north end of the permit area, dense patches of Russian thistle were observed, along with annual sunflowers and some field bindweed. Very little grass was observed in the northern portion of the permit area and patches of bare ground were observed. The Division reminds the Operator to continue to conduct weed control and reseed as necessary per the approved revegetation plan and Technical Revision 4.

Photo 6: View looking south from the north end of the pit. Patches of Russian thistle cover this area, very few patches of desirable grasses observed.

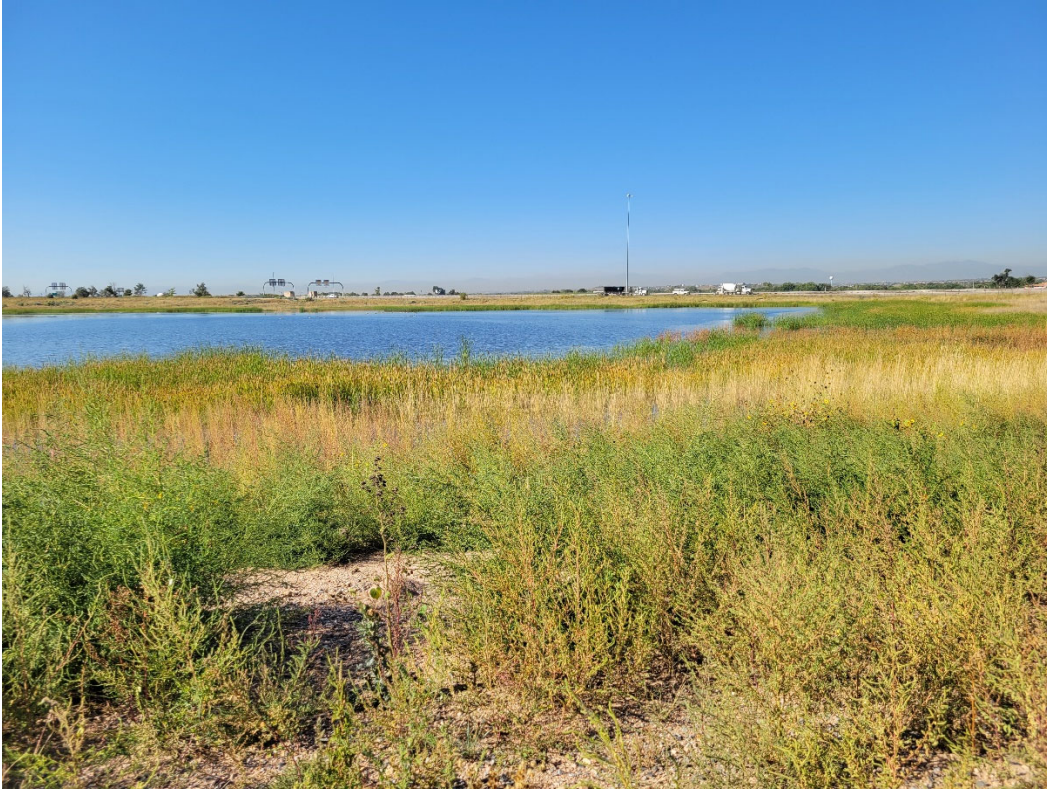
Photo 7: View looking west from the east side of the pit.

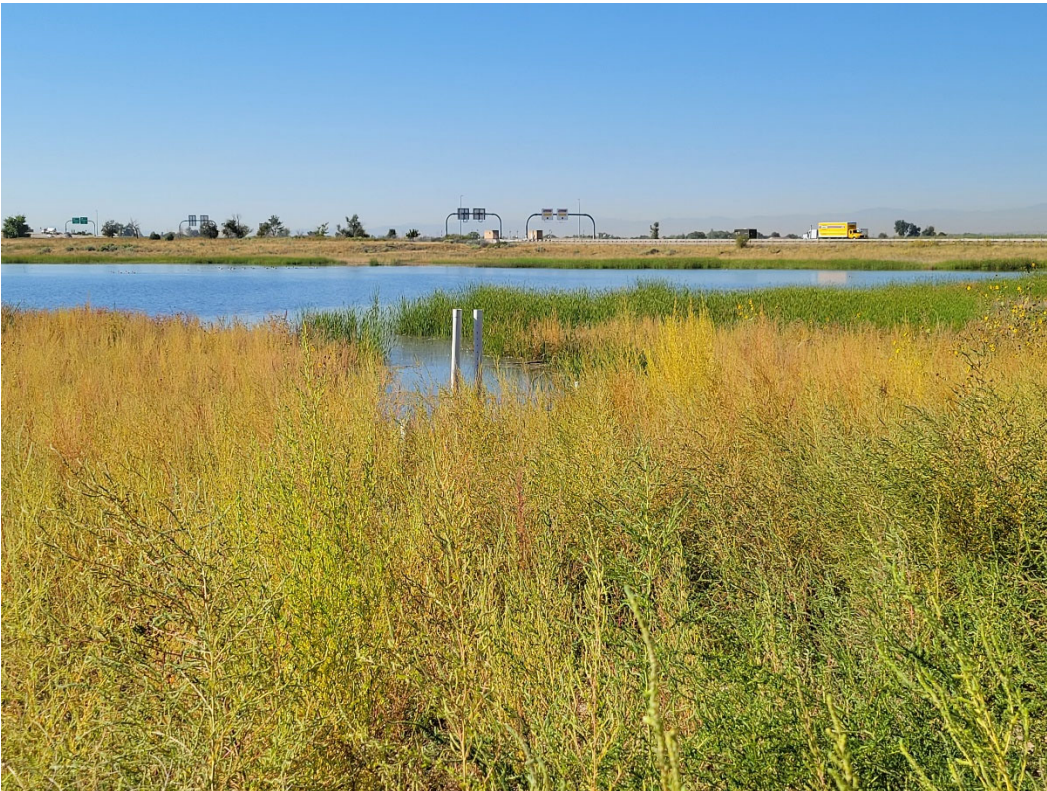
Photo 8: Looking southwest at the passive drainage inlet.

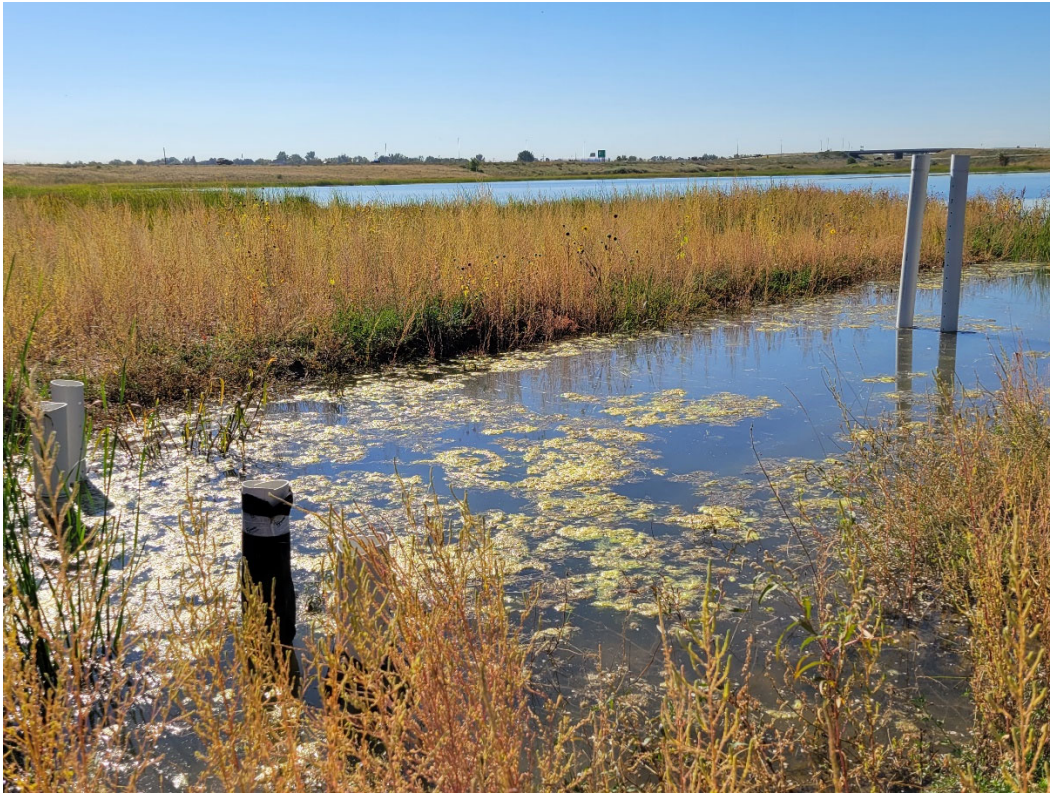
Photo 9: Close up of passive drainage inlet pipes on the north end of the permit area.

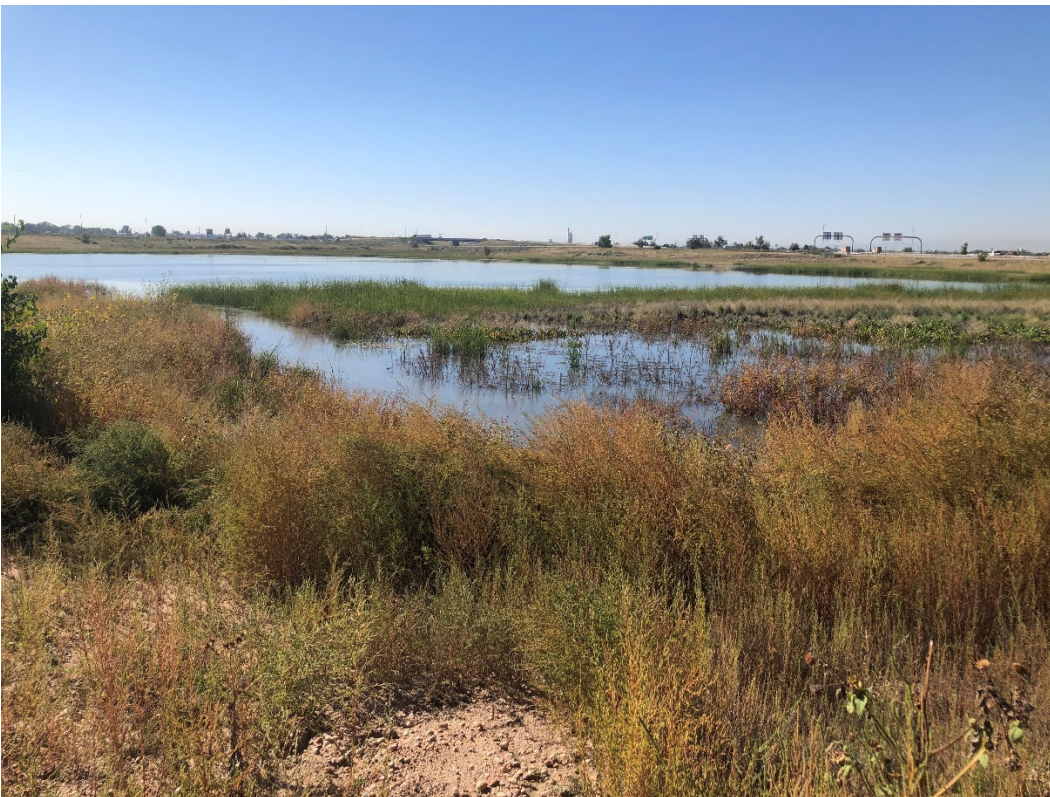
Photo 10: View looking south from the northwest corner of the permit area.

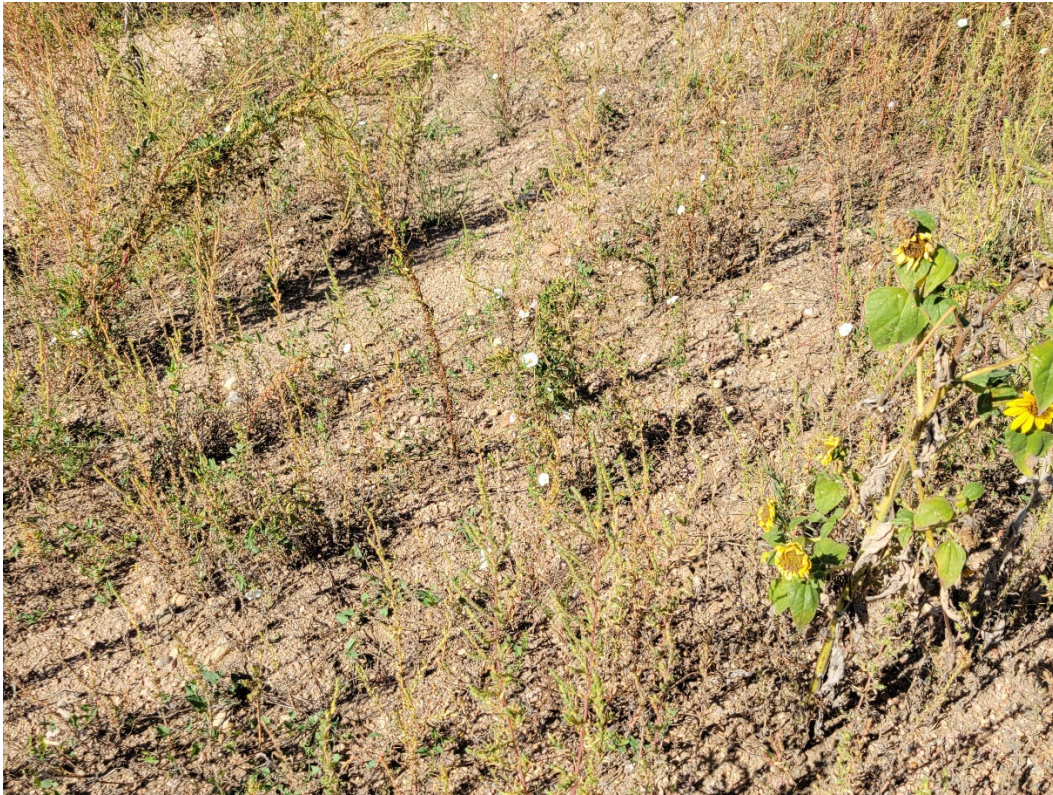
Photo 11: Bare patches of ground and field bindweed observed on the north end of the permit area.

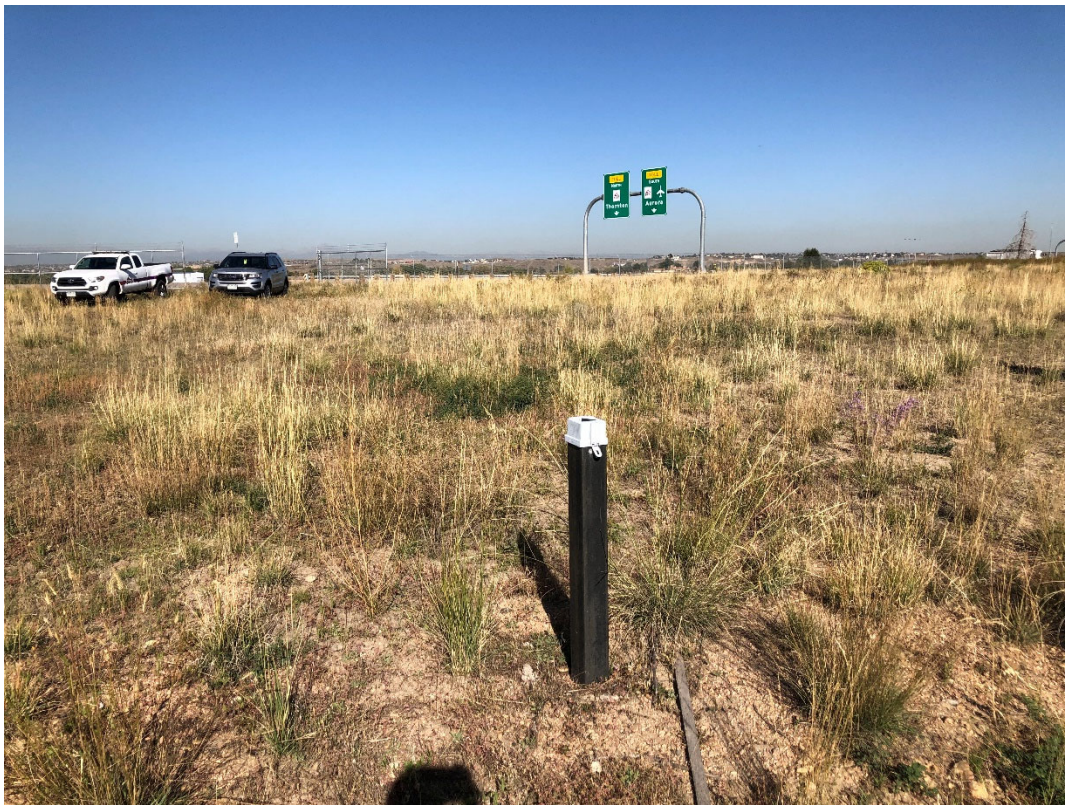
Photo 12: Looking west towards the entrance at Monitoring Well #1.

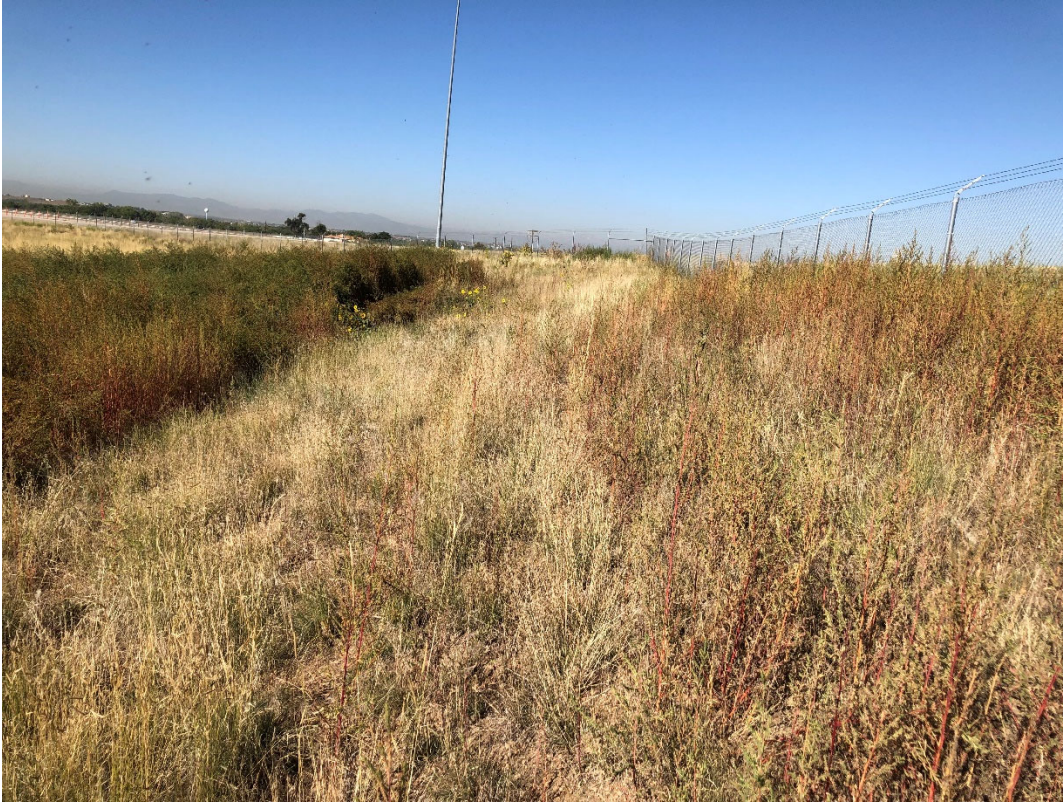
Photo 13: View looking northwest along the northern boundary of the permit area. Dense patches of thistle in this area.

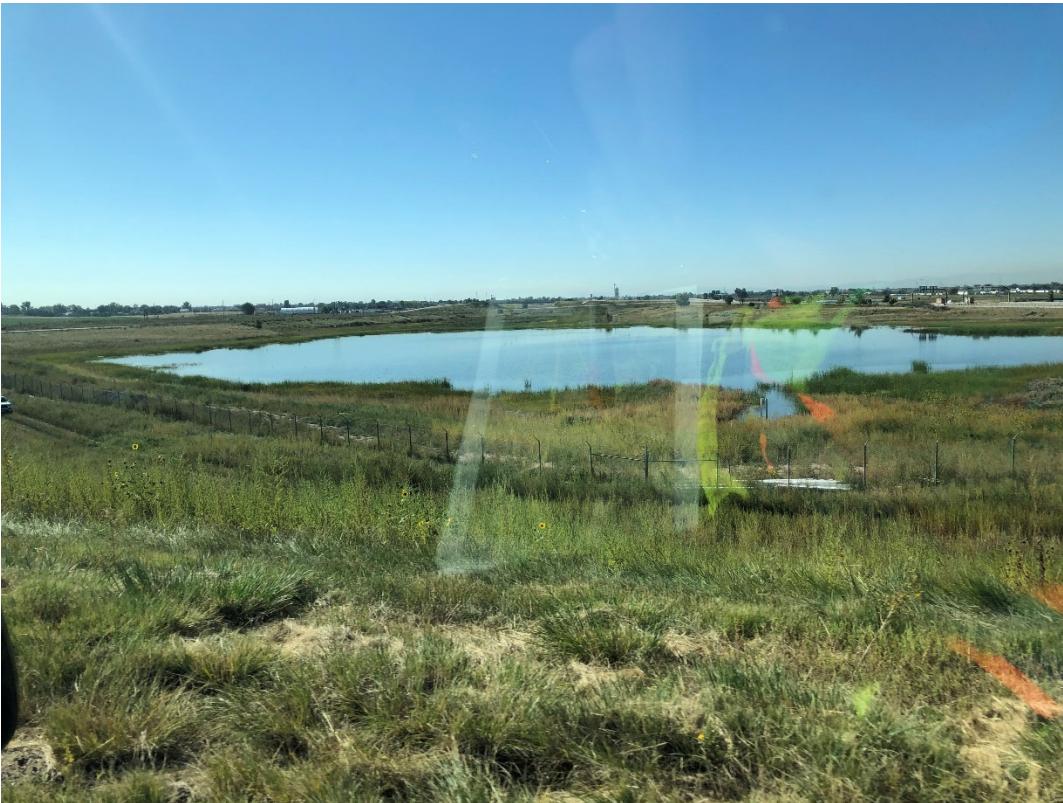
Photo 14: View looking south across the permit area from the highway.
