LORENCITO CANYON MINE
Permit No. C-1996-084

INSPECTION OF EXCESS SPOIL-FILLS 7, 8, & 9
June 14, 2024

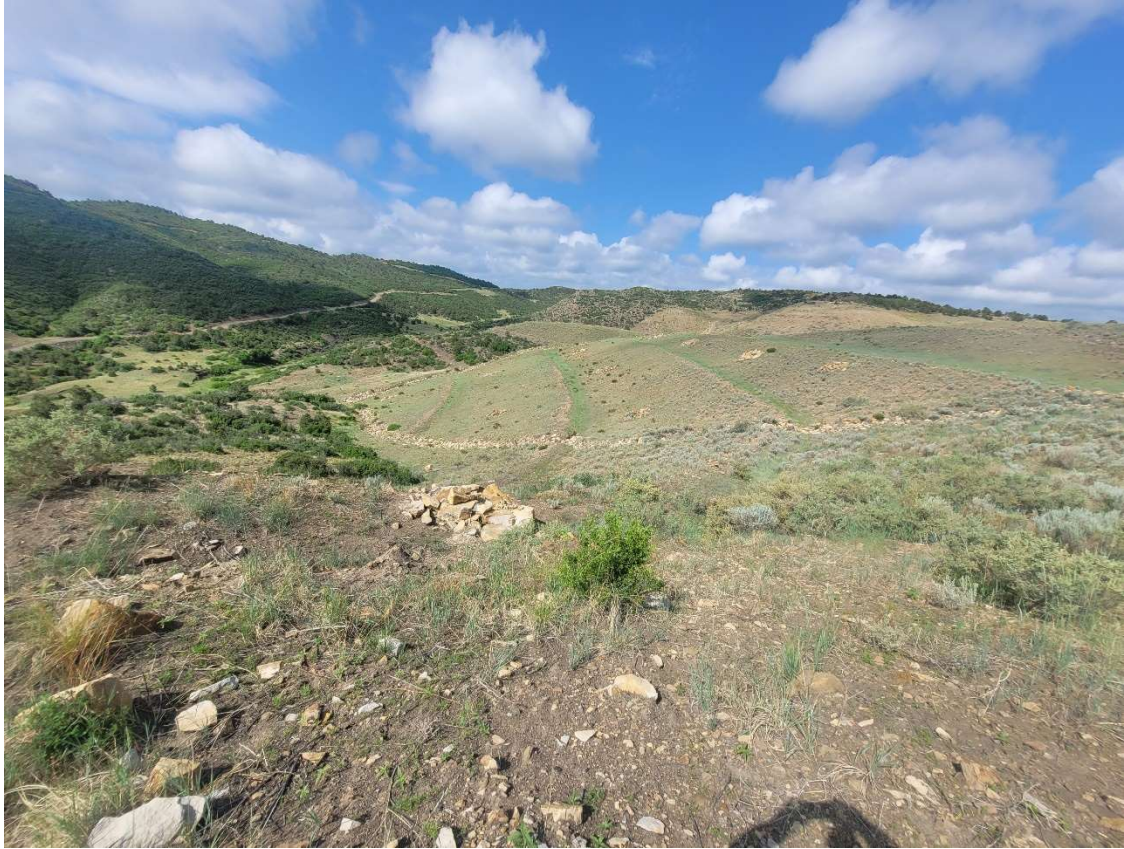
Fill #7

The entire excess spoil fill facility was examined for signs of failure and instability such as tension cracks, ground movement, springs and seeps, and standing water. There was no indication of potential instability at time of inspection.

East armored down drain needs to be monitored and might need a spot that is washed out to be re-armored. All else looks good.

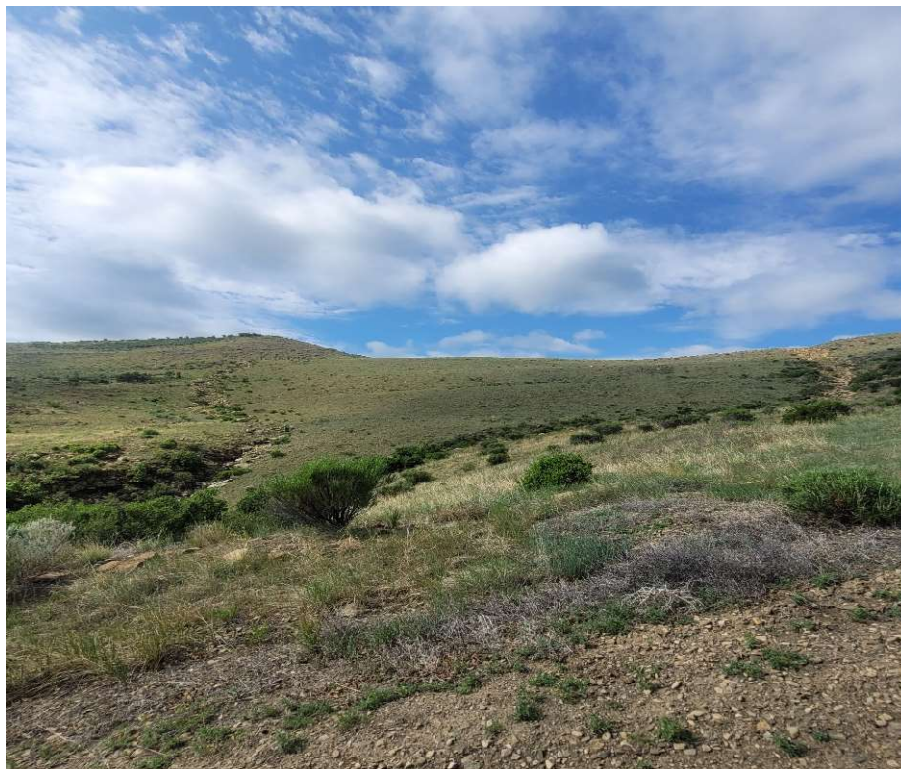
Fill #8

The entire excess spoil fill facility was examined for signs of failure and instability such as tension cracks, ground movement, springs and seeps, and standing water. There was no indication of potential instability at time of inspection.

Lower portion of East down drain needs to be monitored and may need additional rock in bare spots. All else is in good condition.

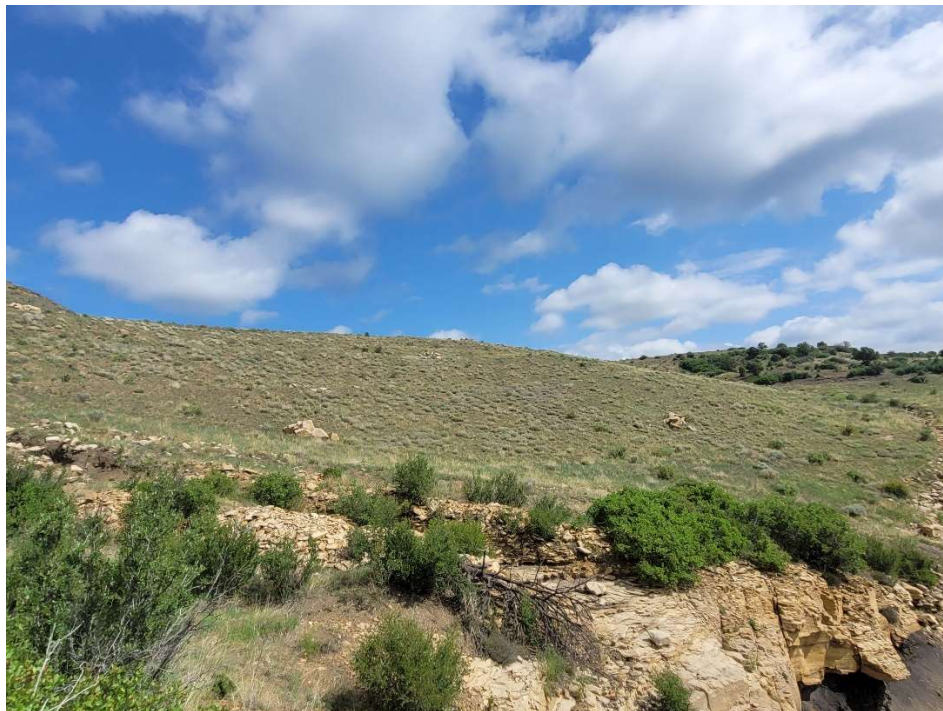
Fill #9

The entire excess spoil fill facility was examined for signs of failure and instability such as tension cracks, ground movement, springs and seeps, and standing water. There was no indication of potential instability at time of inspection.

Overall the site is in good condition.
