NEW ELK MINE
Permit No. C-1981-012

QUARTERLY COAL WASTE BANK INSPECTION REPORT
June 12, 2024

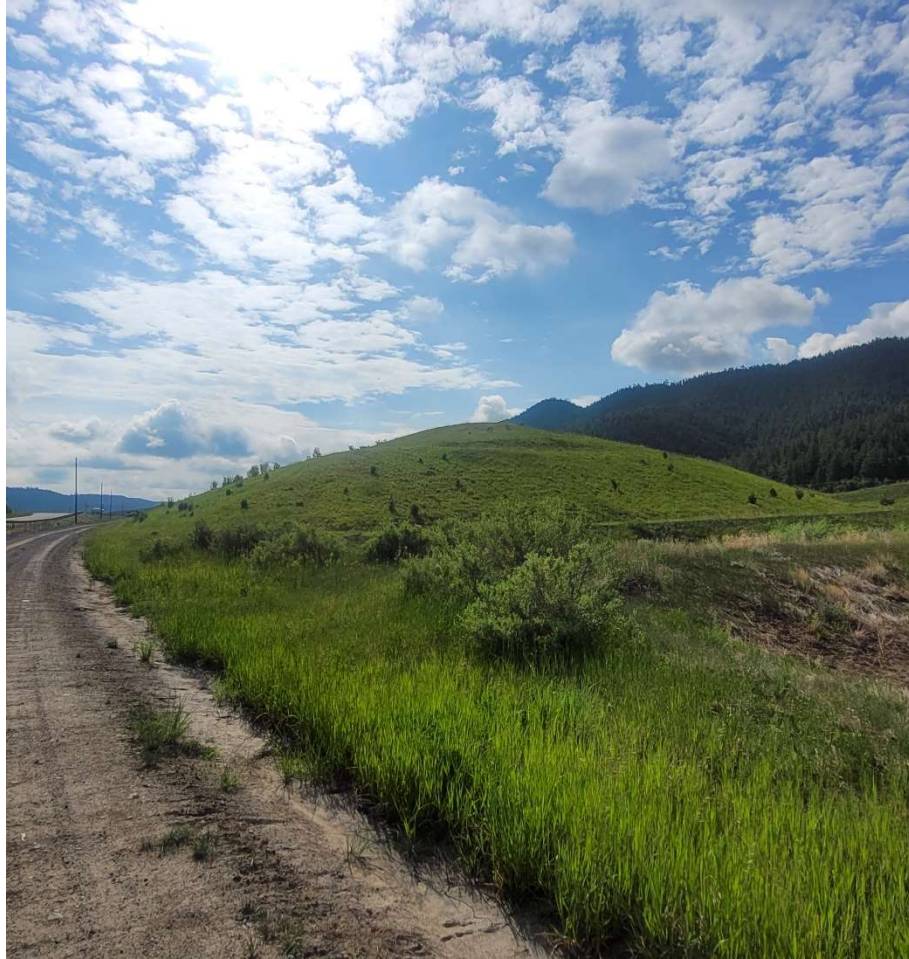
DWDA #1 West Face

Surface and out slopes of the pile were inspected for visible signs of potential failure or instability. None were observed.

Overall the disposal area is in good condition.

Ditch along base of DWDA 1 has been cleaned from the South West Corner around the western face to allow for positive drainage around the area and into Pond 4.

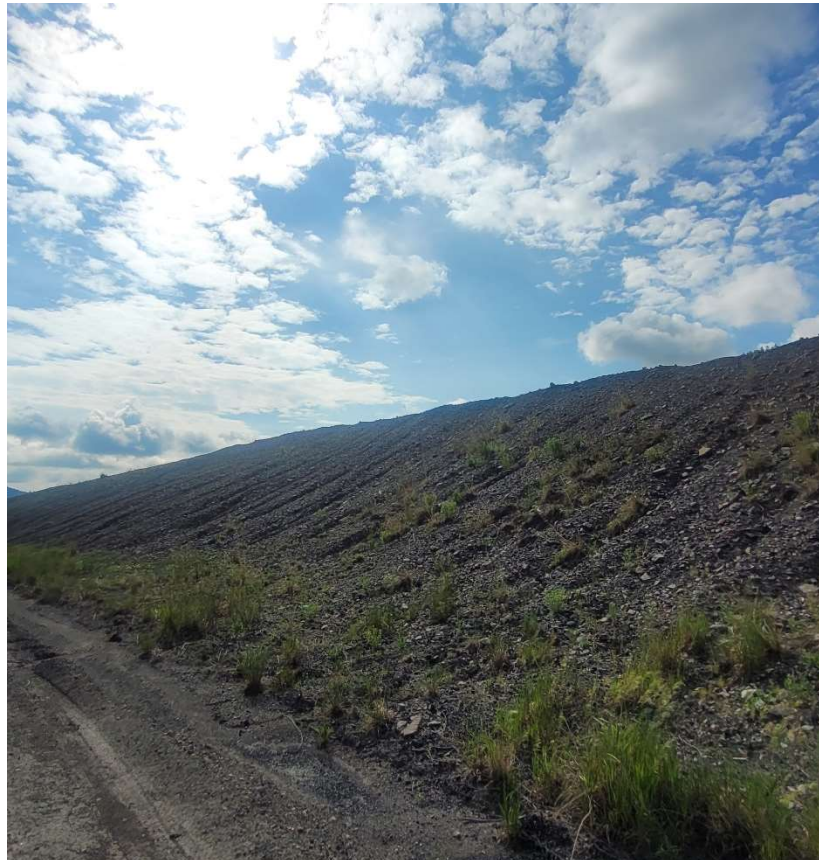
DWDA #2 North Face

Surface and out slopes of the pile were inspected for visible signs of potential failure or instability. There was some surface erosion but not enough to make the area unstable. In all no signs of failure or instability were observed.

Overall the disposal area is in good condition. The ditch around the southern and western toe was cleaned and the banks between the pile and the river buffer area was cleaned and had standard maintenance done to keep water flowing to the sediment pond on the eastern end of pile.

The Rills are being monitored and have not gotten any bigger and there is no sediment loading. Operator is evaluating either reclamation of the area or permitting alternative uses of the land north of the Purgatoire River and south of Highway 12. The ditch along the southern face has been cleaned and the berm between DWDA #2 and the river has been reinforced to prevent any run off to reach the river.

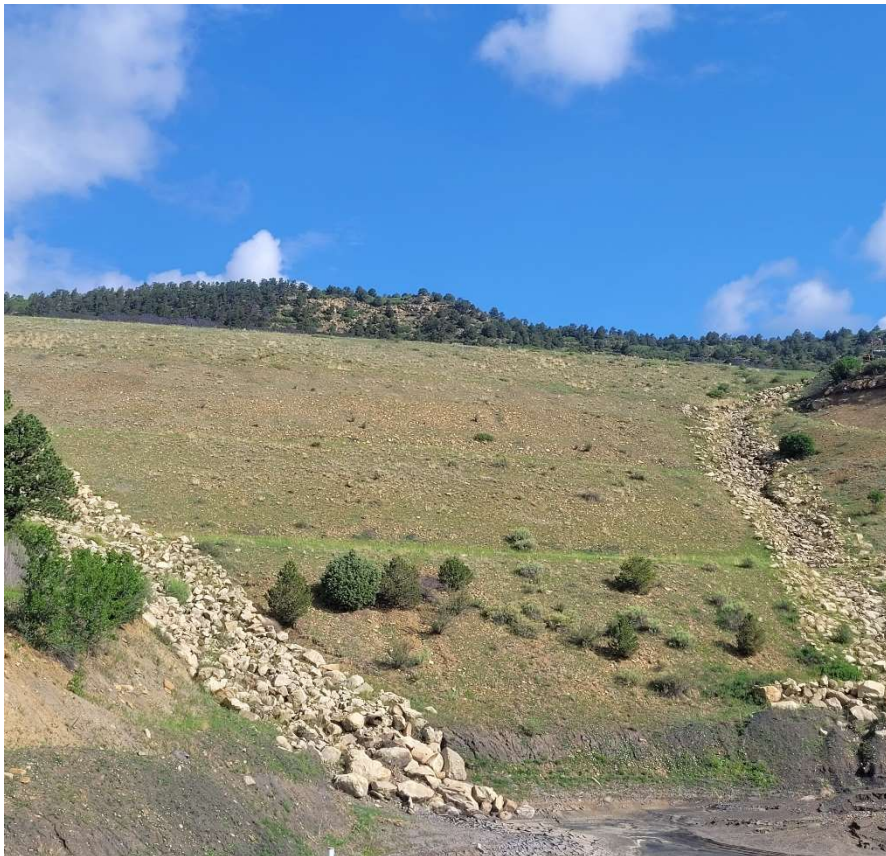
Face of Refuse Disposal Area

Overall the site is in good condition.

Work on the Clean Water Ditch above the RDA Area was finished in May of 2024. Cleaning of the ditch, was to help prevent the clean water from flowing on the RDA Area. Ditch Around the back North west corner was cleaned out of sediment and re-established the positive drainage to Pond 8 (Work completed May 2024).
