## Roadside Mine, C-1981-041, July Partial Inspection Report

**PERMIT INFORMATION**

<b>Permit Number:</b> C-1981-041 <b>Mine Name:</b> Roadside Portals <b>Operator:</b> Snowcap Coal Company, Inc. <b>Operator Address:</b> Ms. Tonya Hammond 743 Horizon Court, Suite 334 Grand Junction, CO 81506	<b>County:</b> Mesa <b>Operation Type:</b> Underground <b>Permit Status:</b> Active <b>Ownership:</b> Private
	<b>Operator Representative Present:</b>  Tonya Hammond
<b>Operator Representative Signature:</b> (Field Issuance Only)

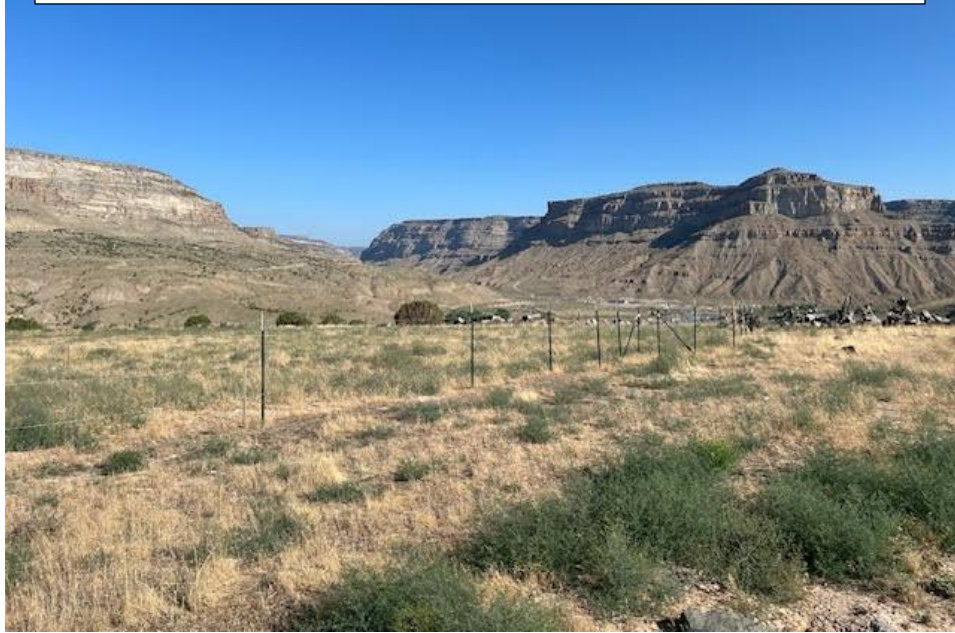
The TR-69 Repair Area is located in the northern portion of Tract 71. The repair area is approximately 0.4 acres in size. Repair work was completed in the fall of 2009 and the area was reseeded in the fall of 2023 following the area being disturbed by the landowner. Vegetation at the site was filling in well and helping stabilize the reclamation. Vegetation was beginning to dry out in the hot summer weather (Photo 1). The site was stable and

.Photo 1: The TR-69 Repair Area. Photo 1 was taken looking to the northwest

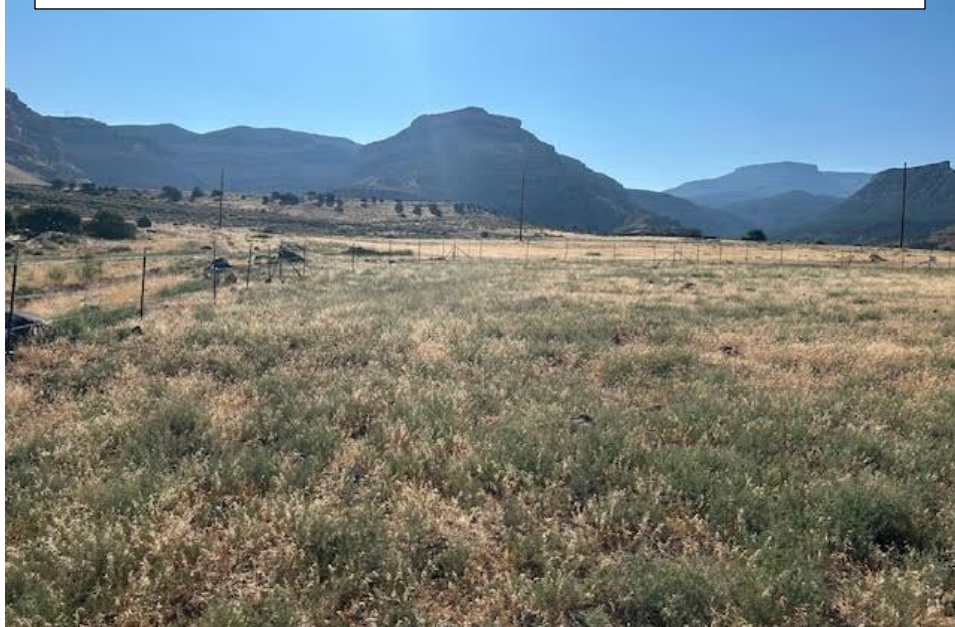
there were no erosional features identified (Photo 2). No indications of differential settling were observed. The perimeter of the repair area is delineated by a wire fence. The fence was intact and in good repair. Straw sediment logs placed at the low topographical spots were in good condition (Photo 3). There was no indication of off-site impacts.

Photo 2: The TR-69 Repair Area. Photo 2 was taken looking to the east.

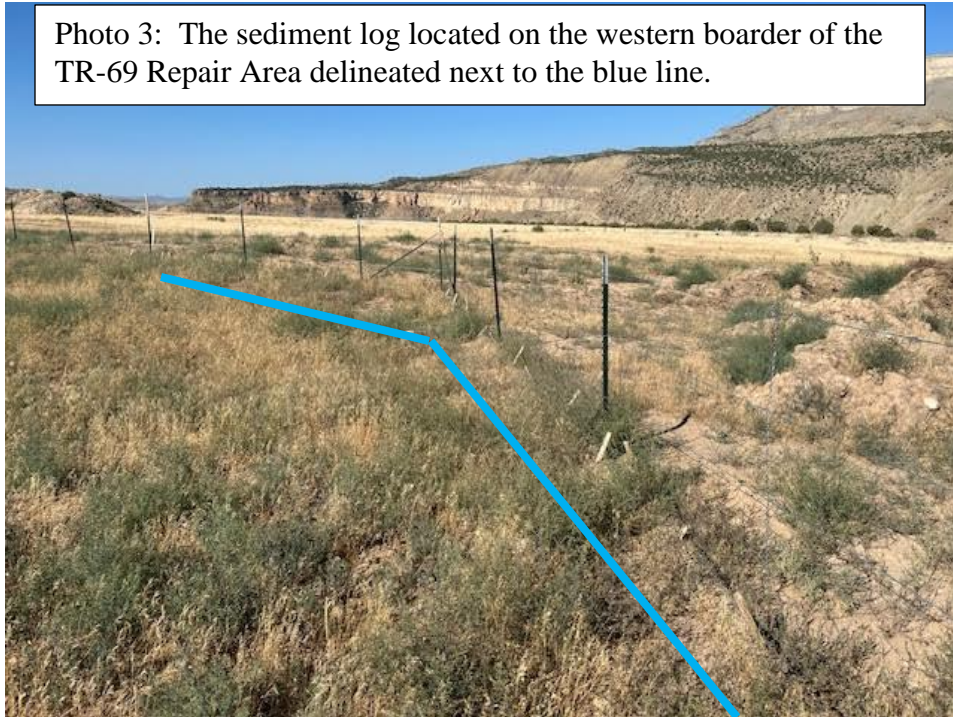
Photo 3: The sediment log located on the western boarder of the TR-69 Repair Area delineated next to the blue line.

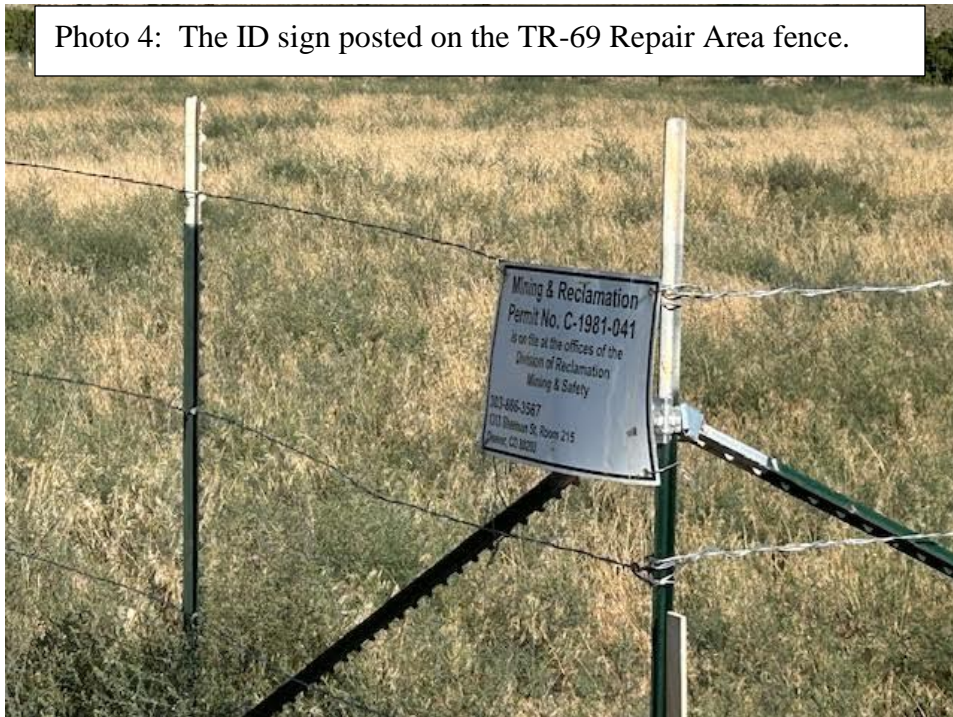
A Mine identification sign is also posted on the southern fence of the TR-69 Repair Area (Photo 4). The sign was posted in a location with an unobstructed viewshed. The sign was legible and displayed the permit number and contact information for the Division.

Photo 4: The ID sign posted on the TR-69 Repair Area fence.
