Hayden Gulch LO, C-1992-081

PERMIT INFORMATION

INSPECTION INFORMATION

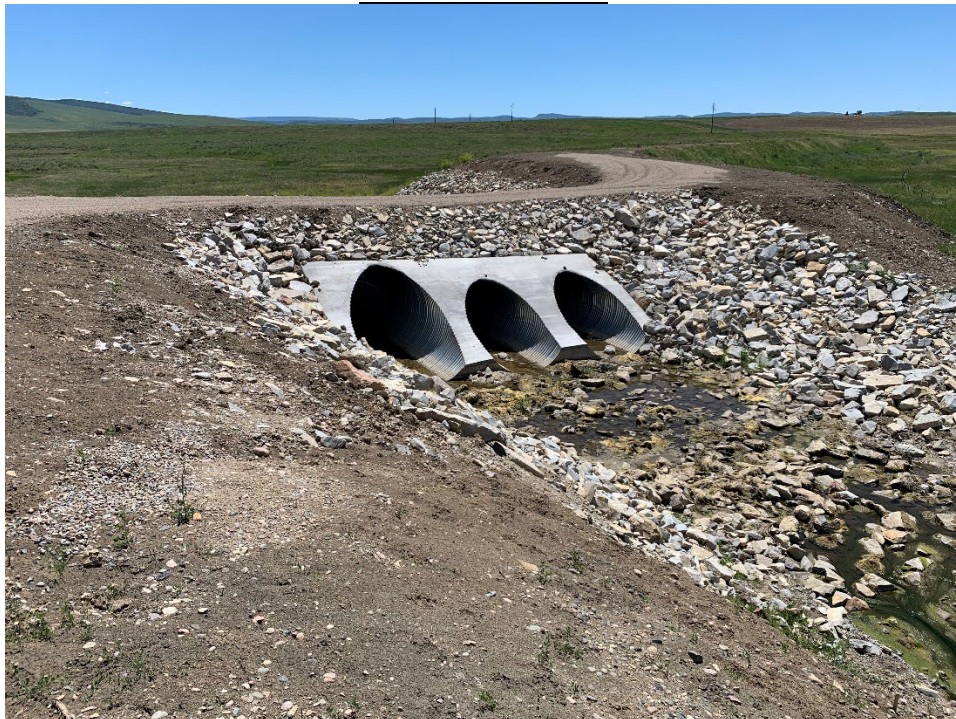
The 3 large culverts in Dry Creek on the northern section of the rail loop trail were free of obstructions and appeared to be in working order (photo 1). Rip rap rocks were in place around the culverts and appeared to be stable (photo 2).

Photo 1 – Three culverts in Dry Creek, north side of hiking trail.

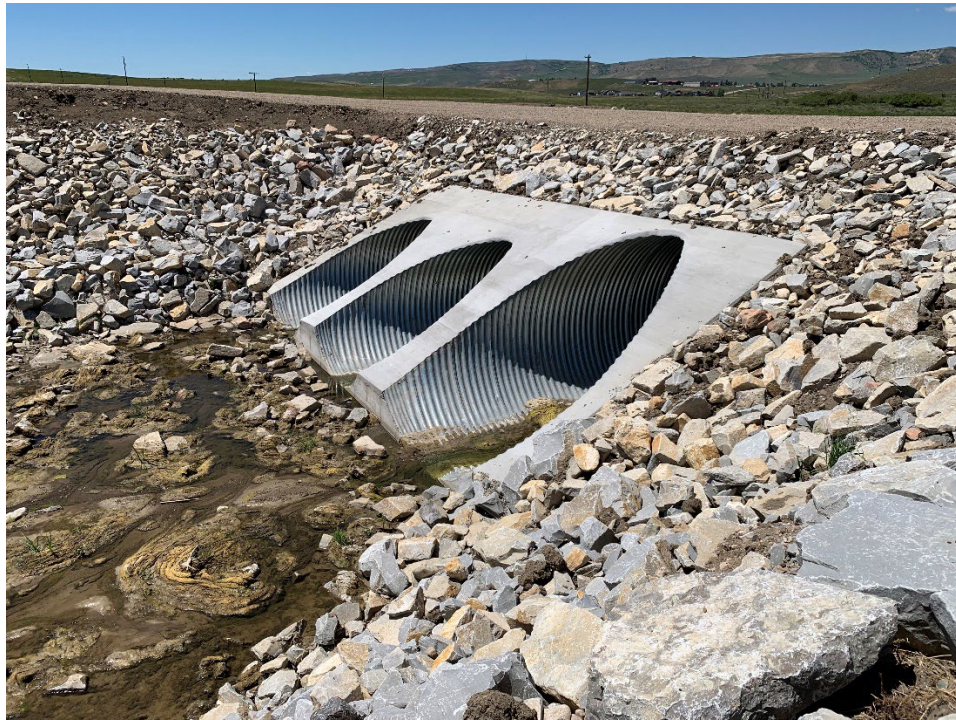
Photo 2 – Three culverts in Dry Creek, south side of hiking trail

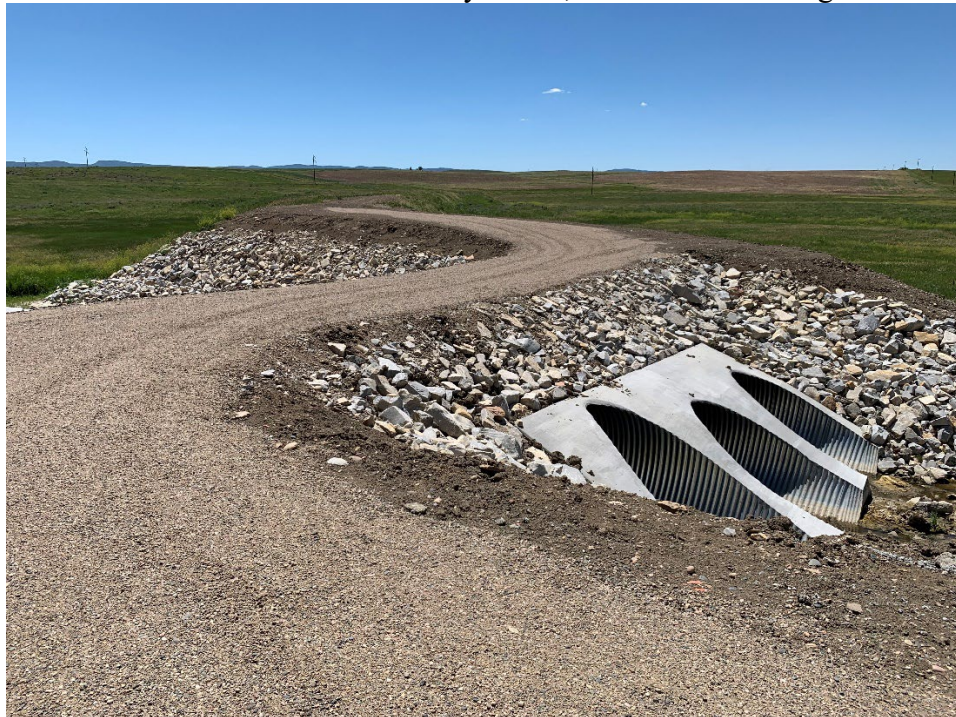
The northern section of the rail loop trail appears to be completed over the Dry Creek crossing (photo 3). No trail maintenance equipment was on site.

Photo 3 – Hiking trail over Dry Creek.

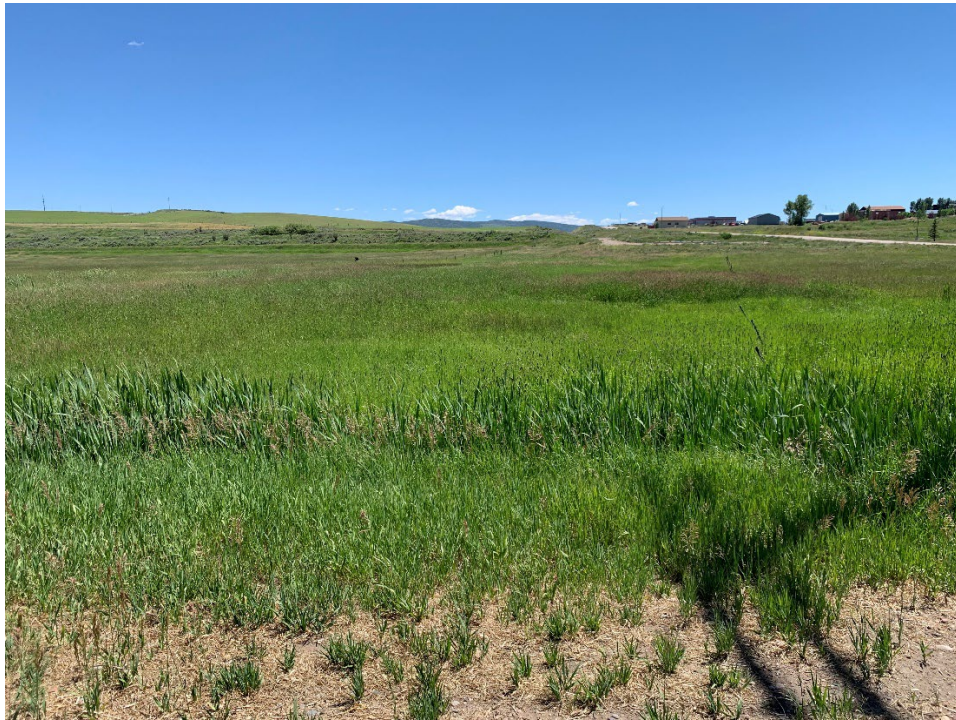
The vegetation between the main rail line and the trailhead parking lot appeared to be doing well (photo 4). The vegetation was dense, and no erosion features were seen.

Photo 4 – Reclaimed area facing south toward trail head parking lot.

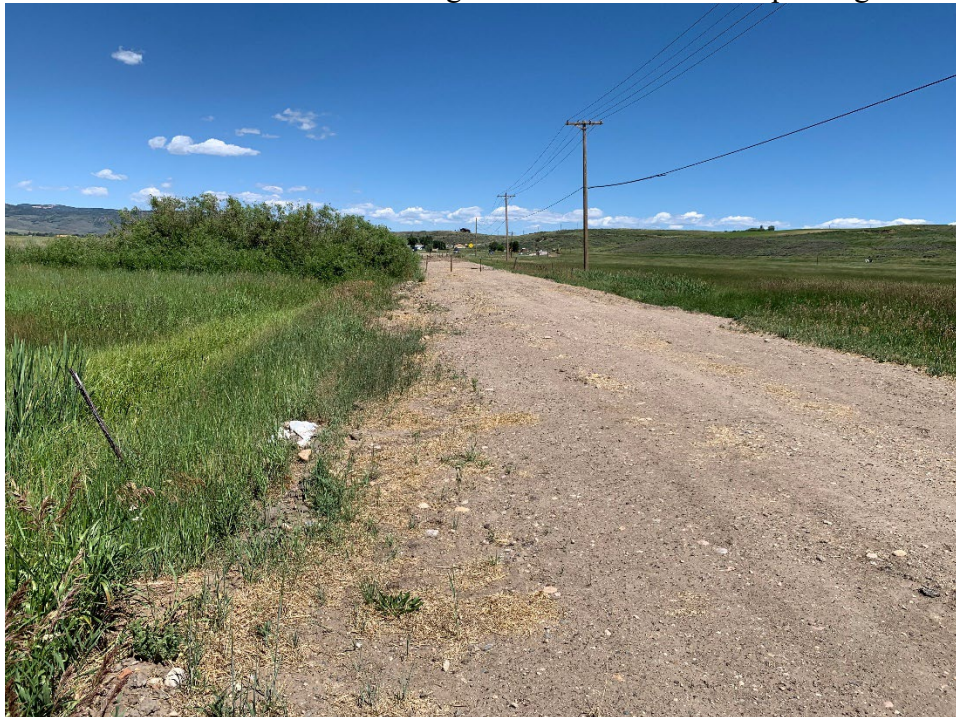
The buried sewer line that was installed by the City of Hayden had been backfilled and graded (photo 5). It is not known at this time if the area was seeded.

Photo 5 – Area of City of Hayden buried sewer line.

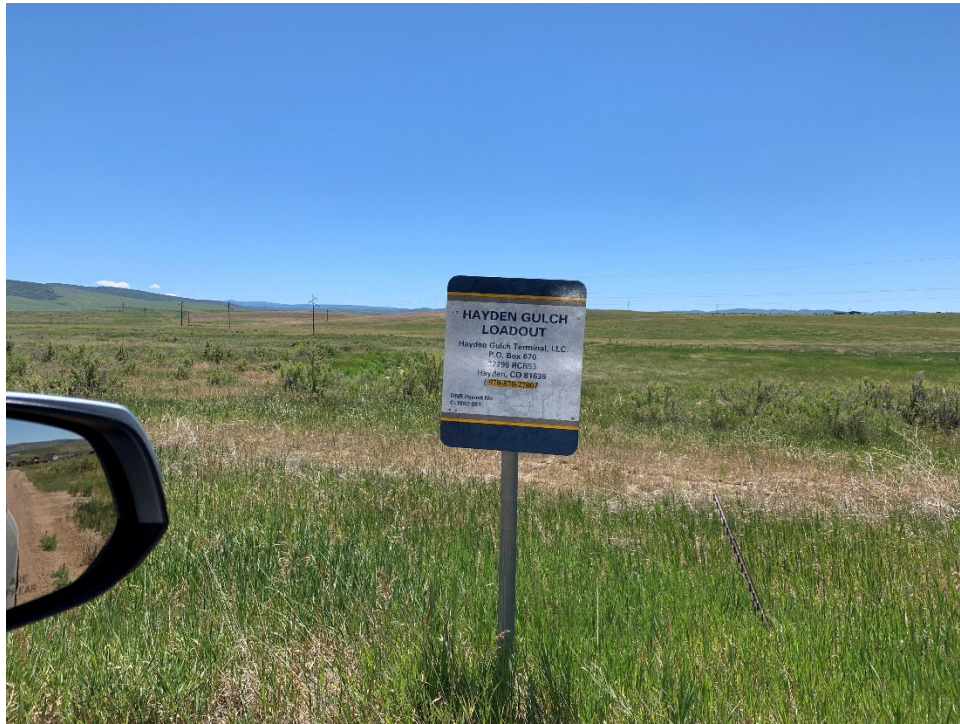
A mine identification sign was in place along CR 37 (photo 6).

Photo 6 – Mine identification sign along CR 37
