QUARTERLY SEDIMENTATION POND INSPECTION REPORT

Mine: New Elk WP Containment #1

Inspection Period: Second Quarter 2024

Inspection Date: 06/14/24

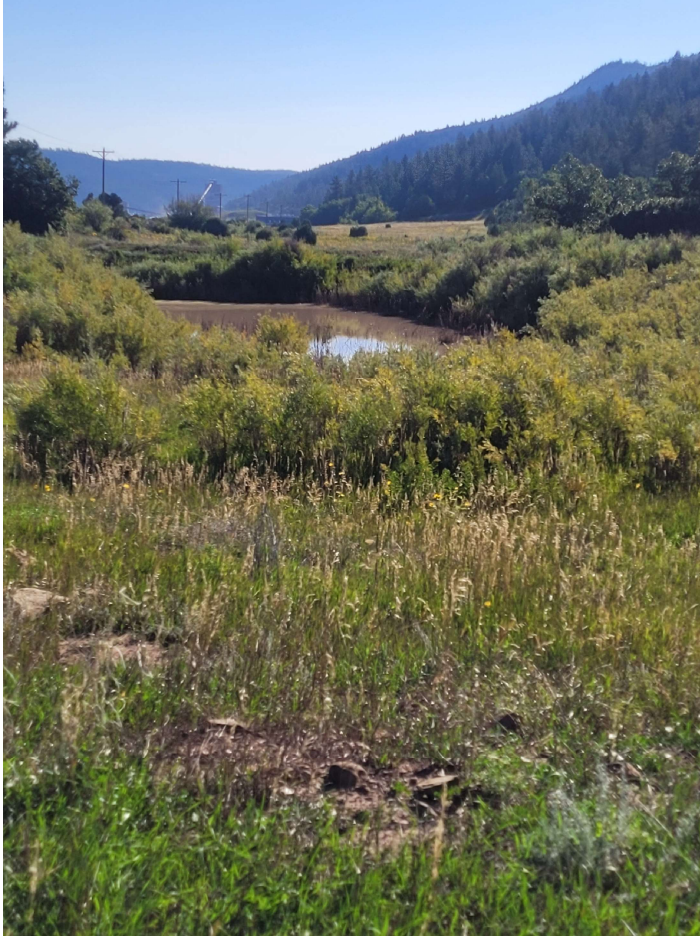
Containment was holding water at the time of inspection.

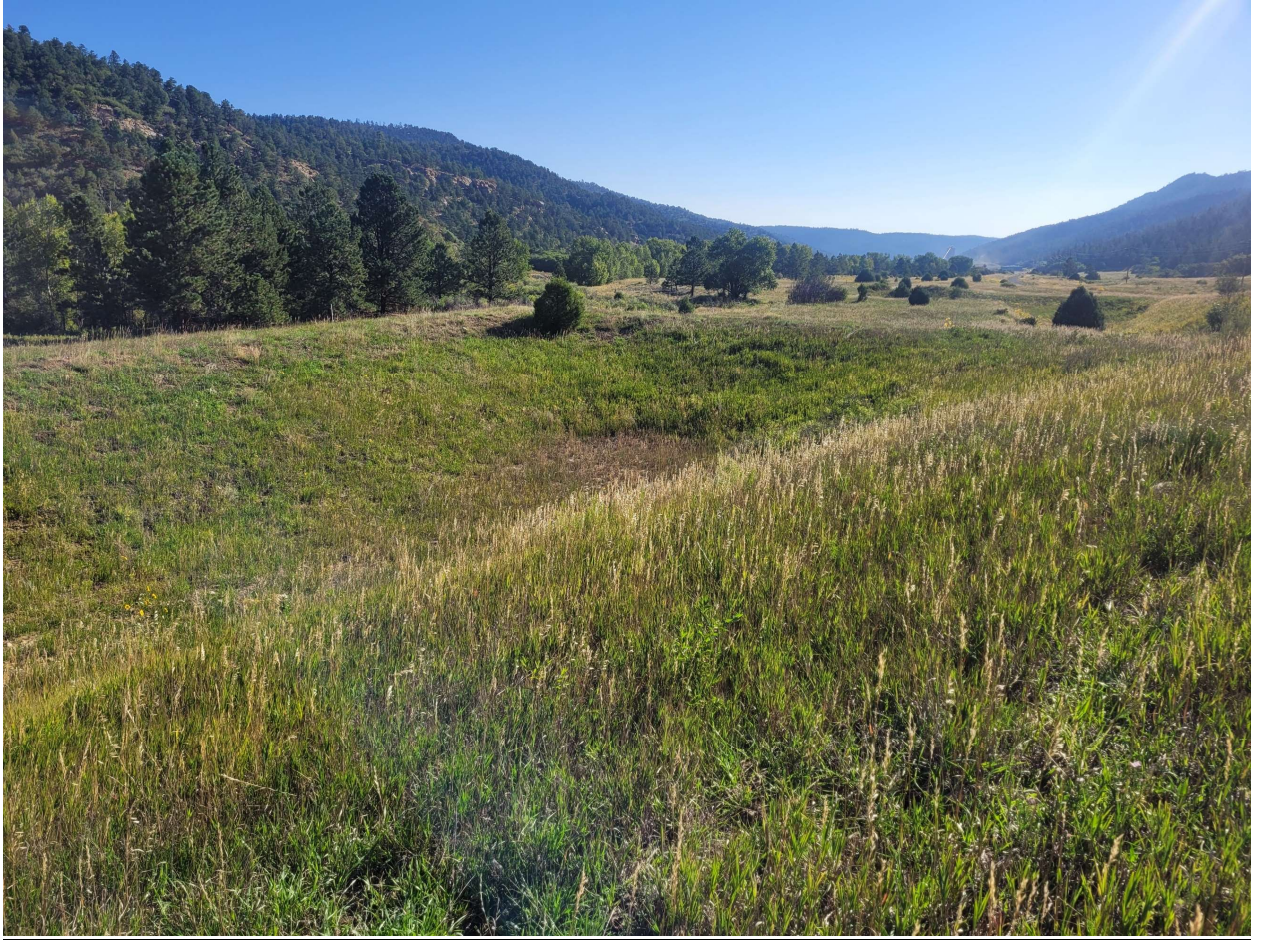
Mine: New Elk WP Containment #2

Containment was empty at time of inspection.

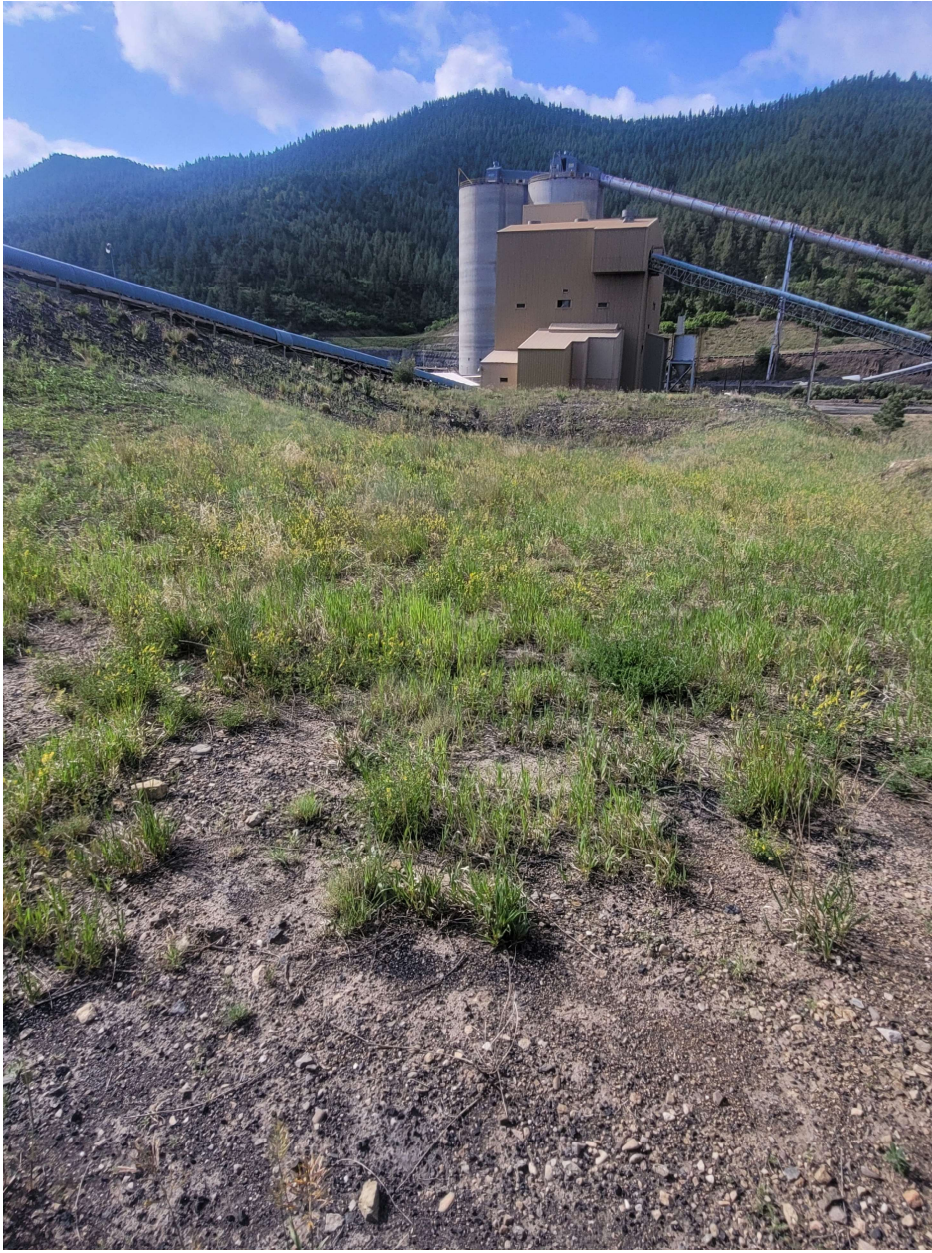
Mine: New Elk Containment #3

Containment Area was holding a small amount water at time of inspection.

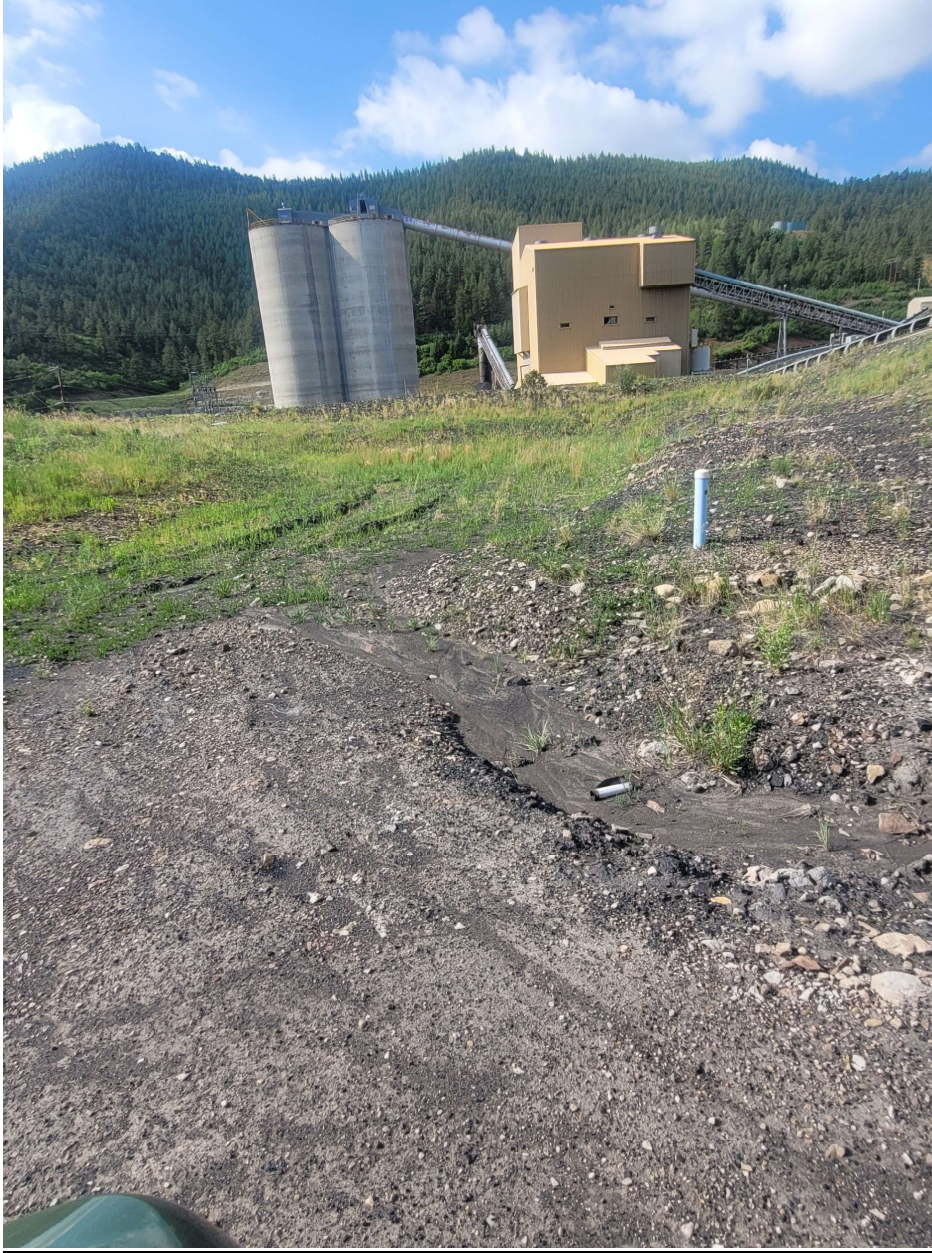
Mine: New Elk Containment #4

Containment Area was in good condition at time of inspection.

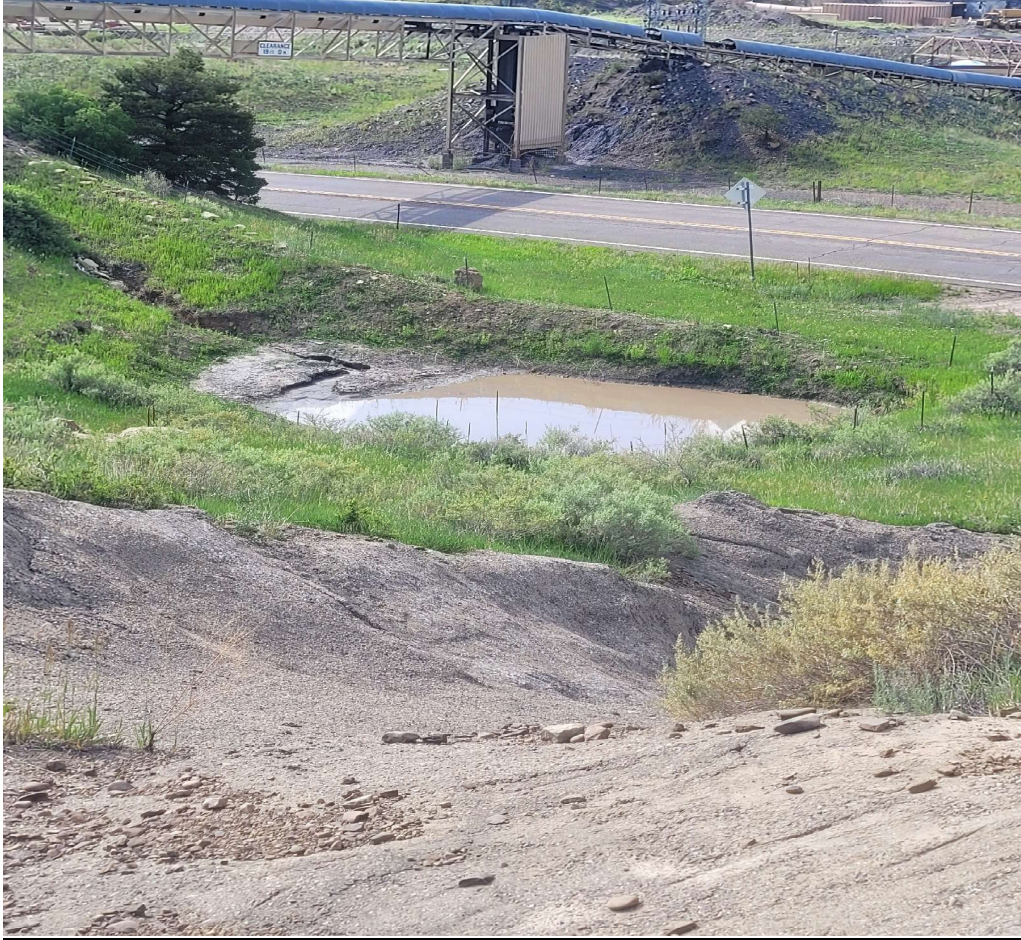
Mine: New Elk Containment #5

Containment Area was holding water r at time of inspection. It was cleaned in May of 2024.

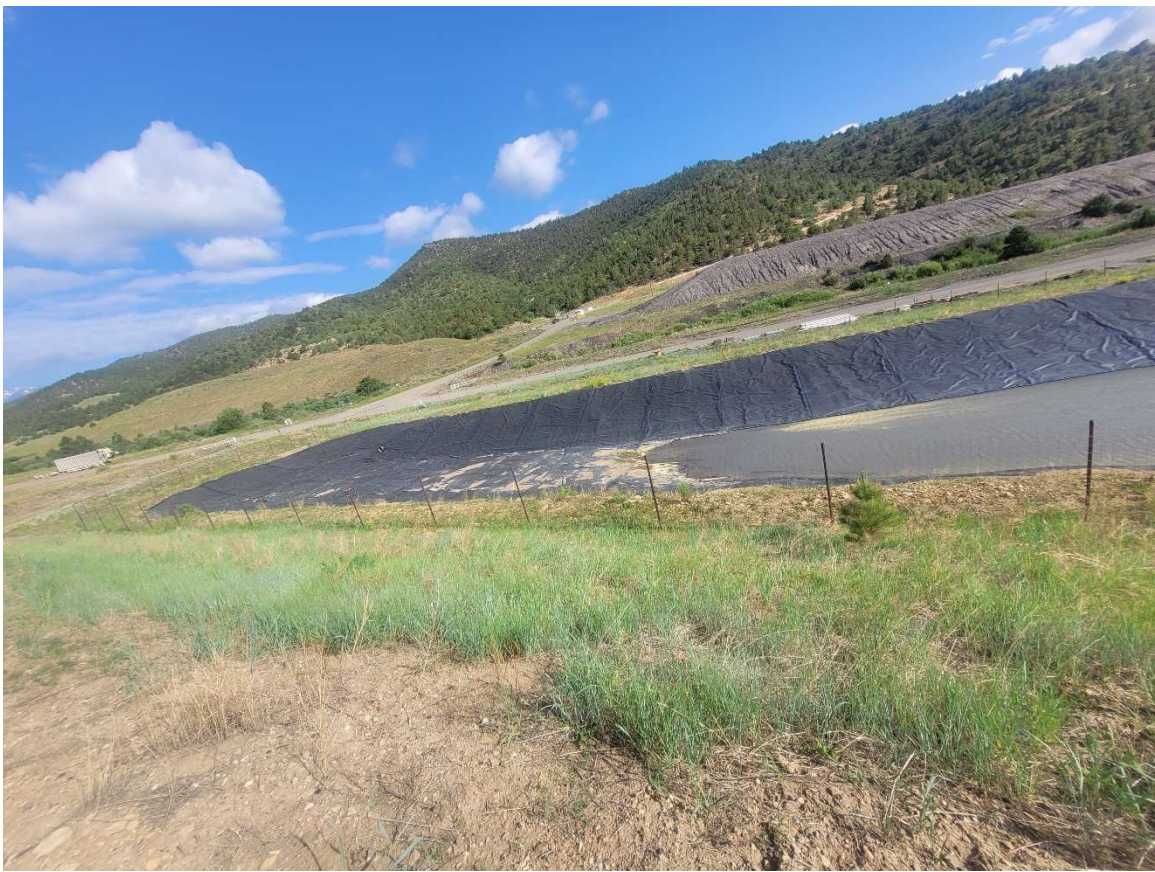
NPDES ID. No.: Pond #1

Pond liner is in good working condition at time of inspection. Pond was holding water at time of inspection. No issues observed.

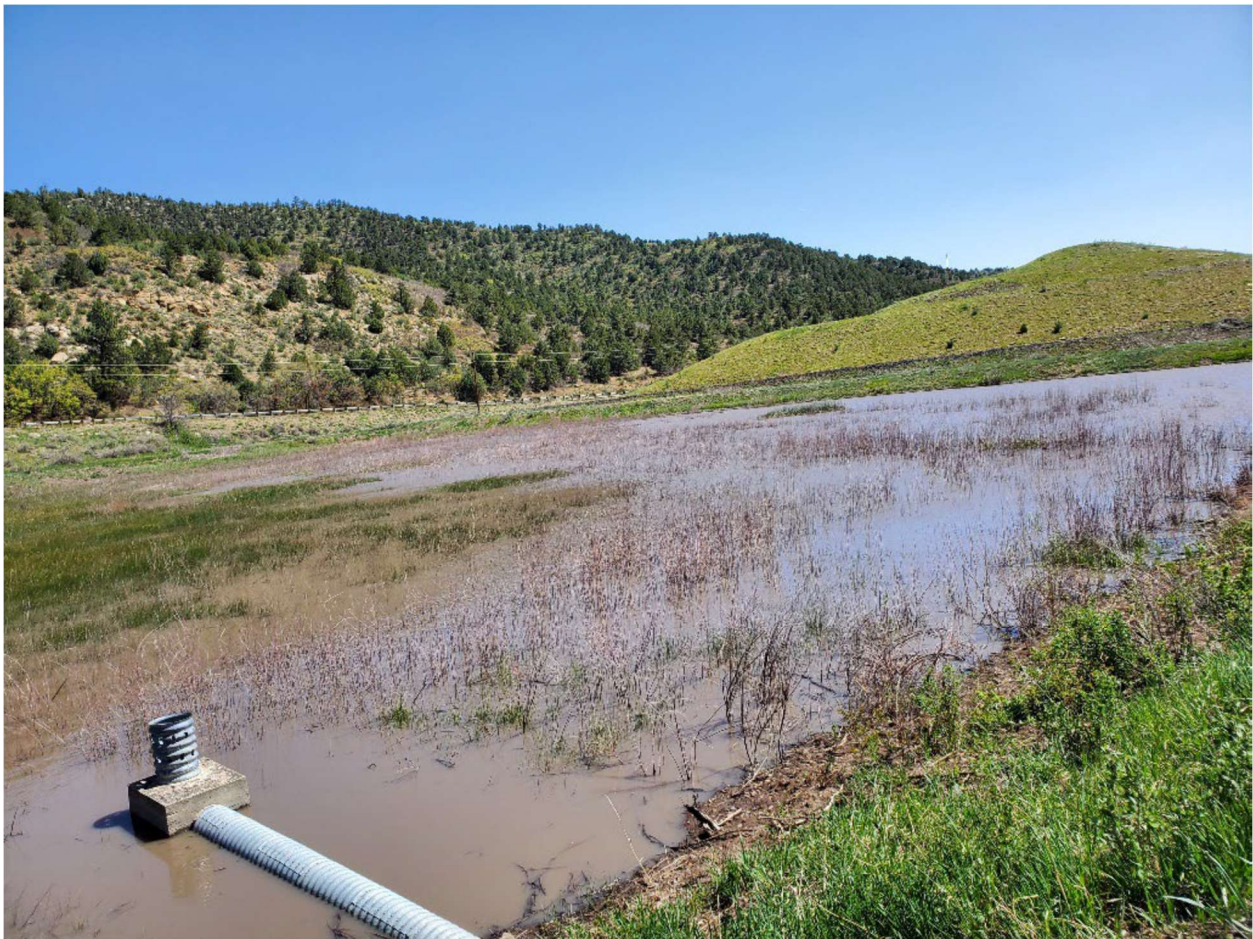
NPDES ID. No.: Pond #4

Pond was holding water at the time of inspection, not near the discharge level. No Issues observed. Water has been pumped into the pond recently from pond 7 and pond 6.

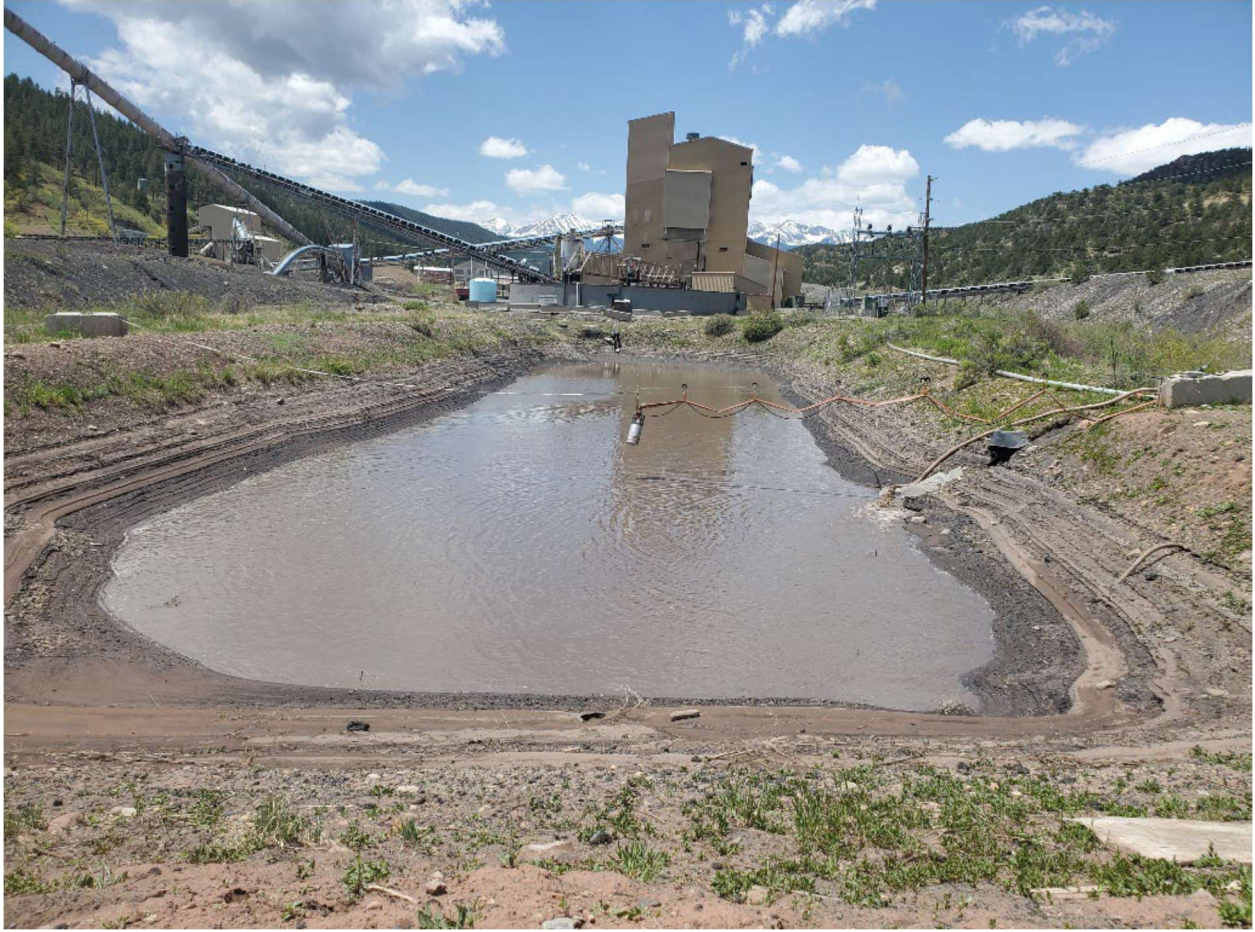
Mine: New Elk Pond 6

Pond is holding water at time of inspection; Water has been pumped to pond 4.

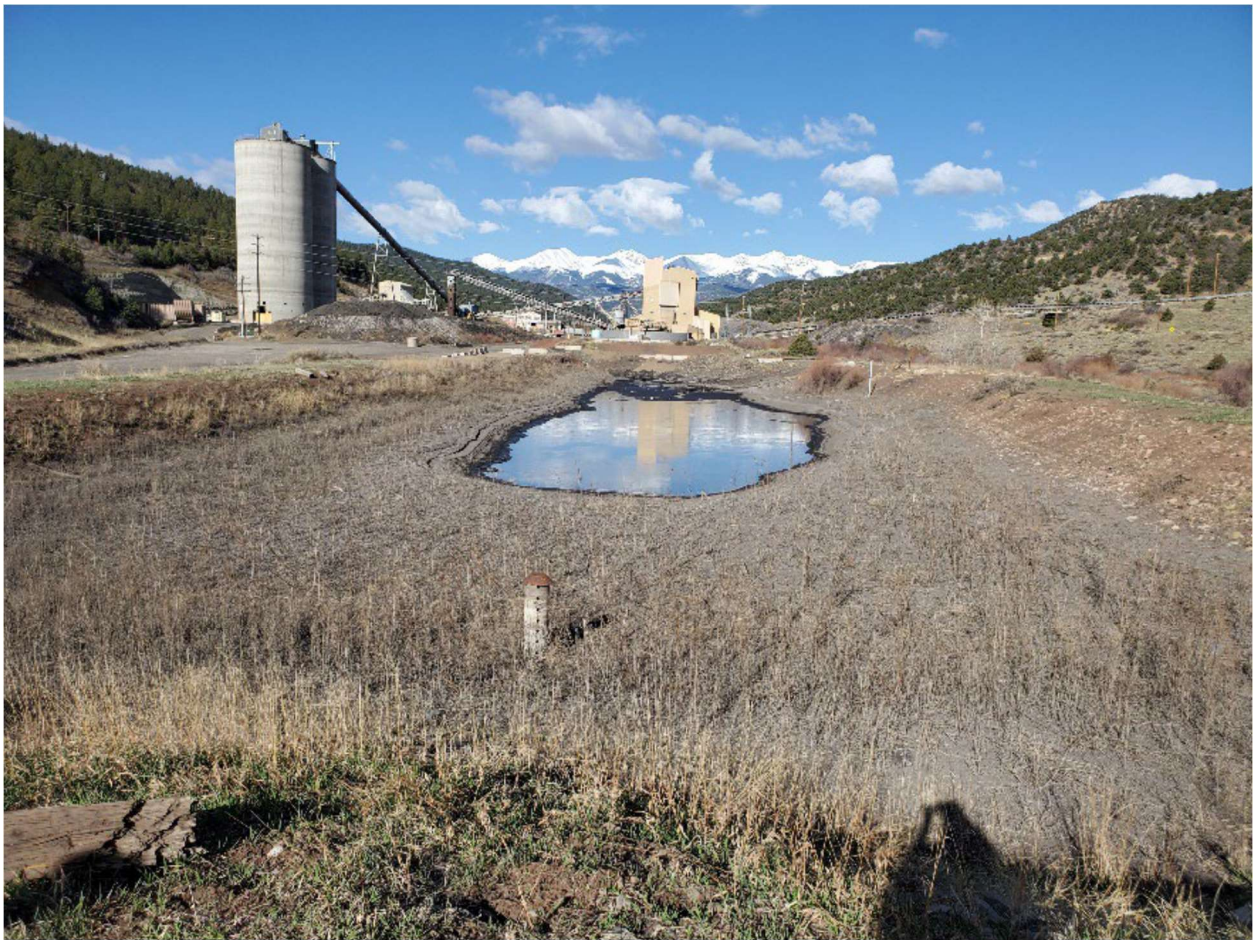
NPDES ID. No.: Pond #7

Pond is holding water at time of inspection. No issues observed.

No discharges have occurred, water level was lowered by pumping to Pond 4.

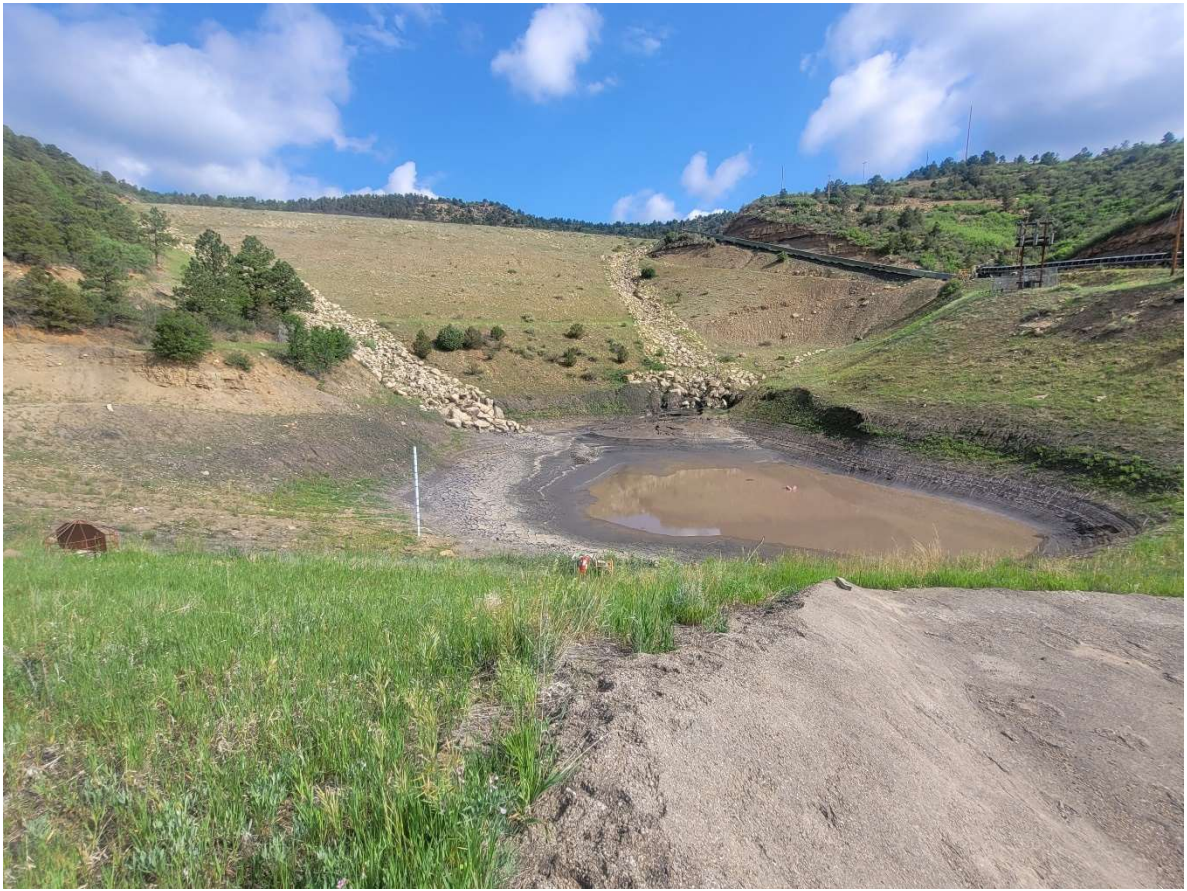
NPDES ID. No.: Pond #8

Pond is holding water at time of Inspection. The water level is now about 3 feet below the measuring device and has more than the design compacity. No discharges have occurred and No issues were found during the inspection.
