QUARTERLY SEDIMENTATION POND INSPECTION REPORT

Mine: Lorencito

Inspection Period: Second Quarter 2024

Inspection Date: 06/13/24

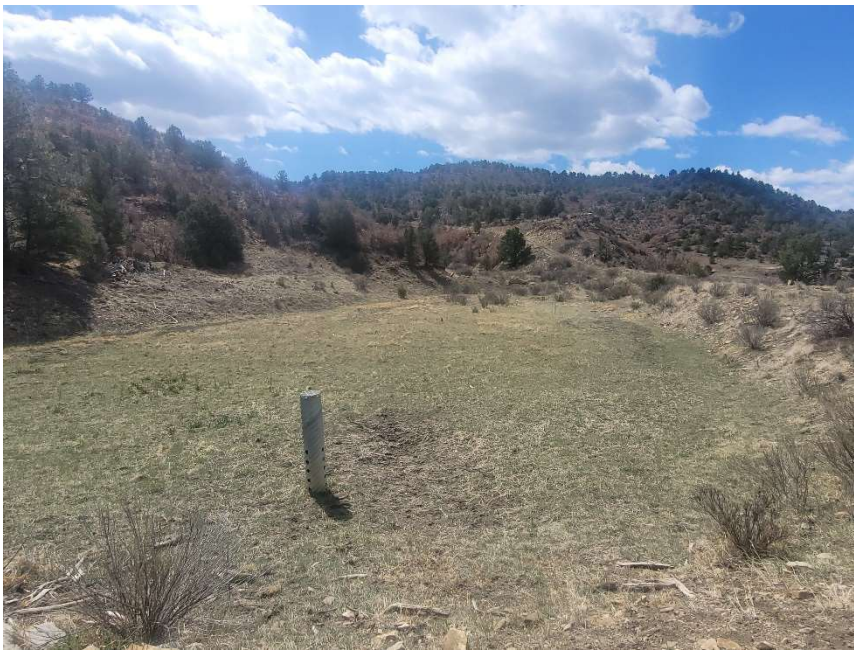
NPDES ID. No.: Pond #5

Explain: Sediment in pond does not appear to be over capacity by visual inspection.

Pond was empty at time of inspection.

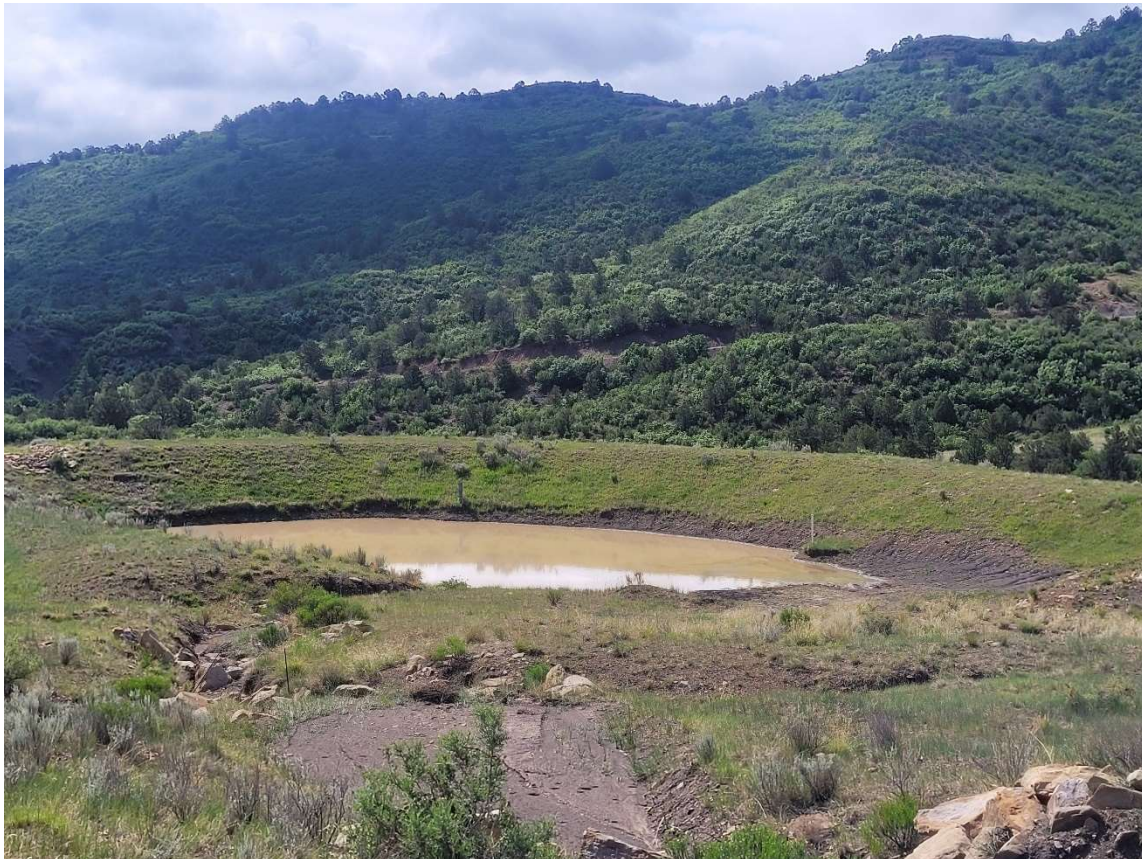
NPDES ID. No.: Pond #6

Pond was holding water at time of inspection, not near the bottom of the decant. Bank was stable during inspection.

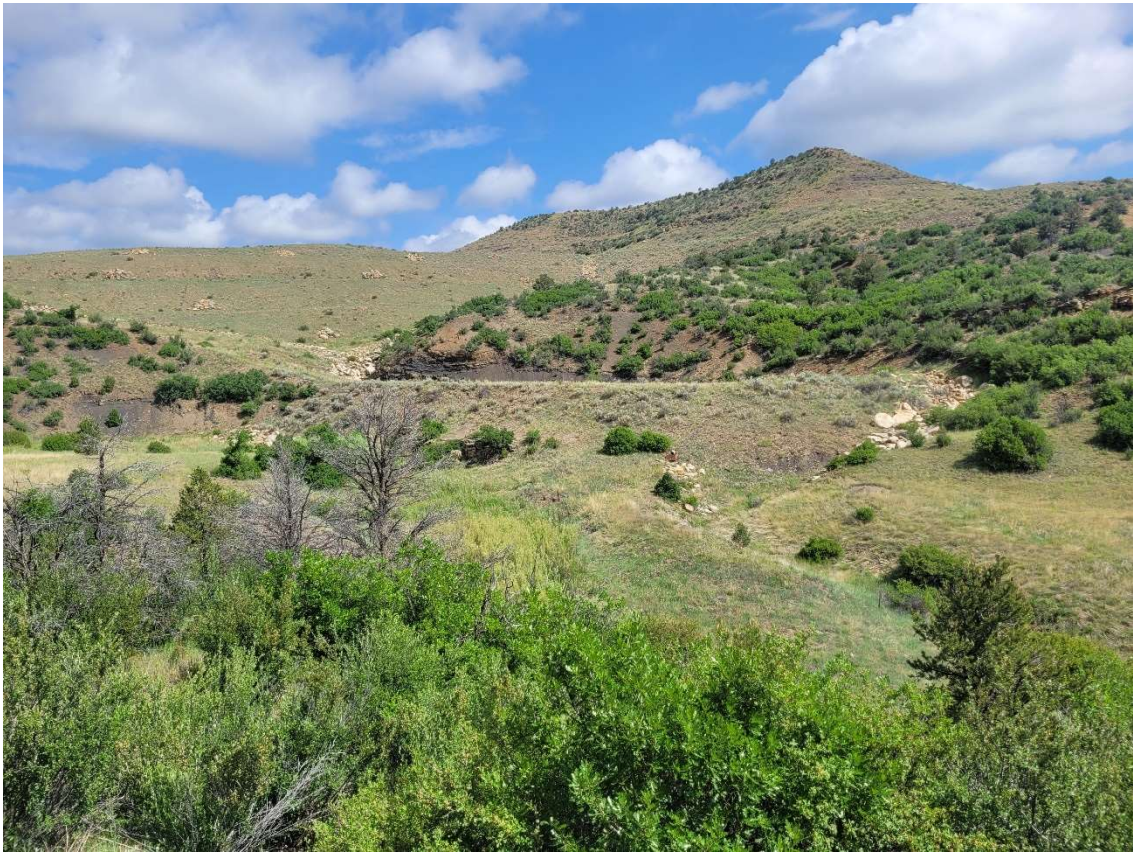
NPDES ID. No.: Pond #7

Pond was holding a small amount of water at time of inspection. Pond Bank in Great Condition.

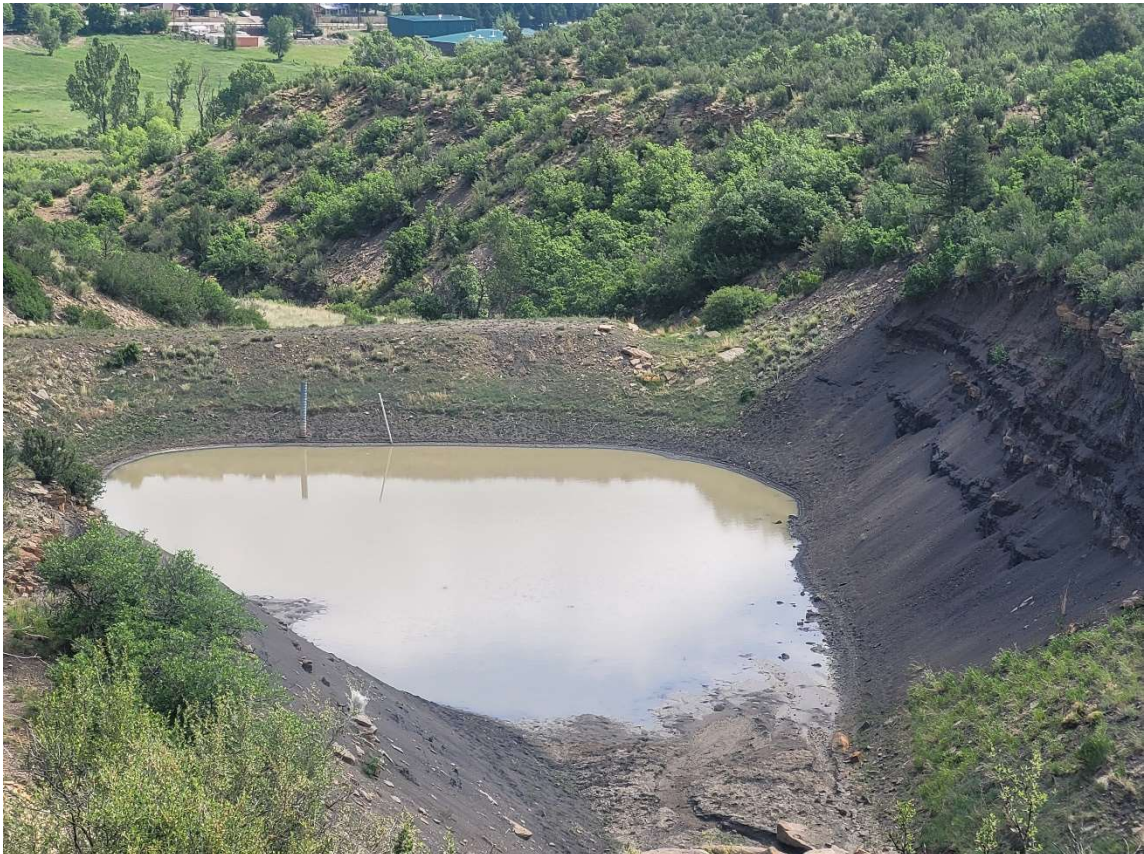
NPDES ID. No.: Pond #8

Pond was holding water at the time of inspection. Appears to have not discharged recently.

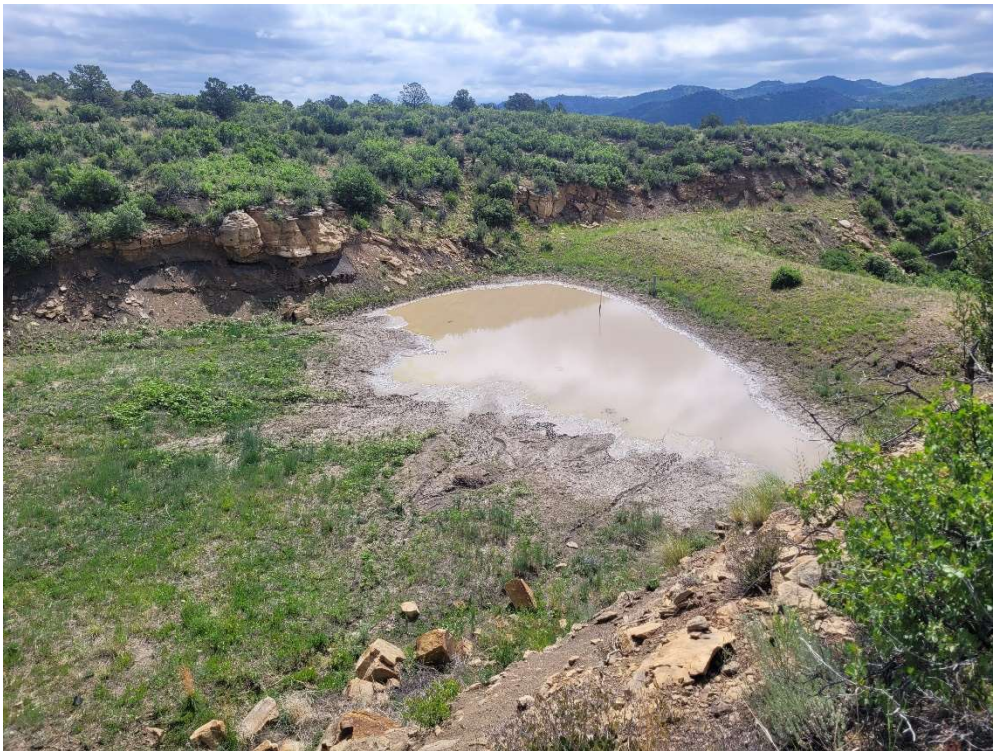
NPDES ID. No.: Pond #9 (North)

Pond was holding some water at time of inspection. Not near the level of the decant.

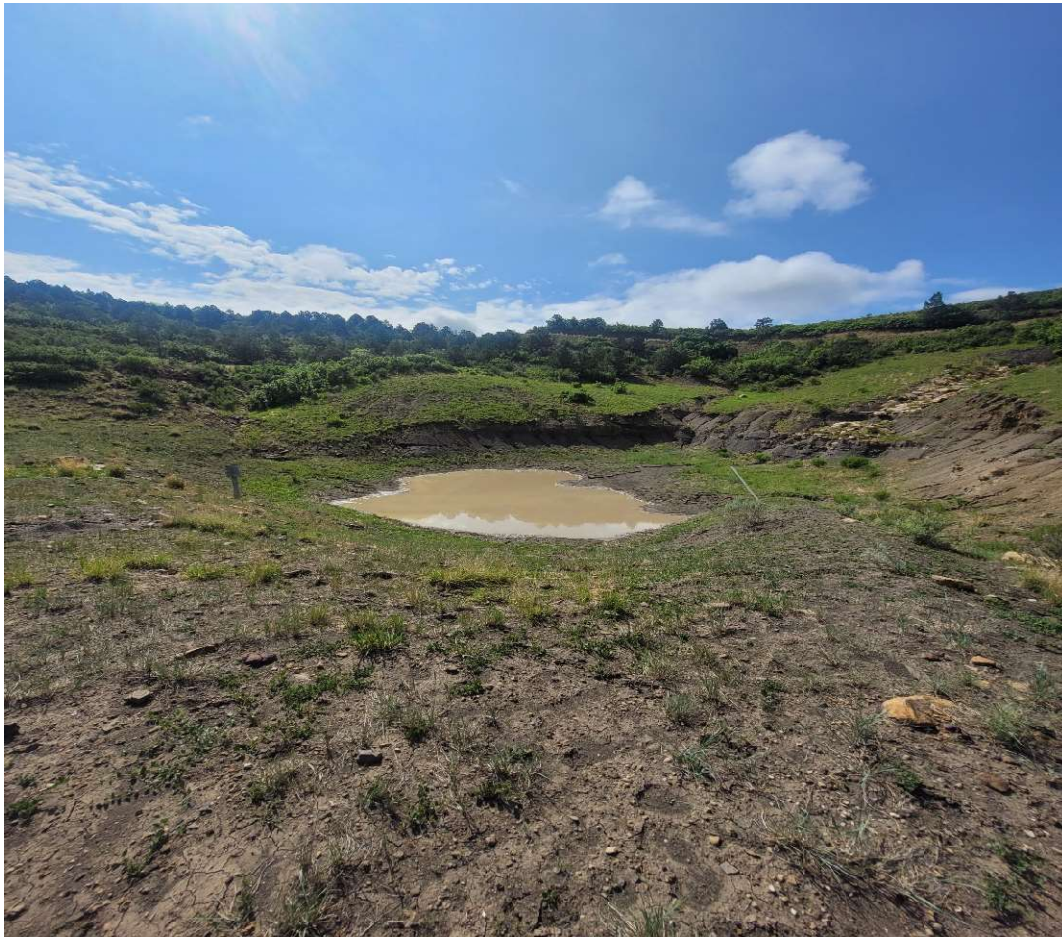
NPDES ID. No.: Pond #9A (South)

Pond was holding water at time of inspection. Does not appear to have recently discharged.
