New Elk Mine C-1981-012, August Inspection Report

PERMIT INFORMATION

Permit Number: C-1981-012 Mine Name: New Elk Mine Operator: New Elk Coal Company, LLC Operator Address: Mr. John Terry 12250 Highway 12 Weston, CO 81091	County: Las Animas Operation Type: Underground Permit Status: Active Ownership: Private
	Operator Representative Present: Jim Begano and Bill Massarotti
Operator Representative Signature: (Field Issuance Only)

INSPECTION INFORMATION

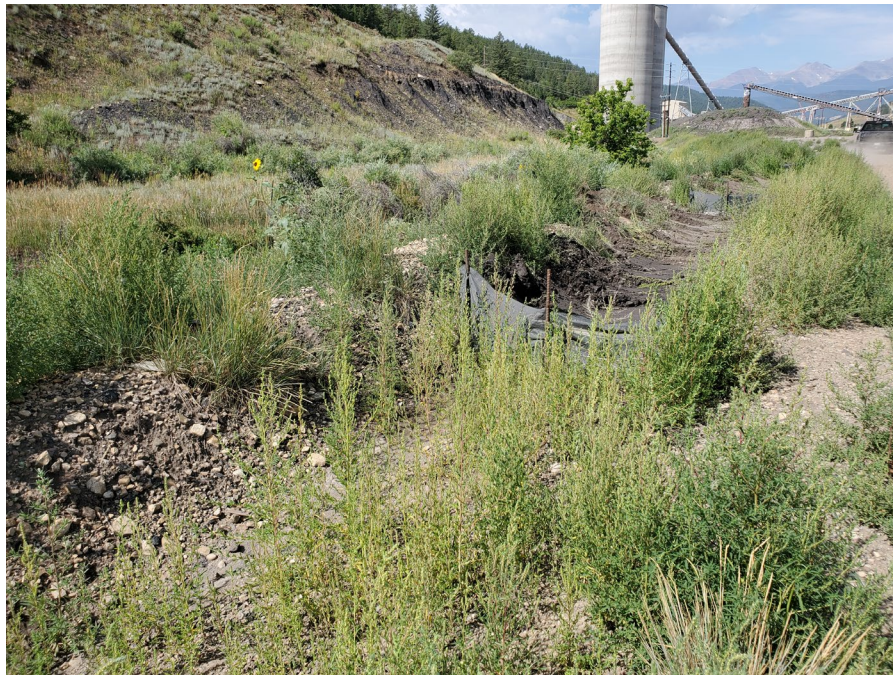
- Bill had recently cleaned multiple ditches of sediment to enable them to function more efficiently. See Photos 1-5 showing the recently cleaned Ditch D58, D22A (east side), D22A (west side), D32B, and D23 (respectively).

Photo 1: Looking west along D58.

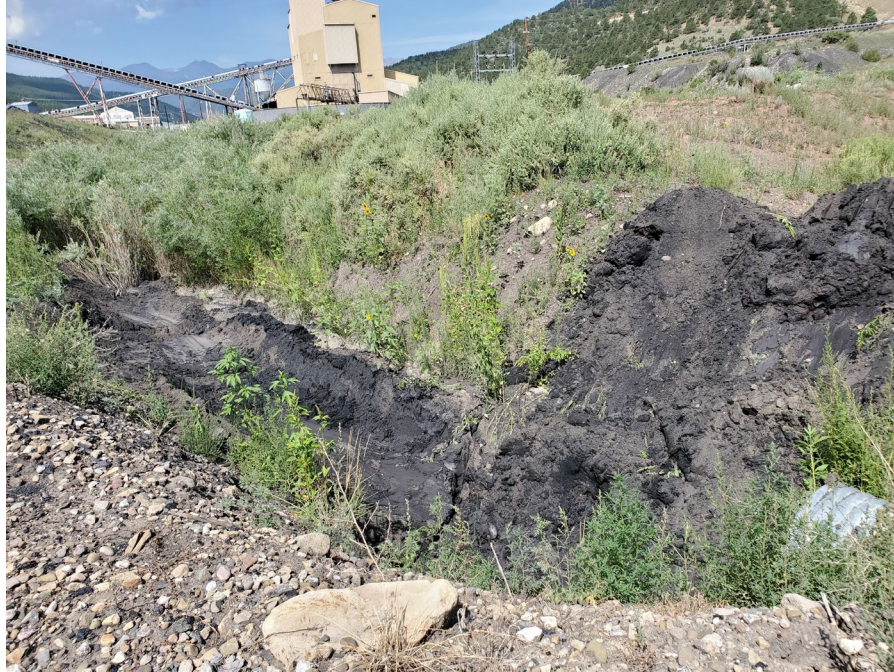
Photo 2: Looking west at the east side of D22A, east of C32.

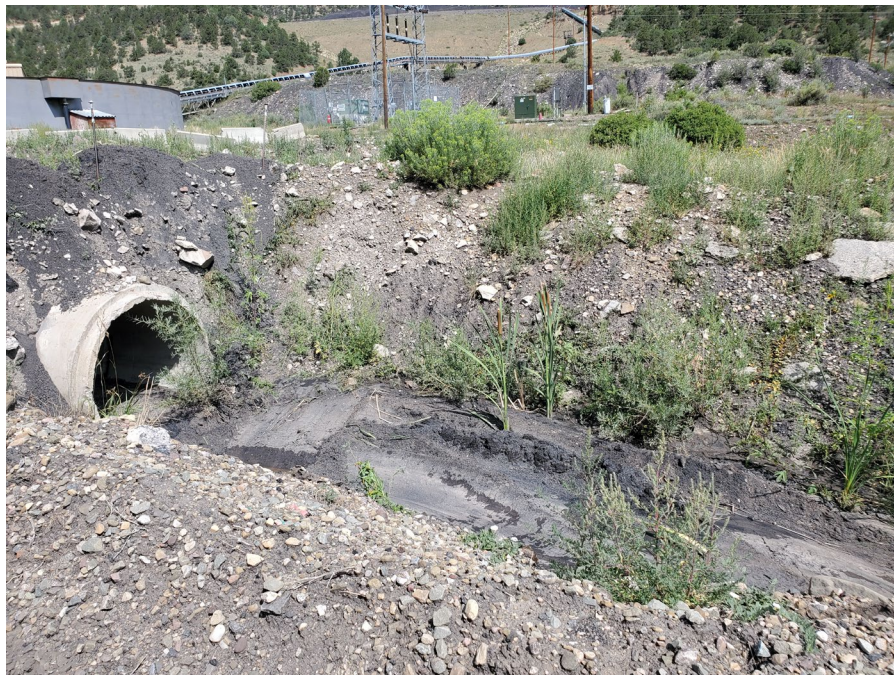
Photo 3: Looking north-west at the west side of D22A, on the east side C22.

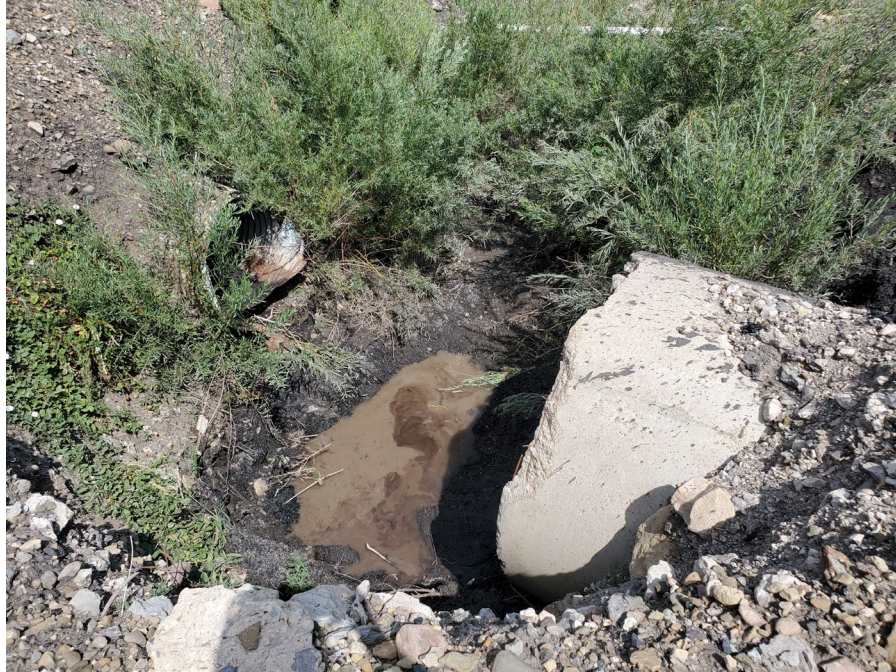
Photo 4: Looking down at D32B, on the west side of C22.

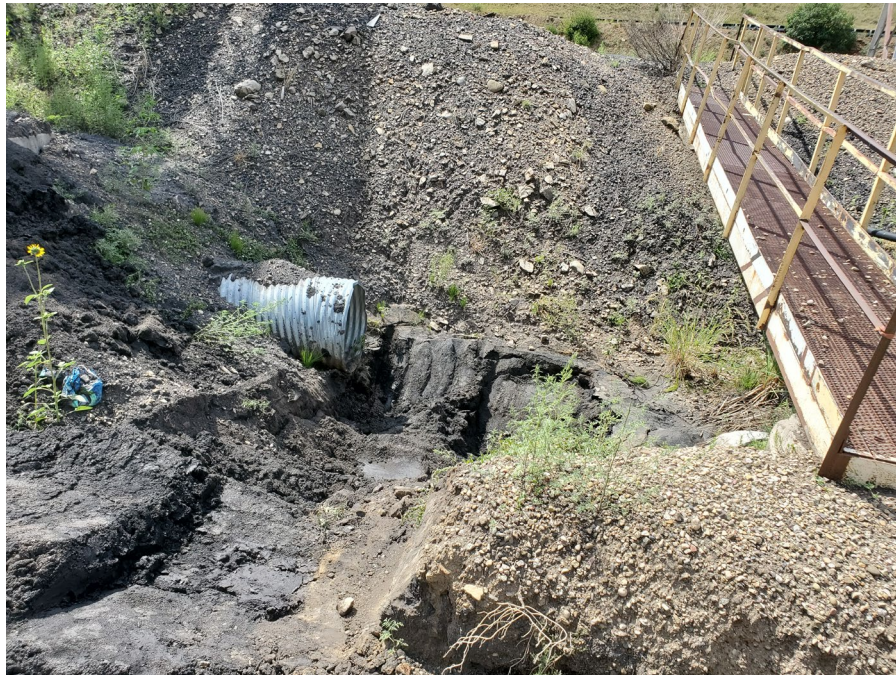
Photo 5: Looking south at D23.

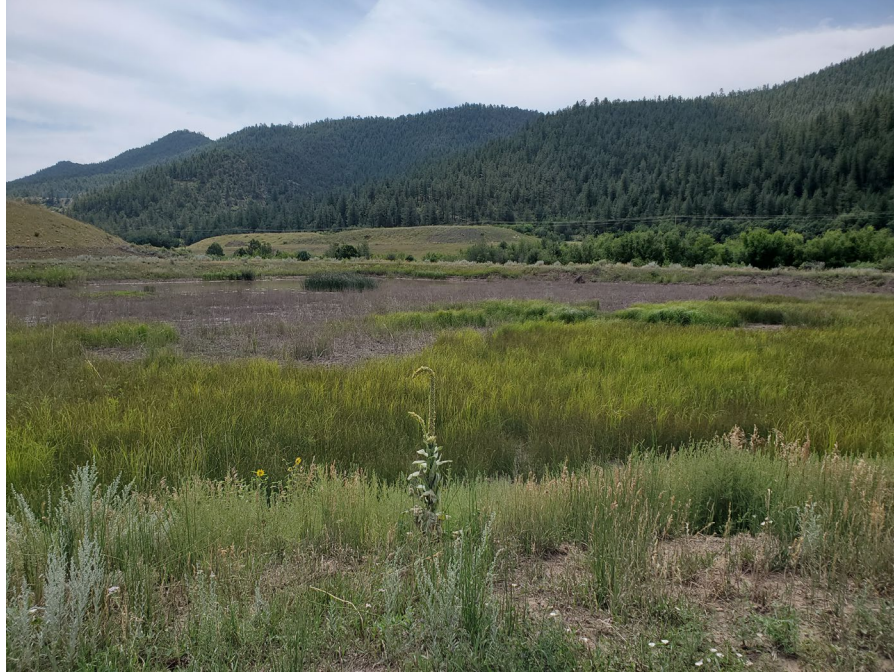
- Pond 004A was mostly dry, with some water restricted to the southeast corner of the pond (Photo 6). Pond 004A was not discharging. The banks were vegetated and appeared to be stable. The principal and emergency spillways were clear.

Photo 6: Looking south-east at Pond 004. A dying Mullein stalk is seen in the foreground.

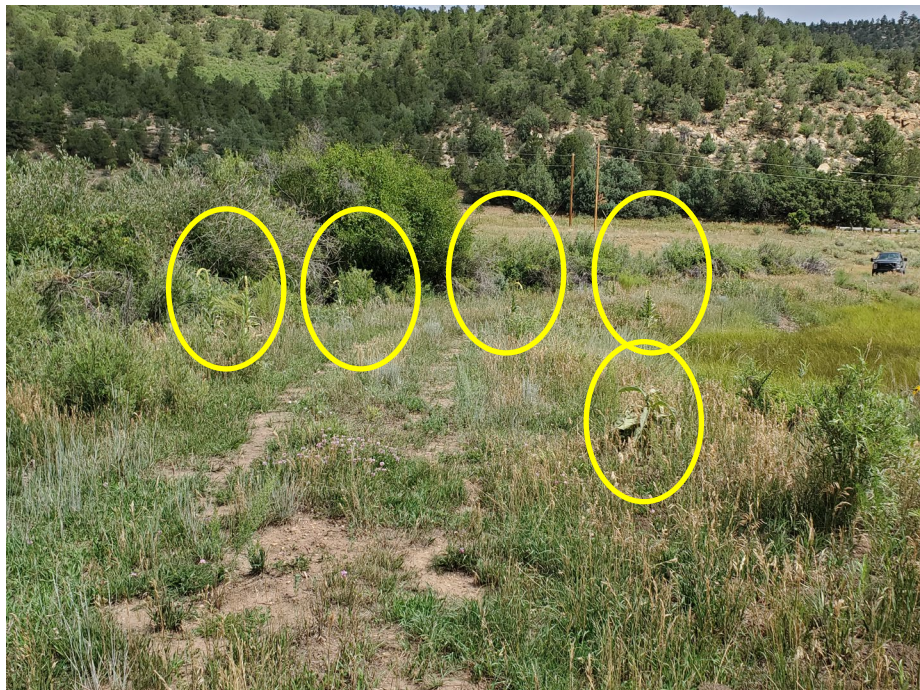
- The state listed noxious weed, Mullein, was observed along the light use road leading to the southwest corner of Pond 004 during the July inspection. The Operator has since treated the Mullein from the area around Pond 004. Dead and dying stalks and florets were observed along the road and at the southwest corner of the pond (Photo 7).

Photo 7: Looking northwest along the light use road to Pond 004 at some dying Mullein stalks.

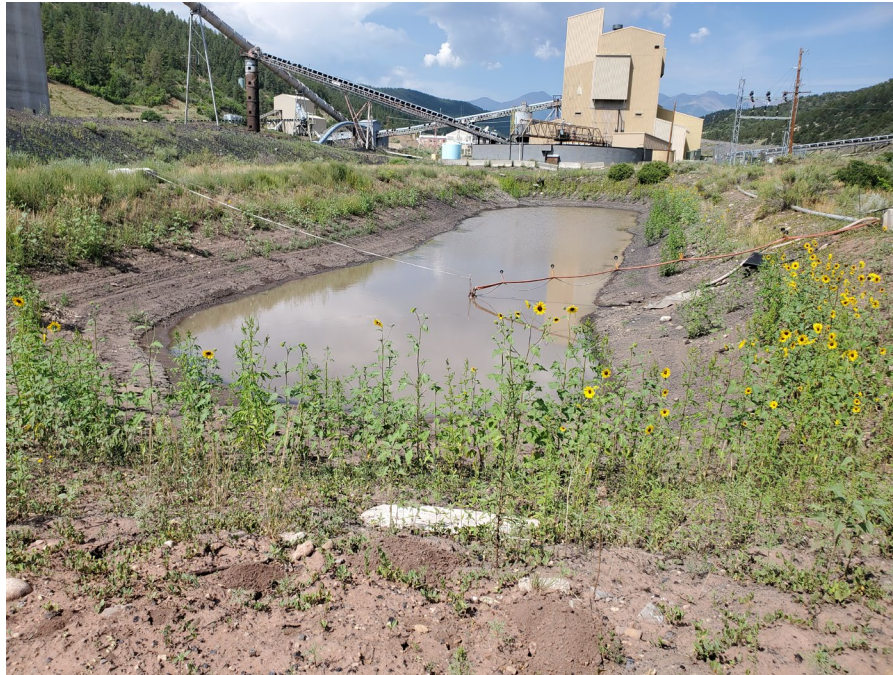
- Pond 006A contained some water and appears to have had plenty of capacity remaining at the time of the inspection (Photo 8). The pond was not discharging. The banks were vegetated and appeared to be stable.

Photo 8: Looking west at Pond 006a.

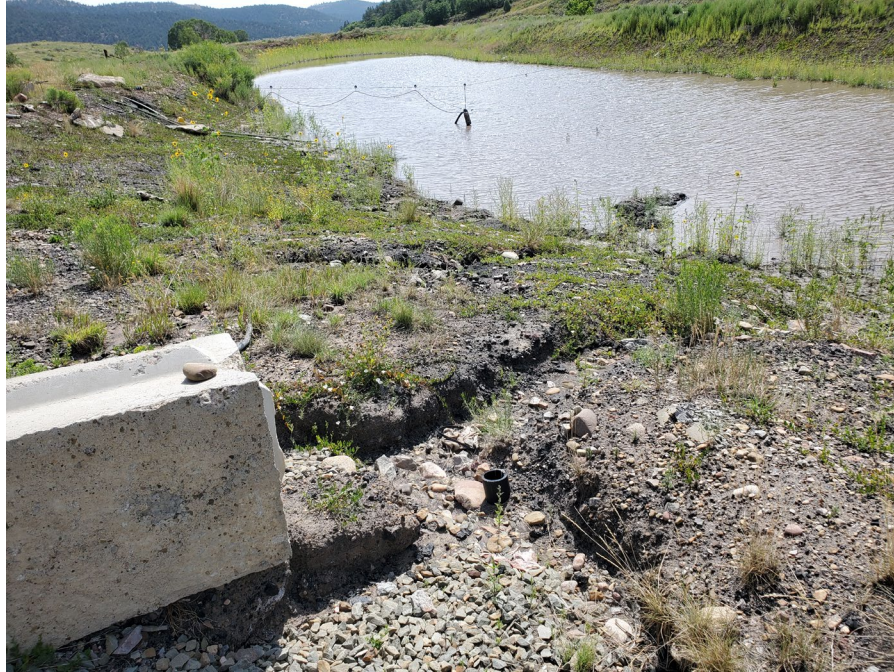
- Pond 007A was mostly dry at the time of the inspection, and was not discharging. The emergency spillway was free of obstructions and the embankment appeared to be stable. The east side of Pond 007A has vegetation growing within it, but the pond itself has plenty of capacity at this time. As noted in the June and July 2024 inspection reports, the Division observed what seems to be new erosion on the north-west side of the northern bank (Photo 9). **The Operator shall repair the erosion on the bank.**

Photo 9: Looking southeast at the erosion along the north-west bank of Pond 007a.

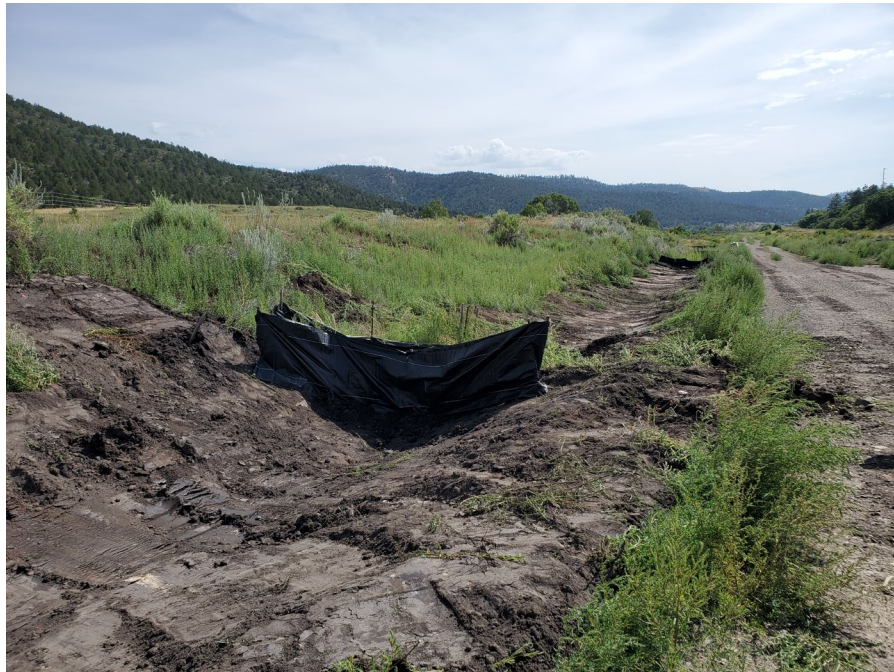
- The silt fences along the SAE near Pond 007A that were damaged as a result of snowfalls, mentioned in the January - June 2024 reports, have been repaired (Photo 10). Additionally, the portion of the ditches between the silt fences in the SAE have been cleared of excess sediment.

Photo 10: Looking east along the series of silt fences on the north side of the SAE, located south of Pond 007a.

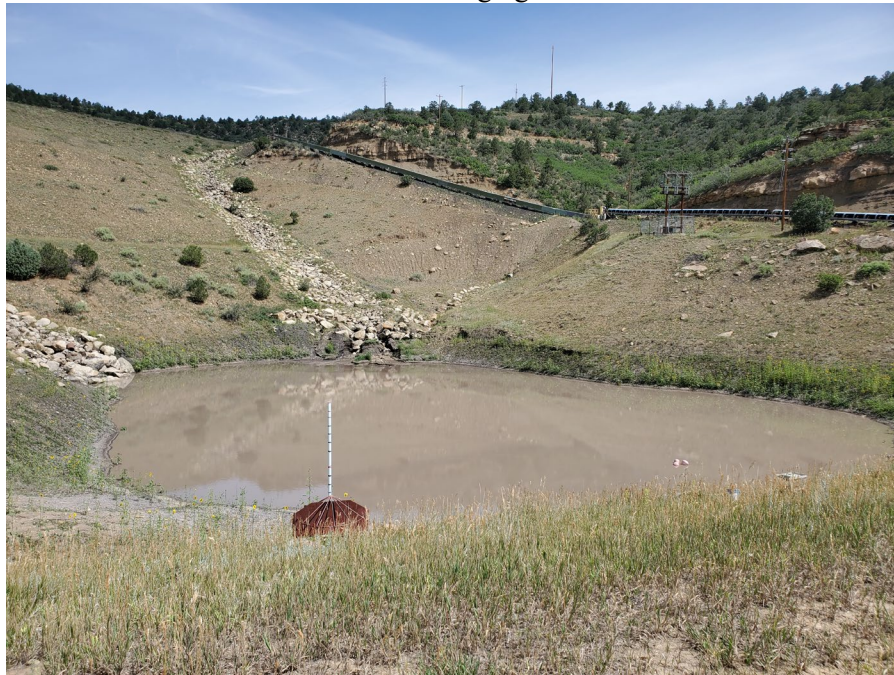
Photo 11: Pond 08.

- Pond 08 contained some water, and was well below its capacity (Photo 11). The spillways appeared clear, and the banks were stable. Pond 08 was not discharging.

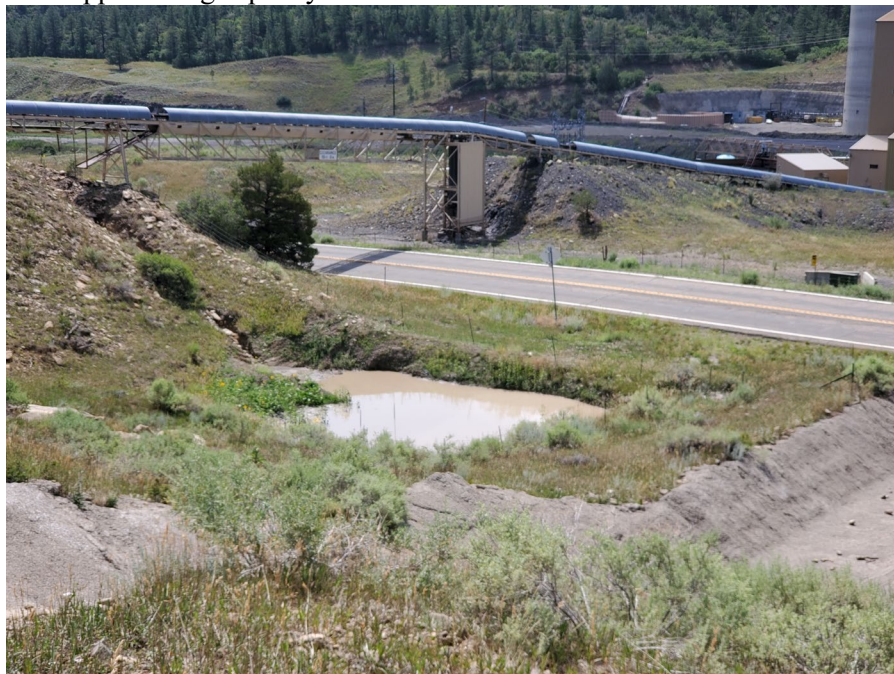
Photo 12: Containment Area #5.

- Containment Area #5 contained some water at the time of the inspection (Photo 12). The containment did not appear to be approaching capacity.
