MINERALS PROGRAM INSPECTION REPORT
PHONE: (303) 866-3567

MINE NAME: Houchin Gravel Pit	MINE/PROSPECTING ID#: M-1980-249	MINERAL: Sand and gravel	COUNTY: El Paso
INSPECTION TYPE: Surety-Related Inspection	WEATHER: Cloudy	INSP. DATE: August 13, 2024	INSP. TIME: 09:30
OPERATOR: Houchin Inc	OPERATOR REPRESENTATIVE: Curt Houchin	TYPE OF OPERATION: 110c - Construction Limited Impact	
REASON FOR INSPECTION: Surety Related	BOND CALCULATION TYPE: Complete Bond	BOND AMOUNT: \$7,177.00	
DATE OF COMPLAINT: NA	POST INSP. CONTACTS: None	JOINT INSP. AGENCY: None	
INSPECTOR(S): Hunter Ridley Ben Hammar	INSPECTOR'S SIGNATURE:

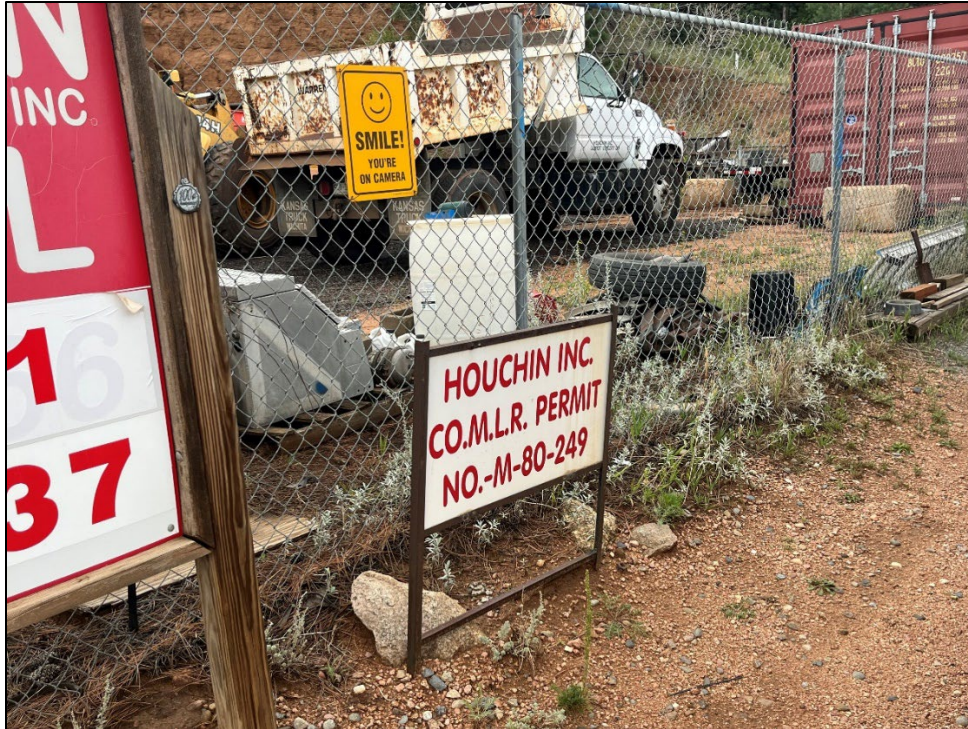
Signs and Markers: The permit sign was properly posted pursuant to Rule 3.1.12 (Photo 1) and boundary markers were noted at the permit boundary corners (Photos 5 and 8).

Photo 1: The permit sign was appropriately posted at the site entrance.

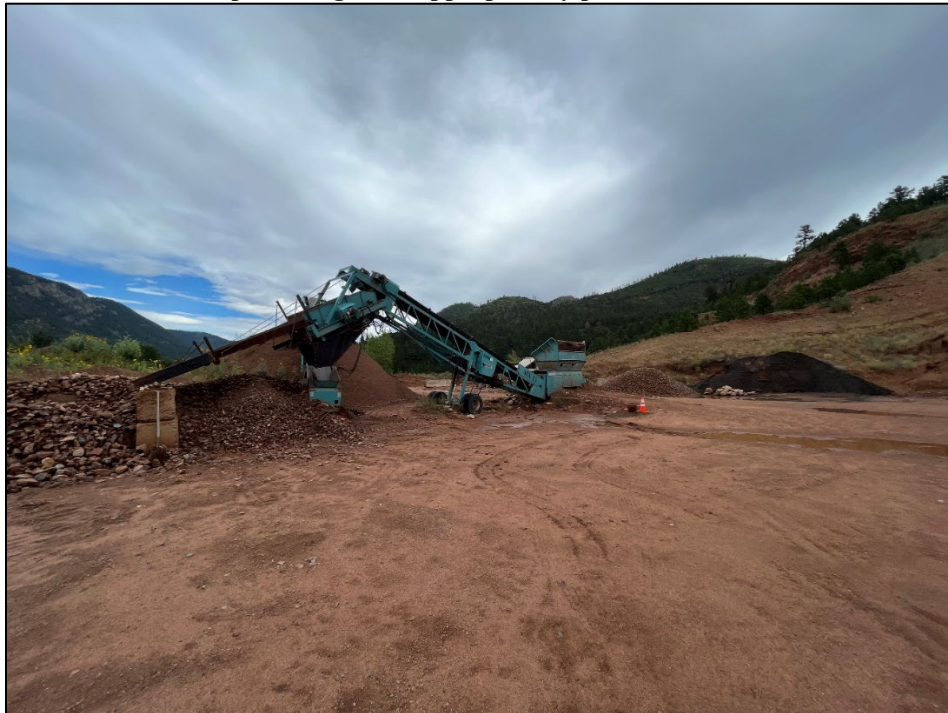
Processing Waste: No processing waste was observed. Mr. Houchin does import offsite material for processing. A stockpile of offsite material was observed during this inspection (Photo 2).

Support Facilities On-site: A screen plant, loader, and two grizzly screens were observed on site (Photos 2, 3, and 7).

Photo 2: View northwest of processing equipment onsite, stockpiles are located behind this equipment.

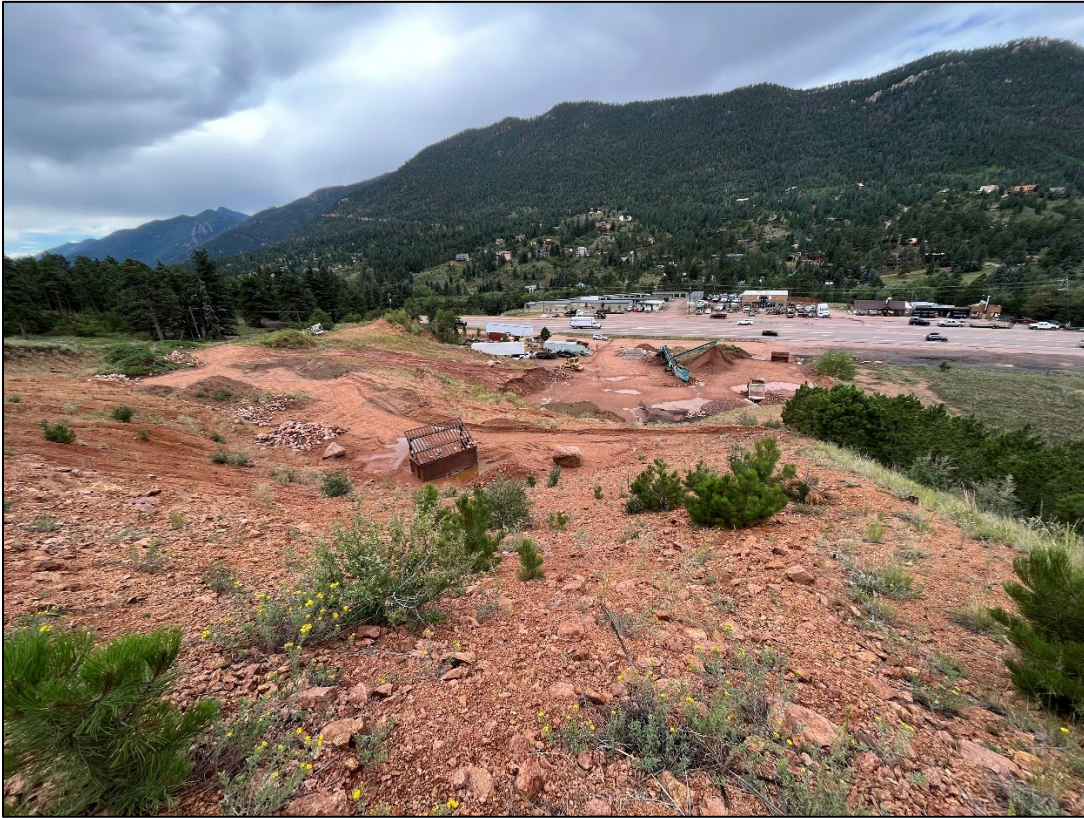
Photo 3: View southeast of the site from the top of the site's sloped area, the one benched area is visible in this photo.

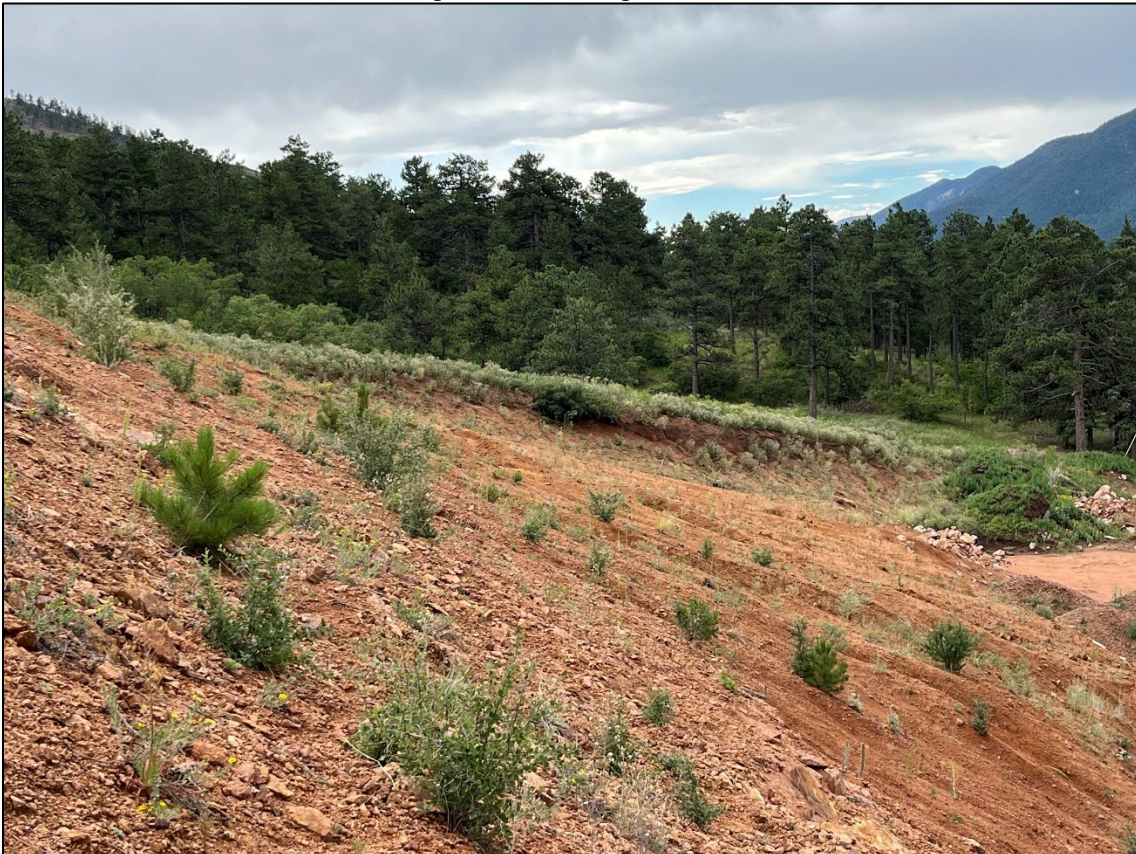
Sediment Control: Some erosion rills were observed above the upper bench (Photos 4 and 7). Slightly larger rills were noted to be forming below the benched area (Photo 8) but did not appear to be leading to any offsite impacts. No BMPs were needed at the time of the inspection.

Topsoil: All salvaged growth media was stripped many years ago and was stockpiled on the east side (Photo 4), as the site's disturbed footprint has not changed in quite some time. Other, smaller piles of what appears to be growth media have been stockpiled onsite (Photo 6).

Photo 4: A topsoil pile, vegetated with volunteer vegetation is located on the northeastern side of the permit, just above the benched area.

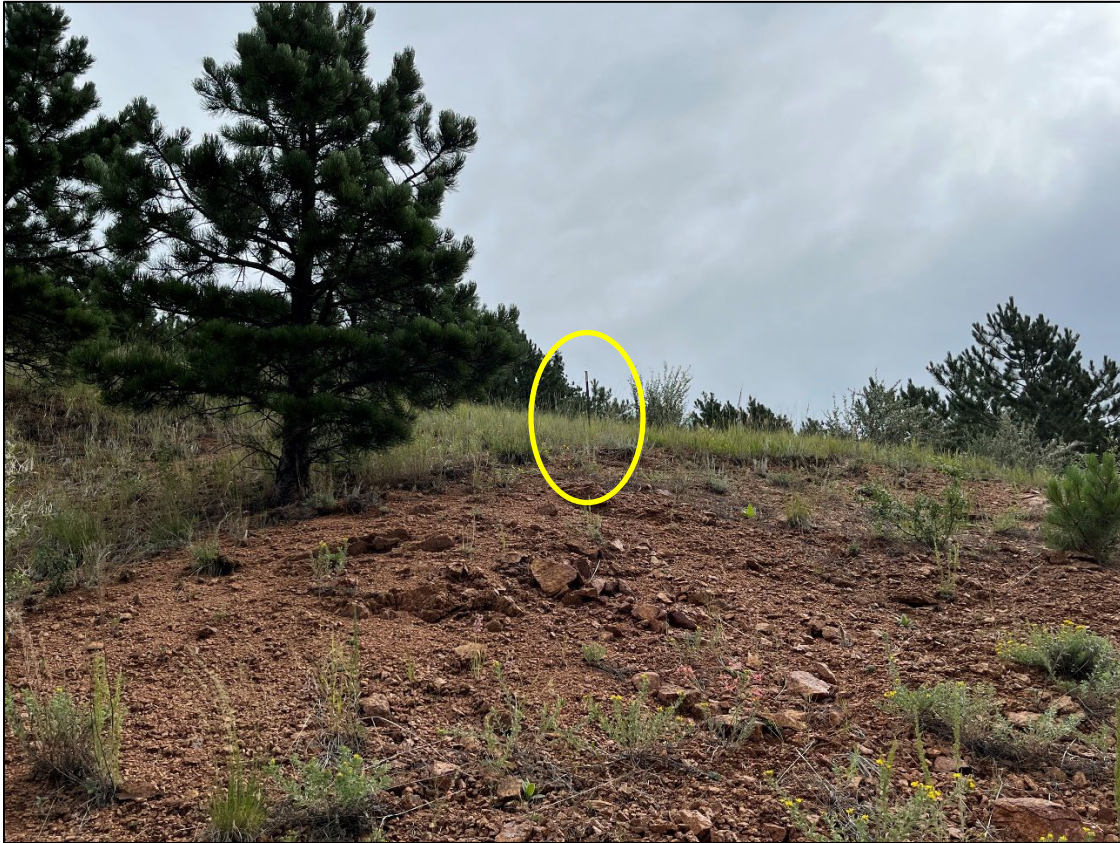
Photo 5: A northwestern permit boundary corner marker was observed.

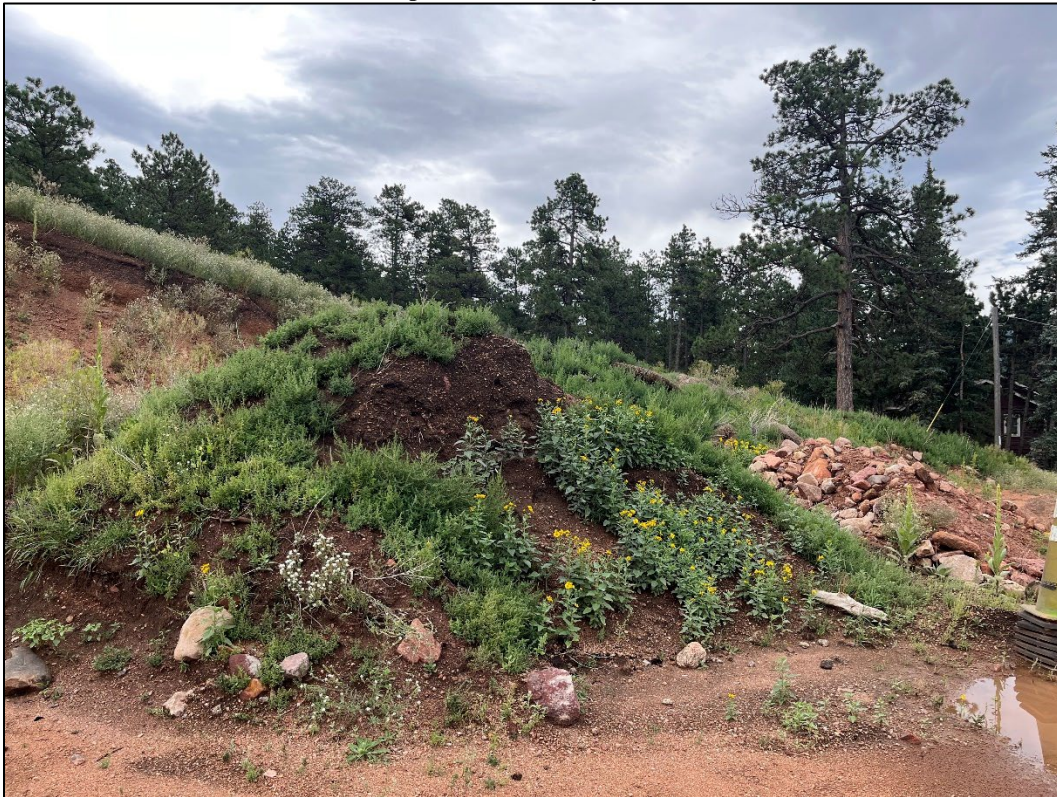
Photo 6: Another pile of what appears to be topsoil is located on the eastern edge of the benched area.

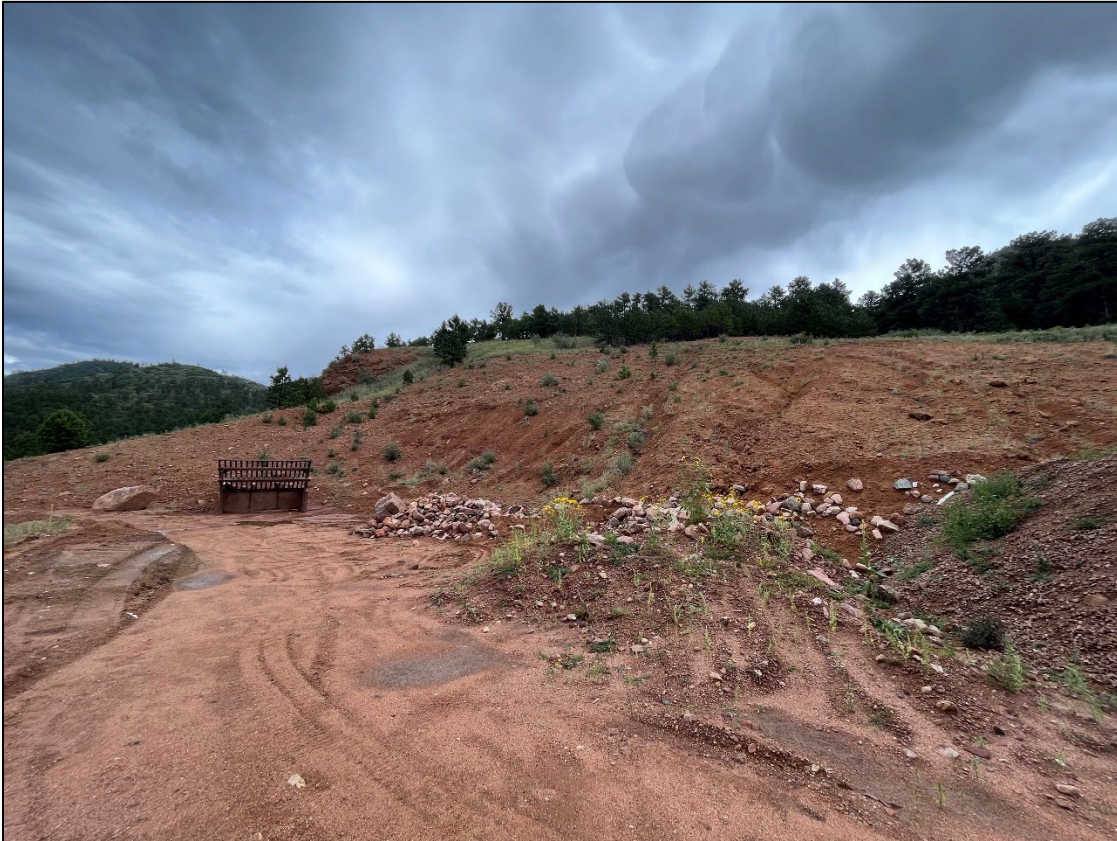
Photo 7: View east of the benched area, a grizzly screen and small stockpiles are located here.

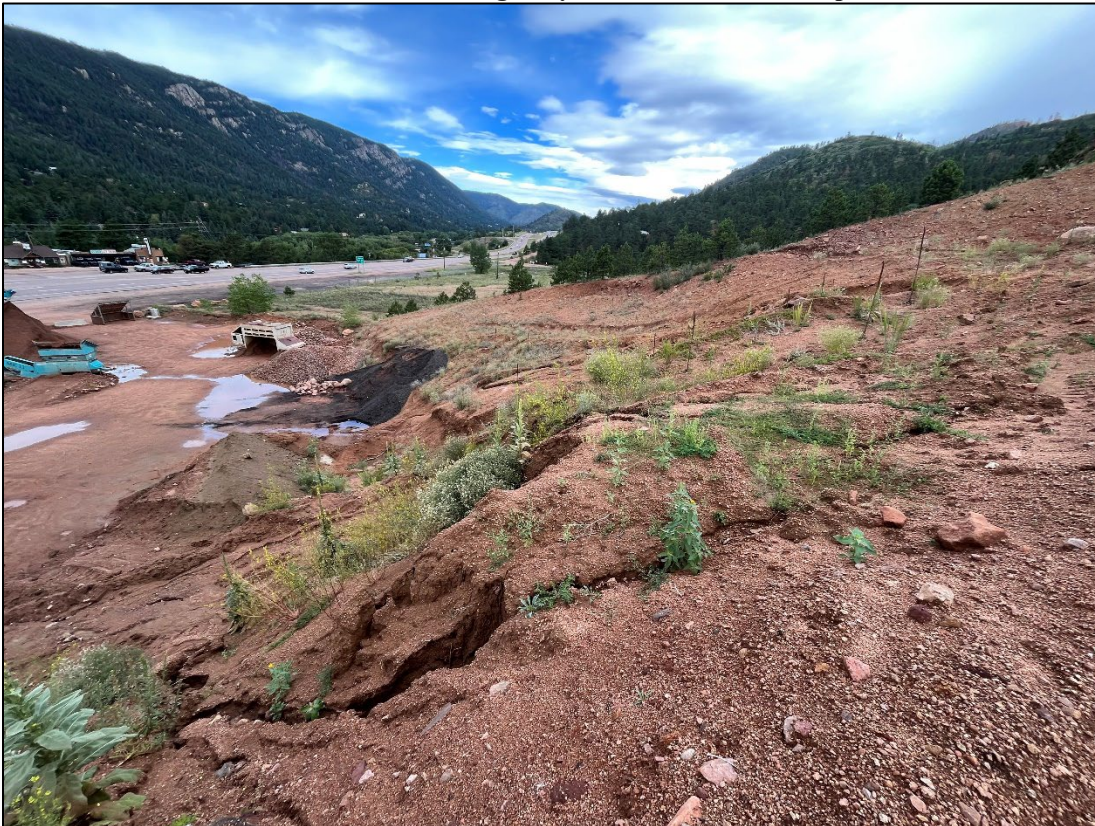
Photo 8: Erosion rills are noted on the ~2H:1V slope below the benched area.

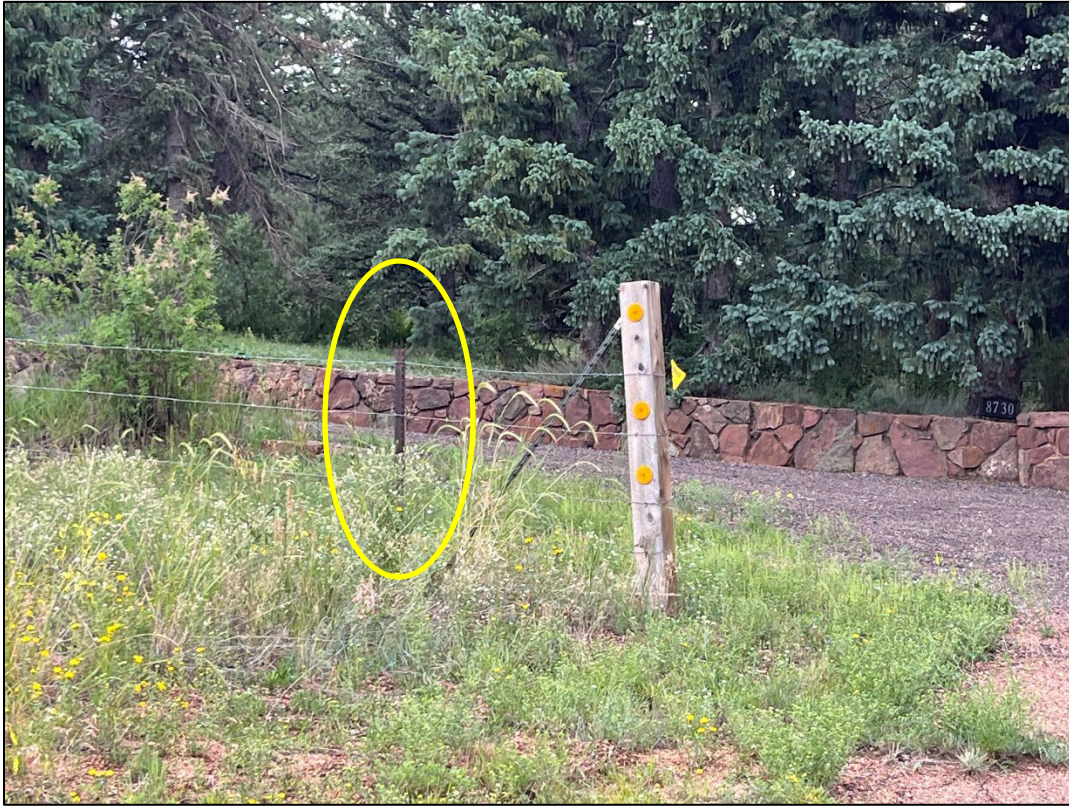
Photo 9: A permit boundary marker was observed in the southeast corner of the site.
