MINERALS PROGRAM INSPECTION REPORT
PHONE: (303) 866-3567

MINE NAME: Solberg Pit	MINE/PROSPECTING ID#: M-1981-044	MINERAL: Sand and gravel	COUNTY: El Paso
INSPECTION TYPE: Monitoring	WEATHER: Clear	INSP. DATE: August 13, 2024	INSP. TIME: 11:00
OPERATOR: Solberg Gravel LLC	OPERATOR REPRESENTATIVE: Jason Ulmer	TYPE OF OPERATION: 112c - Construction Regular Operation	
REASON FOR INSPECTION: Normal I&E Program	BOND CALCULATION TYPE: Complete Bond	BOND AMOUNT: \$1,467,756.00	
DATE OF COMPLAINT: NA	POST INSP. CONTACTS: None	JOINT INSP. AGENCY: None	
INSPECTOR(S): Hunter Ridley Ben Hammar	INSPECTOR'S SIGNATURE:

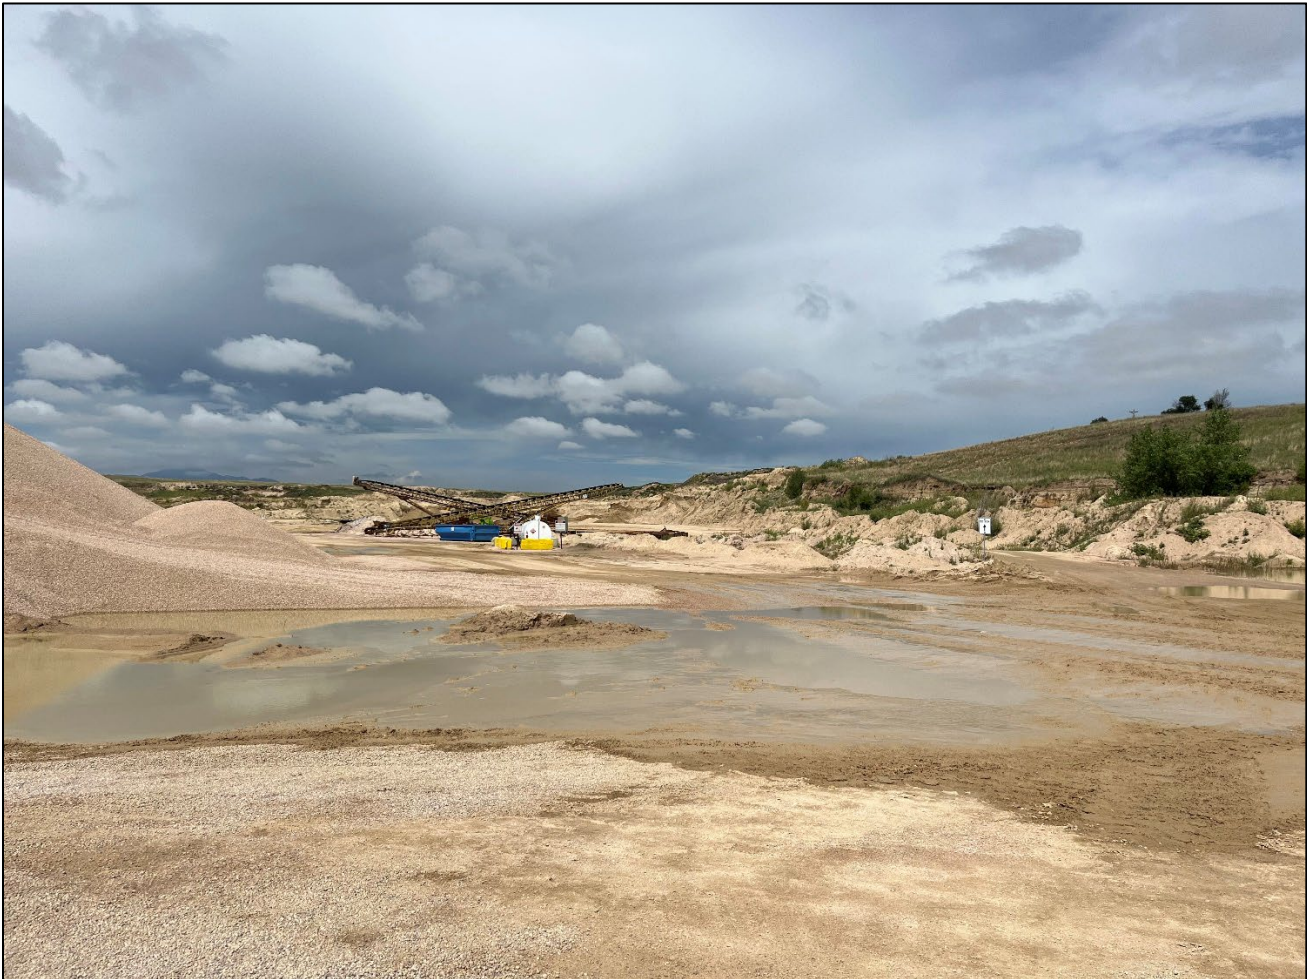
Backfilling and Grading: Current excavations are concentrated in the northwestern corner of the site (Photo 1). Recent backfill activity in the northeastern corner of the site was noted during the inspection (Photo 4). Active mining into the expanded affected area boundary, approved in 2022 under Amendment 3 (AM-3), has not yet commenced. Site representative Kurt Thurmann stated that they are awaiting final El Paso County approval before breaking ground.

(Photo 1 and 4). Stormwater is approved to infiltrate at the site with any additional runoff being directed to the northeast towards the site's approved discharge point. Site representatives state that this point does not often discharge, and all other stormwater infiltrates on site as approved. A freshwater pond is located on site (Photo 2) and is fed by a groundwater well (Well Permit No. 85276-F). This water is directed into the site's wet sand and gravel processing plants. When mixed with flocculant liquid and processed through several other smaller ponds, the groundwater can be recirculated into the freshwater pond and reused in the product washing process.

Reclamation Success: No reclamation has been initiated. However, the northern side of the permit boundary has self-reclaimed as stated in previous inspection reports (Photo 1).

Support Facilities On-site: Several screen plants (Photo 1), a wash plant clarifier (Photo 3), an excavator, loaders, and haul trucks were observed on site. No oil or fuel spills observed. All non-hazardous flocculation liquid and fuel were stored on site in secondary containment.

Photo 1: View of the current northwest corner of excavation, the vegetated slope to the north has been fully reclaimed.

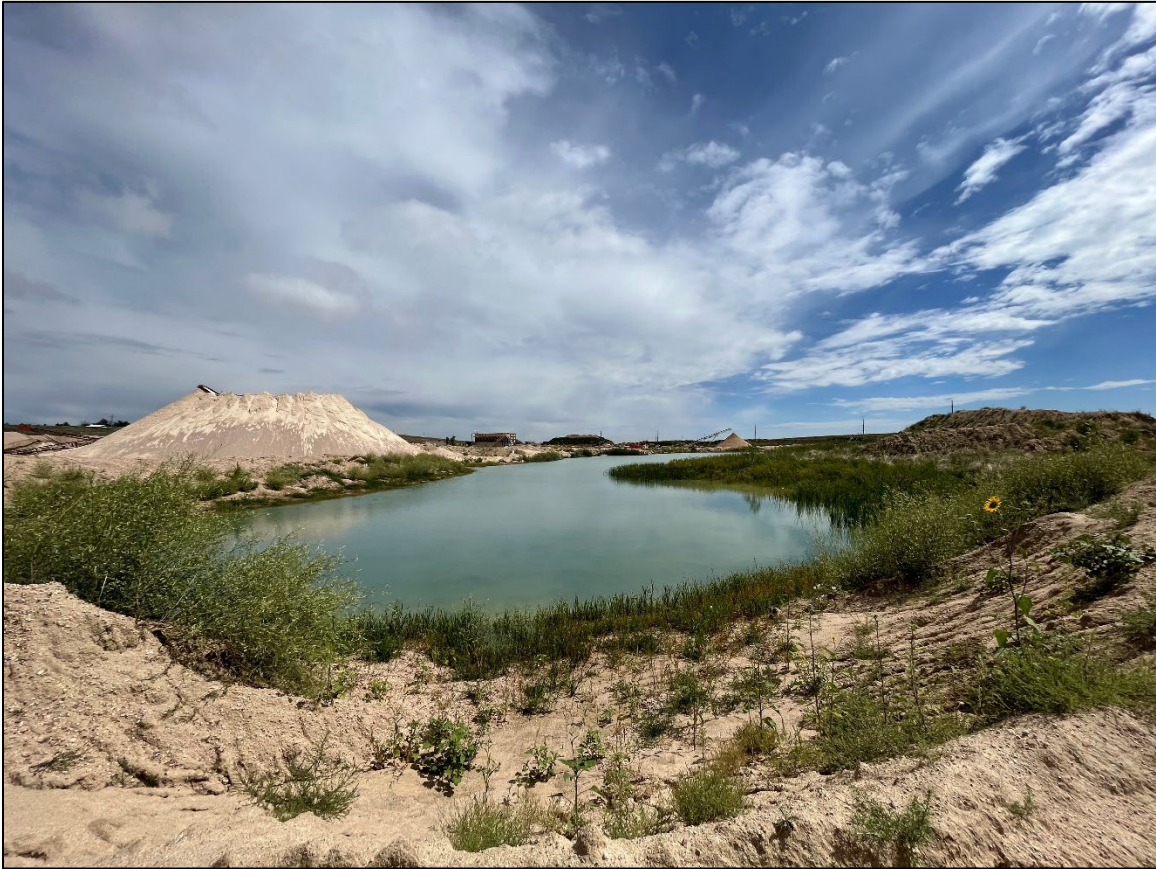
Photo 2: View east of one of several approved ponds, this is a freshwater pond fed by two wells.

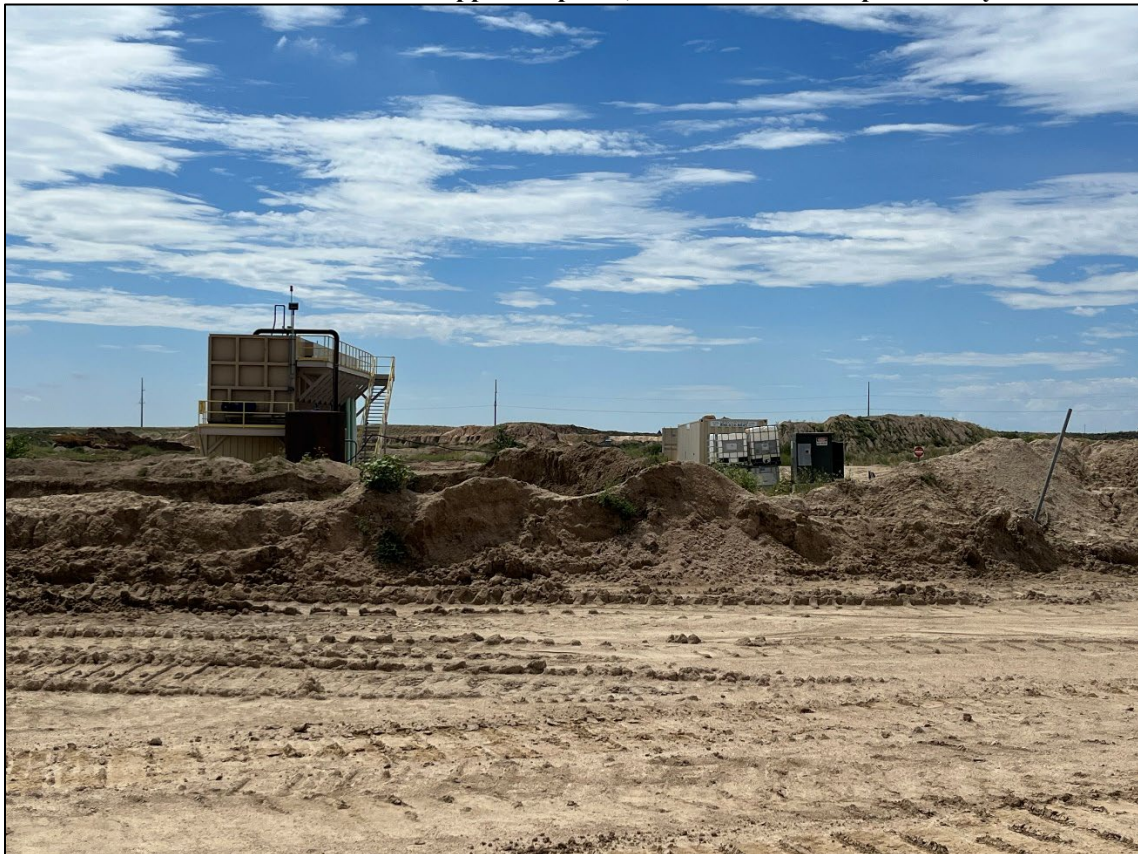
Photo 3: View west of flocculation containment and site processing equipment.

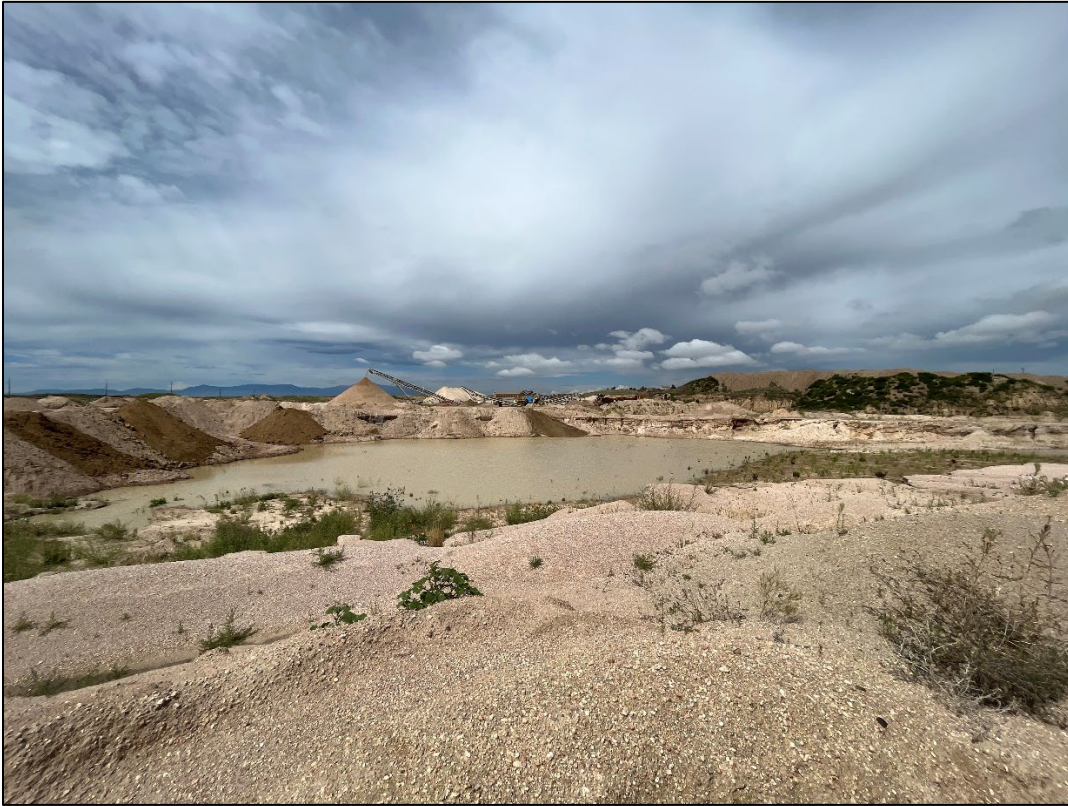
Photo 4: View west of a northeastern corner pit which is being actively backfilled with fines and overburden. Standing water is infiltrating form recent heavy rainfall events. A topsoil pile is visible to the north.

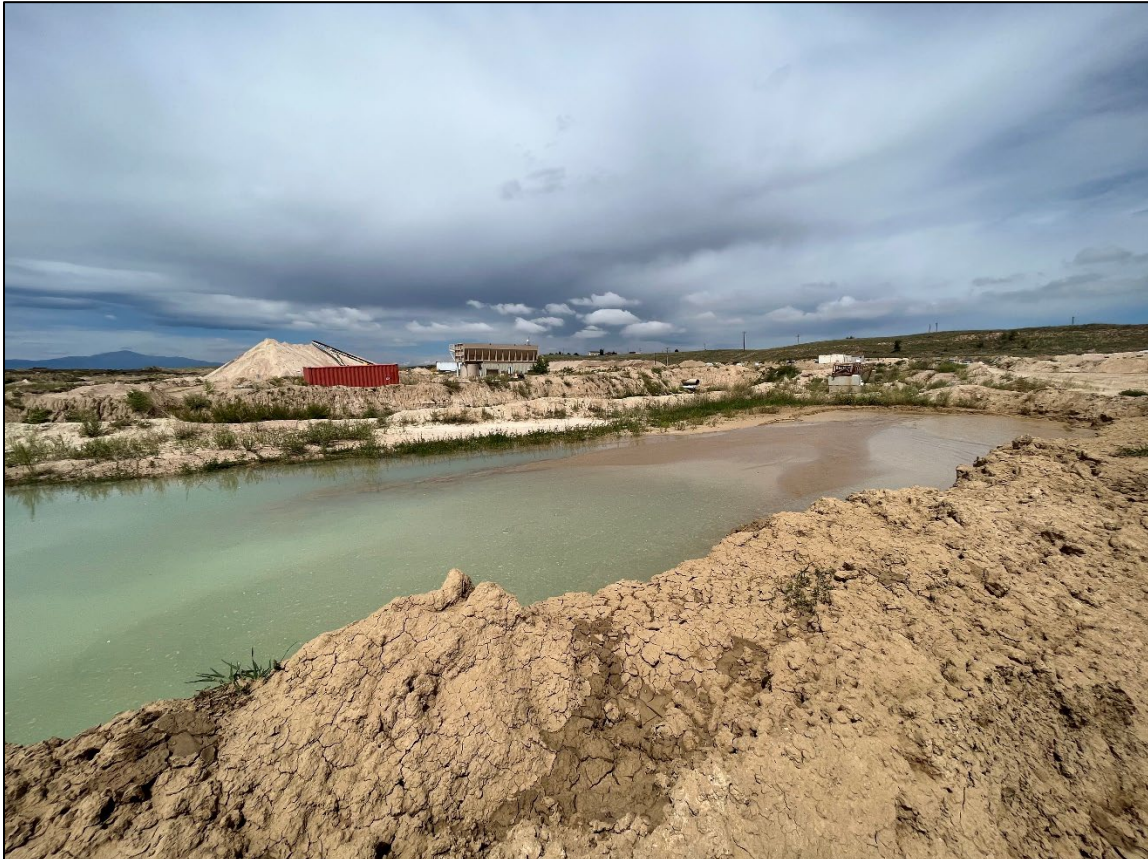
Photo 5" View north of one of several approved ponds, this pond is part of the water recycling system which 'washes' mined material.
