Lorencito Canyon Mine, C-1996-084, Complete Inspection, August 2024

PERMIT INFORMATION

Permit Number: C-1996-084 Mine Name: Lorencito Canyon Mine Operator: New Elk Coal Company, LLC Operator Address: Mr. John Terry 12250 Highway 12 Weston, CO 81091	County: Las Animas Operation Type: Surface Permit Status: Permanent Cessation Ownership: Private
	Operator Representative Present: Jim Begano and Bill Massarotti
Operator Representative Signature: (Field Issuance Only)

Inspection Start Date: August 1, 2024 Inspection Start Time: 09:15 Inspection End Date: August 1, 2024 Inspection End Time: 14:21	Inspection Type: Coal Complete Inspection Inspection Reason: Normal I&E Program Weather: Cloudy
Joint Inspection Agency: None	Joint Inspection Contacts:
Post Inspection Agency: None	Post Inspection Contacts:
Inspector(s): Amber M. Gibson	Inspector's Signature:

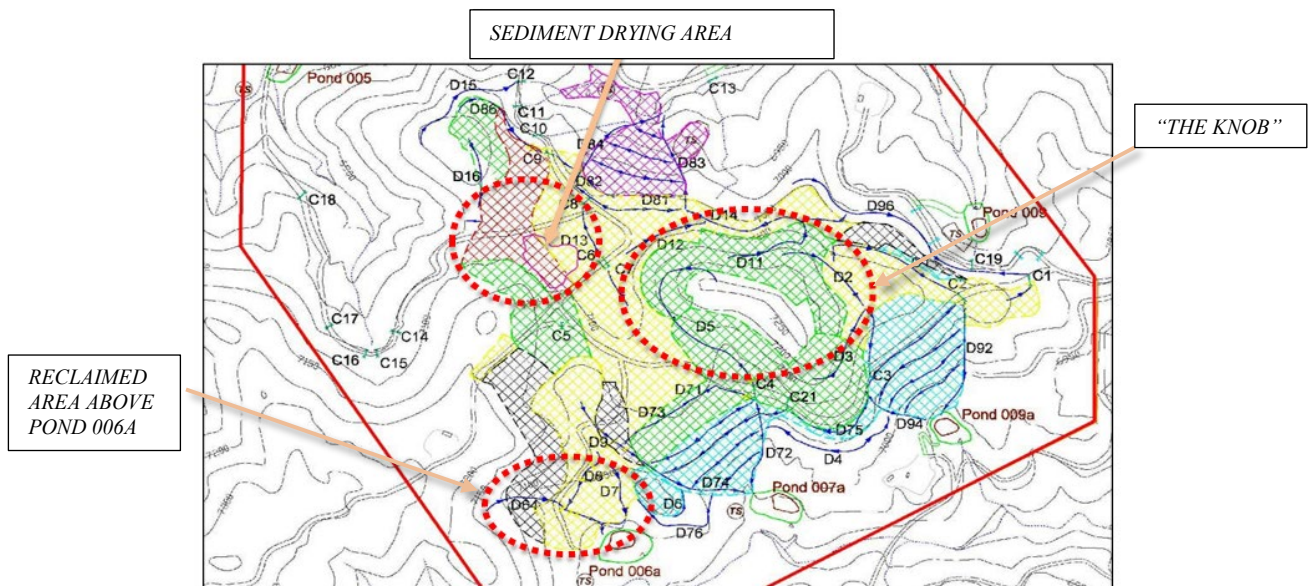
- (4) The following items pertain to ongoing erosional issues in the areas shown in Figure 1, that pursuant to Rule 4.14.6 need to be addressed. A Technical Revision will be required to expand on the current Rill and Gully plan in the PAP. **The Operator shall submit the technical revision, obtain approval, repair the erosion, and stabilize the slopes pursuant to the approved plan by December 31, 2024.**

FIGURE 1. AREAS WHERE RILLS, GULLIES AND SPARSE VEGETATION HAS BEEN FOUND TO BE A PERSISTENT PROBLEM AT THE SITE ARE WITHIN THE DOTTED CIRCLE AREAS. BACKGROUND IMAGE IS THE 2020 ANNUAL REPORT MAP.

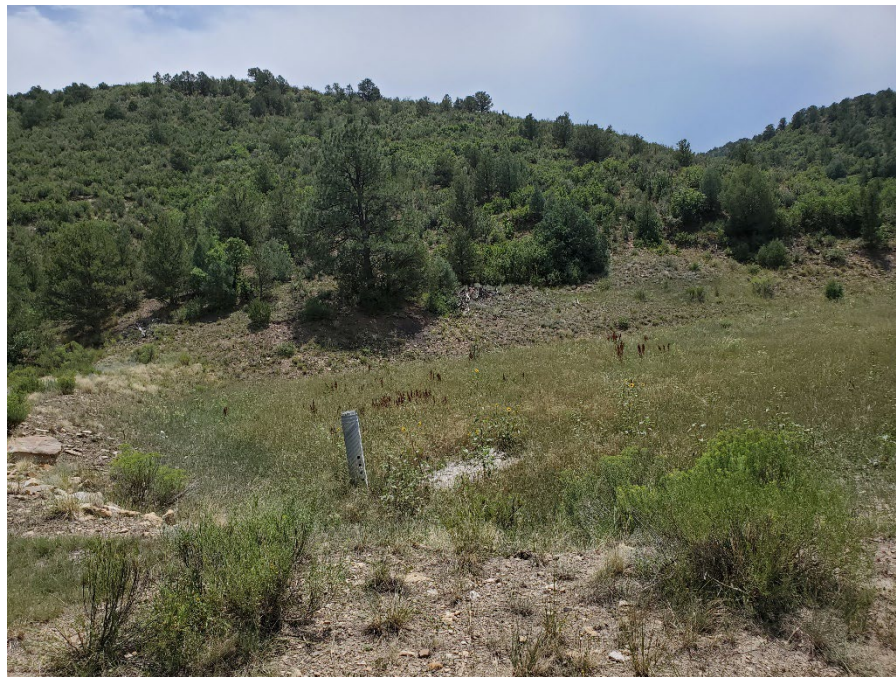
- Pond 005:
 - The pond was dry (Photo 1) and was not discharging.
 - The pond embankment was stable and vegetated.
 - The primary and emergency spillways appeared clear and functional.
 - The state listed noxious weed, Mullein, was observed by the spillway. **The Operator shall treat and/or remove Mullein in this area.**

Photo 1: Looking east along the north border of Pond 005.

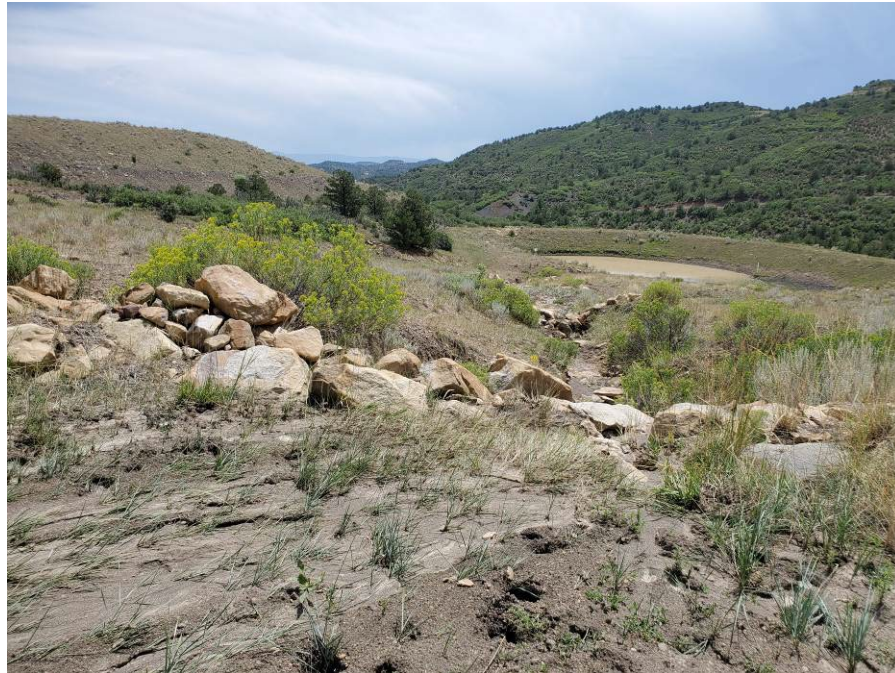
- Ditch D9:
 - The check dams within Ditch D9, leading down to Pond 006a, contain an excess amount of sediment (Photo 2). A gully was also observed cutting down from the road and adding sediment to the third check dam. **The Operator shall remove the excess sediment from the check dams**

Photo 2: Looking southeast down the check dams within D9.

within D9.

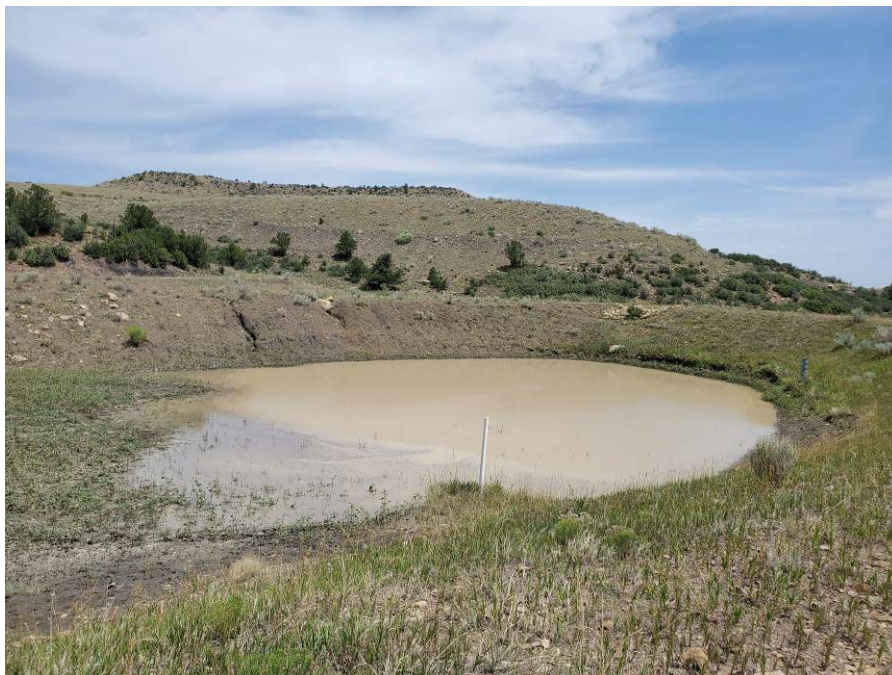
- (1) Erosion rills are forming on the north and west banks of Pond 006a. The erosion on the north bank appears to have been addressed at some point, because rebar is placed above the rills. However, it appears that the prior BMPs are no longer functioning adequately. **Pursuant to Rule 4.05.5(1)(c), the Operator shall address the erosion and repair the north bank.** The erosion on the west bank appears to have been caused by runoff from the road located east of Pond 006a. **Pursuant to Rule 4.05.5(1)(c), the Operator shall address the erosion and repair the west bank.**

- Pond 006a:
 - Pond 006a contained water (Photo 3) and was not discharging.
 - The pond embankment still requires maintenance (see Item # 1 in the outstanding maintenance items list on the first page of this report).
 - The west bank referenced in Item #1 in the outstanding maintenance items list on the first page of this report, currently has a vegetative cover due to volunteer vegetation (circled area in Photo 4). This area will likely still need to be re-stabilized, but may need to be re-addressed at a later date once the vegetation has cleared for the season.
 - The primary and emergency spillways appeared to be clear and functional.

Photo 3: Looking northeast at Pond 006a. The erosion seen on the bank is that which is referred to in Item #1 on the first page of this report.

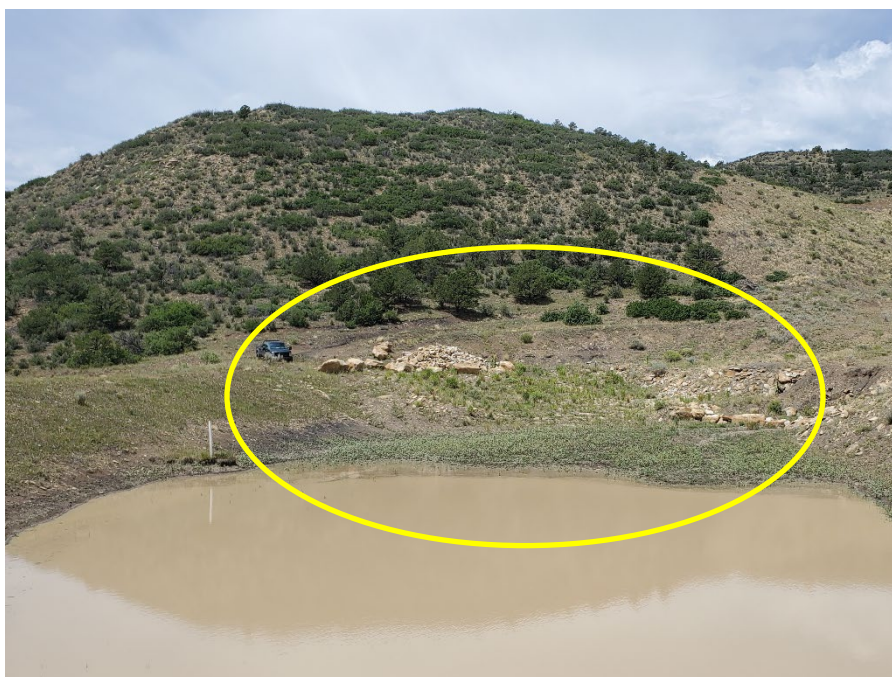
Photo 4: Circled is the area along the west bank of Pond 006a referenced in Item #1 in the ongoing maintenance section on the first page of this report.

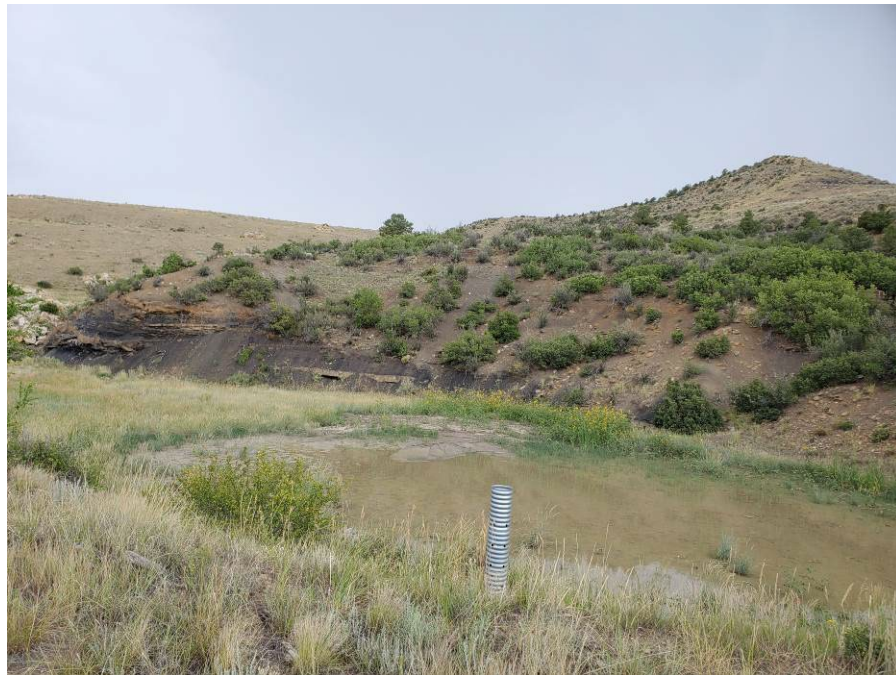
- Pond 007a:
 - The pond contained some water at the time of the inspection (Photo 5).
 - The pond embankment was stable and vegetated.
 - The primary and emergency spillways appeared clear and functional.
 - The flume contained some water (Photo 6), but was not discharging.
 - Mullein was observed in the field to the south and west of Pond 007a, within the permit boundary (Photos 7-8). **The Operator shall treat/remove Mullein within this area.**

Photo 5: Looking northwest across Pond 007a.

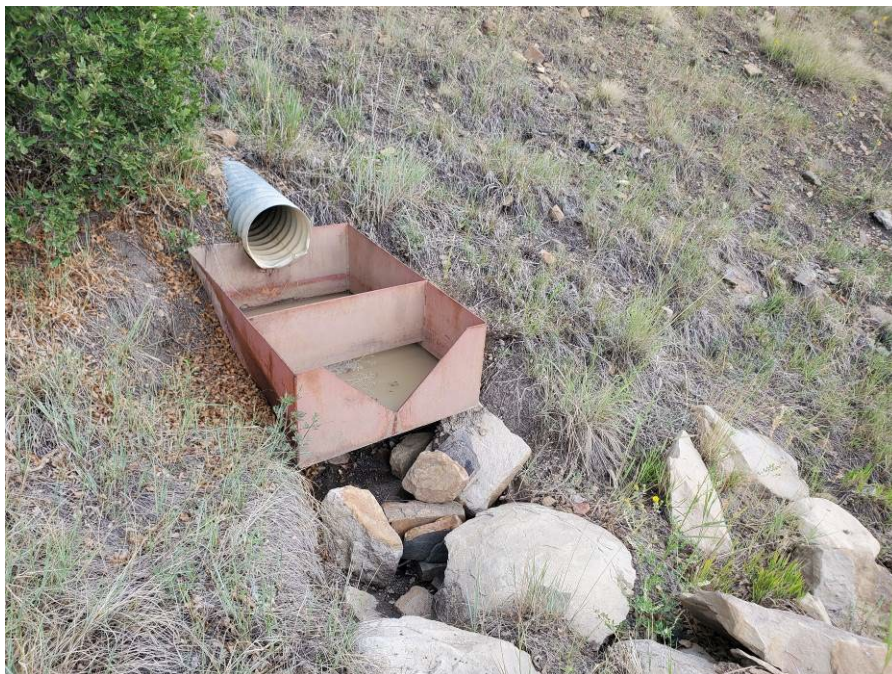
Photo 6: Flume at Pond 007a.

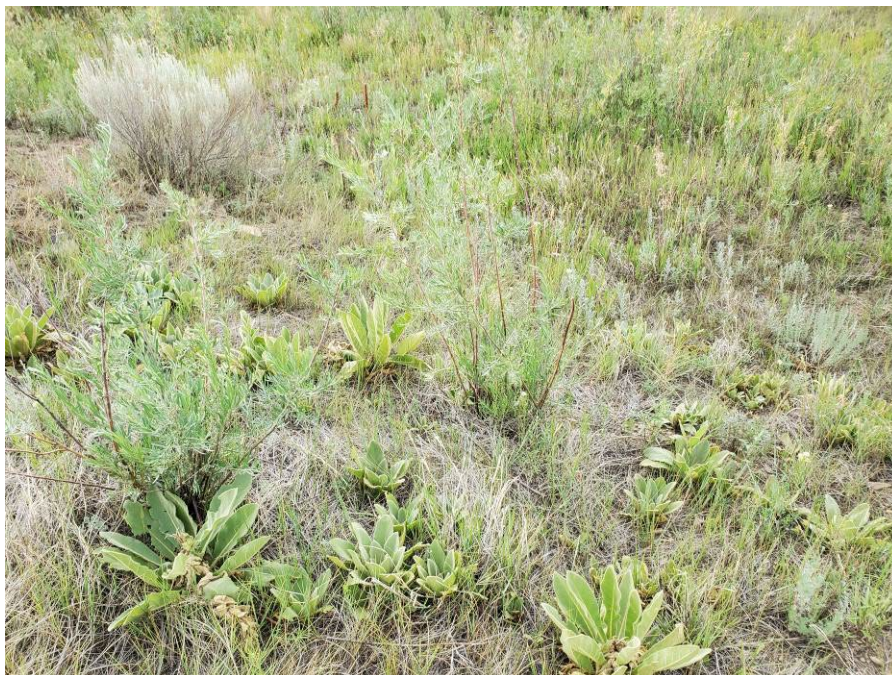
Photo 7: Mullein located west of the flume at Pond 007a.

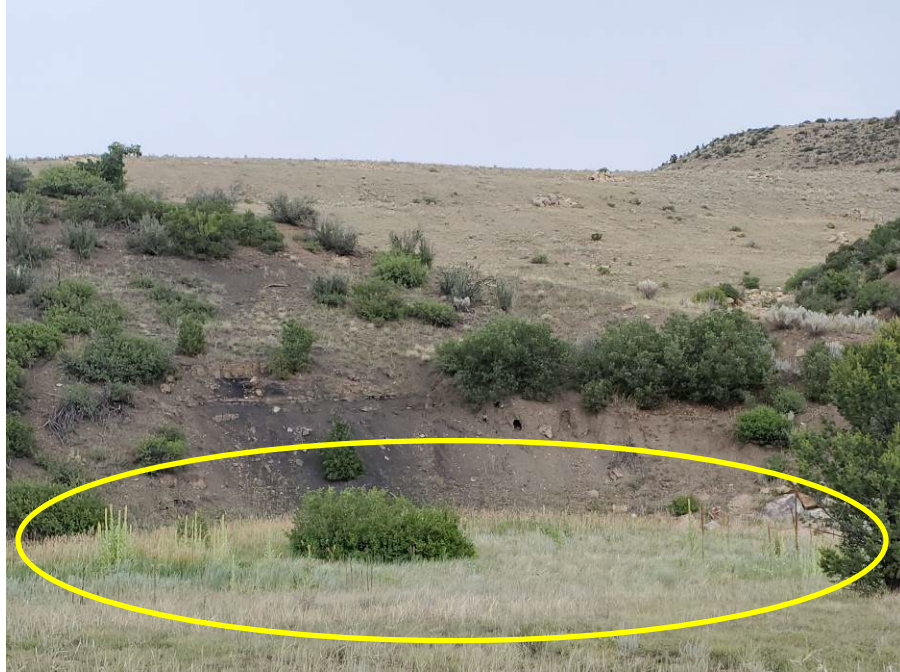
Photo 8: Area circled contains numerous stalks of Mullein. Fill 007 is seen in the background.

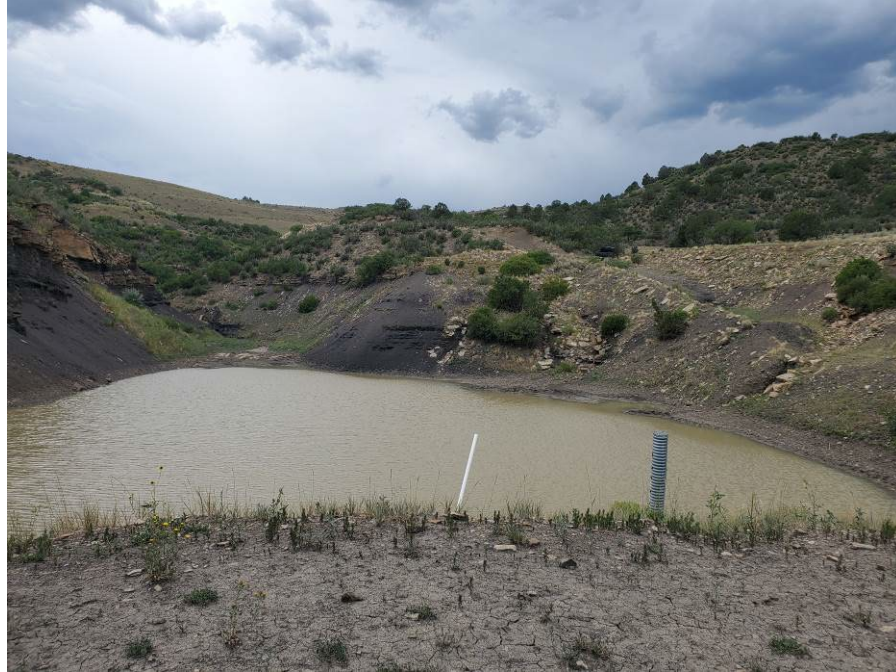
- (2) The majority of Pond 008's embankment was stable and vegetated, however, the west bank contains some erosion rills and gullies. The erosion appears to have been caused by run-off from the roads above and down to the pond. **Pursuant to Rule 4.05.5(1)(c), the Operator shall repair the erosion and stabilize the west bank of Pond 008.** The Operator stated that they will likely install additional rock berms along the western-most road to help prevent run-off from running down the slopes and into the pond. The

- Pond 008:
 - The pond contained water (Photo 9) but was not discharging (Photo 10).
 - The pond embankment still requires maintenance (see Item #2 in the outstanding maintenance items list on the first page of this report).
 - The primary and emergency spillways appeared clear and functional.
 - Some of the state listed noxious weed, Mullein, observed along the west bank of Pond 008 were treated by the Operator during the June inspection. However, more were observed during the August inspection. **The Operator shall treat/remove Mullein within this area.**

Photo 9: Looking south at Pond 008.

Operator also stated that they plan to remove the sediment (deposited as a result of the bank erosion) along the west bank of Pond 008.

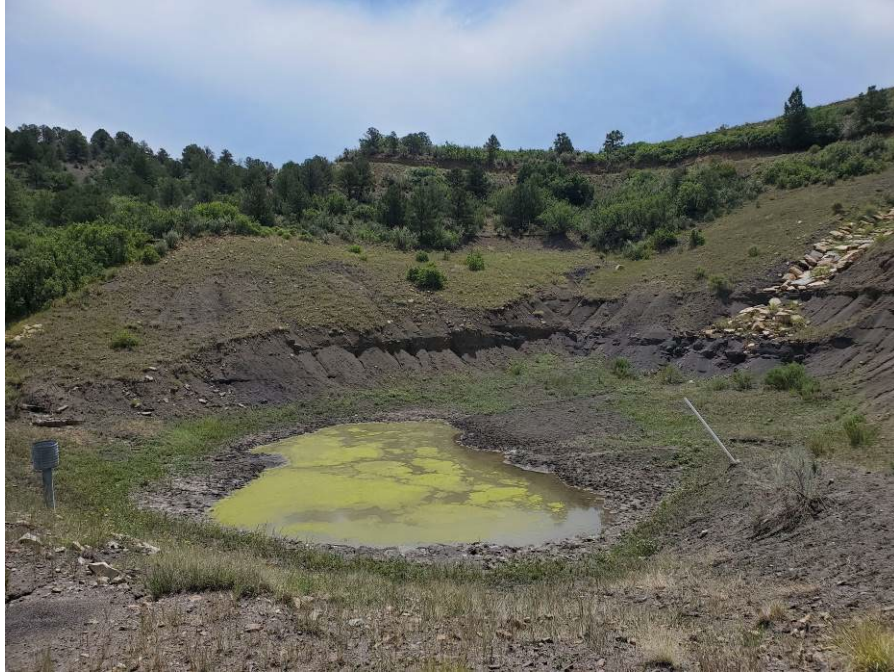
- Pond 009
 - Pond 009 contained water (Photo 11), but was not discharging.
 - The pond embankment was stable and vegetated.
 - The primary and emergency spillways appeared clear and functional.

Photo 11: Looking southeast at Pond 009.

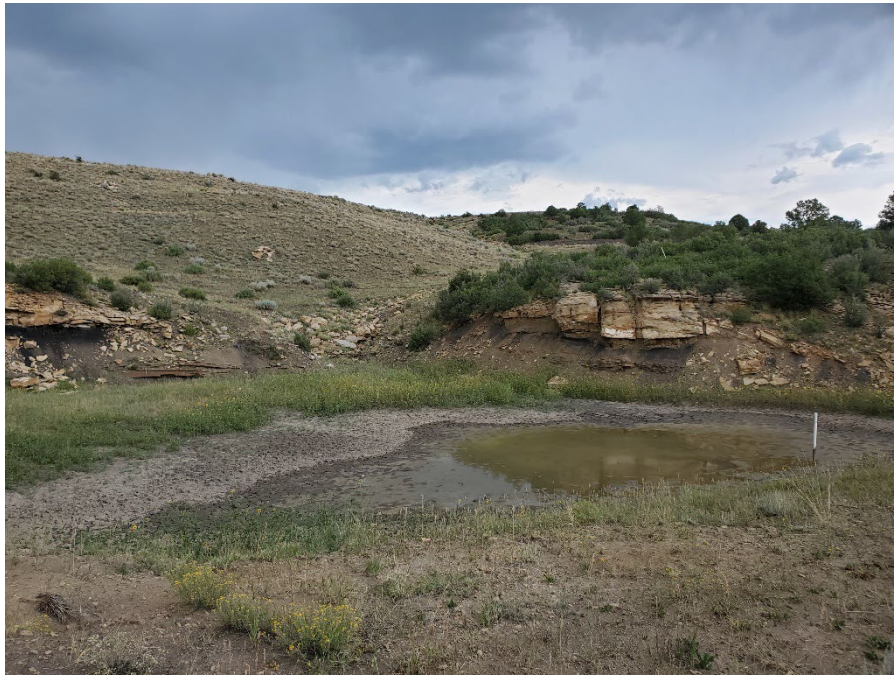
- Pond 009a:
 - The pond contained water (Photo 12).
 - The pond embankment was stable and vegetated.
 - The primary and emergency spillways appeared clear and functional.
 - The flume was dry (Photo 13), and was not discharging.

Photo 12: Looking northeast at Pond 009a.

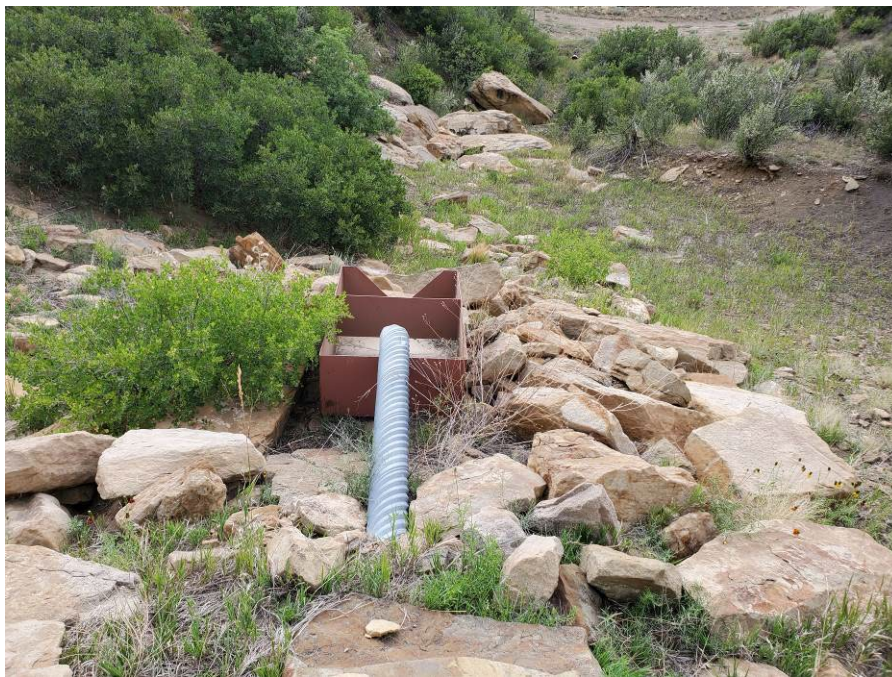
Photo 13: Looking south at the flume at Pond 009a.

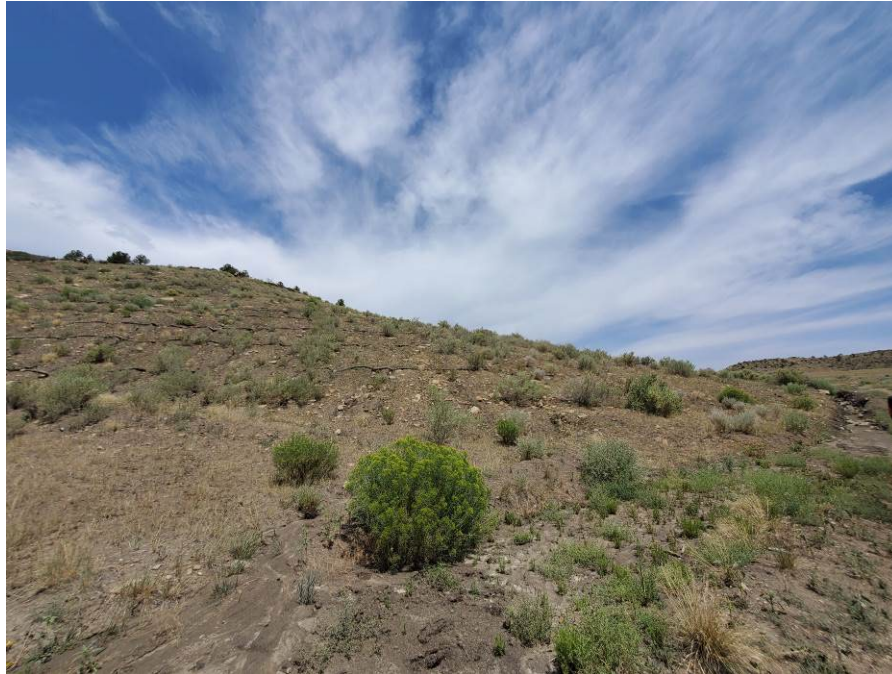
- a. The ditch along the road leading to Pond 006a is eroding and nearly full of sediment. The overloaded ditch is contributing to the build-up of sediment in the check dams of ditches D8 and D64. **Pursuant to Rule 4.03.2(4), the ditch along the west side of the road leading to Pond 006a needs to be cleaned out and repaired.**

- b. The check dams leading to Pond 006a, within ditches D8 and D64, are nearly full of sediment. **Pursuant to Rules 4.05.3(1)(c)-(e) and 4.05.5, the Operator shall clean out the sediment from the check dams to prevent excess sediment from entering the pond.**

- The Reclaimed Area above and to the west of Pond 006a was observed (Photo 14). This area still requires maintenance (See Items 3 and 4 in the Ongoing Maintenance Items section on the first page of this report).

Photo 14: Reclaimed area to the west of Pond 006a. Run-off from reclaimed slopes is carrying sediment into and across the road, and depositing the sediment into the check dams.

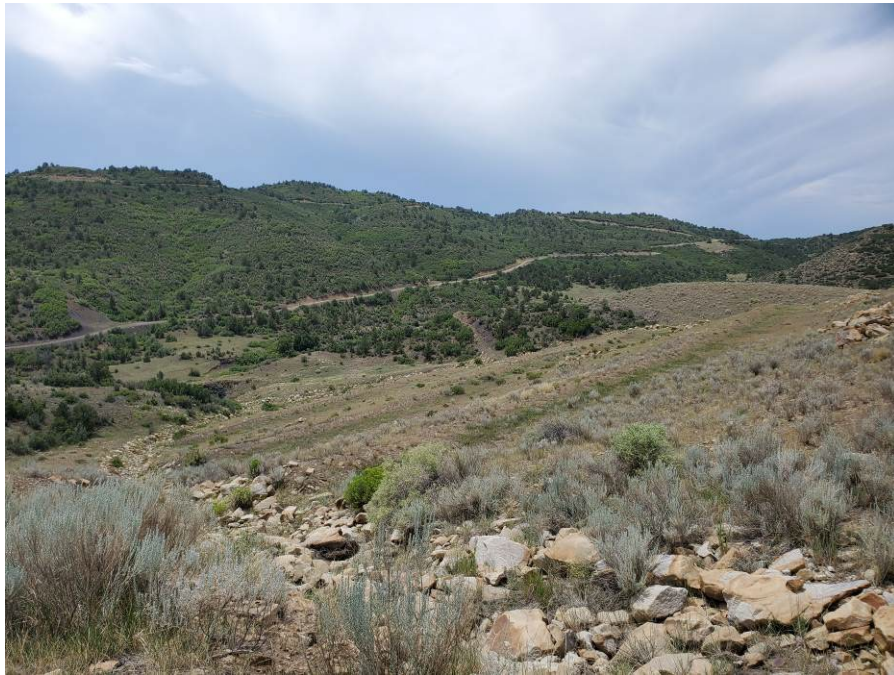
- Fill 7 – was well vegetated and appeared stable (Photo 15)

Photo 15: Looking southwest at Fill 7.

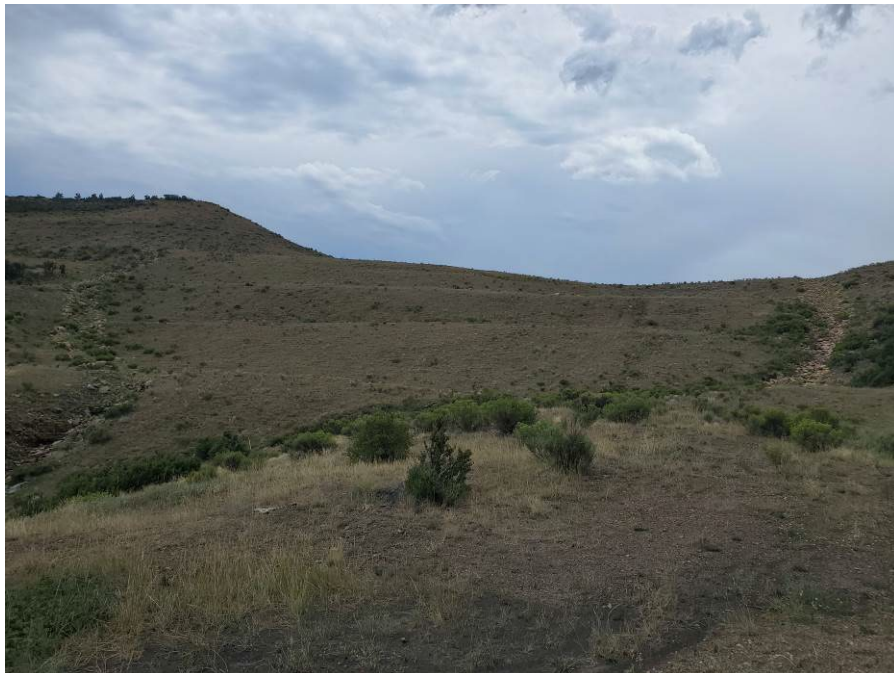
- Fill 8 was well vegetated and appeared stable (Photo 17).

Photo 16: Looking southeast at Fill 8.

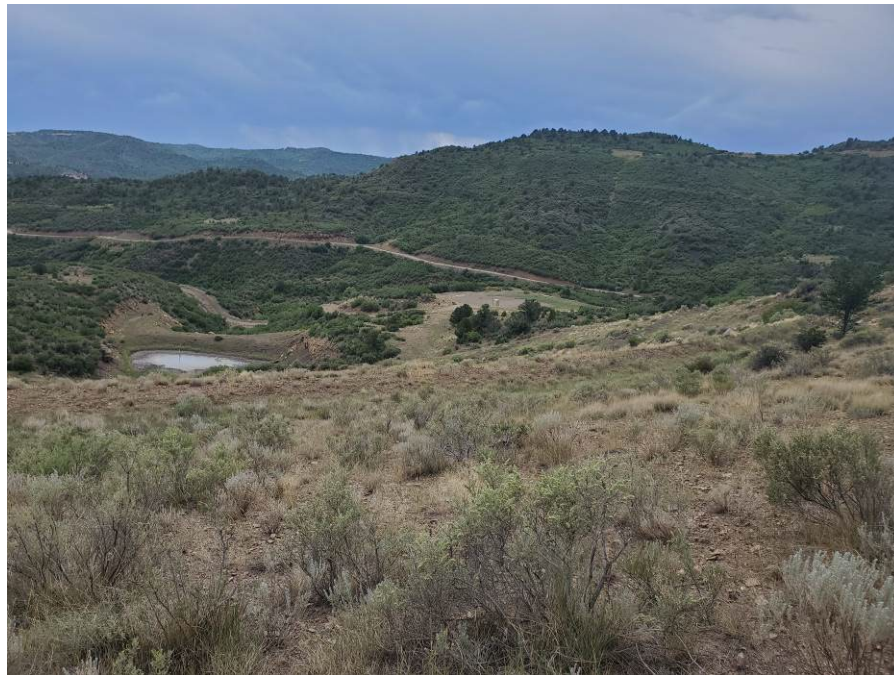
- Fill 9 was well vegetated and appeared stable (Photo 18).

Photo 17: Looking south down Fill 9.

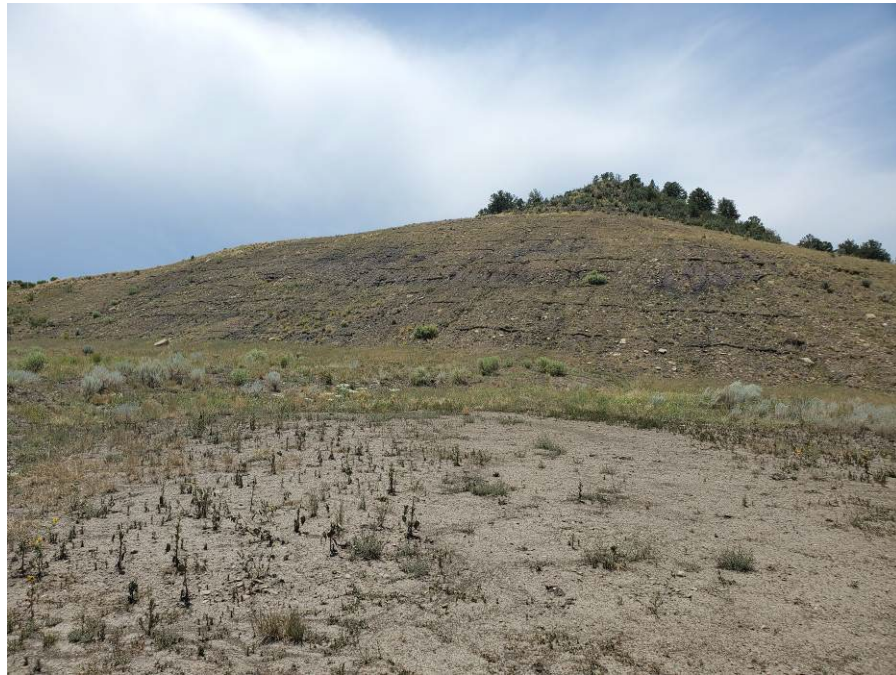
- The area above where NECC stores pond and ditch cleanings consists of a steep slope. This slope was observed (Photo 18). Erosion rills and gullies were observed but the vegetation on this slope appears better established this year than previously observed by DRMS. NECC is encouraged to continue to monitor this area and conduct maintenance as needed.

Photo 18: Sediment drying area and seeded slope.

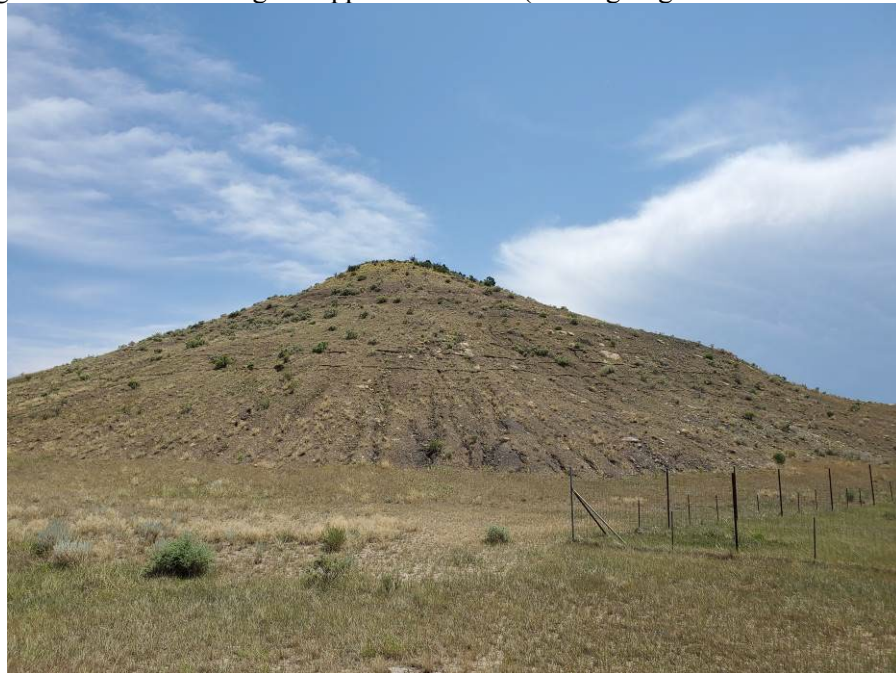
- A previously disturbed area north of Fill 7 and north of the road, referred to as “The Knob”, exhibits erosion on the south facing slope (Photo 19). There is also a small catchment at the base of the slope that was not holding water at the time of the inspection. NECC is required to provide a plan to stabilize this area through a revision following the approval of RN5 (see ongoing maintenance item number 4).

Photo 19: The “Knob” with rills that have formed on the less vegetated areas on the south and west facing slopes.

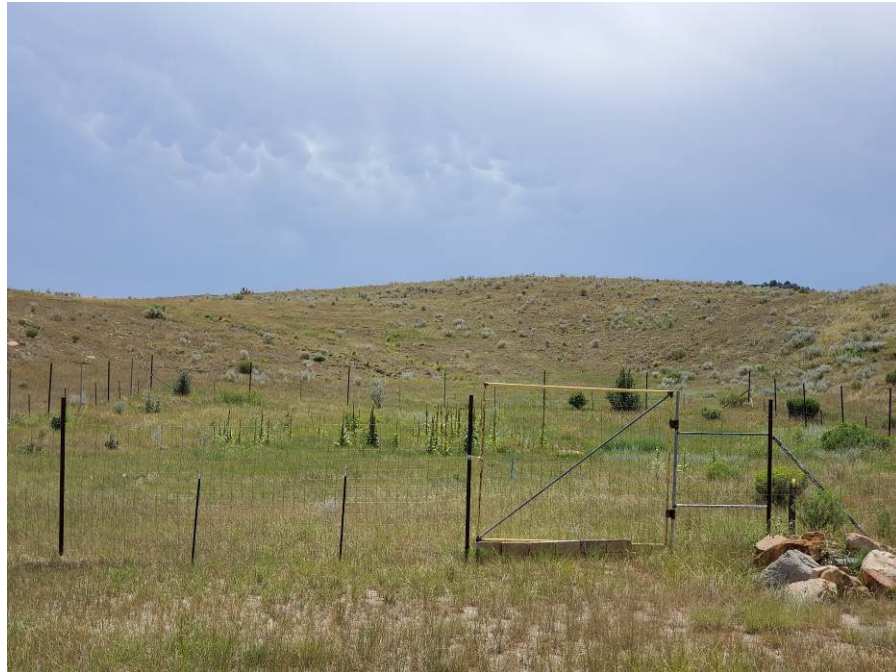
- An area designated as a vegetation test plot has been infested with Mullein (Photo 20). **The Operator shall treat and/or remove the Mullein within this area.**

Photo 20: Mullein growing in the test plot area southwest of the “Knob”.
