MINERALS PROGRAM INSPECTION REPORT
PHONE: (303) 866-3567

| MINE NAME: Henderson Mine | MINE/PROSPECTING ID#: M-1977-342 | MINERAL: Molybdenum | COUNTY: Clear Creek, Grand |
| INSPECTION TYPE: Monitoring | WEATHER: Sunny and Clear, Windy | INSP. DATE: July 30, 2024 | INSP. TIME: 09:00 |

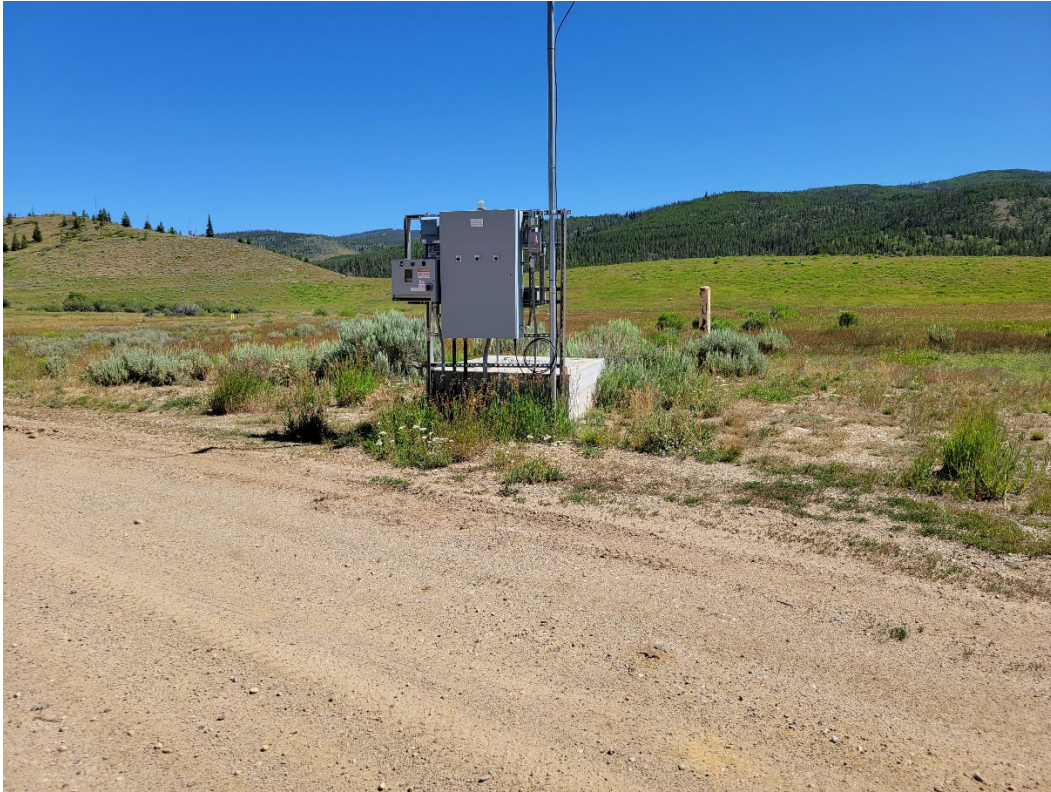
Five extraction wells were observed during this inspection. MLEX 1-4 which combine into a single underground header that discharges into the 1-Dam seepage collection area, and MLEX 5 which is piped separately to the Ute Park pump station. The operator stated the wells are routinely visually and remotely monitored and inspected. There is a light on top of the unit that will light up if there is a problem with the well controls. The control panels are backed up by telemetry batteries and the telemetry system stores the data and transmits it later in a power outage situation. The extraction well system is addressed in technical revisions TR-23, TR-25 and TR-28. The Division is currently reviewing the Ute Park Extraction Wellfield Phase IV - Technical Revision 36 received on August 20, 2024. TR-36 proposes two additional extraction wells, MLEX-6 and MLEX-7 to further mitigate seepage-impacted groundwater that could migrate downgradient. During this inspection, Mr. Hamarat showed the Division the location of the two proposed additional extraction wells. MLEX-6 will be installed on the east side of Ute Park and MLEX-7 will be installed on the south end of the gravel pit area.

Photo 1: Extraction well MLEX-2 in the Ute Park Extraction Wellfield.

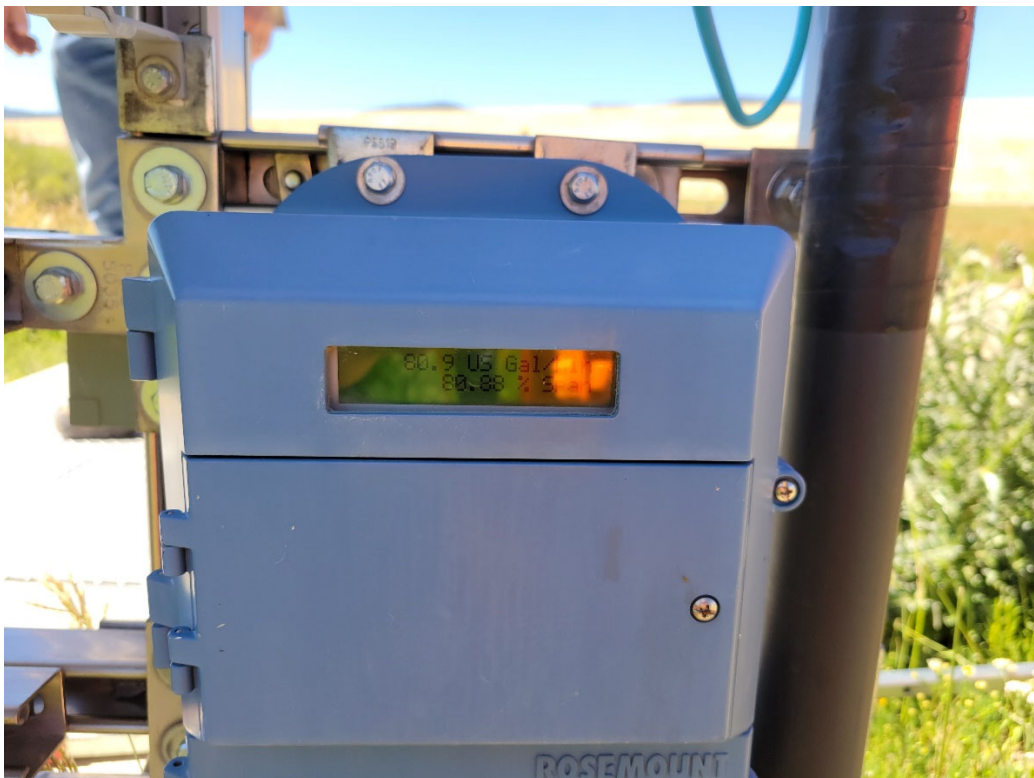
Photo 2: Control panel on extraction well MELX-4 displaying 80.9 gal/Min.

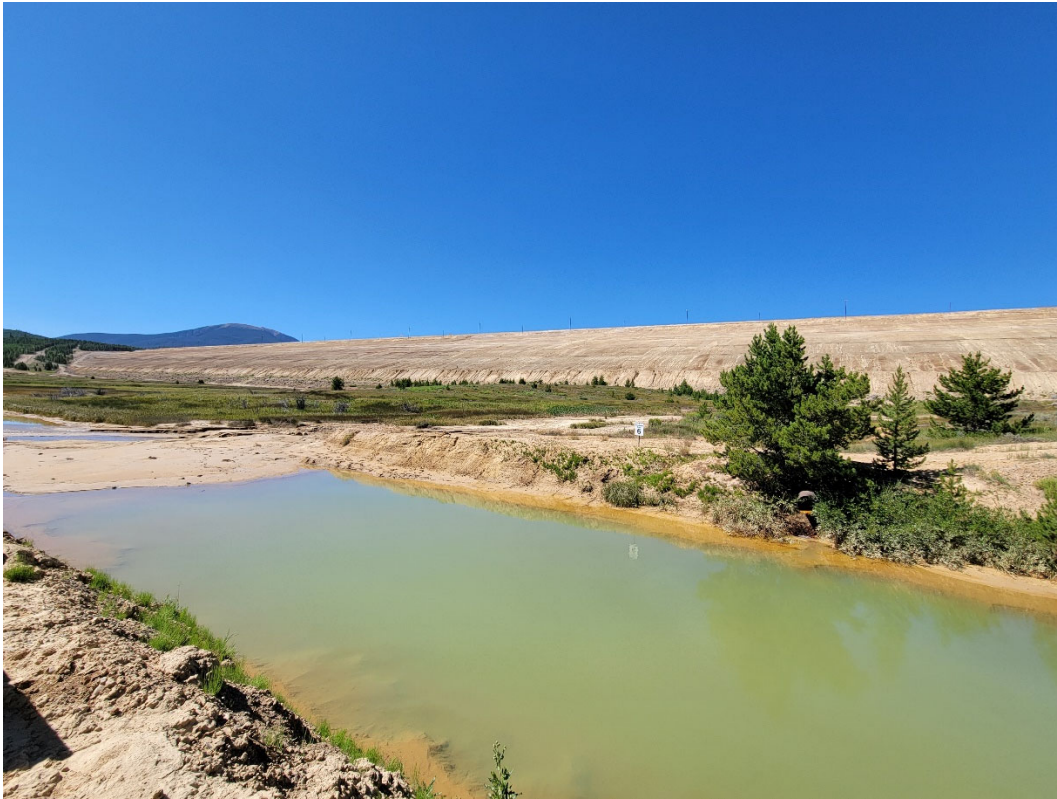
The Division observed water flowing to the Ute Park Pump Station via the seep water collection canals. The horizontal drains installed at the base of the Tailings Storage Facility (TSF) embankment were also observed and water was flowing out of them into the collection area during the inspection.

Photo 3: Seepage collection area at the base of 1-Dam.

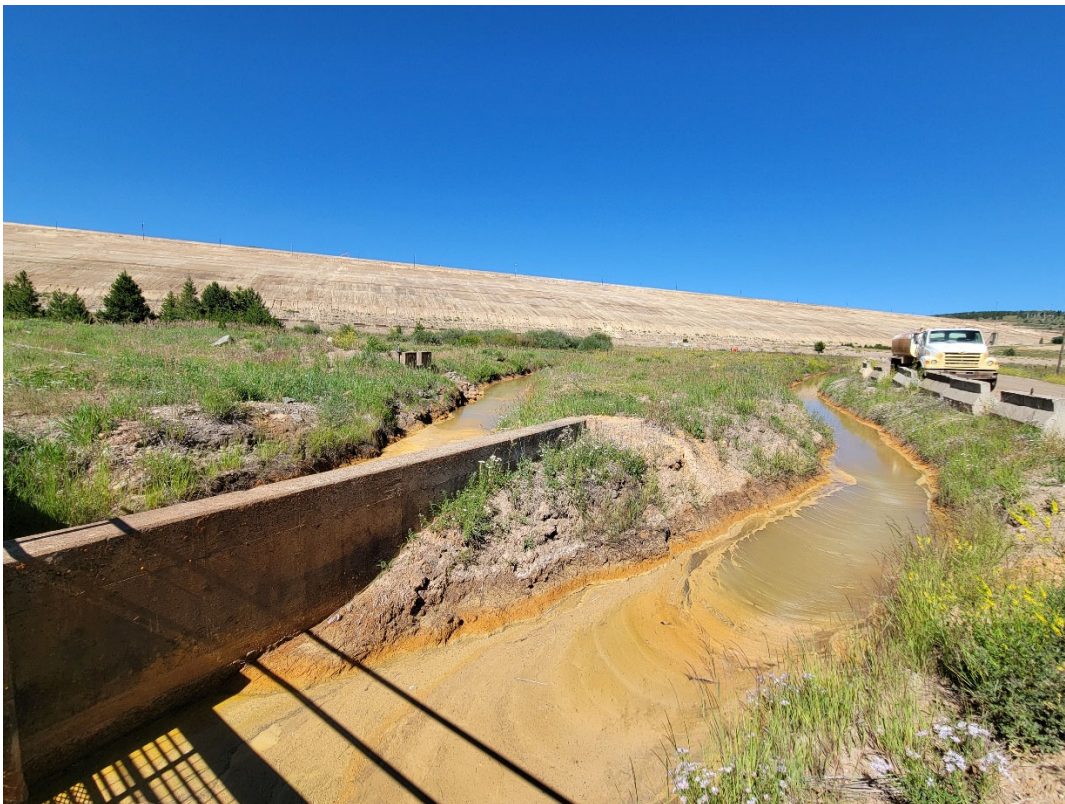
Photo 4: Looking at north and south canals in the seep water collection area moving water to the Ute Park Pump Station.

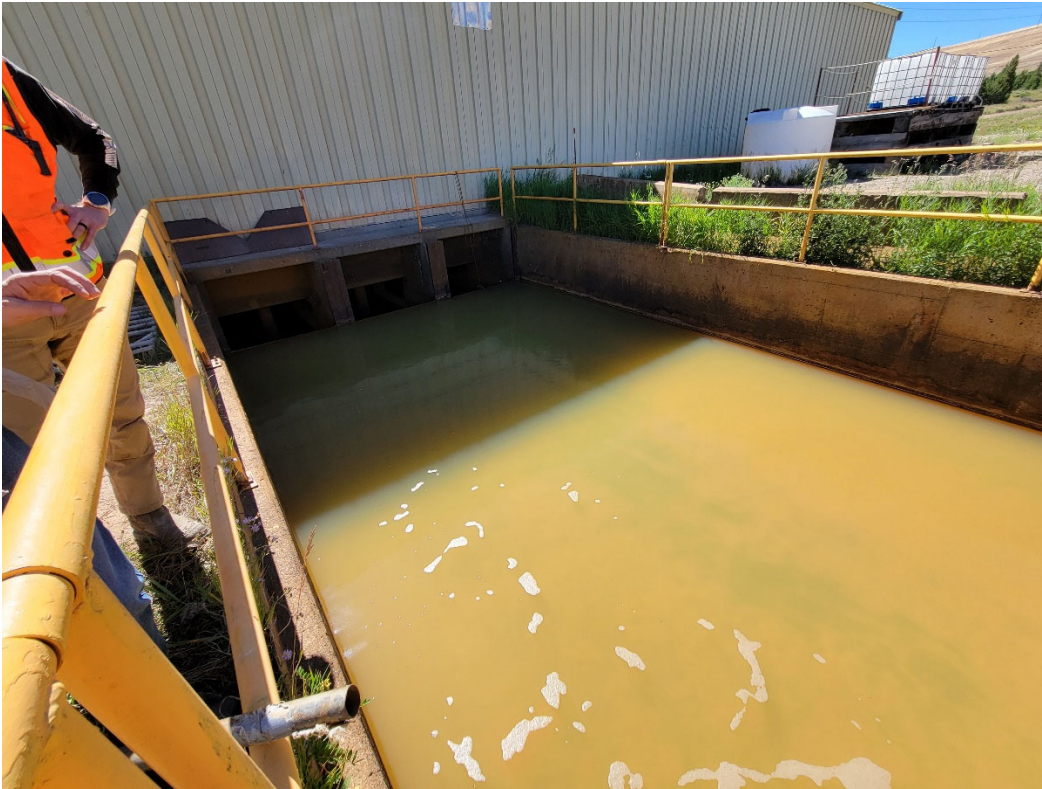
Photo 5: Ute Park Pump Station inlet on the west side of the building.

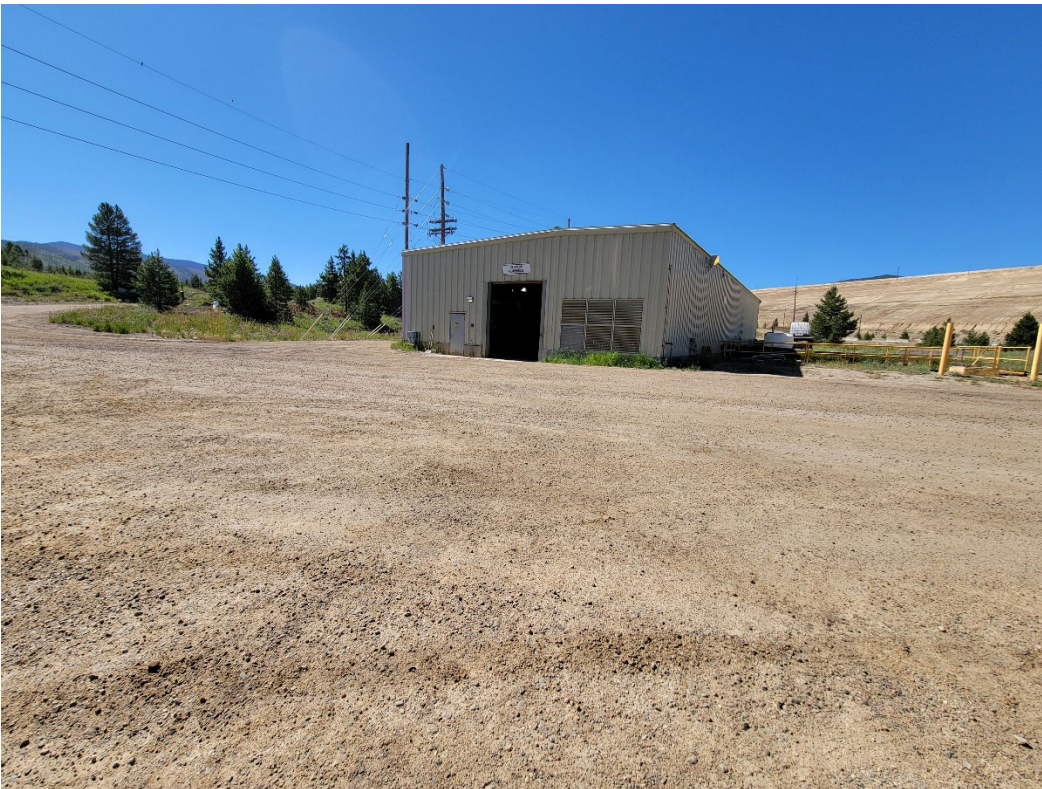
Ute Park Pumphouse - Mill EPF 1.7: The Ute Park Pumphouse collects seep water from the tailings storage facility and water from the extraction wellfield and returns the water to the tailings storage facility. The Division observed the exterior and interior of the Pumphouse. Mr. Hamarat showed the Division automatic gates on the north and south canals that will close to prevent water from flowing into the pumphouse during a power outage. The Division also observed an emergency generator in the seep collection area that is used to pump water from the canals directly to the TSF. Henderson routinely powers up the generator and conducts regular maintenance.

Photo 6: Exterior of the Ute Park Pump Station.

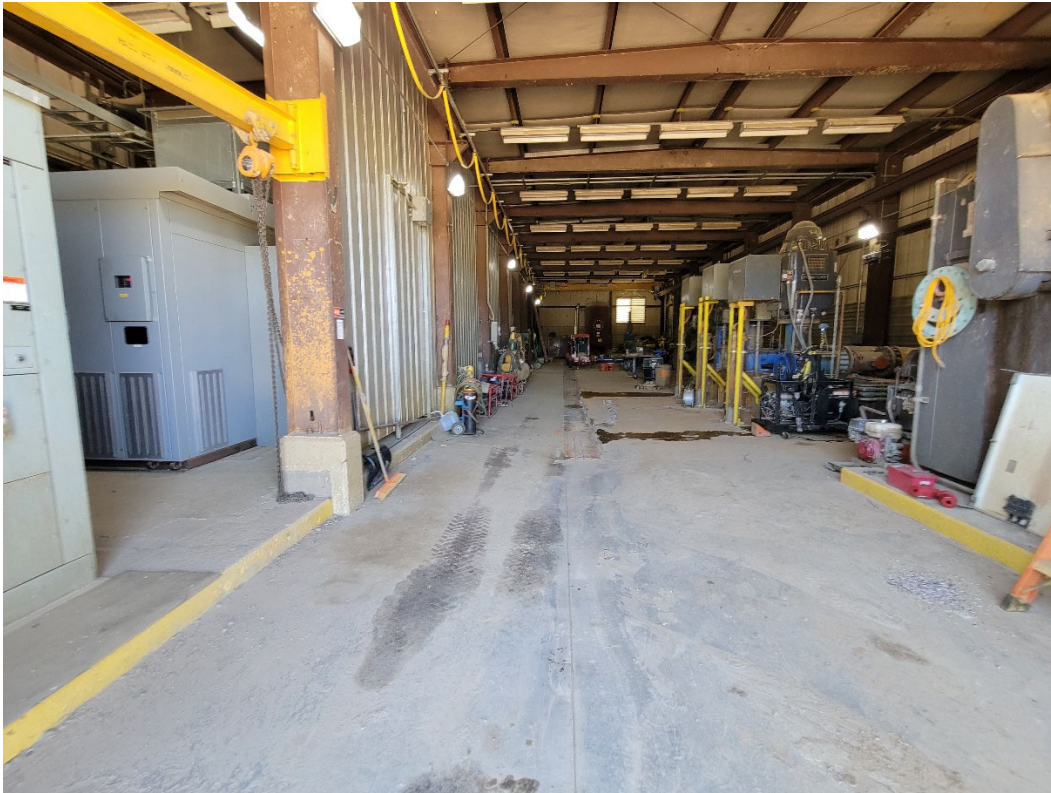
Photo 7: Interior of the Ute Park Pump Station

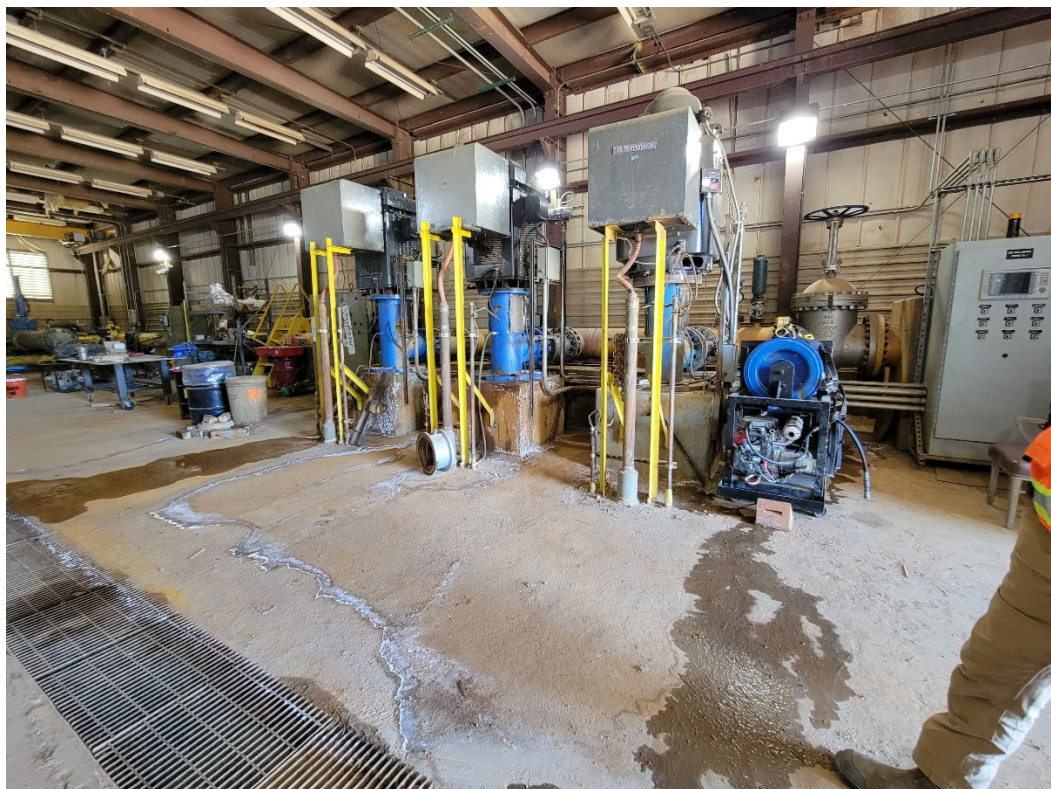
Photo 8: Turbine pumps in the Ute Park Pump Station

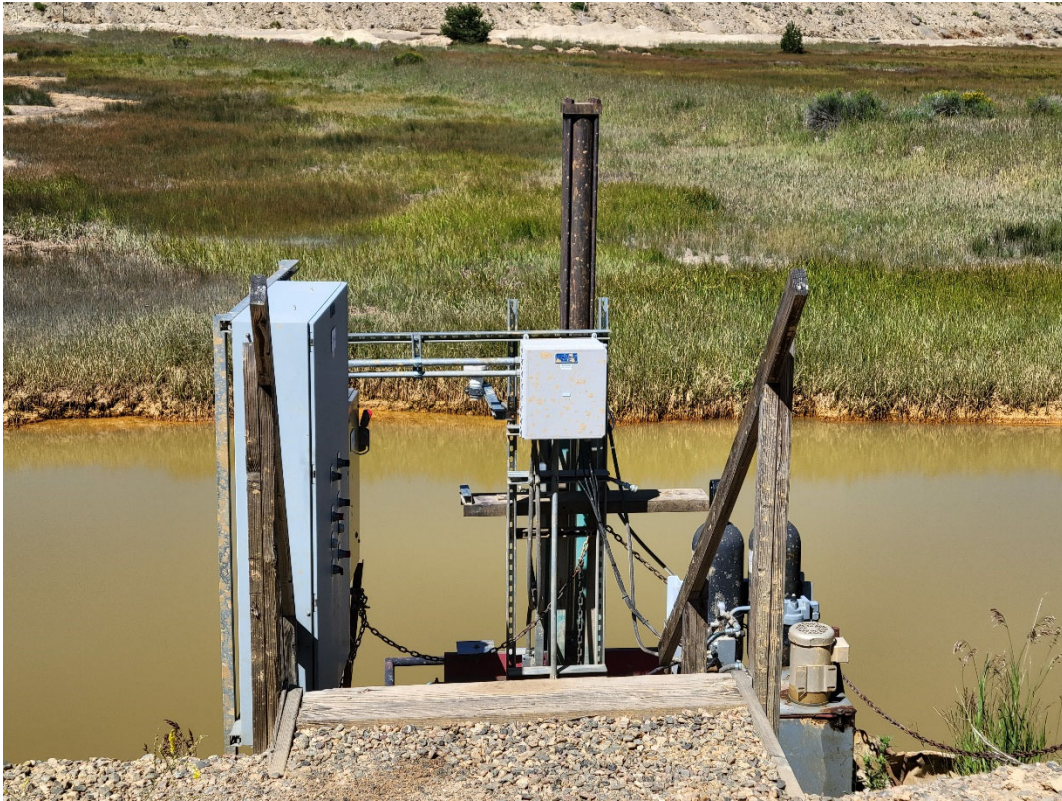
Photo 9: Gate on the north canal controlling seep water feed channels to the pump house.

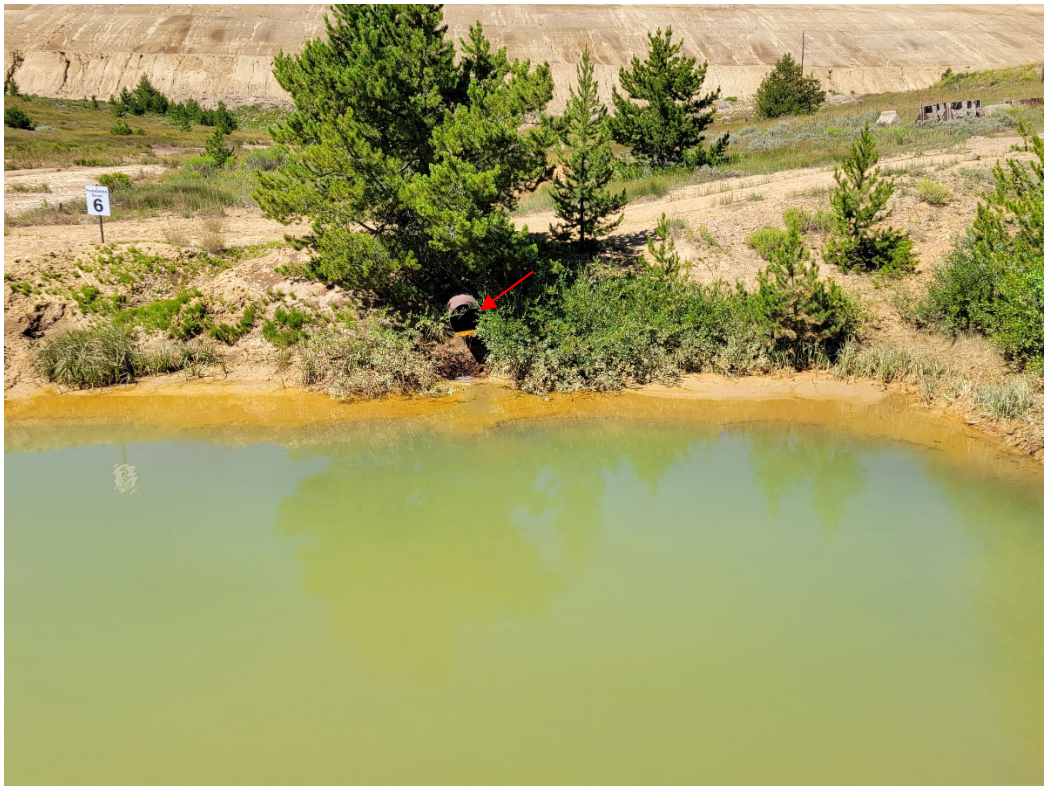
Photo 10: Seep water storage area in Ute Park. Red arrow points to flowing underground drain.

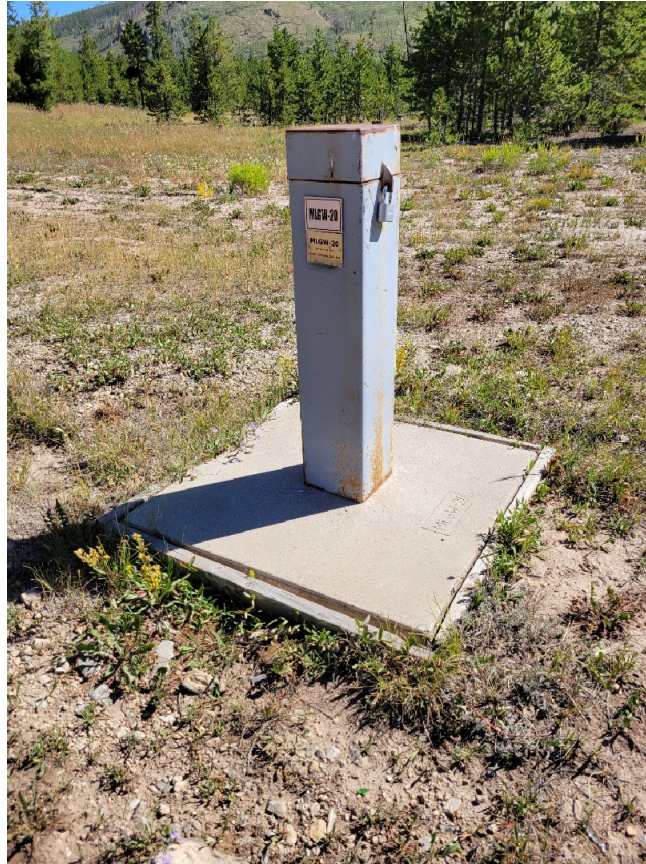
Photo 11: Groundwater monitoring well MLGW-20.

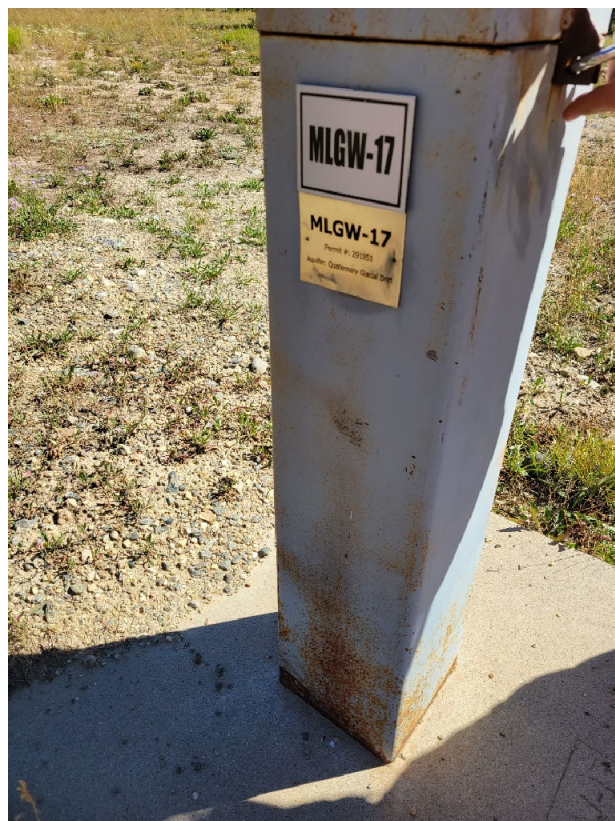
Mr. Bates informed the Division that low flow bladder pumps were recently installed in monitoring wells MLGW 7, 15, and 17. This is discussed in the 2023 Annual Water Monitoring Report.

Photo 12: Groundwater monitoring well MLGW-17.

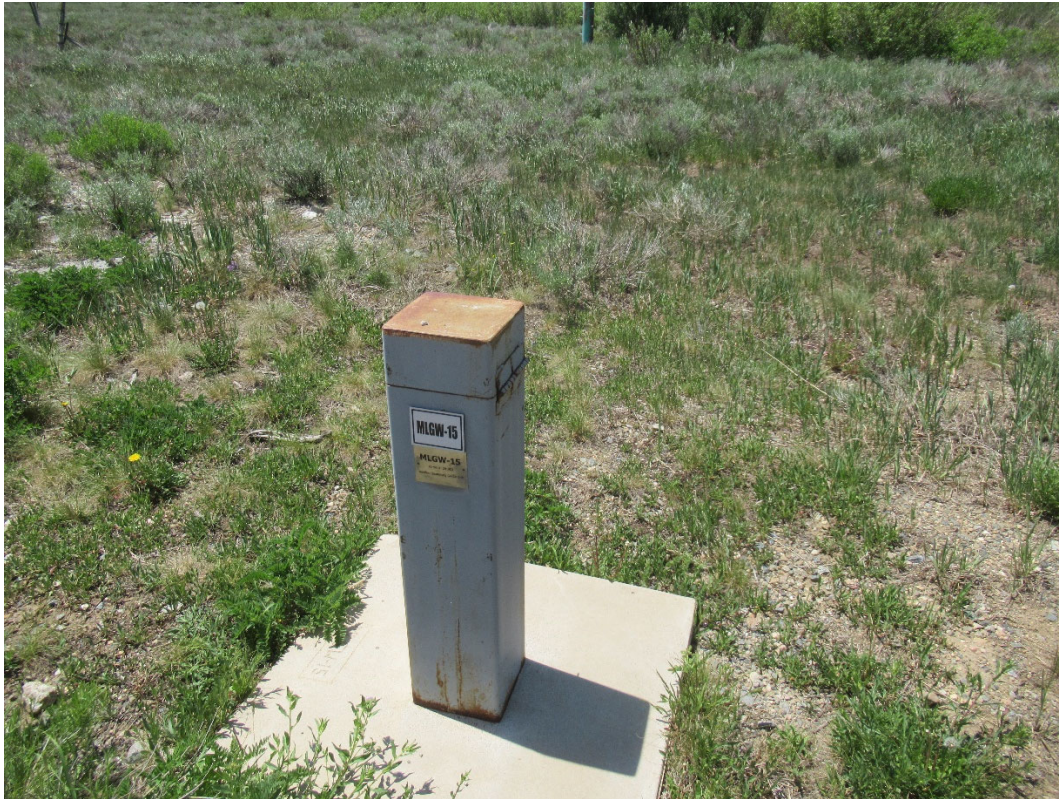
Photo 13: Groundwater monitoring well MLGW-15.

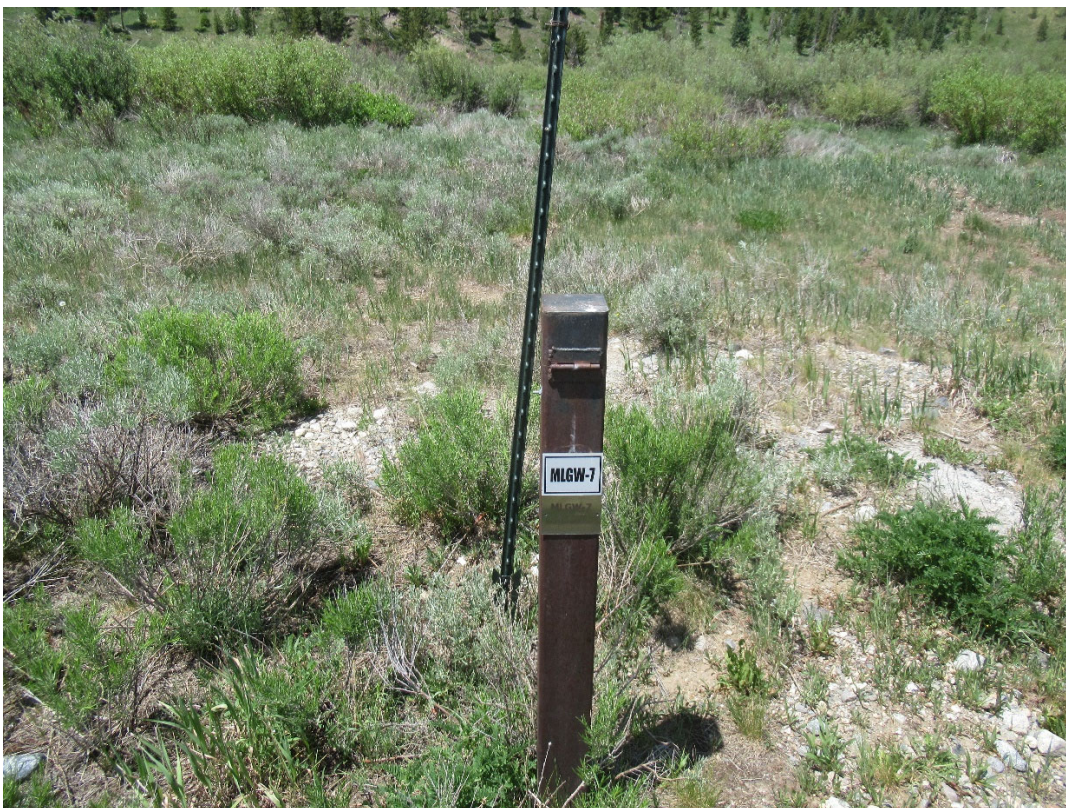
The groundwater compliance facilities were inspected by the Division. Four groundwater wells MLGW-7, MLGW-15, MLGW-17, and MLGW 20 were observed and discussed during the inspection. MLGW-7 is the point of compliance (POC) well. MLGW 15 and MLGW 17 are proposed as a point of compliance wells. Mr. Hamarat stated that MLGW 20 is shallower and very little water has been observed in this well. POC well MLGW-ACR was not accessible during this inspection due to a locked gate and no trespassing sign at the entrance of the ranch property. On July 17, 2024, the Division received a letter from Henderson stating that they attempted to reach the new ownership to gain access to sample the well, however, as of this inspection, little progress has been made. Henderson drilled a new monitoring well on property owned by Henderson, MLGW-37. This well was sampled during the spring sampling period and reported the data to the Division as an alternative to satisfy the POC requirement. Henderson plans to submit a Technical Revision later this year to add the three POC wells to the approved monitoring plan.

Photo 14: POC groundwater monitoring well MLGW-7.

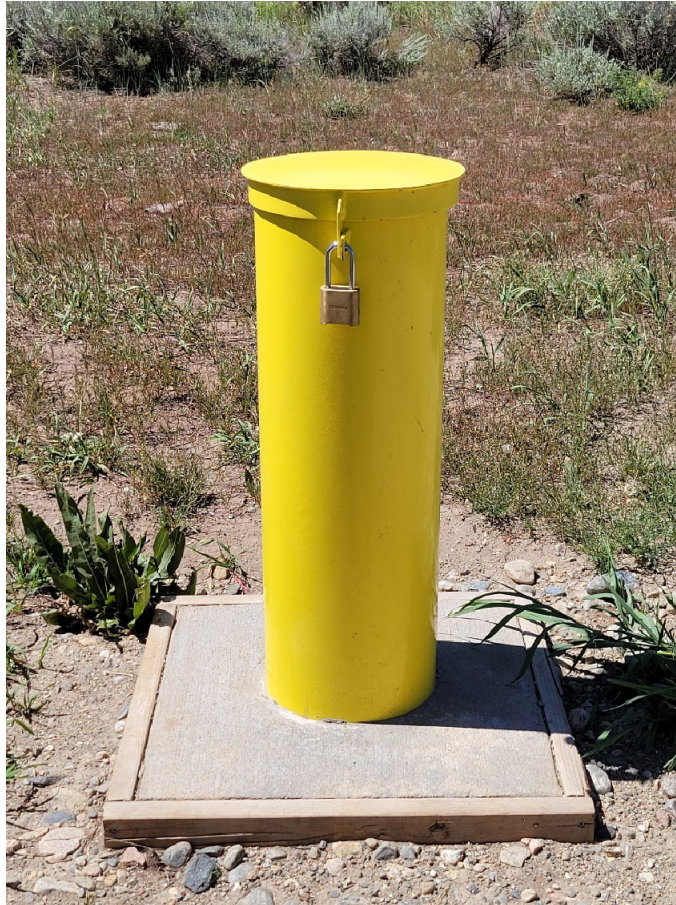
Photo 13: View of the new monitoring well on property owned by Henderson, MLGW-37.

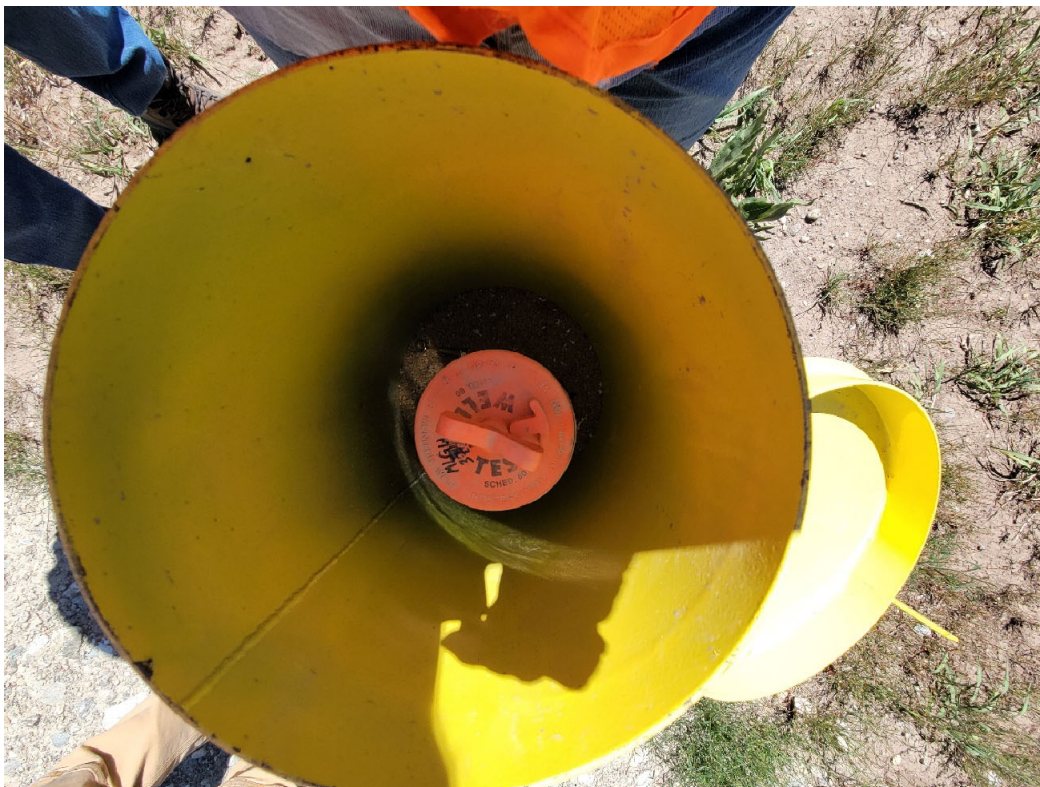
Photo 14: Inside view of MLGW-37.

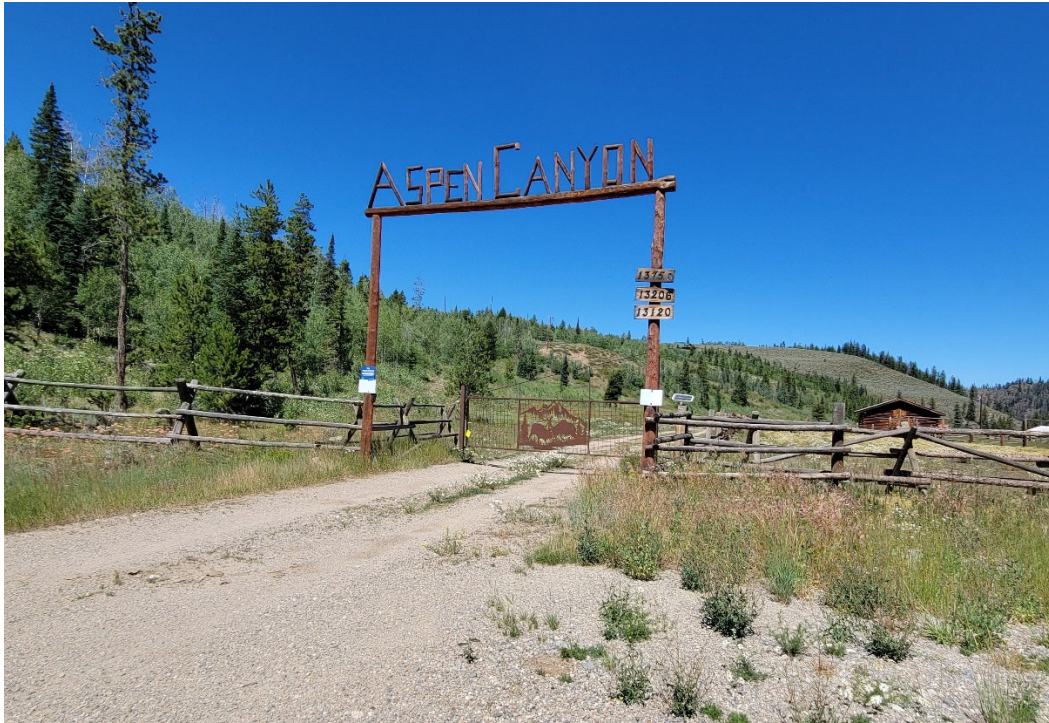
Photo 15: Locked entrance to Aspen Canyon where MLGW-ACR is located.

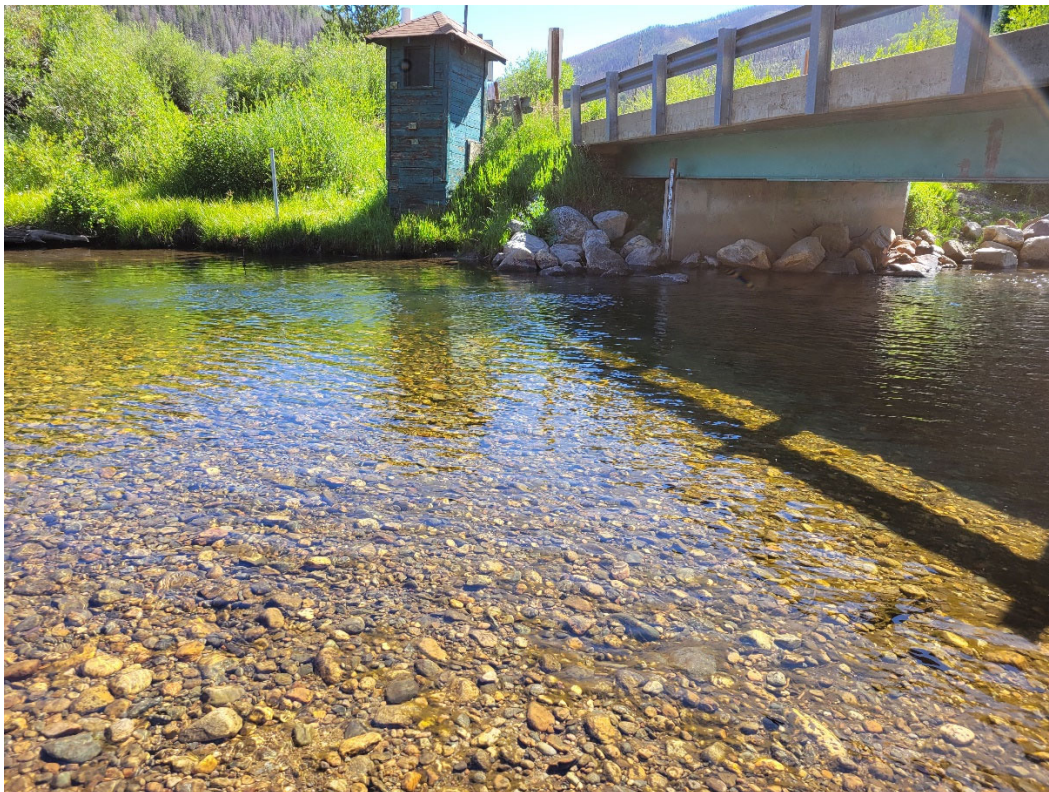
Long-term surface water monitoring locations WFR-20 and WFR-40 were observed and discussed during the inspection. WFR-20 is the upgradient location in the southeast corner of the permit area. WFR-40 is downgradient, northeast of the tailings dam.

Photo 16: Looking at surface water monitoring location WFR-20 on the Williams Fork River in the southeast corner of the permit area.

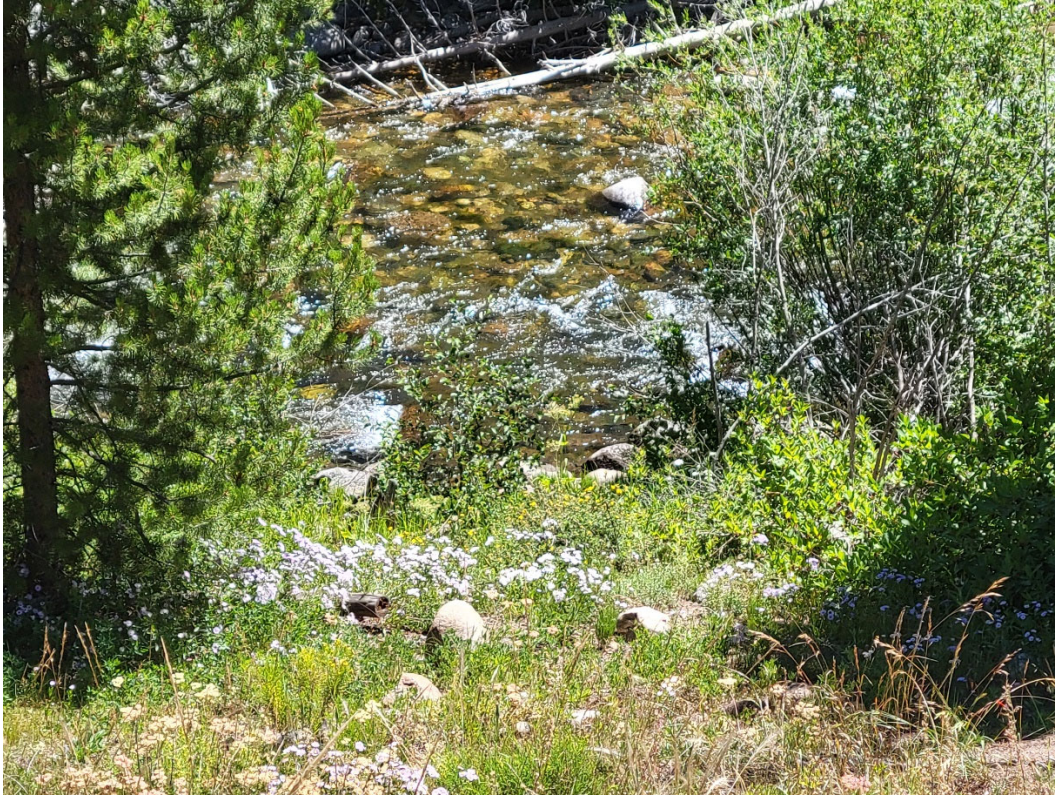
Photo 17: Looking at surface water monitoring location WFR-40 on the Williams Fork River in the southeast corner of the permit area.

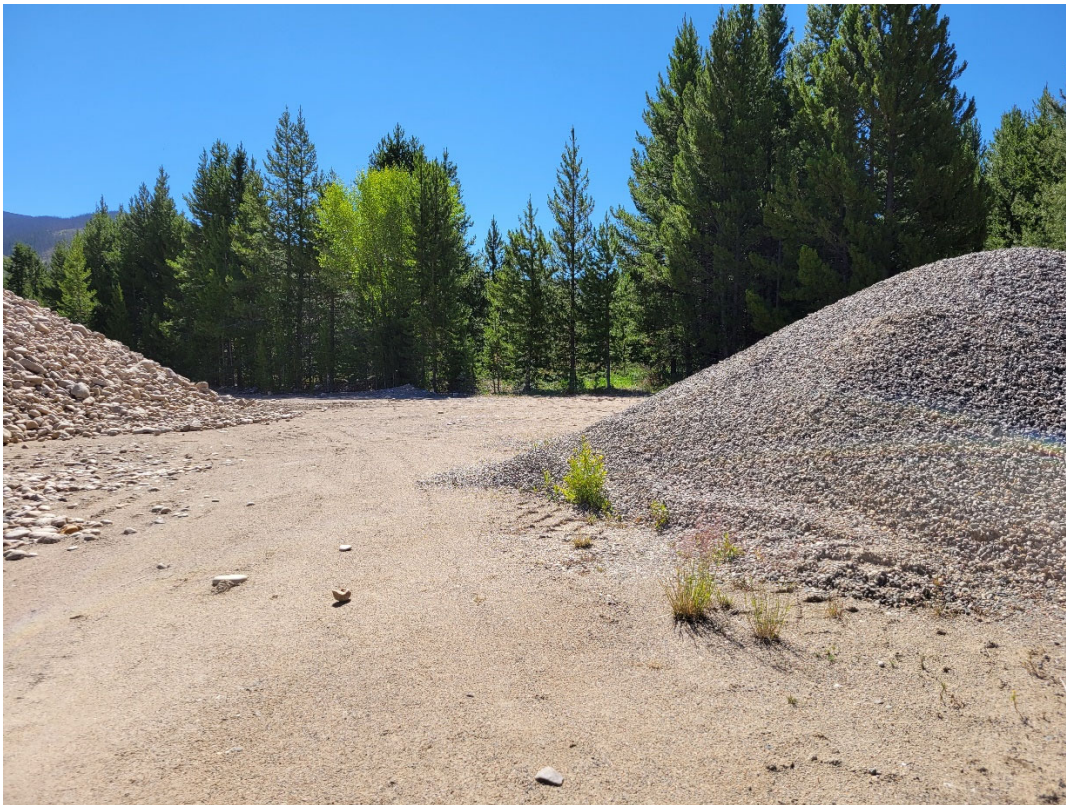
Photo 18: Looking at proposed location for extraction well MLEX-7 on the south end of the gravel pit area

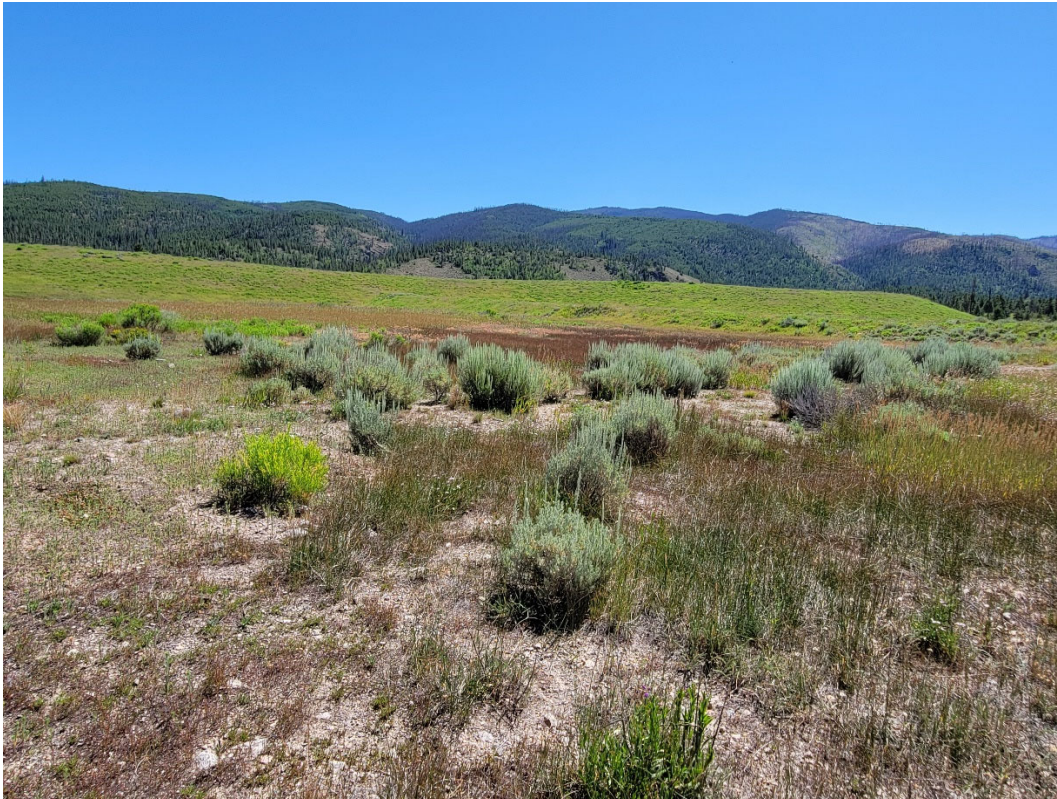
Photo 19: Looking at proposed location for extraction well MLEX-6 on the east side of Ute Park
