MINERALS PROGRAM INSPECTION REPORT
PHONE: (303) 866-3567

MINE NAME: Richard Bachman Pit	MINE/PROSPECTING ID#: M-1980-112	MINERAL: Sand and gravel	COUNTY: Rio Blanco
INSPECTION TYPE: Monitoring	WEATHER: Clear	INSP. DATE: August 7, 2024	INSP. TIME: 09:00
OPERATOR: Rio Blanco County	OPERATOR REPRESENTATIVE:	TYPE OF OPERATION: 112c - Construction Regular Operation	
REASON FOR INSPECTION: Normal I&E Program	BOND CALCULATION TYPE: None	BOND AMOUNT: \$0.00	
DATE OF COMPLAINT: NA	POST INSP. CONTACTS: DRMS	JOINT INSP. AGENCY: None	
INSPECTOR(S): Amy Yeldell	INSPECTOR'S SIGNATURE:

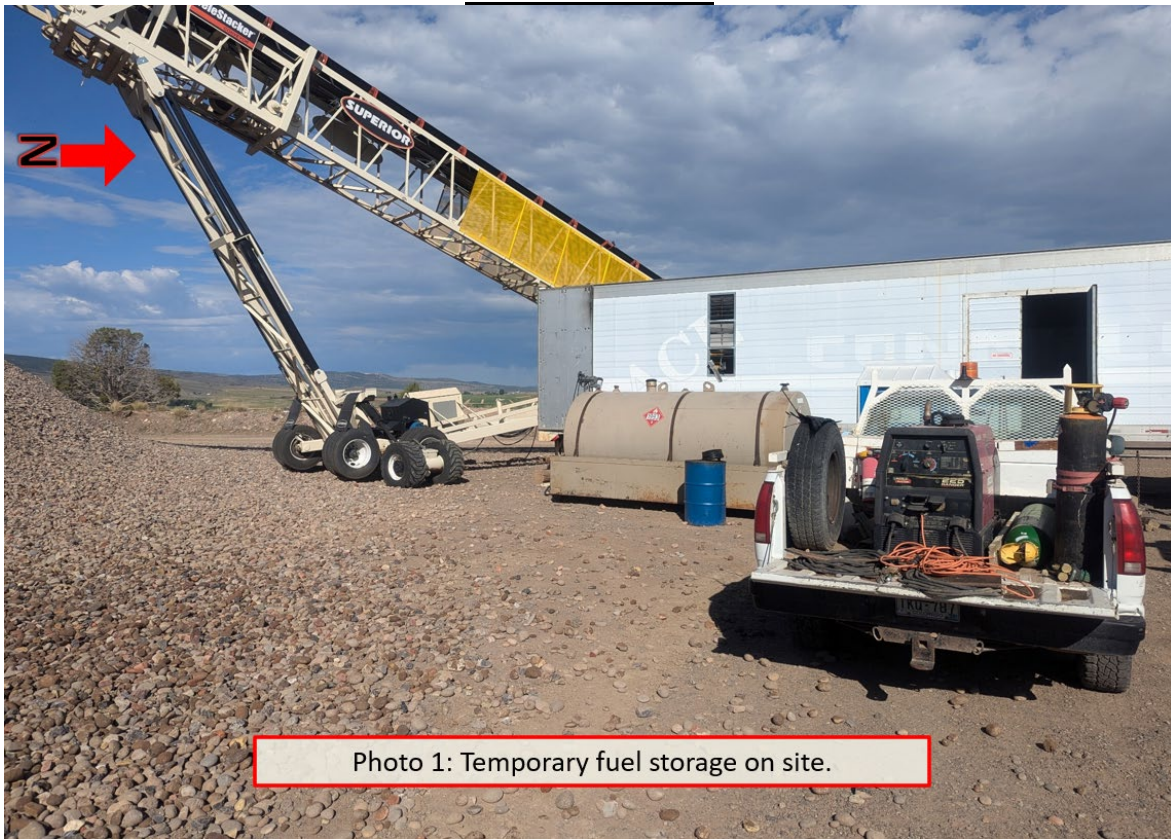
All fuel is stored within secondary containment (Photo One). Fuel is only located on site during a crushing campaign. All hydrocarbons are removed upon completion of crushing.

Photo 1: Temporary fuel storage on site.

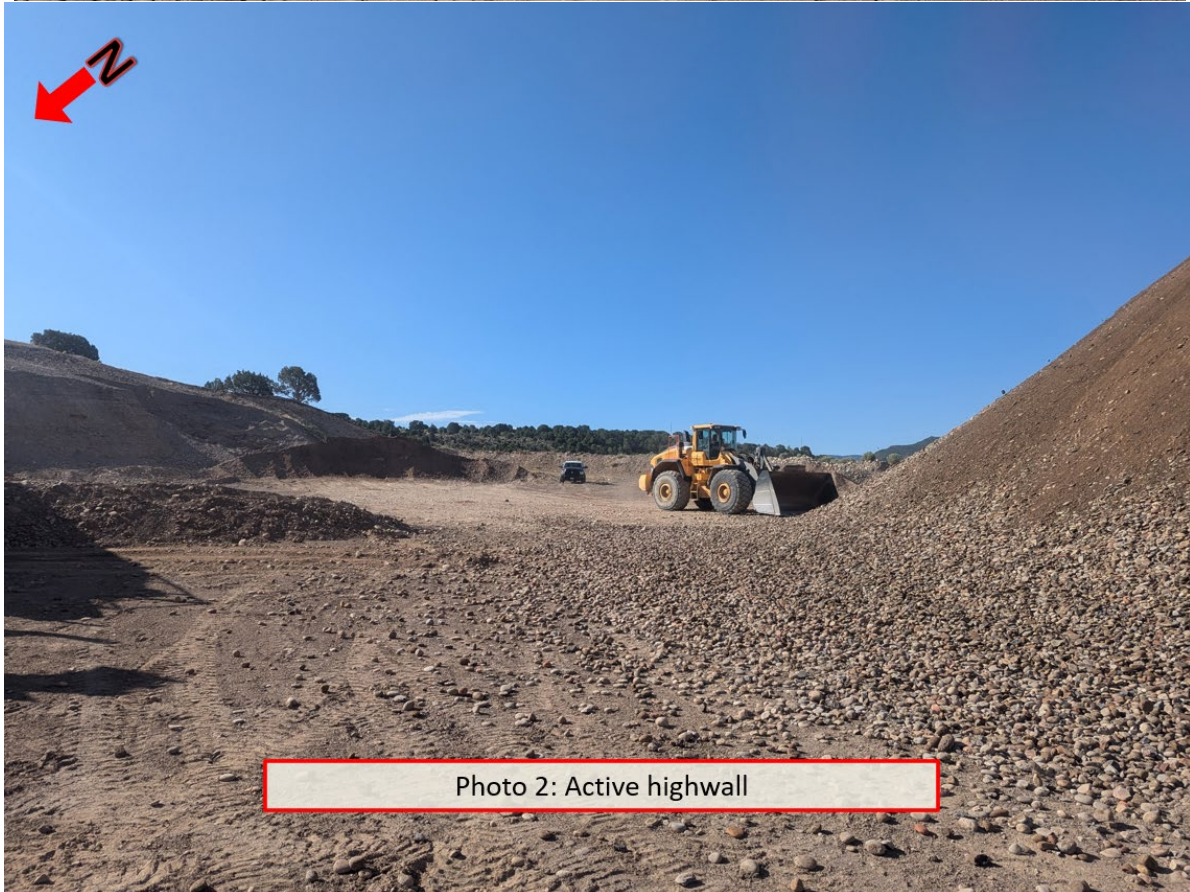
Active mining is taking place along the east side of the southern highwall. Disturbances are largely located within the existing disturbance footprint. The active highwall is approximately 25'H by 175 yards long (Photo Two). Further to the north is the existing highwall that has not changed since the previous inspection (Photo Three). No additional stripping will be required for this crushing campaign.

Photo 2: Active highwall

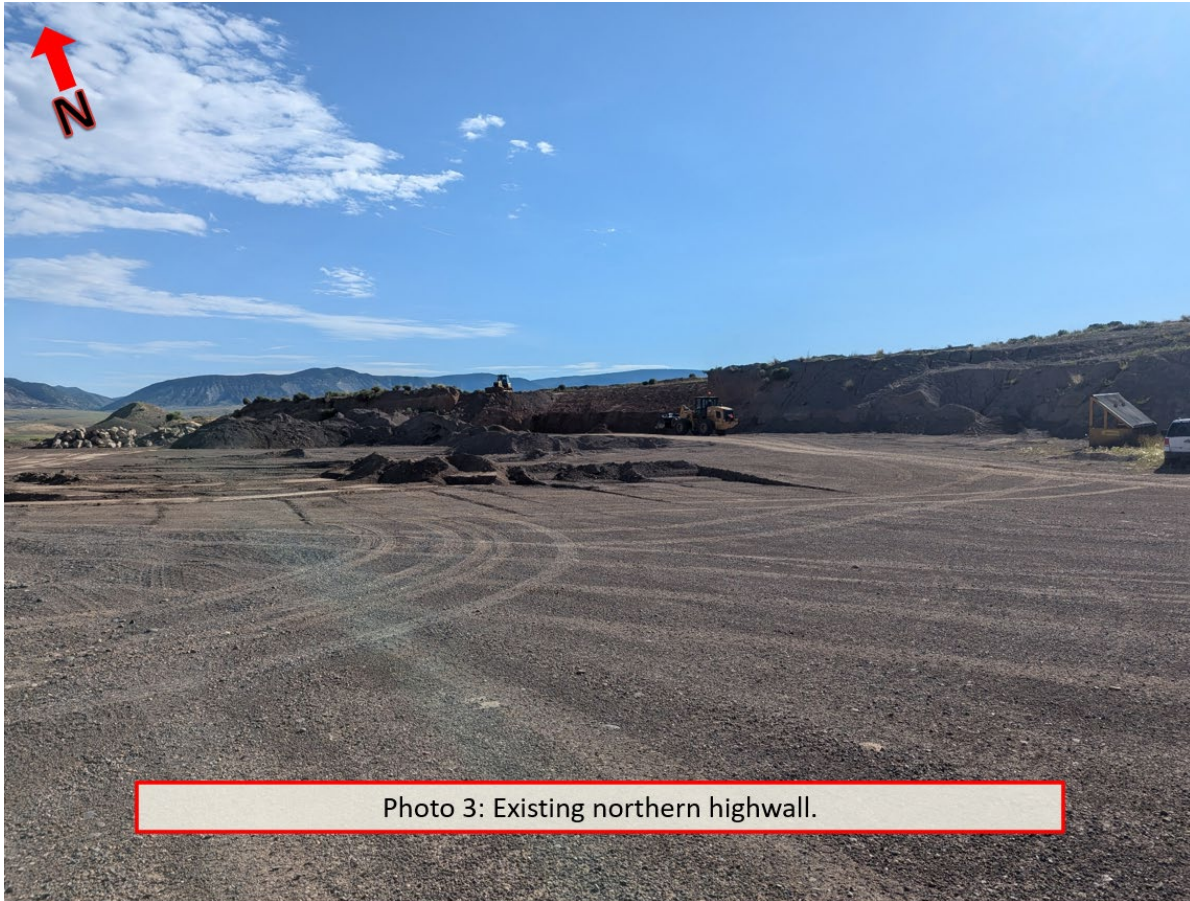
Grading is also taking place on the north side of the pit. Large amounts of previously processed gravel are present on the pit floor (Photo Three). The county is in the process of consolidating this material.

Photo 3: Existing northern highwall.

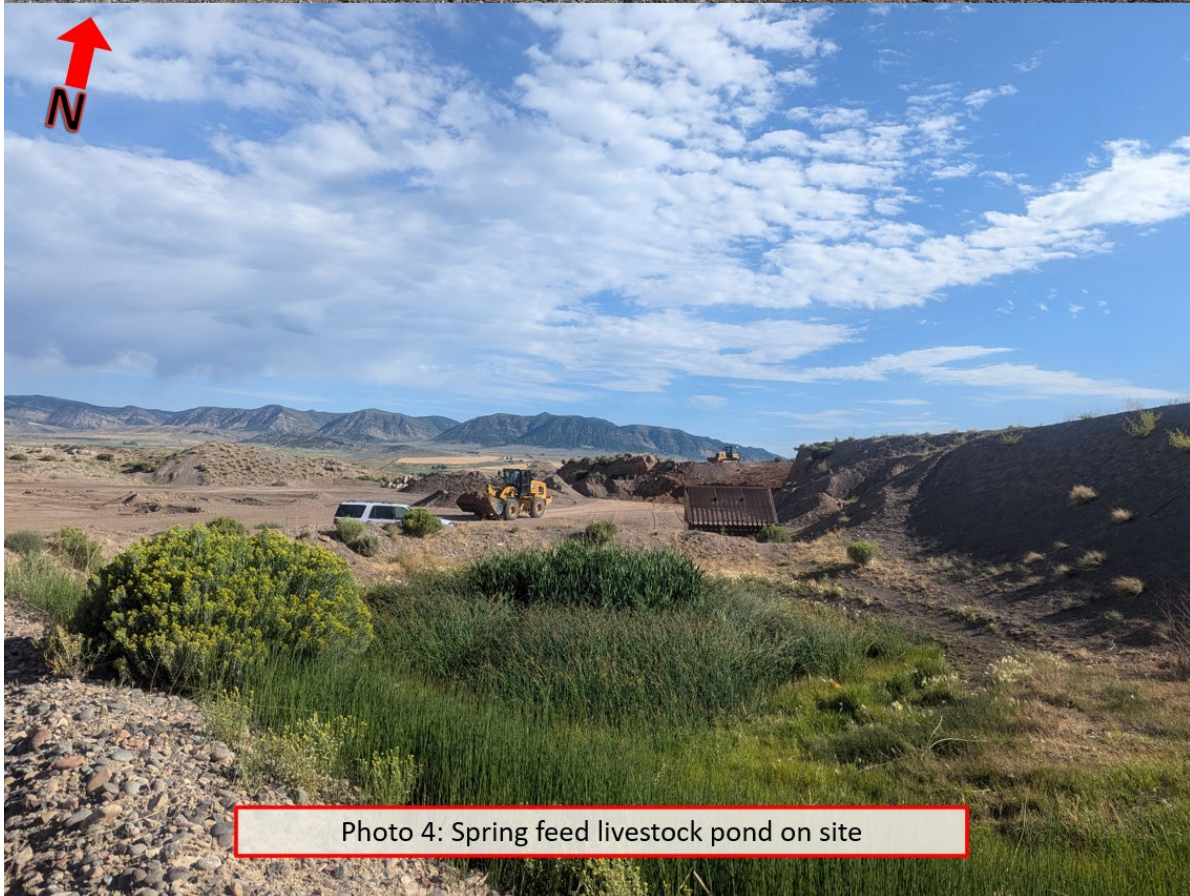
Small amounts of seeps/springs are present on this site. Water is directed to a small livestock pond on the pit floor at the landowners request (Photo Four). No other water was observed.

Photo 4: Spring feed livestock pond on site

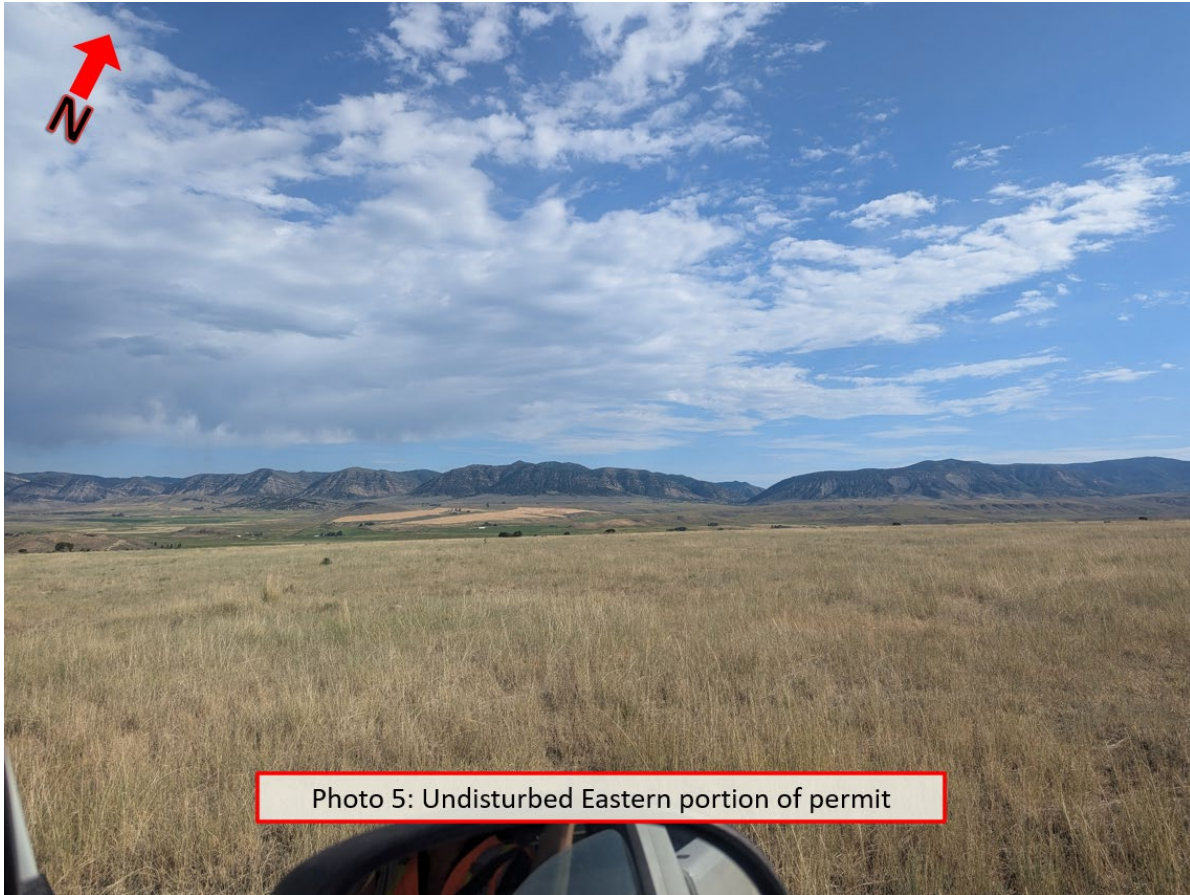
The permitted area is 73.77 acres, at this time its estimated that approximately 19 acre is disturbed. The eastern portion of the permit area remains undisturbed (Photo Five). Mining continues to progress form west to east. Crushing operations occur every 5 years or as needed. No washing, asphalt or cement production occur at this site. There are no permanent structures.

Photo 5: Undisturbed Eastern portion of permit

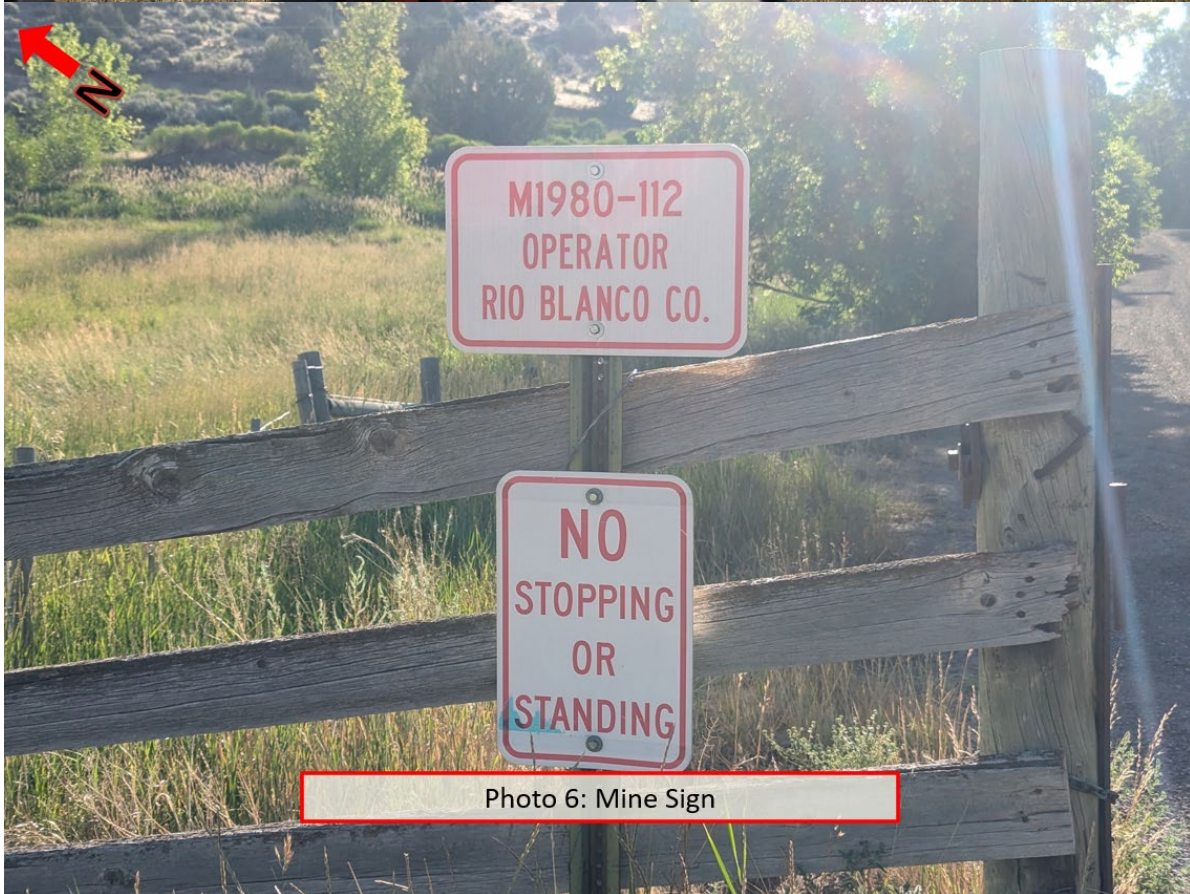
A mine sign was posted at the entrance to the mine site as required by Rule 3.1.12(1). The information depicted was correct/ up to date and the sign was of sufficient size (Photo six). The permit boundary of the affected land was clearly delineated primarily by t-posts with a white PVC sleeve pursuant to Rule 3.1.12(2).

Photo 6: Mine Sign
