To: Jerald Schnabel
Castle Aggregate
File: July 2024 Monitoring Summary

From: Paul Kos
Denver, CO 80202
Date: August 23, 2024

Reference: July 2024 Geotechnical Monitoring Summary Pikeview Quarry

Client/Project
CASTLE AGGREGATE
PIKEVIEW QUARRY SLOPE
MONITORING
Project No.
2057288200

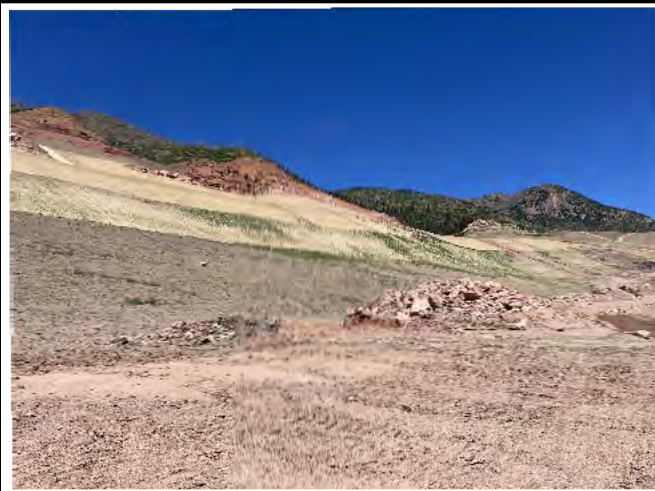
6. VEGETATION GROWING ON RECLAIMED SLOPES WITH RIPRAP STOCKPILED BELOW.

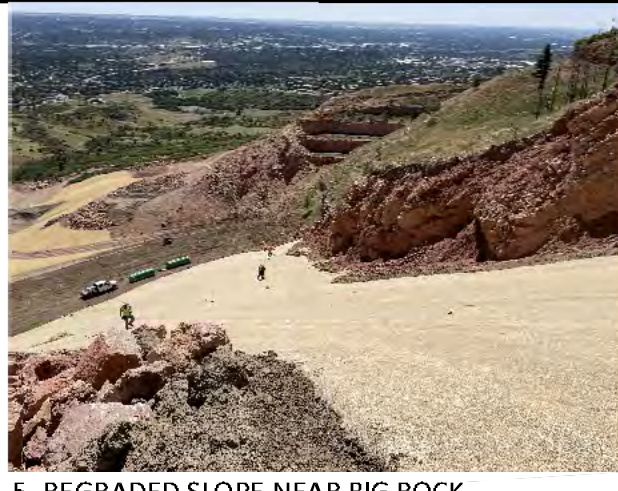
5. REGRADED SLOPE NEAR BIG ROCK.

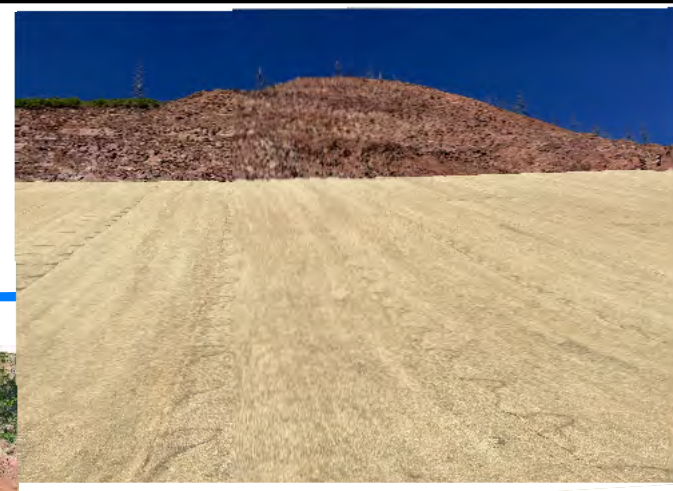
4. EROSION CONTROL FABRIC BENEATH MIDDLE PEAK.

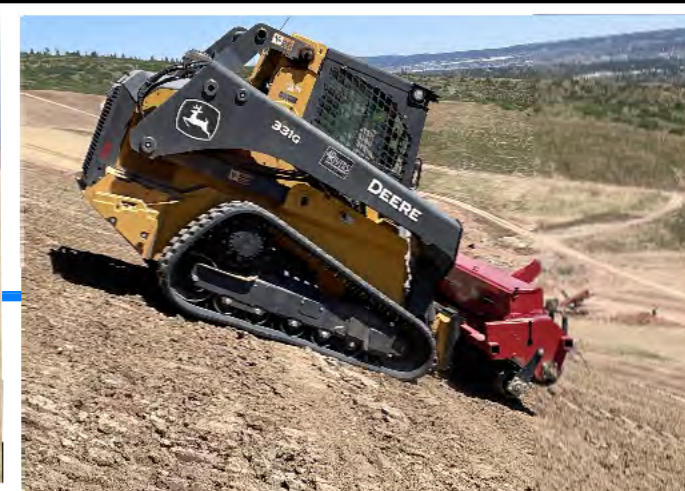
3. DRILL SEEDING BUTTRESS SLOPE.

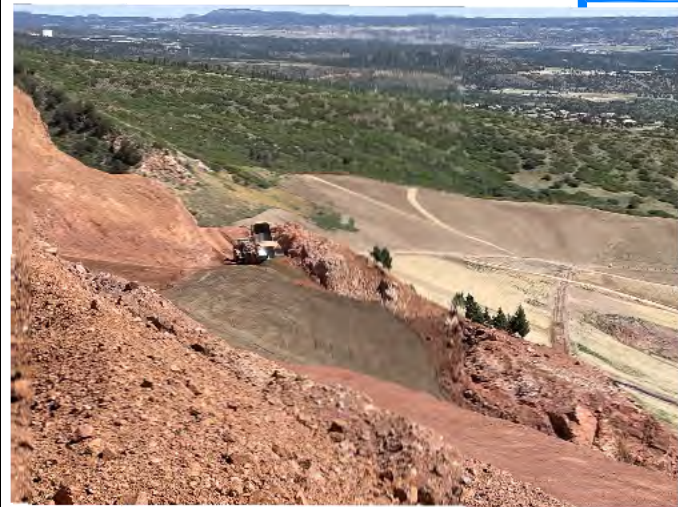
7. FILL PLACED ABOVE BIG ROCK.

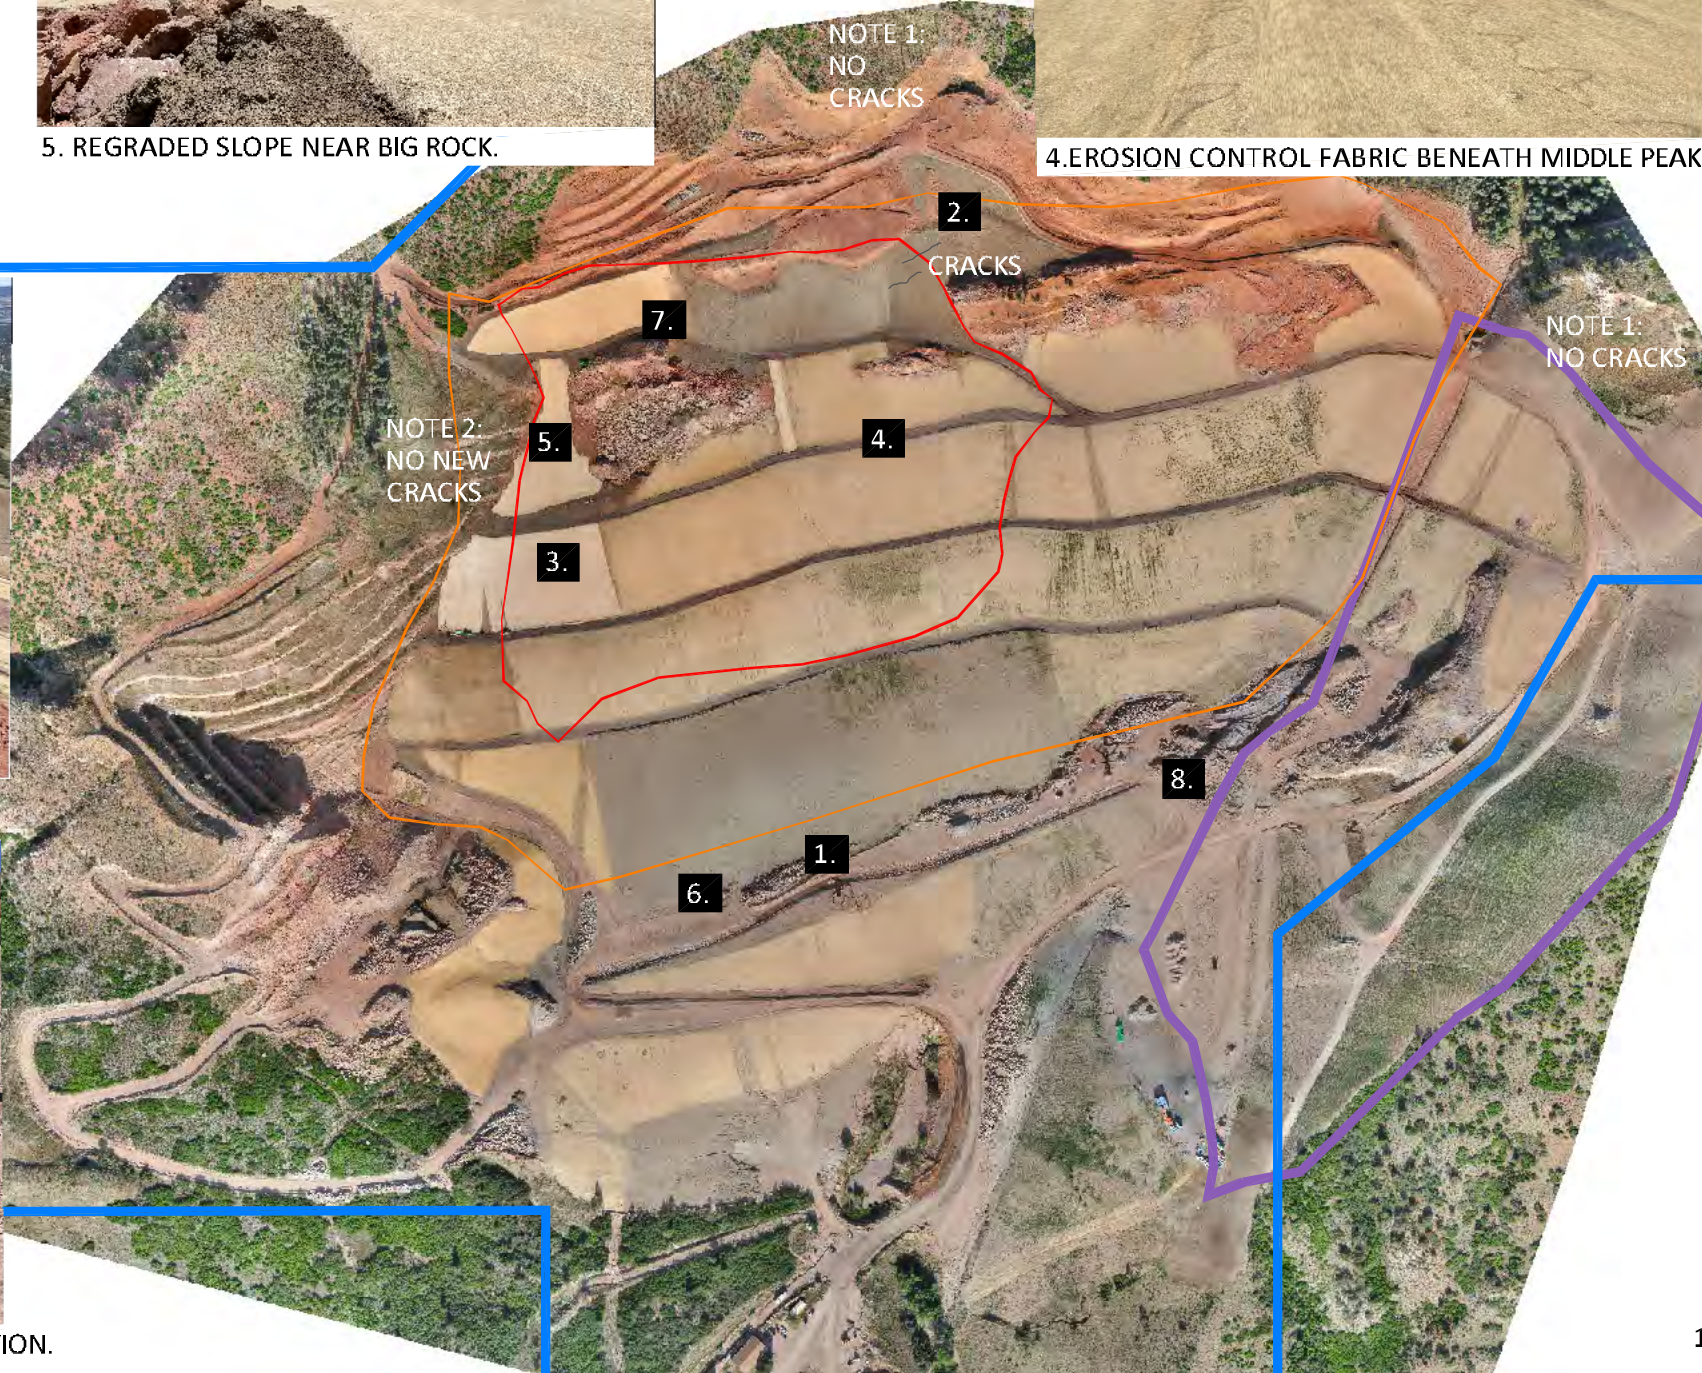
Title
OBSERVATIONS FROM JULY INSPECTIONS

- NOTES**
1. NO CRACKS OBSERVED IN THIS AREA.
 2. NO NEW CRACKS OBSERVED IN THIS AREA.
 3. PHOTOS TAKEN JULY 10 AND 30, 2024.

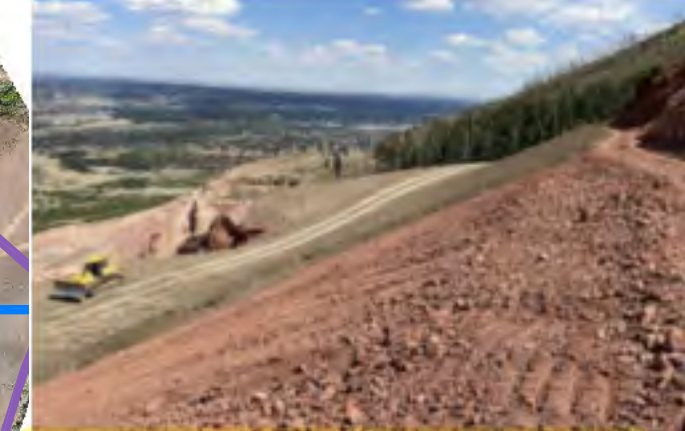
- Cracking was previously observed on the graded slopes near the upper extents of the fill slope. These tension cracks were inspected in July and observed to be similar in nature and extent from previous inspections.

2. AREA WITH PREVIOUS CRACKING. NO NEW CRACKING OBSERVED.

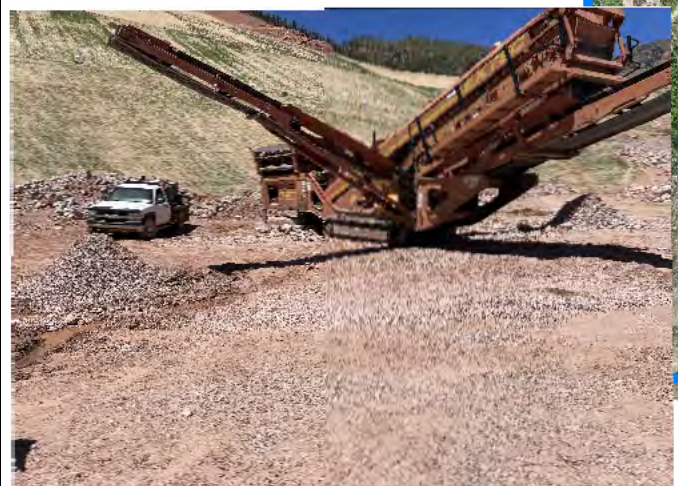
8. RIPRAP BEING SORTED FOR CHANNEL CONSTRUCTION.

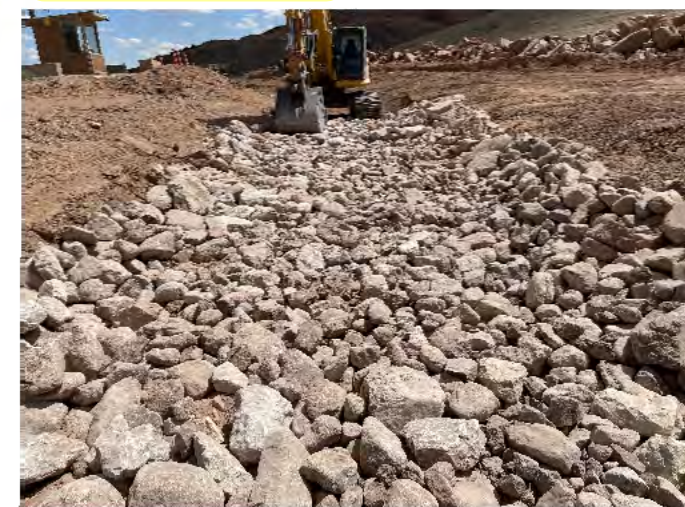
1. RIPRAP PLACED DURING CHANNEL CONSTRUCTION.

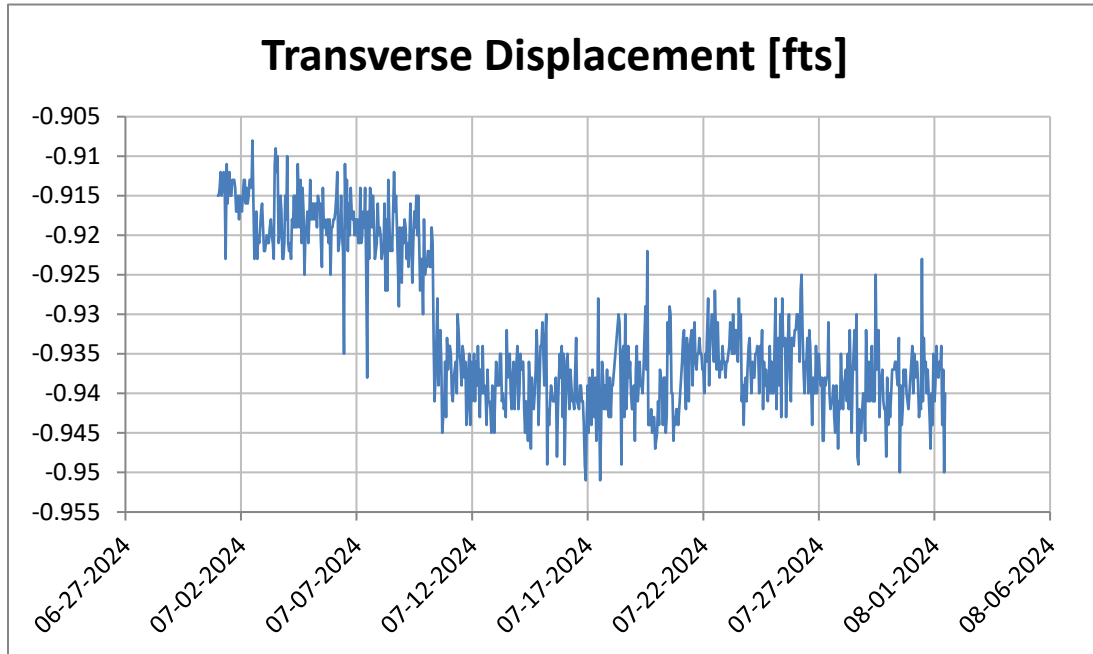
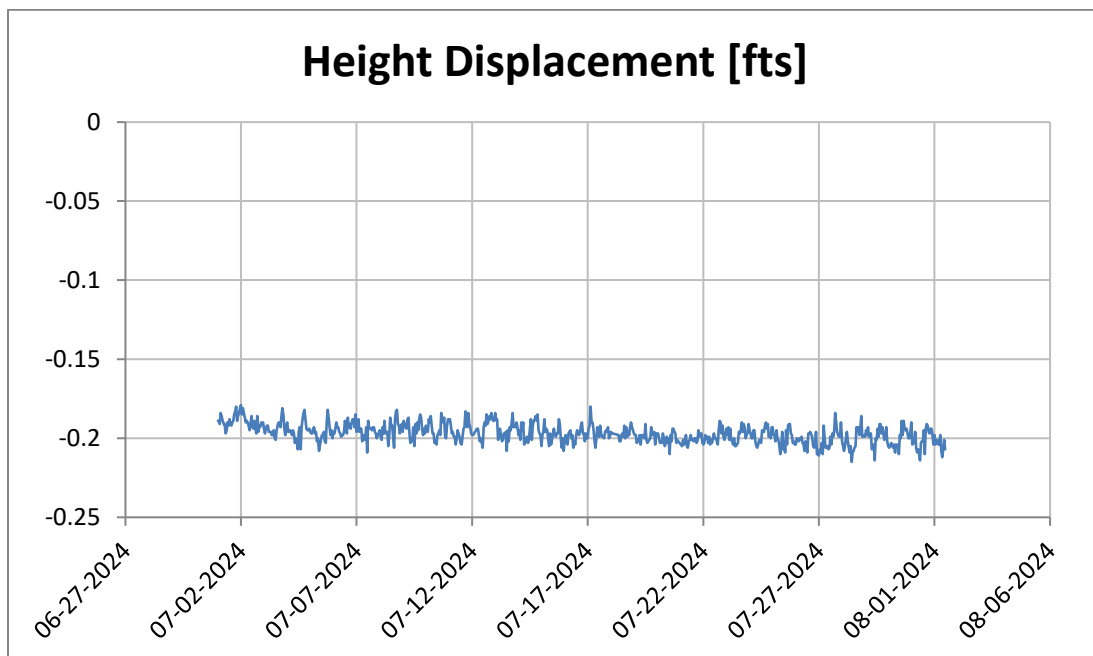
Prism B7300-0

1. Survey accuracy is ± 0.016 feet.
2. Alert threshold is ± 0.35 feet.
3. Transverse displacement is in the horizontal direction. Positive direction means closer to the robotic total station.
4. Height displacement is in the vertical direction. Positive direction means higher in elevation.
5. Equipment operations in prism area on July 10 is likely cause for small movement recorded.

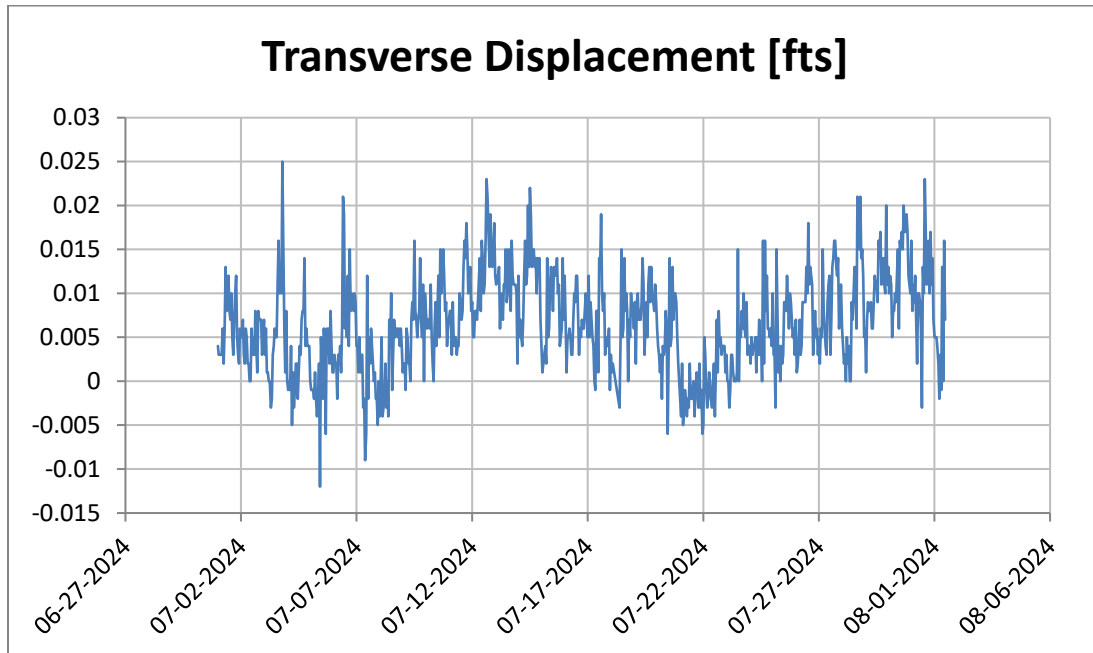
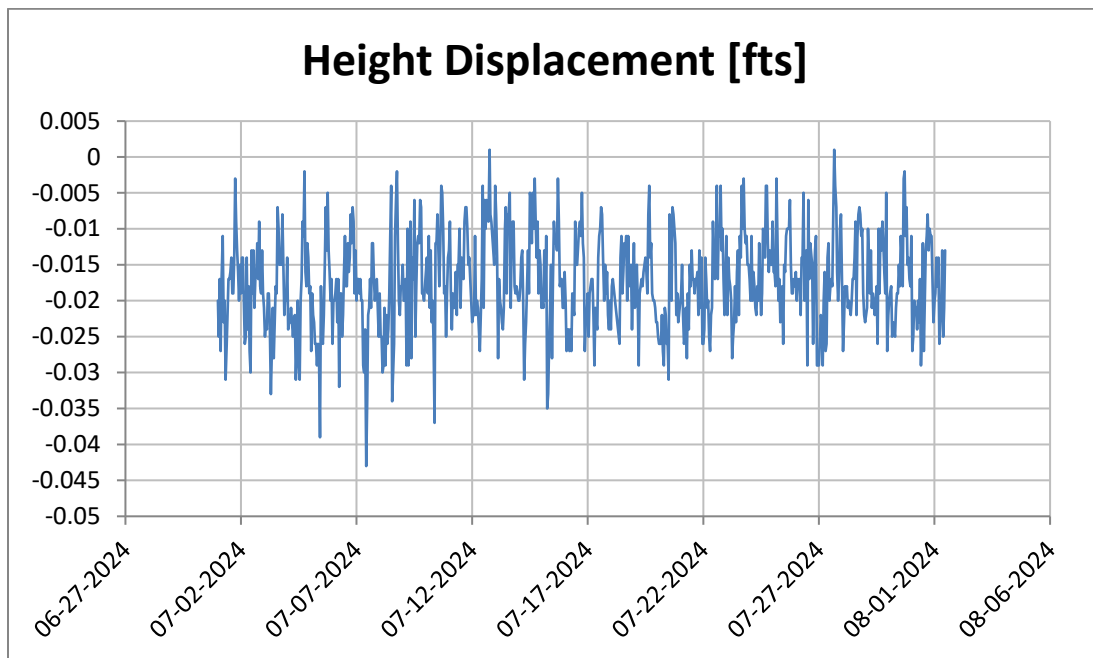
Prism P5

1. Survey accuracy is ± 0.016 feet.
2. Alert threshold is ± 0.35 feet.
3. Transverse displacement is in the horizontal direction. Positive direction means closer to the robotic total station.
4. Height displacement is in the vertical direction. Positive direction means higher in elevation.
5. Regression limit alerts received on July 1.

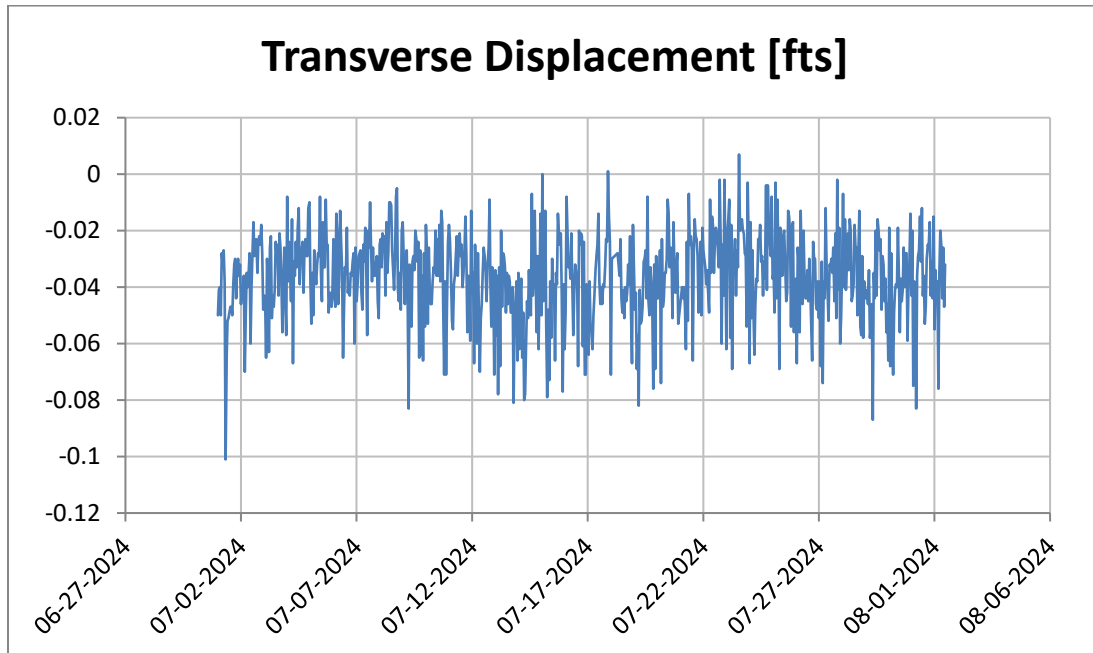
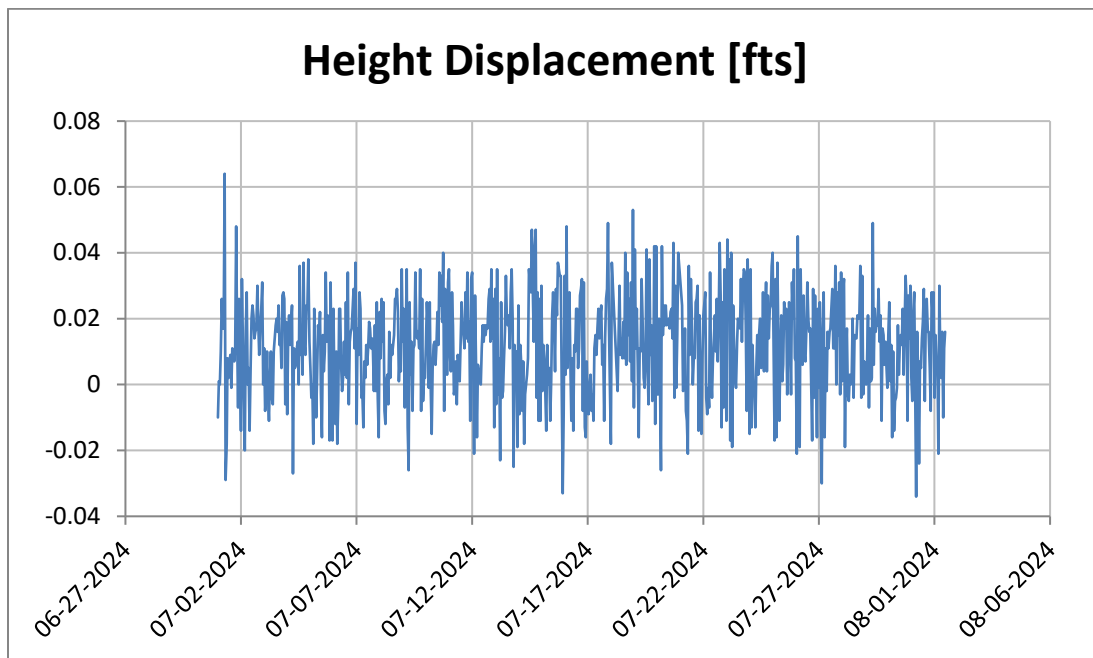
Prism P32R

1. Survey accuracy is ± 0.016 feet.
2. Alert threshold is ± 0.35 feet.
3. Transverse displacement is in the horizontal direction. Positive direction means closer to the robotic total station.
4. Height displacement is in the vertical direction. Positive direction means higher in elevation.
5. Regression limit alert received for P32 on July 15. P32 was replaced by P32R, and no alert was received for P32R.

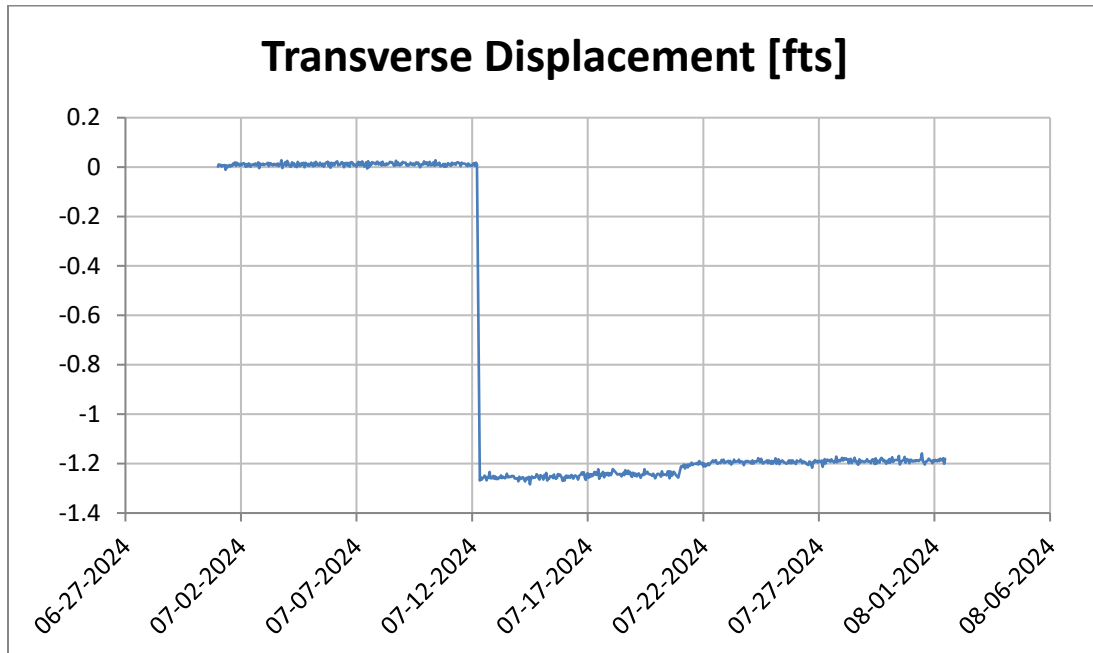
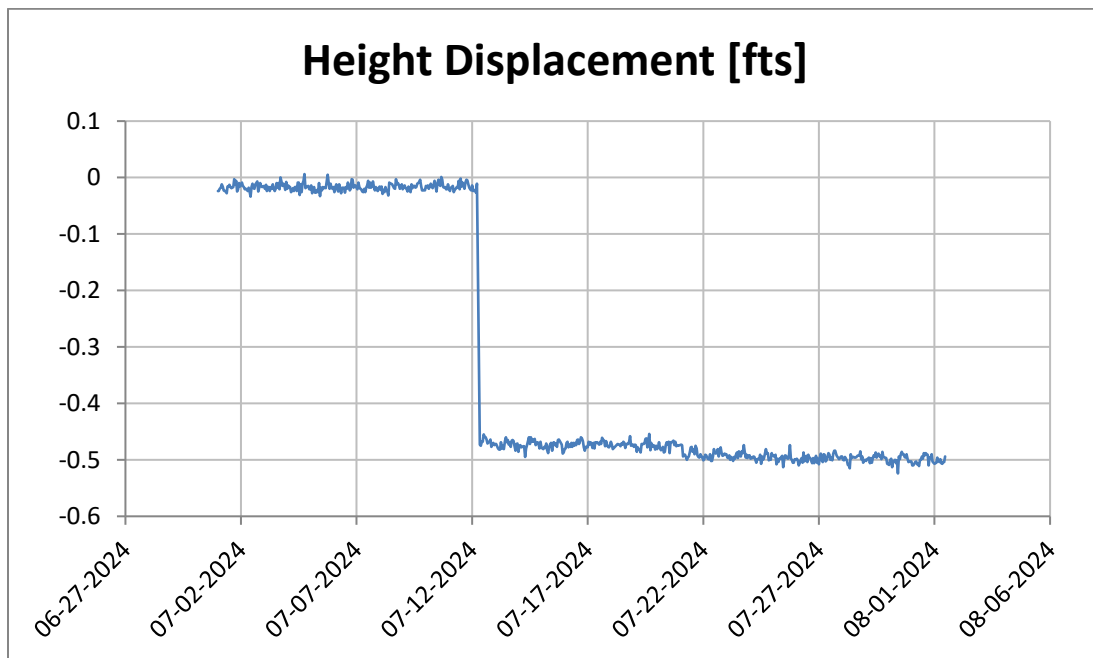
Prism P70R

P25	0.019	0.016	0.007	0.026	
P32r	-0.032	0.016	-0.014	0.037	
P33	0.102	-0.001	0.001	0.125	
P70R	-1.181	-0.494	2.043	2.068	Prism location moved by crew as part of earthworks.

1. Survey accuracy is +/-0.016 feet.
2. Alert threshold is +/-0.35 feet.
3. Transverse displacement is in the horizontal direction. Positive direction means closer to the robotic total station.
4. Height displacement is in the vertical direction. Positive direction means higher in elevation.
5. Prism removed on July 12 prior to earthworks in the area and replaced in a slightly different location. It could not be found by the Leica system so there were no regression limit alerts.
No slope movements identified.
