**MINERALS PROGRAM INSPECTION REPORT**  
**PHONE: (303) 866-3567**

<b>MINE NAME:</b> Climax Mine	<b>MINE/PROSPECTING ID#:</b> M-1977-493	<b>MINERAL:</b> Molybdenum	<b>COUNTY:</b> Lake, Summit
<b>INSPECTION TYPE:</b> Monitoring	<b>WEATHER:</b> Clear	<b>INSP. DATE:</b> August 20, 2024	<b>INSP. TIME:</b> 13:00
<b>OPERATOR:</b> Climax Molybdenum Company, Climax Mine	<b>OPERATOR REPRESENTATIVE:</b> Eric Detmer	<b>TYPE OF OPERATION:</b> 112d-3 - Designated Mining Operation	
<b>REASON FOR INSPECTION:</b> Normal I&E Program	<b>BOND CALCULATION TYPE:</b> None	<b>BOND AMOUNT:</b> \$91,011,850.00	
<b>DATE OF COMPLAINT:</b> NA	<b>POST INSP. CONTACTS:</b> None	<b>JOINT INSP. AGENCY:</b> None	
<b>INSPECTOR(S):</b> Dustin Czapla	<b>INSPECTOR'S SIGNATURE:</b>

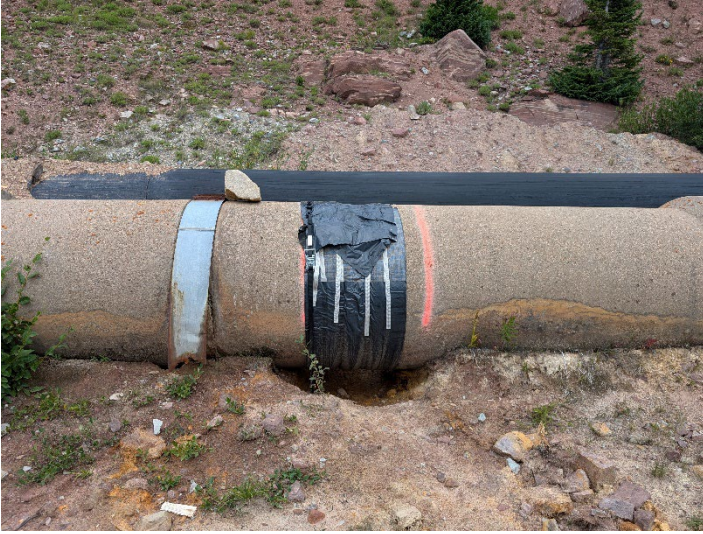
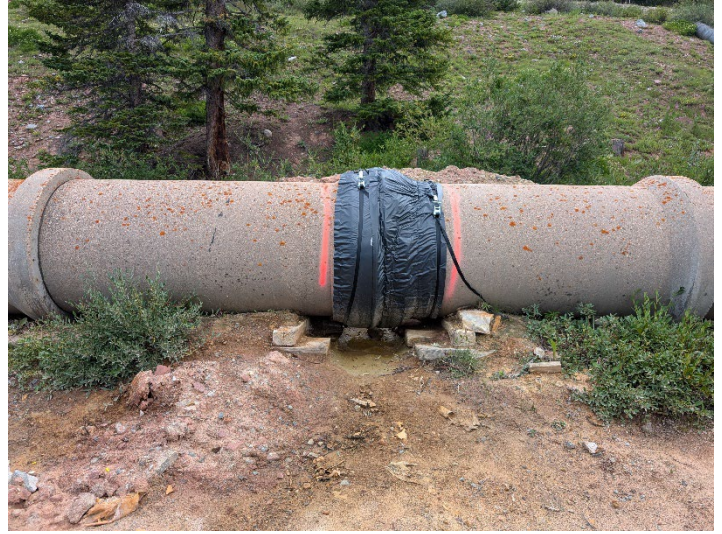
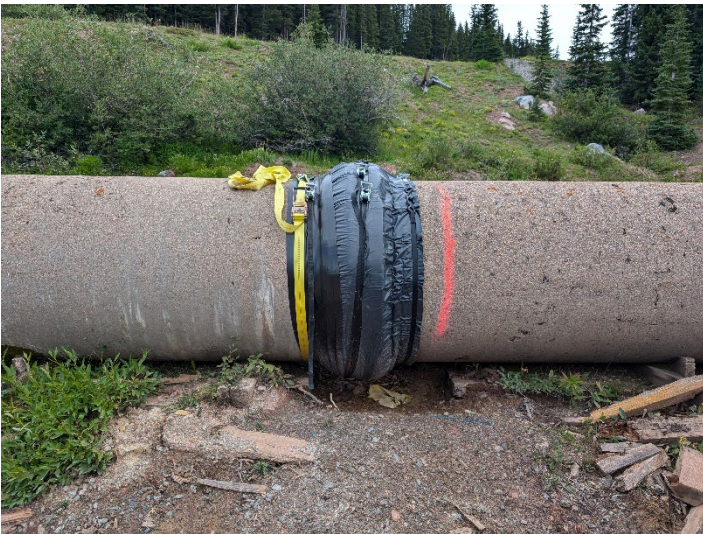
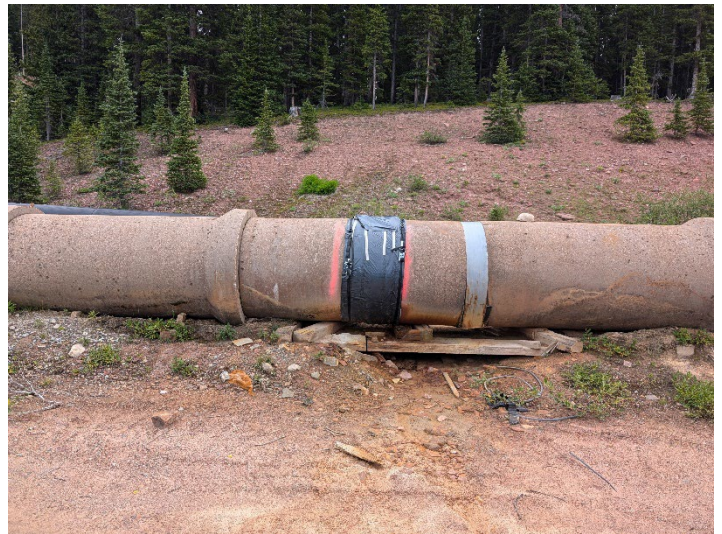
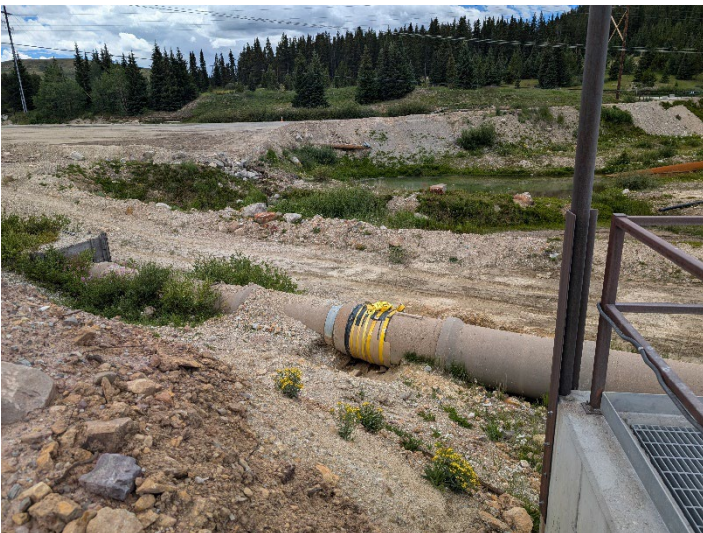
### **East Tailings Delivery Line (ETDL)**

On Wednesday, July 24, 2024, Climax personnel discovered five leaks on the ETDL on the west side of Hwy 91. According to Climax, the maximum single flow of these five locations was approximately 10 gpm. Leaks from the ETDL flowed into the East Side Channel that runs parallel to the ETDL. The East Side Channel serves as secondary containment for the ETDL and conveys drainage to the process water/water treatment system. There was no release of water outside of the process water containment system. Climax reported that upon recognizing the pipeline condition, personnel turned off the pumps located at 5-Shaft as well as the pit dewatering system, which contribute to ETDL flow. The pumps remained off until repairs were completed. Climax utilized a systematic and gradual flow increase to ensure no further leaks.

The leak locations were observed during this inspection. The patches that were installed at each location appeared effective. Climax is currently evaluating alternative long-term solutions to repair or possibly replace the ETDL.

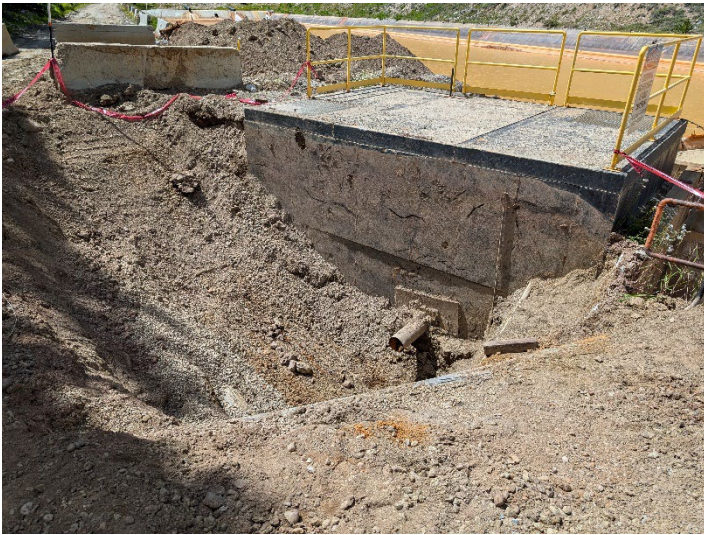
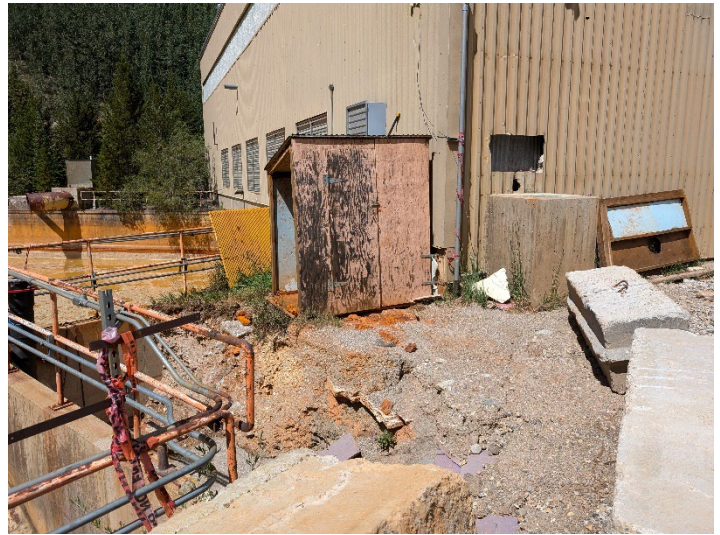
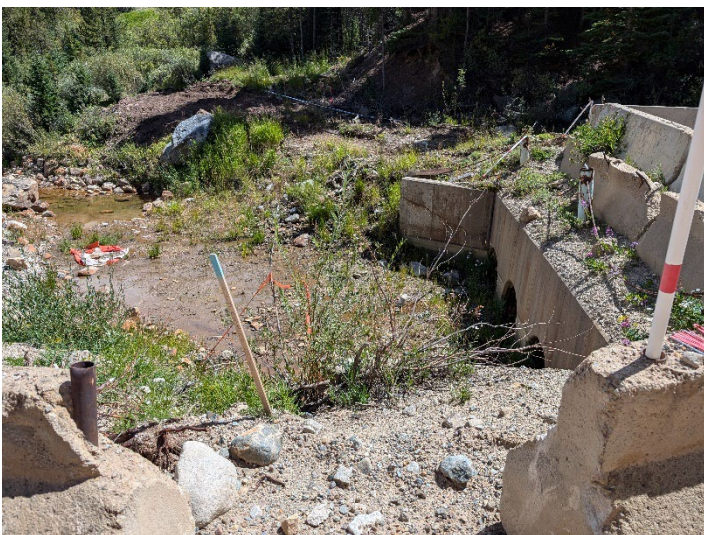
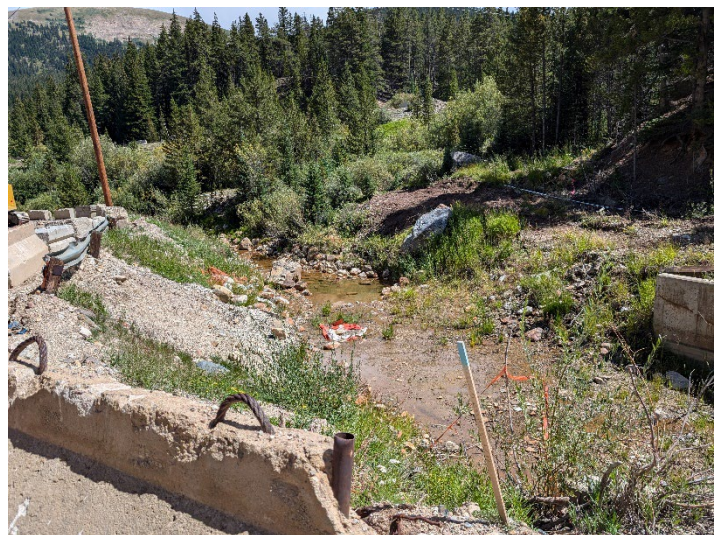
Mayflower Pump Station and 5 Dam Seepwater Collection Area (TR36)

On July 18, 2024, a leak event occurred at the Mayflower Pump Station. Climax reported that after a routine pipe jetting job was completed and the Mayflower Pump Station was being brought back online, operator error when restarting the pumps resulted in failure of a blind flange at the end of a pipeline junction. Approximately 1,875 gallons of process water was released into a Climax drainage that ultimately drains into Tenmile Creek at Outfall 001A. Climax collected samples at the outfall following the event. Samples were analyzed for Climax's CDPS analytical suite. No exceedances of the permit limit were reported.

Climax is currently constructing a pump back system in this area that will be able to prevent events like this from occurring in the future. Plans for this pump back system were approved by the Division through TR36. Construction of the system was nearly complete at the time of this inspection. A contractor was onsite completing the electrical work.
