Climax Mine
Highway 91 - Fremont Pass
Climax, CO 80429
Phone (719) 486-7718
Fax (719) 486-2251

Re: Climax ETDL EPF Leak – Climax Mine Permit No. M-1977-493

## Description of Incident

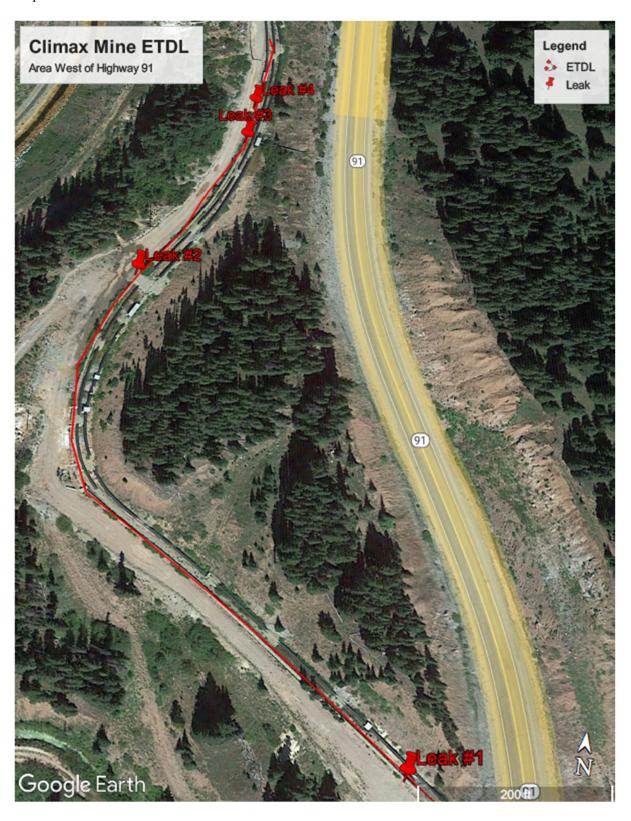
Map 1

At approximately 1:10 pm on July 24, 2024, a leak was discovered along the ETDL. After the discovery, Climax employees inspected the remainder of the concrete portion of the line and discovered a total of five locations with leaks. The maximum single flow of these five locations was approximately 10 gallons per minute. Leaks from the ETDL flowed into the East Side Channel that runs parallel to the ETDL. The East Side Channel also is an EPF described in the Climax EPP (Section T-5.3.2) as follows: "This channel collects seepage and run-off from the Camp/Mill area and serves as a secondary containment for potential releases from the TDL and ETDL pipelines." Like the ETDL, the East Side Channel conveys mine drainage to the Climax process water/water treatment system. Given the redundancy provided by the ETDL/East Side Channel, there was no release of water outside of the process water containment system. Leak locations are depicted on attached Maps 1 and 2.

Upon recognizing the pipeline condition, Climax turned off the pumps located at 5-Shaft as well as the pit dewatering system, which contribute to ETDL flow. The pumps remained off until repairs were completed. Climax utilized a systematic and gradual flow increase to ensure no further leaks.
