Inspections Partial 2024 August Yoast and Seneca IIW

Permit Number: C-1994-082 **Mine Name:** Yoast Mine

INSPECTION INFORMATION

| Inspection Start Date: 20 Aug. 2024 Inspection Start Time: 12:00 a.m. Inspection End Date: 20 August 2024 Inspection End Time: 1:00 p.m. | | Inspection Type: Coal Partial Inspection Inspection Reason: Normal I&E Program Weather: Partly Cloudy | |

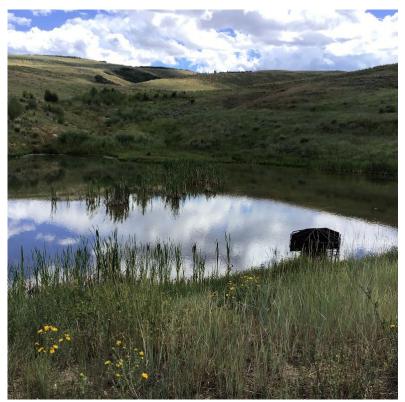
Photo 1: Pond 12.

\circ Pond 12 was discharging clear water at the time of inspection.

- Flume is difficult to reach due to verdant summer vegetation.
- Pond 13 appeared slightly turbid with some algal growth. The pond was not discharging at the time of inspection.
- Springs above Ponds 12 and 13 were dry at the time of inspection.
- Pond 14 held water at the time of inspection and was not discharging.

- 1. Decant structures at ponds 10 and 14 require repairs.
- 2. Cattails at Pond 12 flume entrance and along upstream portion of flow path should be removed.

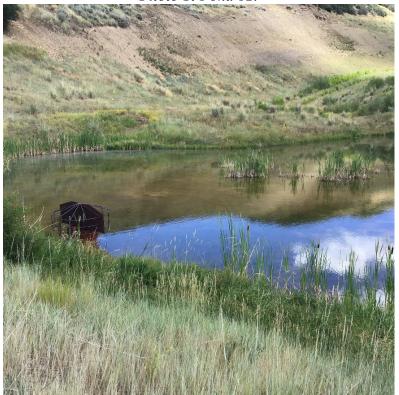
Photo 2: Pond 12 looking toward the highwall.

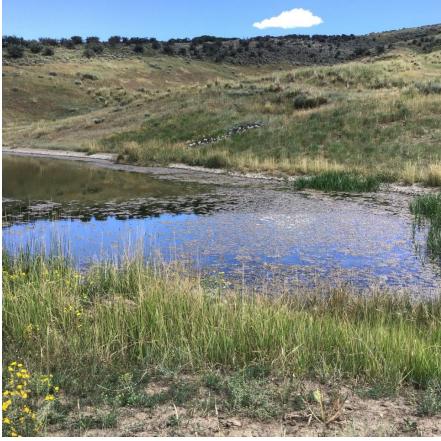
Photo 3: Pond 13 exhibiting algal growth.
