## Inspections Partial 2024 August Yoast and Seneca IIW

<b>Permit Number:</b> C-1982-057 <b>Mine Name:</b> Seneca IIW Mine <b>Operator:</b> Seneca Property LLC <b>Operator Address:</b> Ms. Miranda Kawcak 29515 Routt County Road 27 Oak Creek, CO 80467	<b>County:</b> Routt <b>Operation Type:</b> Surface <b>Permit Status:</b> Permanent Cessation <b>Ownership:</b> Private
	<b>Operator Representative Present:</b>  Miranda Kawcak
<b>Operator Representative Signature: (Field Issuance Only)</b> This report was issued electronically from the Divisions' Denver Office.

<b>Inspection Start Date:</b> 20 August 2024 <b>Inspection Start Time:</b> 2:15. p.m. <b>Inspection End Date:</b> 20 August 2024 <b>Inspection End Time:</b> 3:30 p.m.		<b>Inspection Type:</b> Coal Partial Inspection <b>Inspection Reason:</b> Normal I&E Program <b>Weather:</b> Scattered Clouds	
<b>Joint Inspection Agency:</b>  None		<b>Joint Inspection Contacts:</b>	
<b>Post Inspection Agency:</b>  None		<b>Post Inspection Contacts:</b>	
<b>Inspector(s):</b>  Robin Reilley, M.S. GISP	<b>Inspector's Signature:</b>

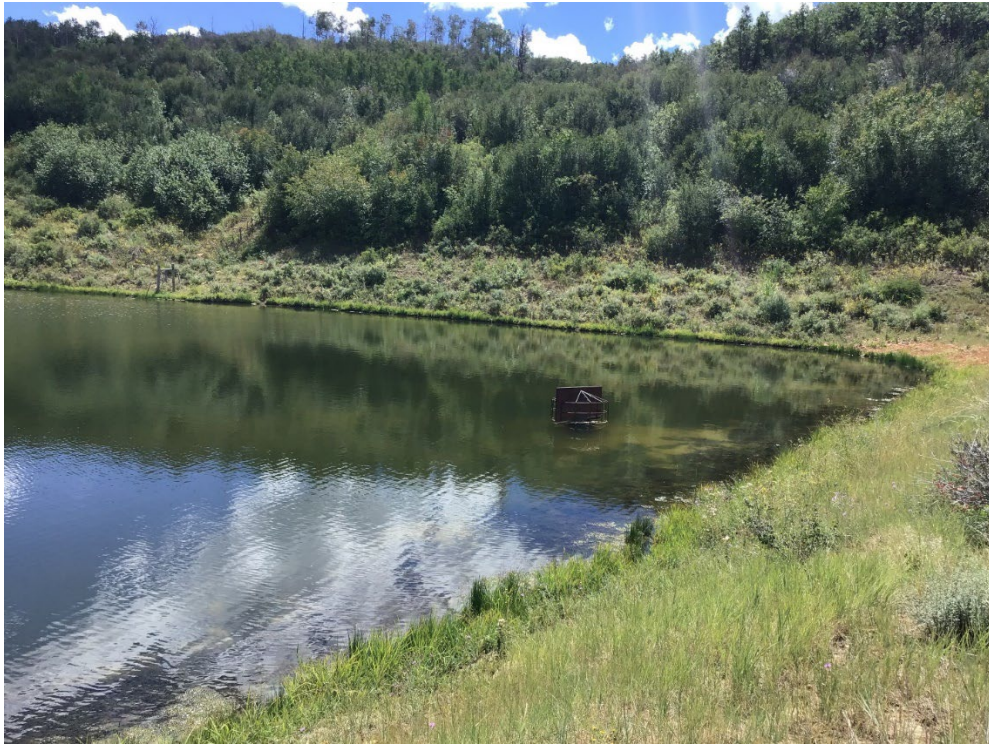
16 and 17. All ponds held water. Ponds 6 and 16 were discharging clear water. Pond 17 appeared turbid. Ducks were present on ponds 6 and 16.

*Photo 1: Pond 6.*

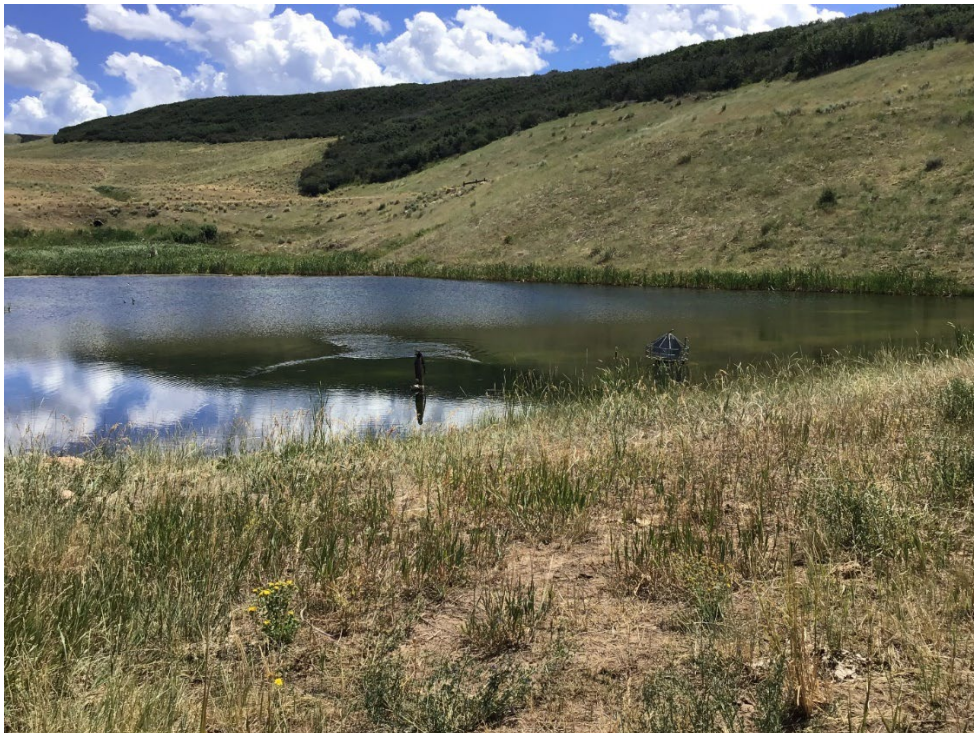
*Photo 2: Pond 16.*

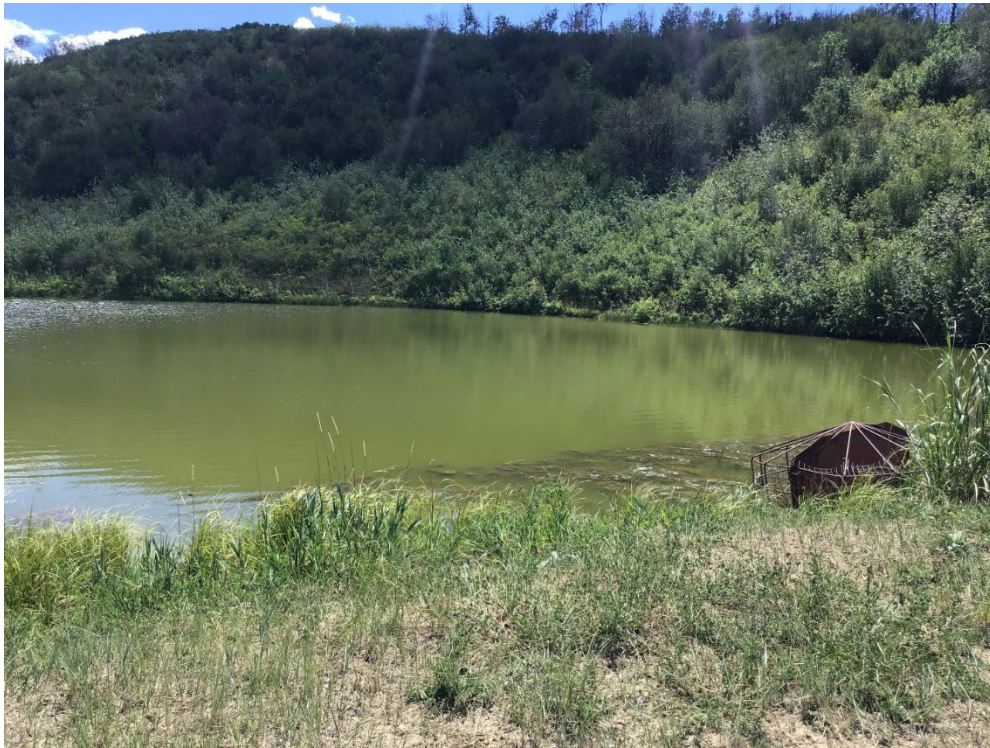
*Photo 3: Pond 17 exhibiting its usual turbid water.*

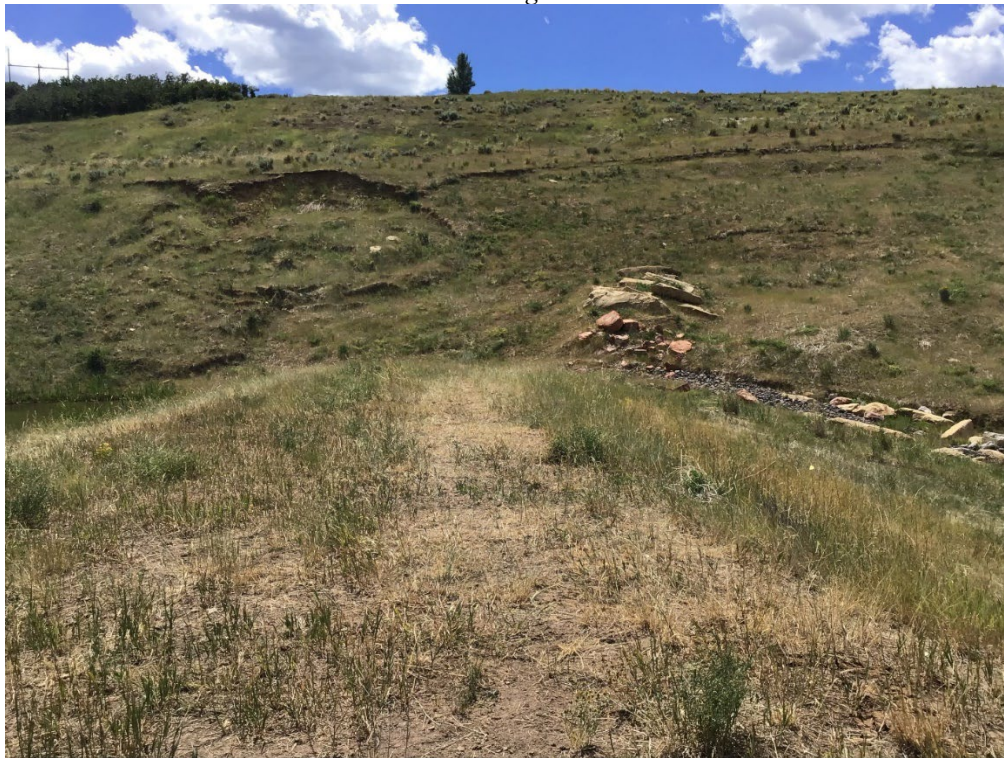
The two slumps and associated crack between them at Pond 6 were noted. No new movement was noted at the time of inspection. The slumps appeared stable with vegetation establishing.

*Photo 4: Pond 6 slump and 2023 crack going across the slope.*

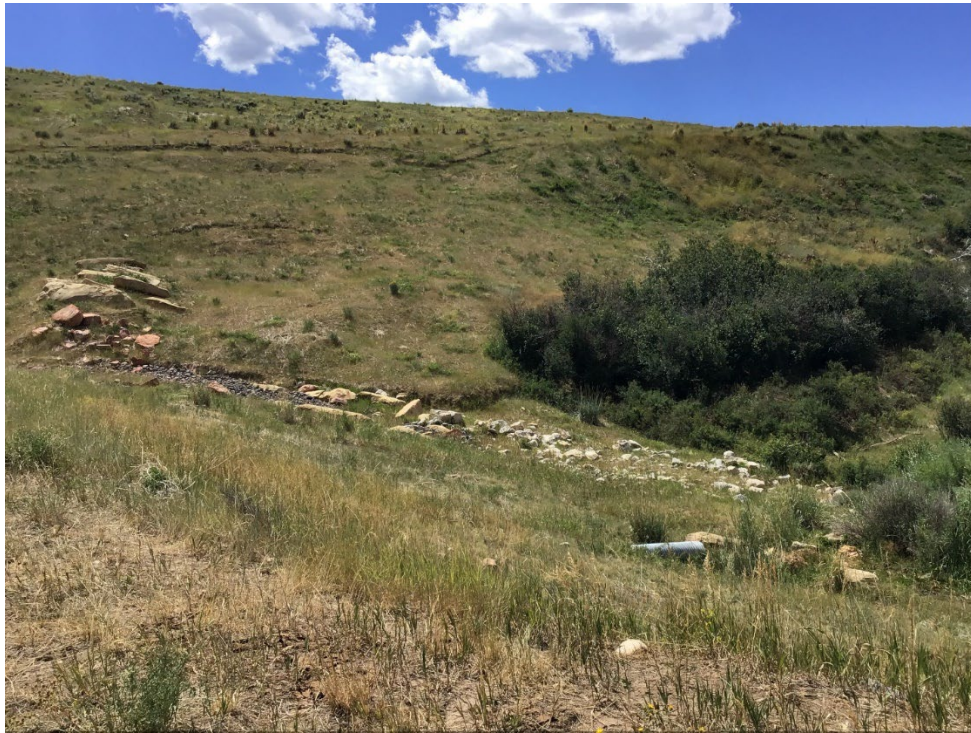
*Photo 5: Pond 6 slump of spring 2023 with crack going across the slope.*
