## Inspection Complete Trapper 2024 August

**22 August 2024**

Permit Number: C1981010 Mine Name: Trapper Mine Operator: Trapper Mining, Inc. Operator Address:  Mr. Graham Roberts P.O. Box 187 Craig, CO 81626	County: Moffat Operation Type: Surface Permit Status: Active Ownership: Federal
	Operator Representative Present:
This report was issued electronically from the Divisions' Denver Office.

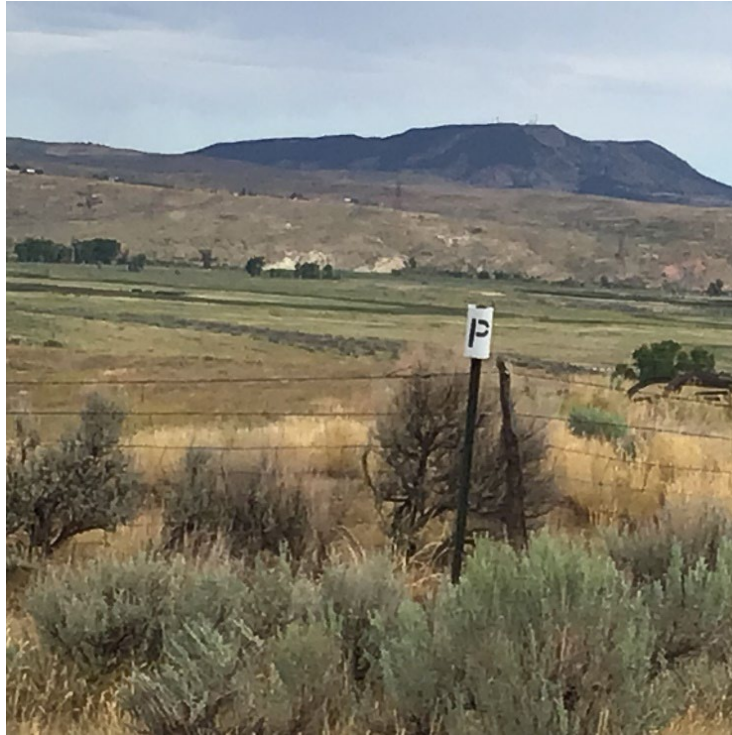
**Photo 3:** Permit boundary signs at the PR11 expansion area.

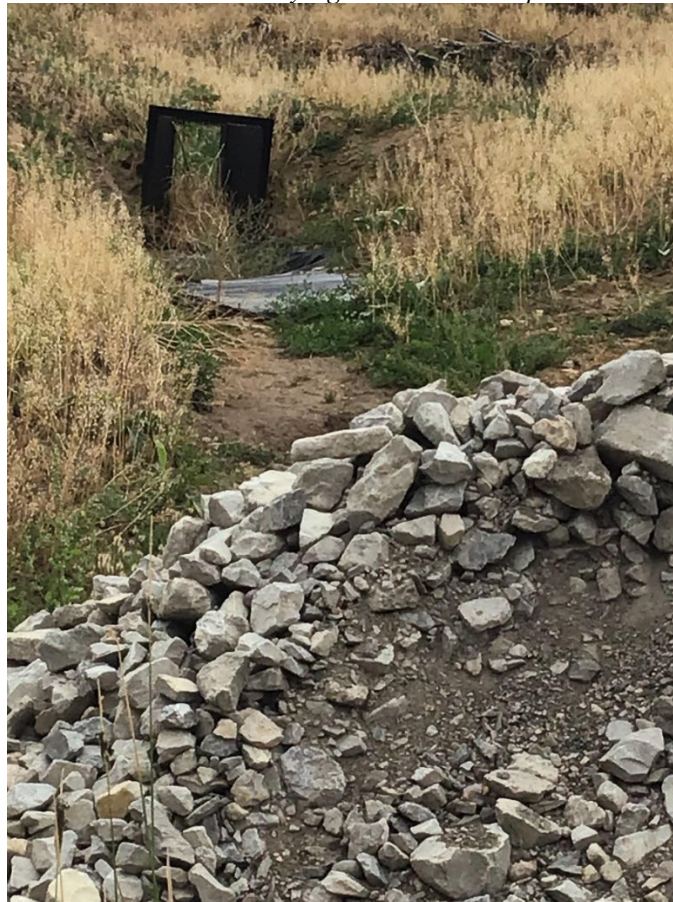
- East Buzzard #3 holding turbid water at the time of inspection. The pond was not discharging. Rock is staged for lining the spillway.
- West Buzzard #4 holding a small amount of water. Rock is staged for lining spillway.

**Photo 4:** East Buzzard Pond #3 rock piled for spillway repairs.

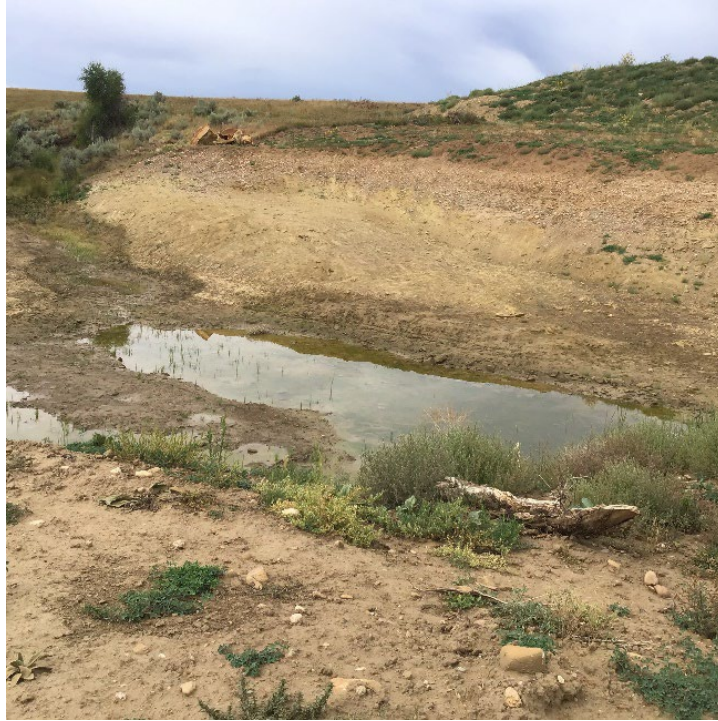
***Photo 5:*** East Buzzard Pond #3 holding a small amount of water.

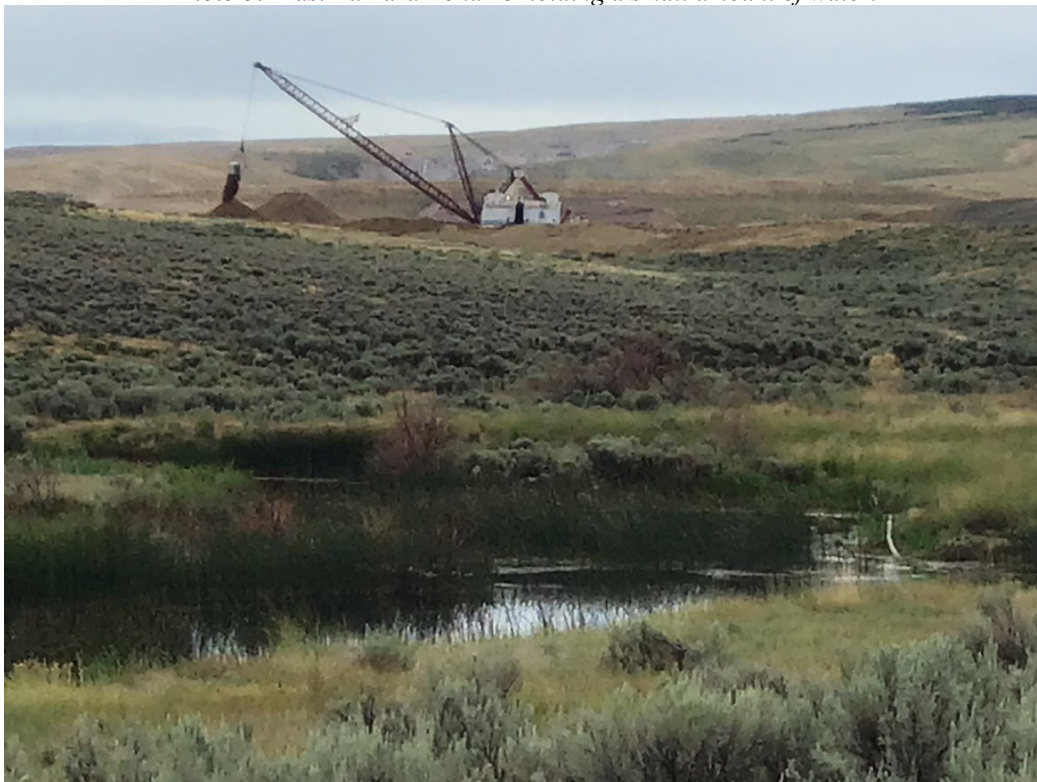
***Photo 6:*** Coyote Pond holding water and the dragline working in J Pit.

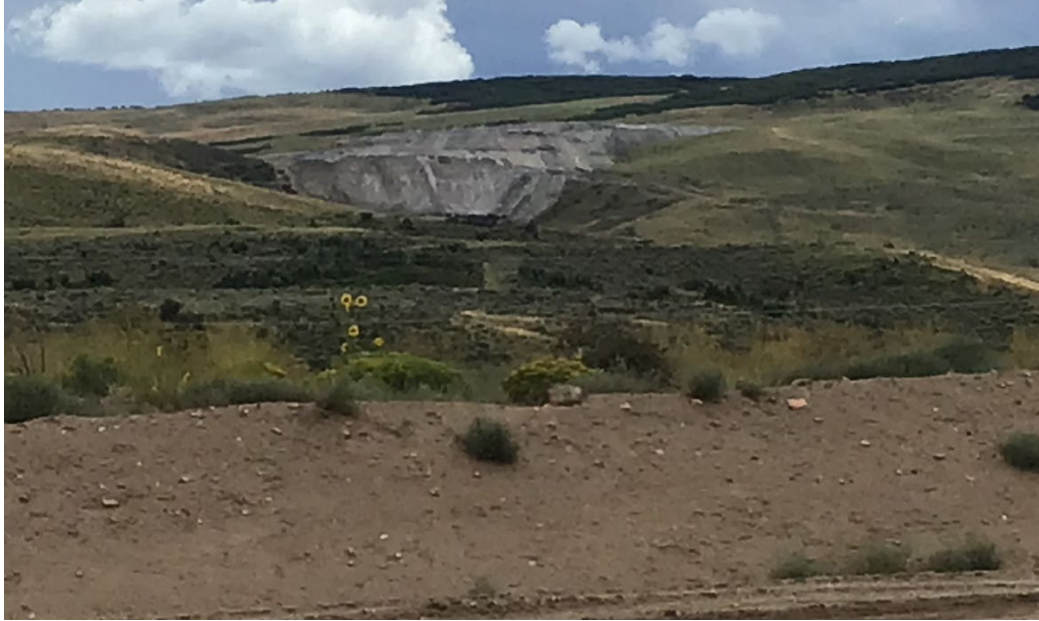
- The flat surfaces of the Ash Pit were dry and firm, with no standing water or ruts and appeared to be functioning adequately at the time of inspection.
- Ash was being hauled and dumped at the time of inspection.

*Photo 7: Ash Pit looking toward the east.*

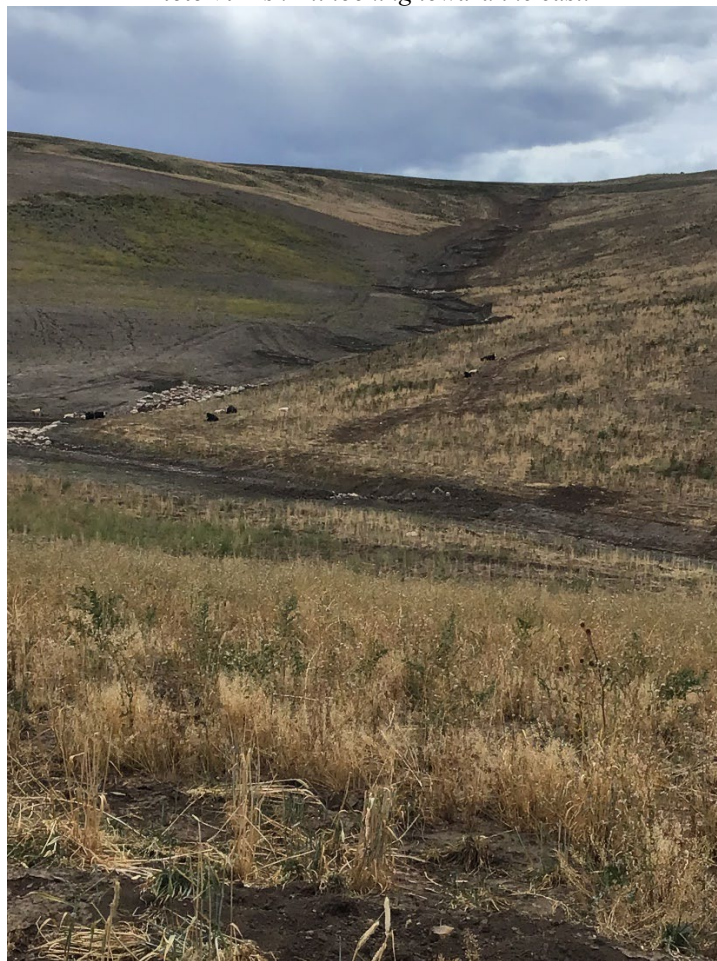
**D Pit:** The temporary seed mixture comprised of triticale showed good germination and cover. Erosional features existing at the apex of the D Pit constructed drainage as well as areas between check dams and along slopes had been repaired.

*Photo 8: D Pit looking south up the constructed drainage.*

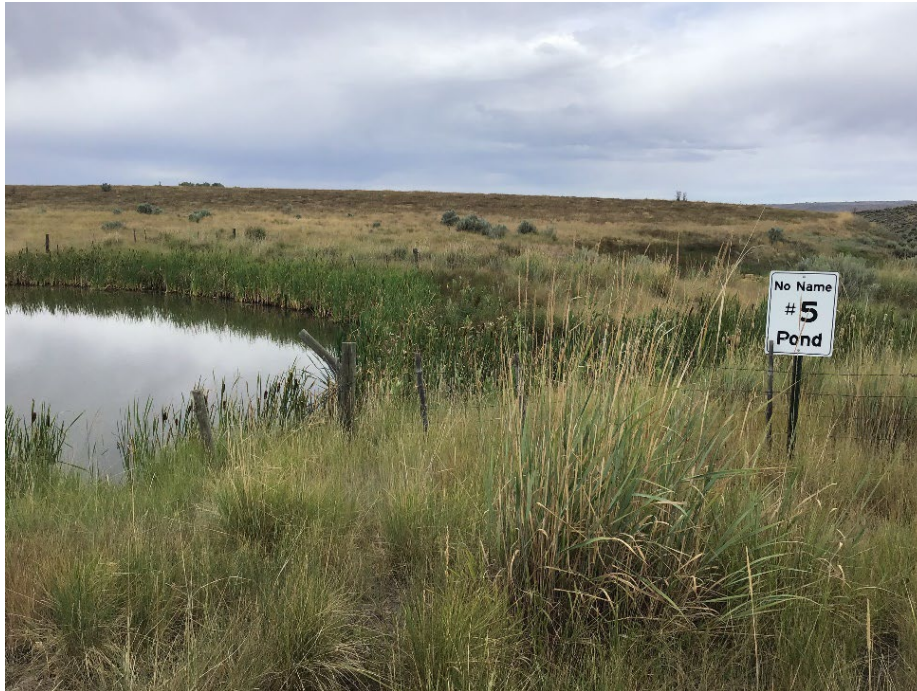
**Photo 9:** No Name Pond holding water and discharging clear water.

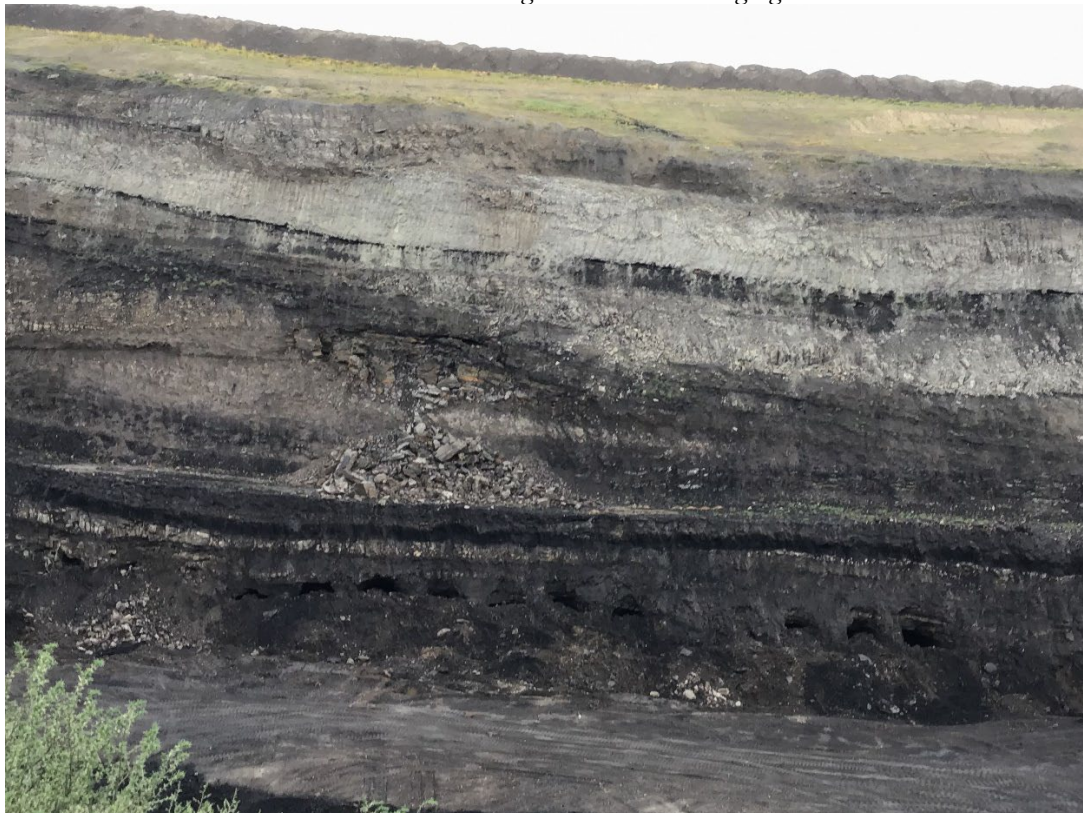
**N Pit:** Coal extraction is idle as there was a high wall slump about 20 feet wide. The rocks fell onto the bench. However, the highwall minor is stuck and cannot be extracted at this point. Cracks are exhibited in a horseshoe pattern on the slope above the highwall and some horizontal cracking (east west) in the haul road above was observed. N Pit is ready to back fill at west end for access to the next level coal. All the adits in the N Pit are backfilled.

- A crack has existed at top of D Pit. Despite 2023 efforts to mitigate the cracking, the crack remerged in 2024.
- A crack is evident where A Pit ends.
- A highwall slump occurred in N Pit and cracking, possibly associated with the failure was observed in the slopes to the south above the slump and in the road above the highwall to the south.
- The operator will routinely monitor the areas for any changes, specifically additional movement, cracking or slumping.

**Photo 10:** N Pit south highwall rock fall of approximately 20 feet wide.

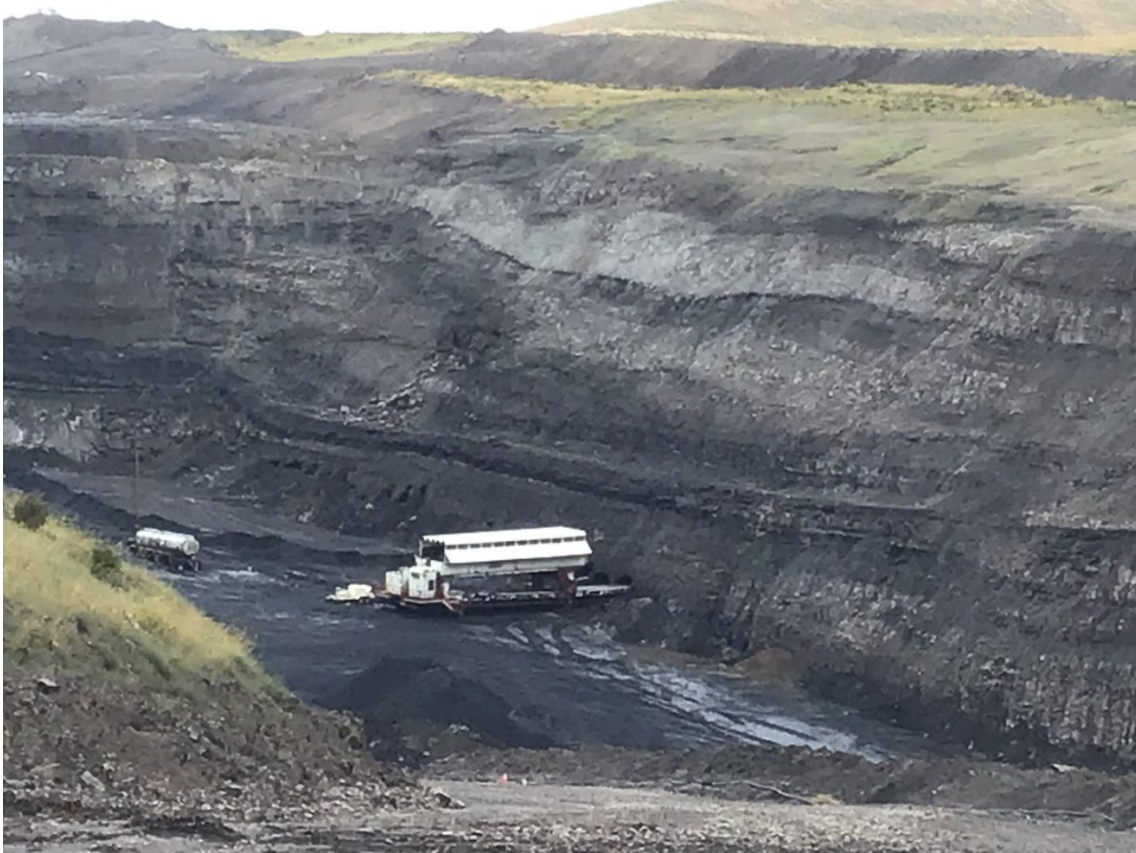
***Photo 11: N Pit overview of south wall and highwall miner.***

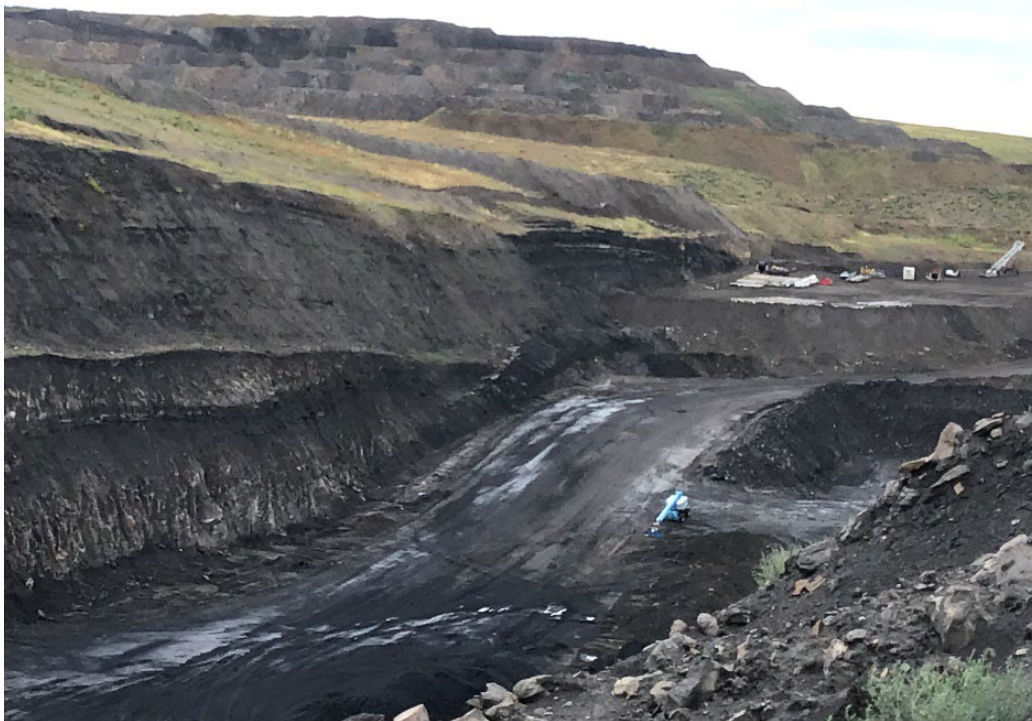
***Photo 12: N Pit activities at the west end, looking west.***

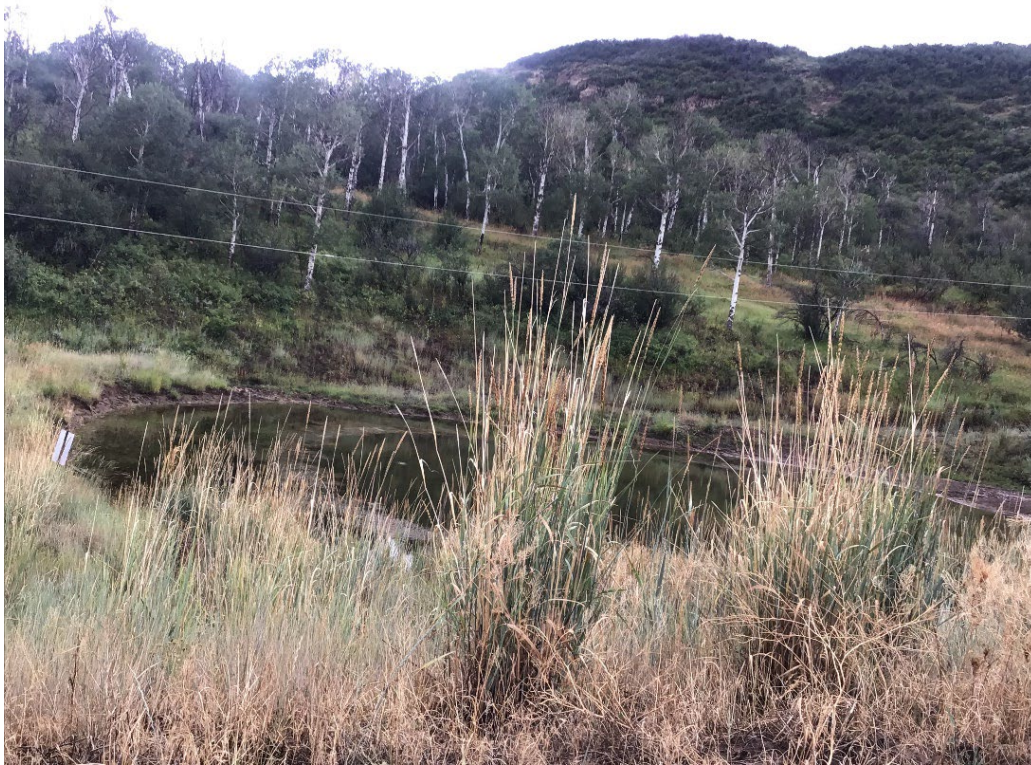
- Deal Pond #1 holding water and not discharging at the time of inspection. Sumps have been installed in the drainage above the pond as snowmelt in recent years has been significant.

***Photo 13:** DealPond #1 looking up the drainage.*

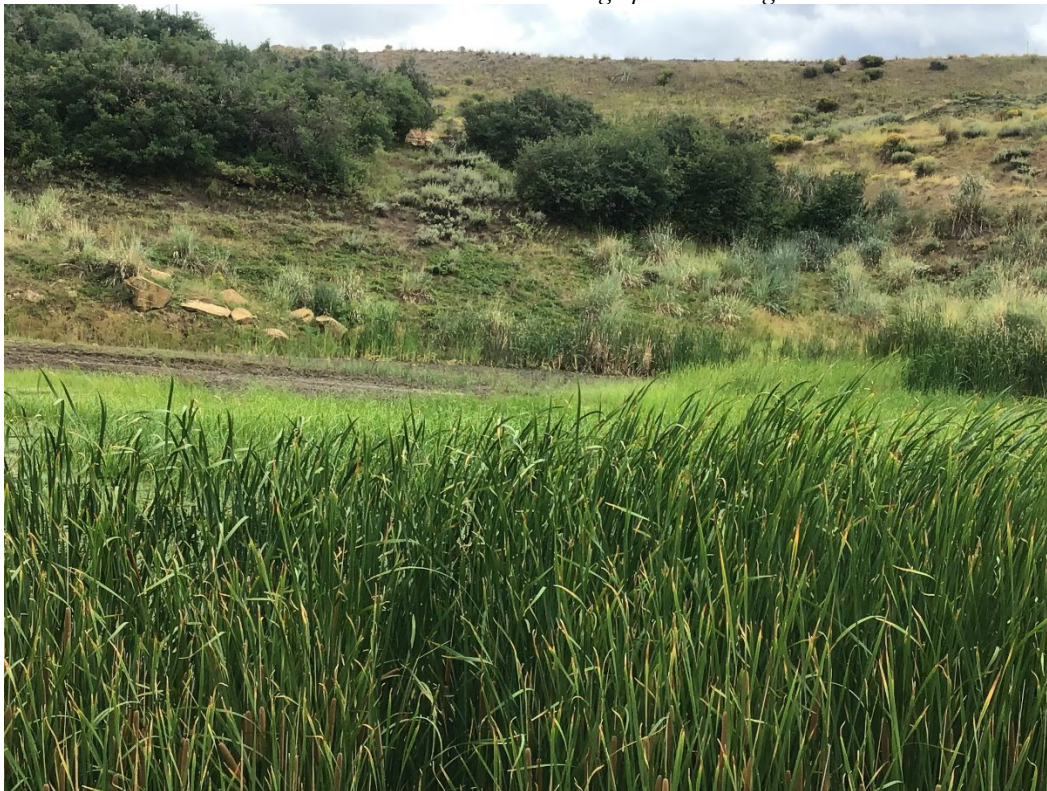
- Middle Flume #1 held water and exhibited some algal growth.

***Photo 14:** Middle Flume #1 Pond exhibiting a verdant growth of vegetation.*

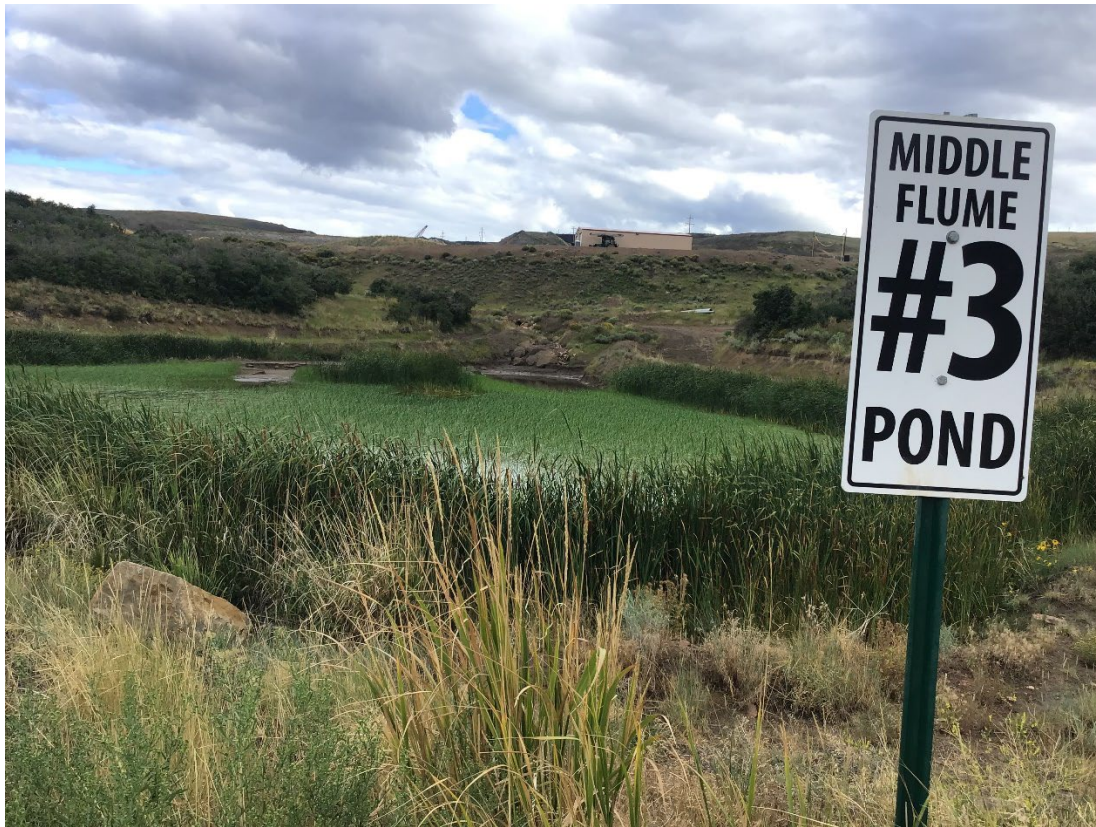
- Middle Flume#3, a portion of the delta has been removed. There is grass growing throughout the pond and a formidable stand of cattails around the perimeter. The pond was not discharging at the time of inspection.

*Photo 15: Middle Flume #3 Pond exhibiting a verdant growth of vegetation.*

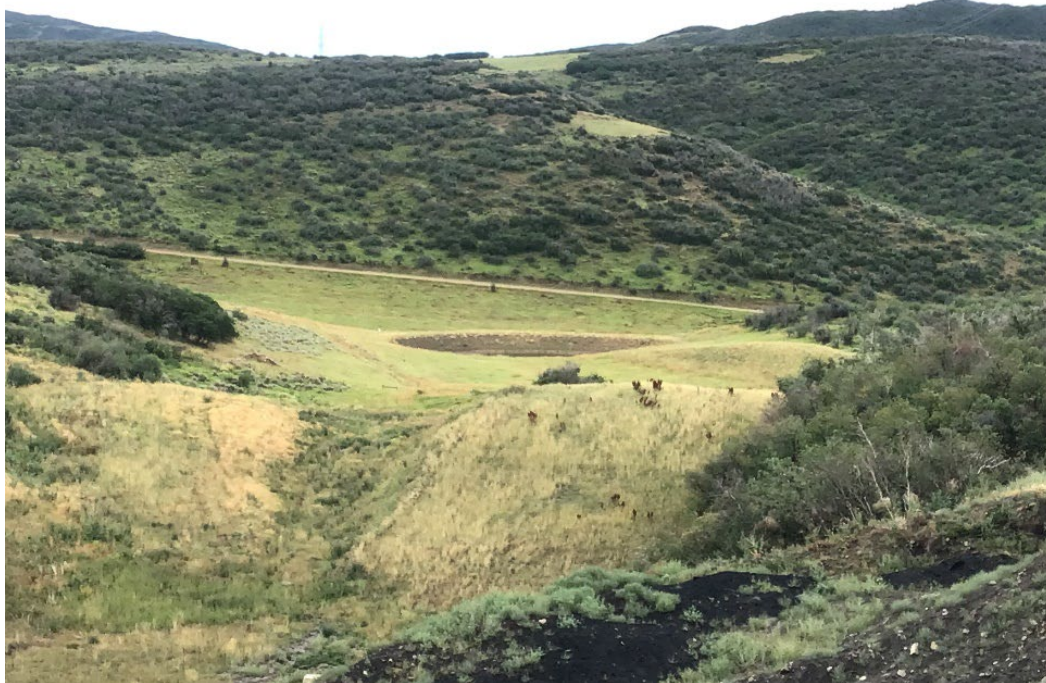
*Photo 16: Jeffway from above looking sout east.*
