**MINERALS PROGRAM INSPECTION REPORT**  
**PHONE: (303) 866-3567**

<b>MINE NAME:</b> Prather Pit	<b>MINE/PROSPECTING ID#:</b> M-1977-136	<b>MINERAL:</b> Sand and gravel	<b>COUNTY:</b> Rio Blanco
<b>INSPECTION TYPE:</b> Monitoring	<b>WEATHER:</b> Clear	<b>INSP. DATE:</b> August 7, 2024	<b>INSP. TIME:</b> 09:50
<b>OPERATOR:</b> Rio Blanco County	<b>OPERATOR REPRESENTATIVE:</b> Clint Chappell	<b>TYPE OF OPERATION:</b> 112c - Construction Regular Operation	
<b>REASON FOR INSPECTION:</b> Normal I&E Program	<b>BOND CALCULATION TYPE:</b> None	<b>BOND AMOUNT:</b> \$0.00	
<b>DATE OF COMPLAINT:</b> NA	<b>POST INSP. CONTACTS:</b> None	<b>JOINT INSP. AGENCY:</b> None	
<b>INSPECTOR(S):</b> Amy Yeldell	<b>INSPECTOR'S SIGNATURE:</b>

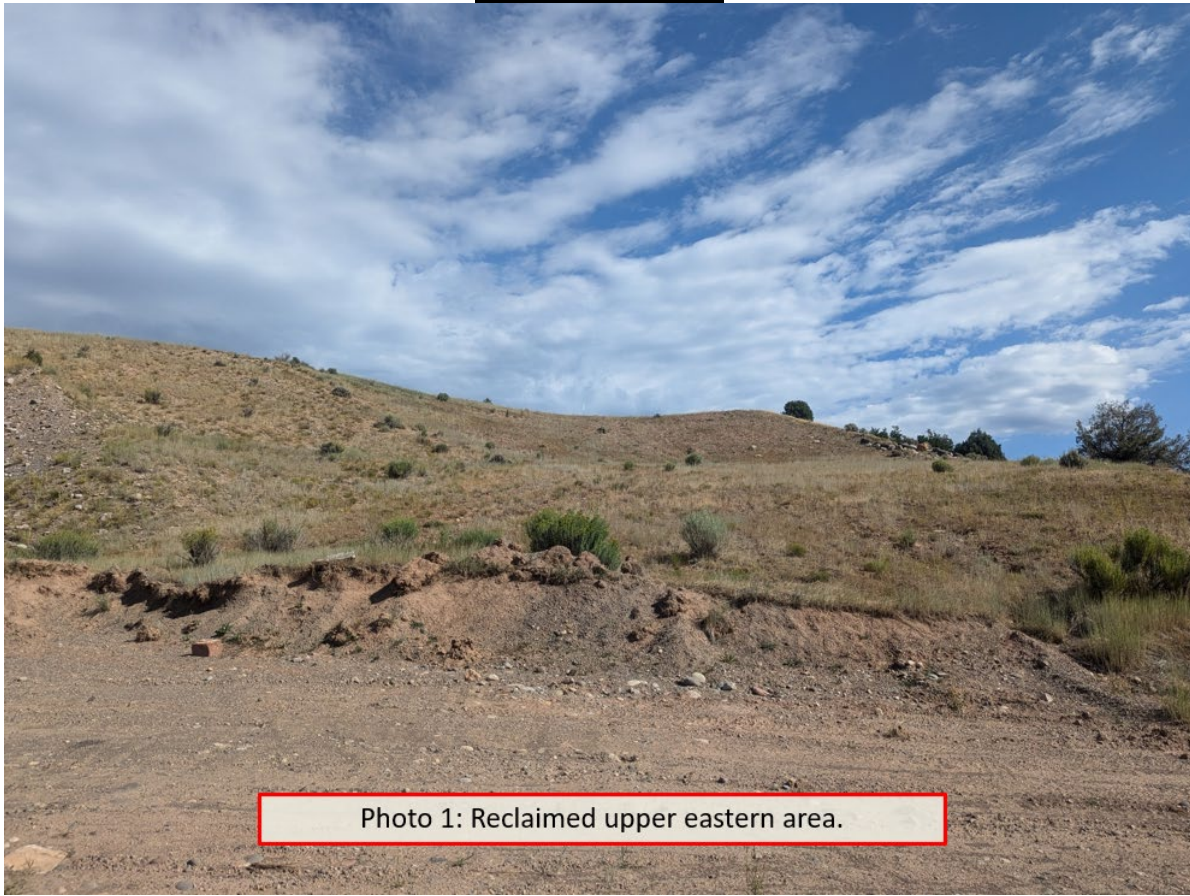
Site conditions remain unchanged from the previous inspection. The eastern reclaimed slopes are graded to a 3H:1V or less and have well established grasses. The "Active" highwall area is at approximately 2H: 1V.

Photo 1: Reclaimed upper eastern area.

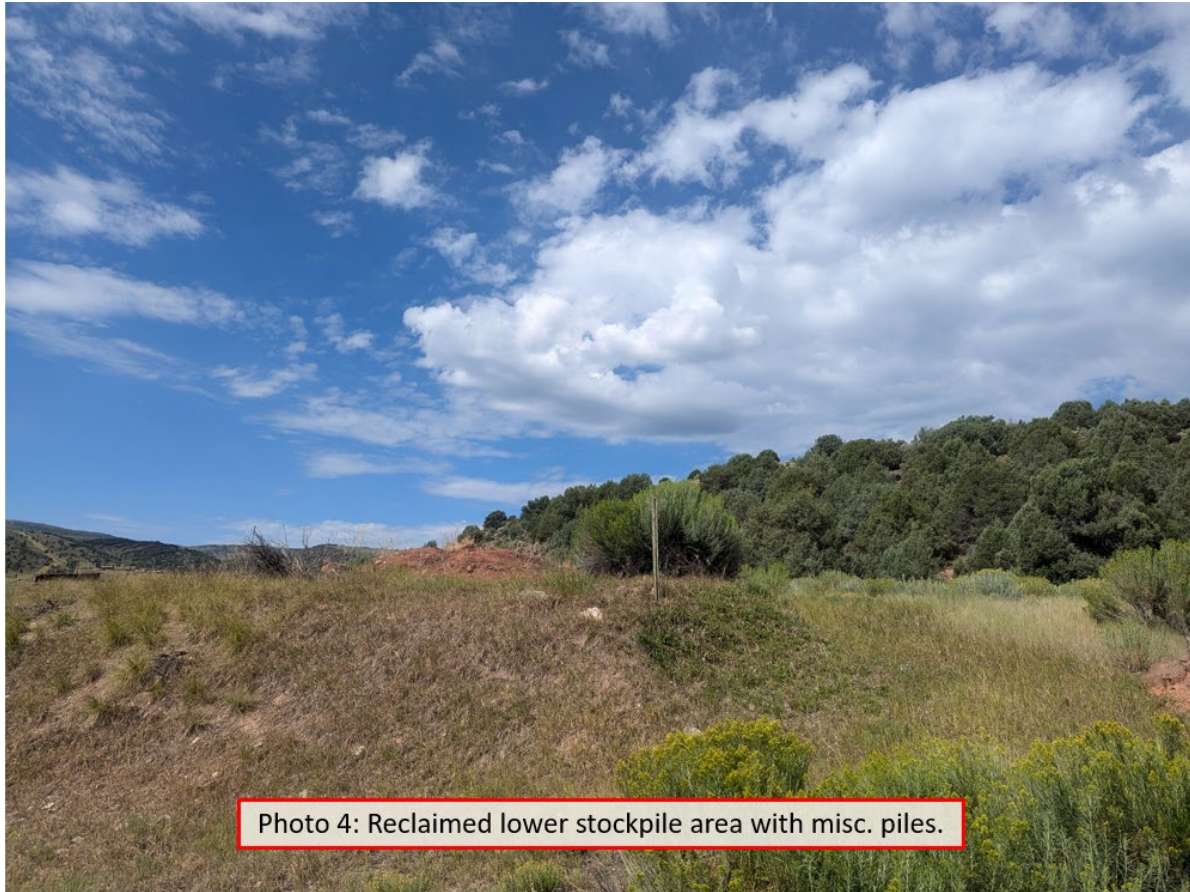
Areas indicated as previously reclaimed on the Annual Report appear stable and well vegetated. The lower pad area has a hand full of stockpiles that need to be removed prior to that are being considered for release. Photo 4.

Photo 4: Reclaimed lower stockpile area with misc. piles.

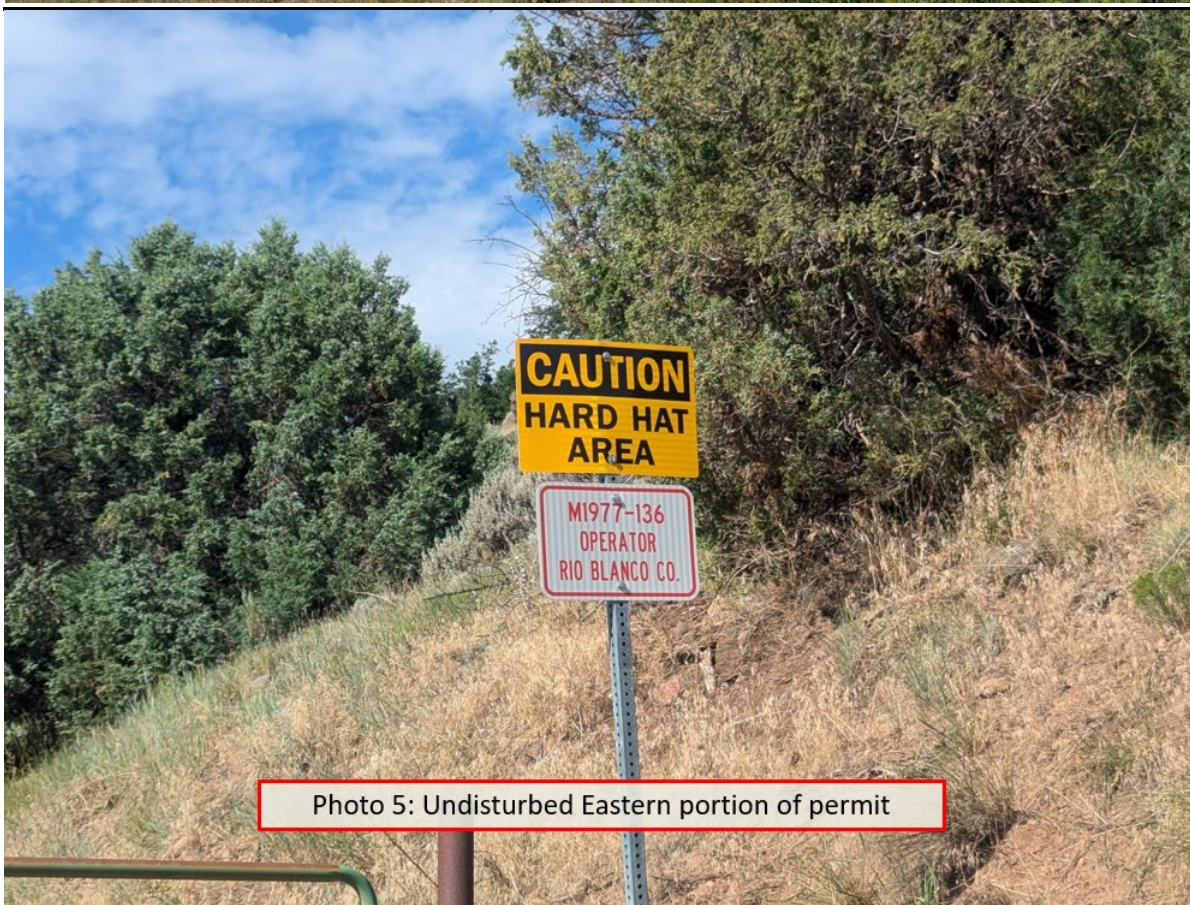
Photo 5: Undisturbed Eastern portion of permit
