MINERALS PROGRAM INSPECTION REPORT
PHONE: (303) 866-3567

MINE NAME: Half Moon Pit	MINE/PROSPECTING ID#: M-1977-071	MINERAL: Aggregate	COUNTY: Lake
INSPECTION TYPE: Monitoring	WEATHER: Cloudy	INSP. DATE: June 27, 2024	INSP. TIME: 08:55
OPERATOR: Lake County	OPERATOR REPRESENTATIVE: Jimmy Romero	TYPE OF OPERATION: 112c - Construction Regular Operation	
REASON FOR INSPECTION: Normal I&E Program	BOND CALCULATION TYPE:	BOND AMOUNT: \$0.00	
DATE OF COMPLAINT: NA	POST INSP. CONTACTS: None	JOINT INSP. AGENCY: None	
INSPECTOR(S): Lucas West	INSPECTOR'S SIGNATURE:

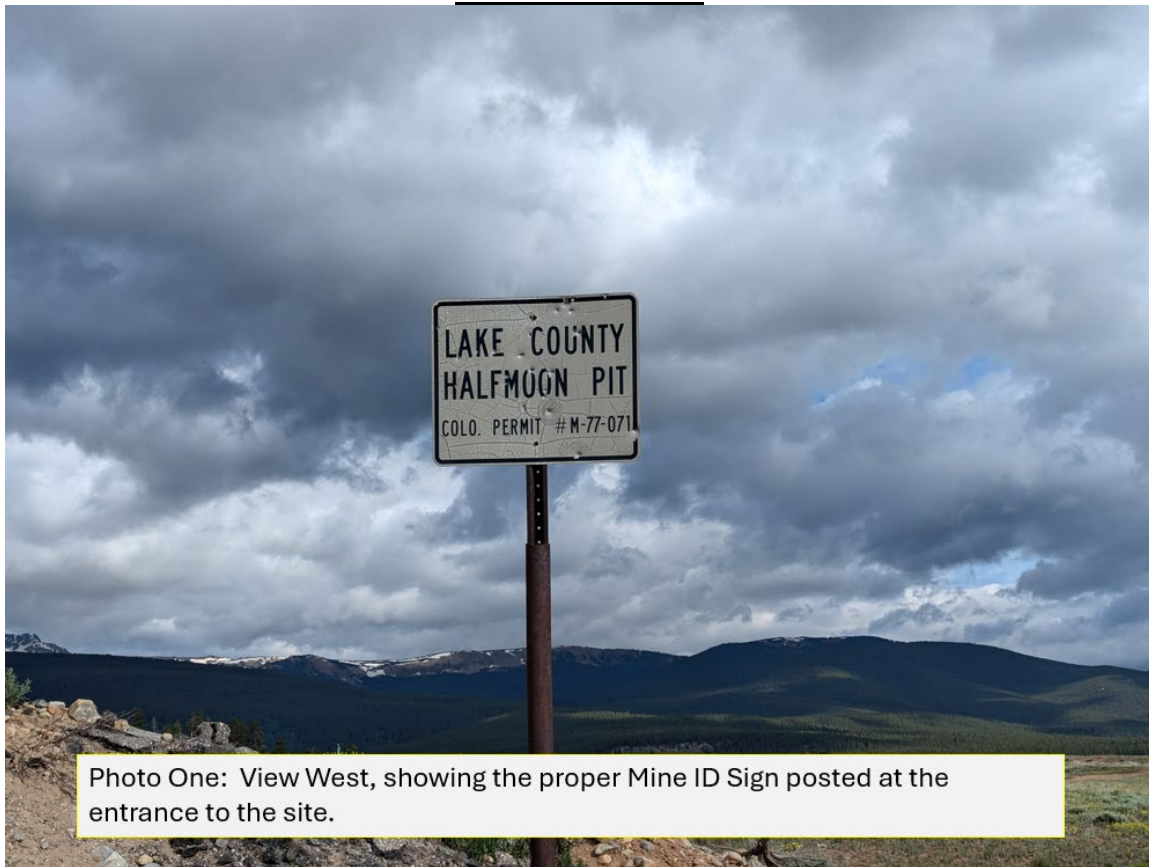
The proper mine Identification signage was posted at the entrance to the site as can be seen in Photo One. The Permit Boundary was clearly marked by t-posts around it's perimeter. The mining operation is being conducted as to not utilize highwalls, but rather mine the slopes at the reclamation grade of approximately 3H:1V. All pit slopes around the perimeter of the pit appeared stable at the time of the inspection, and an example of them can be seen in Photo Two. No evidence of settling, slumping or erosion was noted. The pit exhibits positive drainage, and no impounded stormwater was noted on the pit floor. Similar to the pit slopes, no evidence of settling or slumping was noted on the floor. An example of the pit floor can be seen in Photo Three.

Photo One: View West, showing the proper Mine ID Sign posted at the entrance to the site.

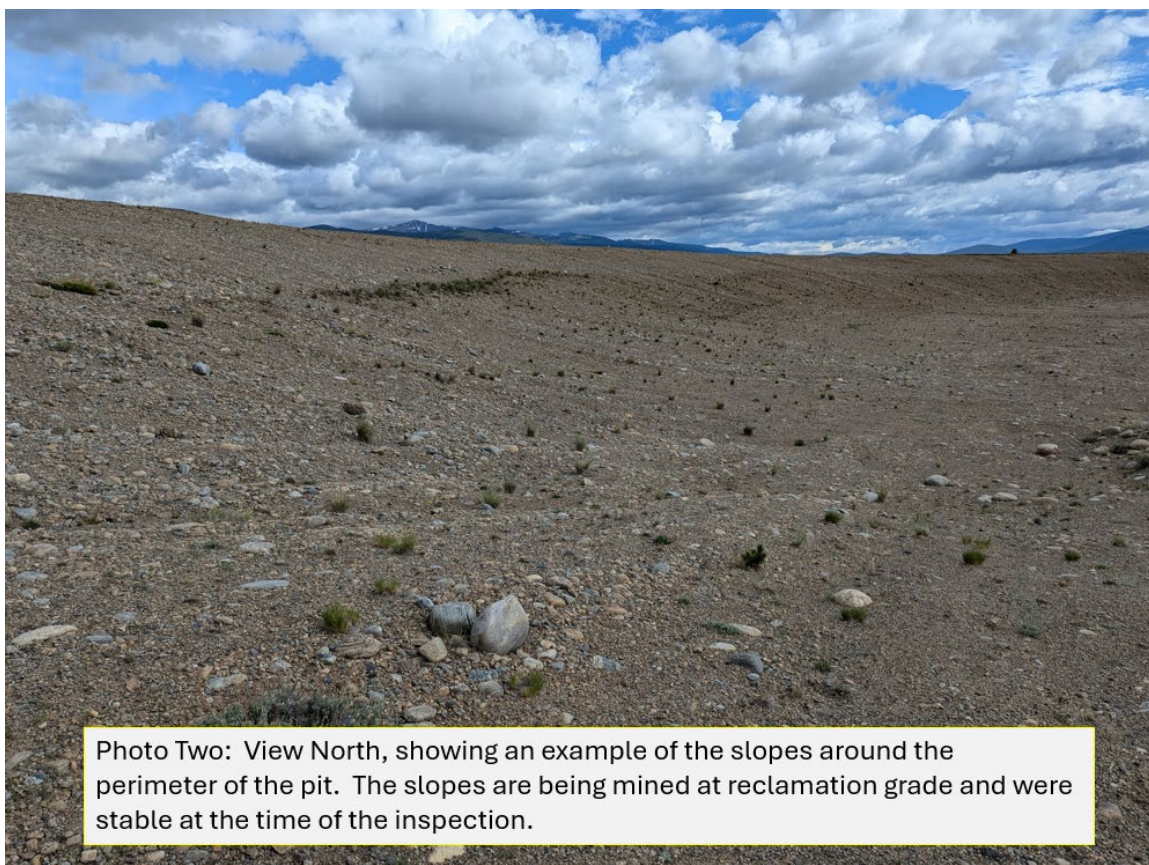
Photo Two: View North, showing an example of the slopes around the perimeter of the pit. The slopes are being mined at reclamation grade and were stable at the time of the inspection.

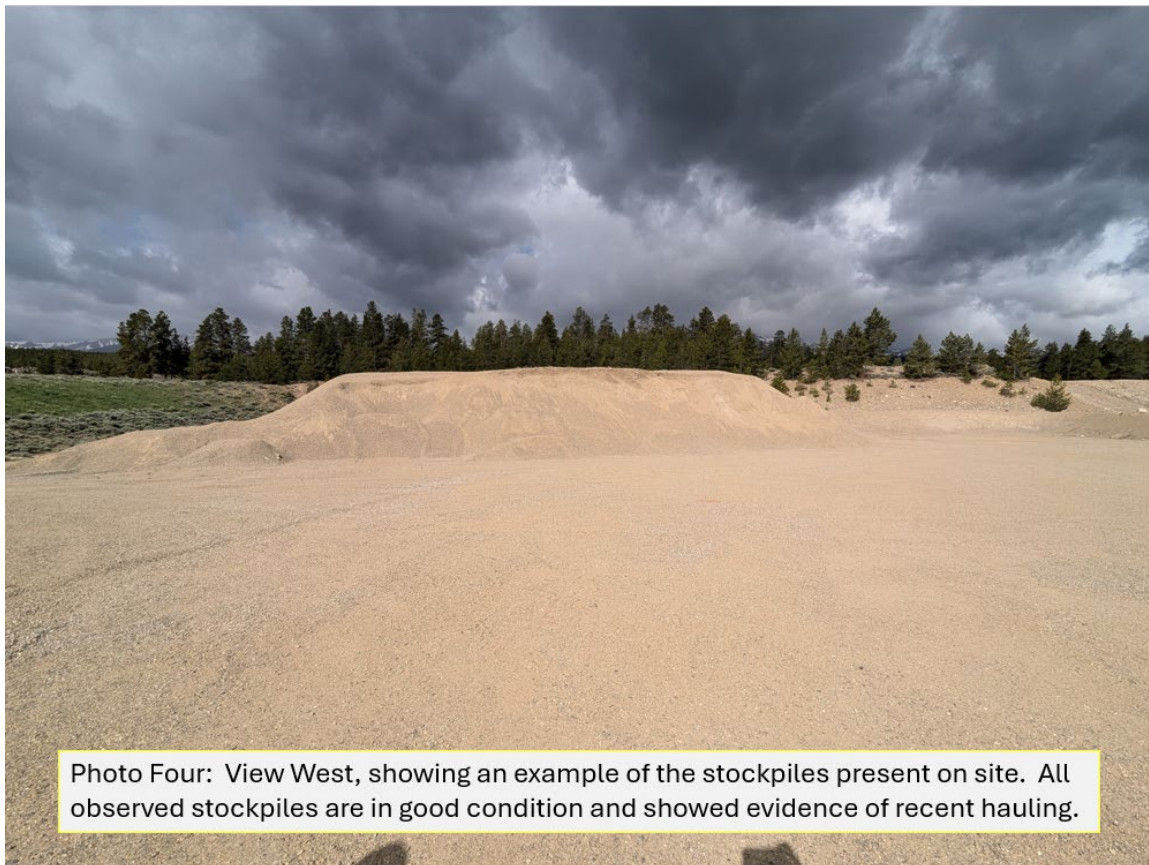
Various stockpiles of processed material were present around the pit, and example of which can be seen in Photo Four. All observed stockpiles appeared stable at the time of the inspection and in good condition. Removed topsoil from the disturbed area has been stockpiled around the pit near the shoulder of the slope. All topsoil stockpiles are vegetated for stability and in good condition. Near the entrance to the site, various construction materials such as jersey barriers, and bridge components are being stored. The items are stored in a neat and orderly fashion and not considered a problem at the time.
