**MINERALS PROGRAM INSPECTION REPORT**  
**PHONE: (303) 866-3567**

<b>MINE NAME:</b> Revenue Mine	<b>MINE/PROSPECTING ID#:</b> M-2012-032	<b>MINERAL:</b> Lead, silver and gold	<b>COUNTY:</b> Ouray
<b>INSPECTION TYPE:</b> Multi Person Inspection	<b>WEATHER:</b> Clear	<b>INSP. DATE:</b> July 23, 2024	<b>INSP. TIME:</b> 10:40
<b>OPERATOR:</b> Thorin Resources, LLC	<b>OPERATOR REPRESENTATIVE:</b> Chris Skerik	<b>TYPE OF OPERATION:</b> 112d-1 - Designated Mining Operation	
<b>REASON FOR INSPECTION:</b> Normal I&E Program	<b>BOND CALCULATION TYPE:</b> None	<b>BOND AMOUNT:</b> \$517,219.00	
<b>DATE OF COMPLAINT:</b> NA	<b>POST INSP. CONTACTS:</b> None	<b>JOINT INSP. AGENCY:</b> None	
<b>INSPECTOR(S):</b> Lucas West Amber Gibson Hunter Ridley	<b>INSPECTOR'S SIGNATURE:</b>

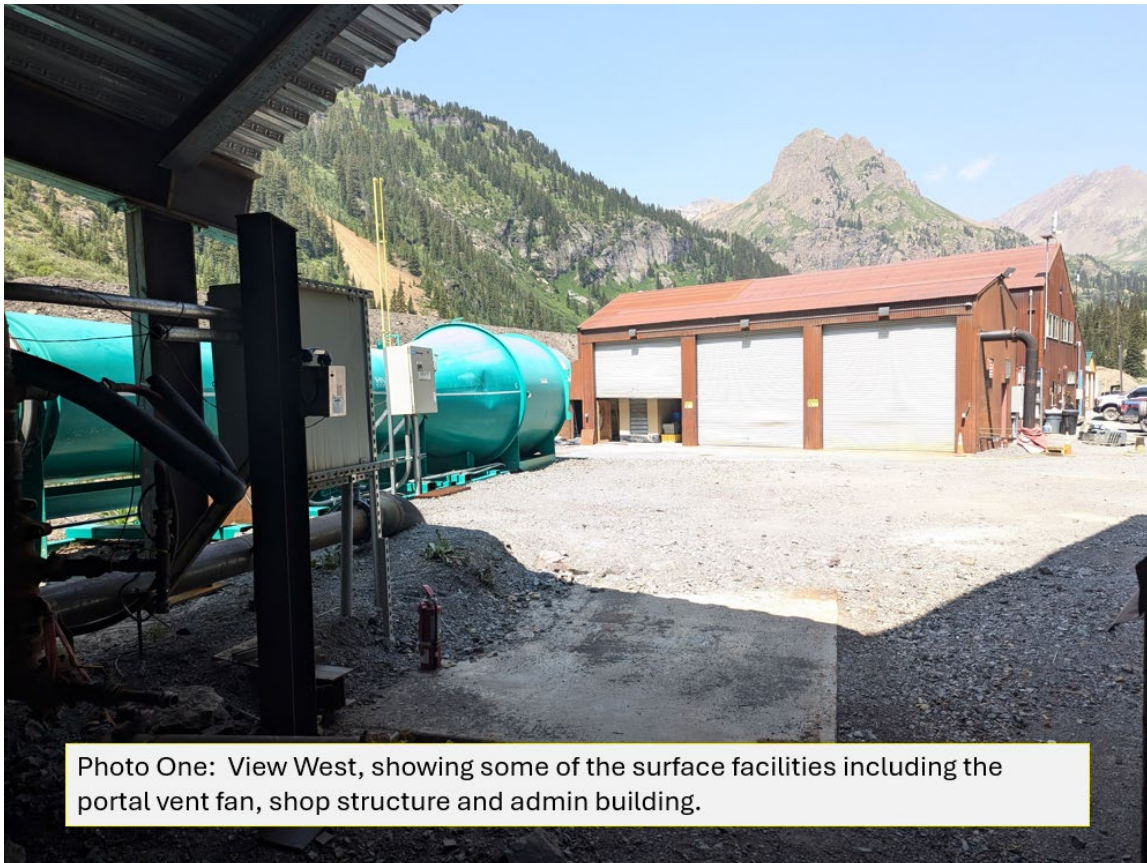
All Surface facilities including the materials storage warehouse, waste storage building, railyard building, compressor building and admin building are in good condition. Examples of the surface facilities including the railyard building can be seen in Photos One and Two. All hazardous materials stored in the waste storage building and materials storage warehouse is stored on appropriate spill pallets and was neat and orderly. The storage areas can be seen in Photos Three and Four. The onsite fuel storage tanks were observed and are in good condition with no evidence of leaks or spills. The dump wall and associated stockpiles of waste rock appeared to be stable at the time of the inspection and no evidence of significant erosion was noted. Throughout the entire site, despite the recent Precipitation, no evidence of erosion was observed. All observed storm water control structures appeared to be functioning as designed.

Photo One: View West, showing some of the surface facilities including the portal vent fan, shop structure and admin building.

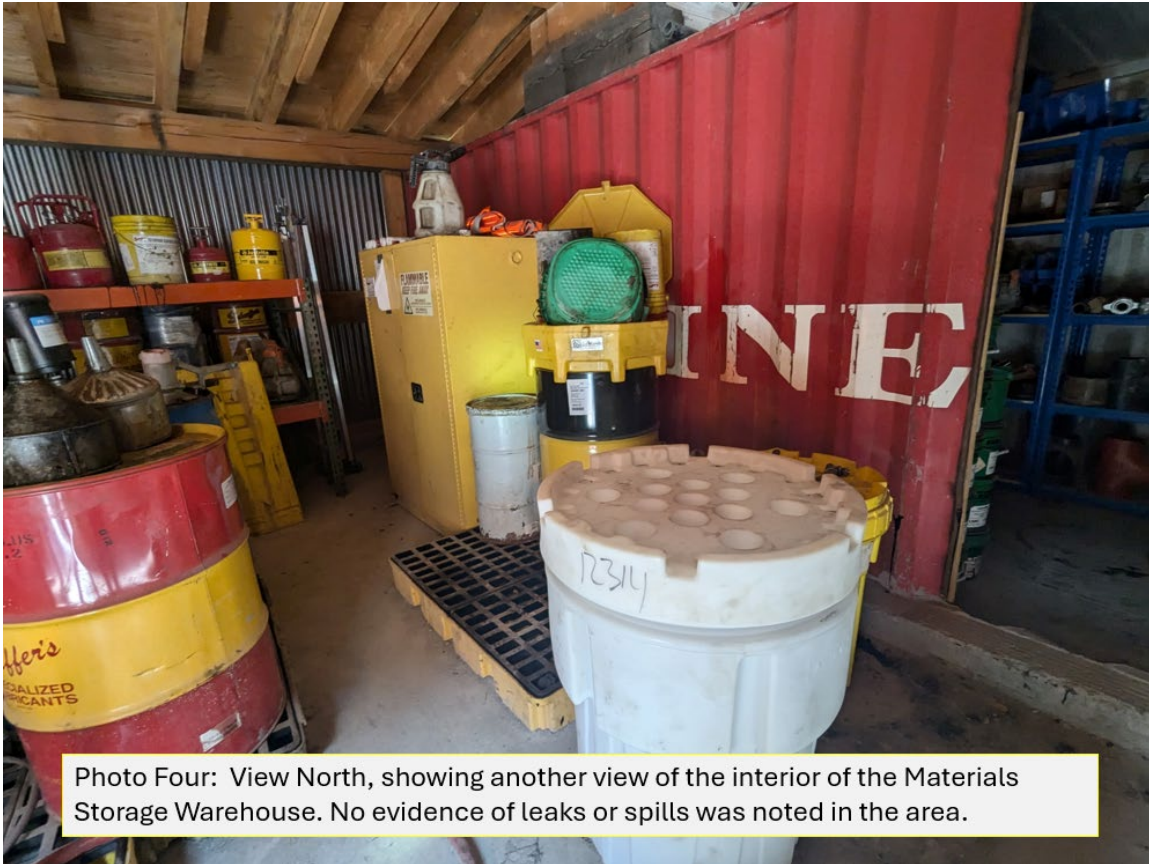
Photo Four: View North, showing another view of the interior of the Materials Storage Warehouse. No evidence of leaks or spills was noted in the area.

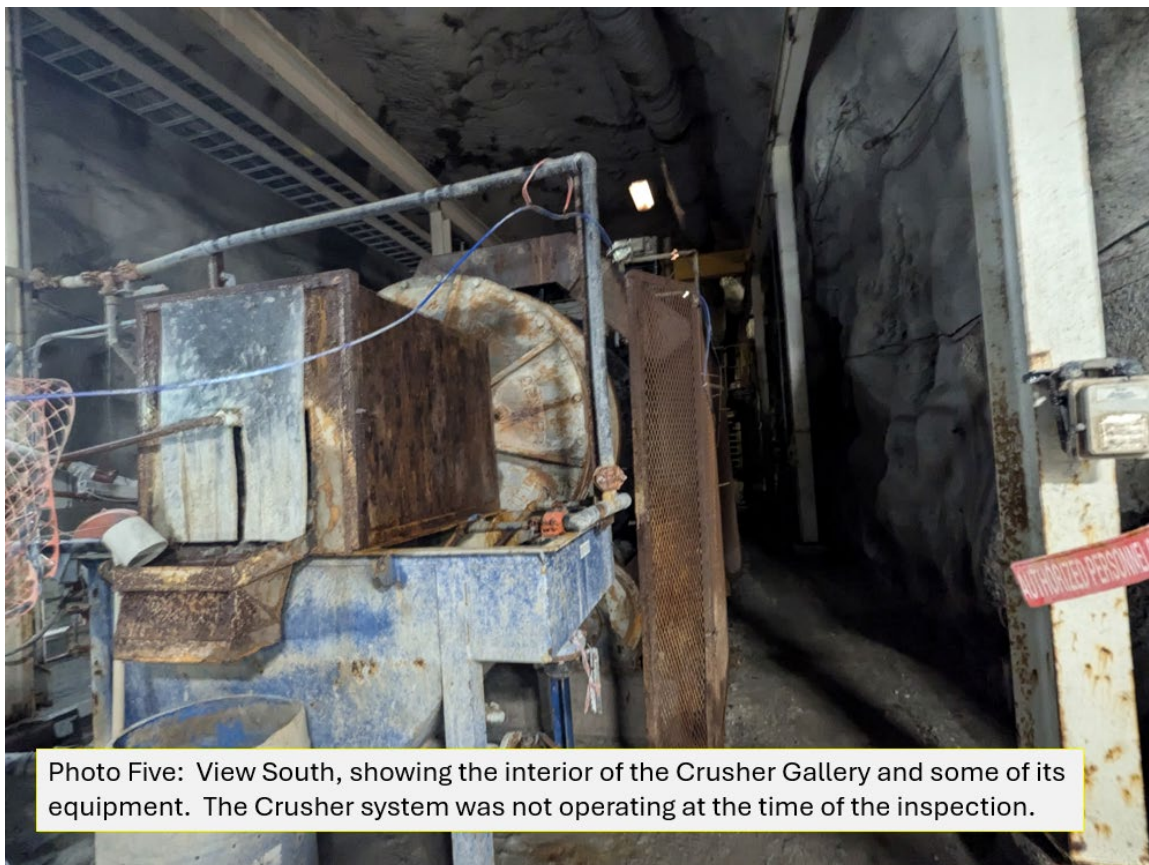
The underground elements of the crusher and floatation circuits of the Mill were observed during the inspection. The crusher gallery was not in operation during the inspection, however all elements and equipment associated with it was observed to be in good condition. None of the sumps were pumping during the inspection and minimal water was noted in the containment area of the crusher gallery. The crusher gallery and equipment can be seen in Photo Five. Similar to the crusher equipment the equipment associated with the flotation circuit was not active during the inspection. The flotation circuit, all equipment and the mill tunnel can be seen in Photo Six. All equipment appeared to be in good working order, and evidence of various maintenance activities were observed. All reagents involved in the milling process have been removed from the site, and the day tanks in the flotation gallery were confirmed to be empty. The concentrate packing area, filter press bay, and tailings dump bay were observed to be in good condition.

Photo Five: View South, showing the interior of the Crusher Gallery and some of its equipment. The Crusher system was not operating at the time of the inspection.

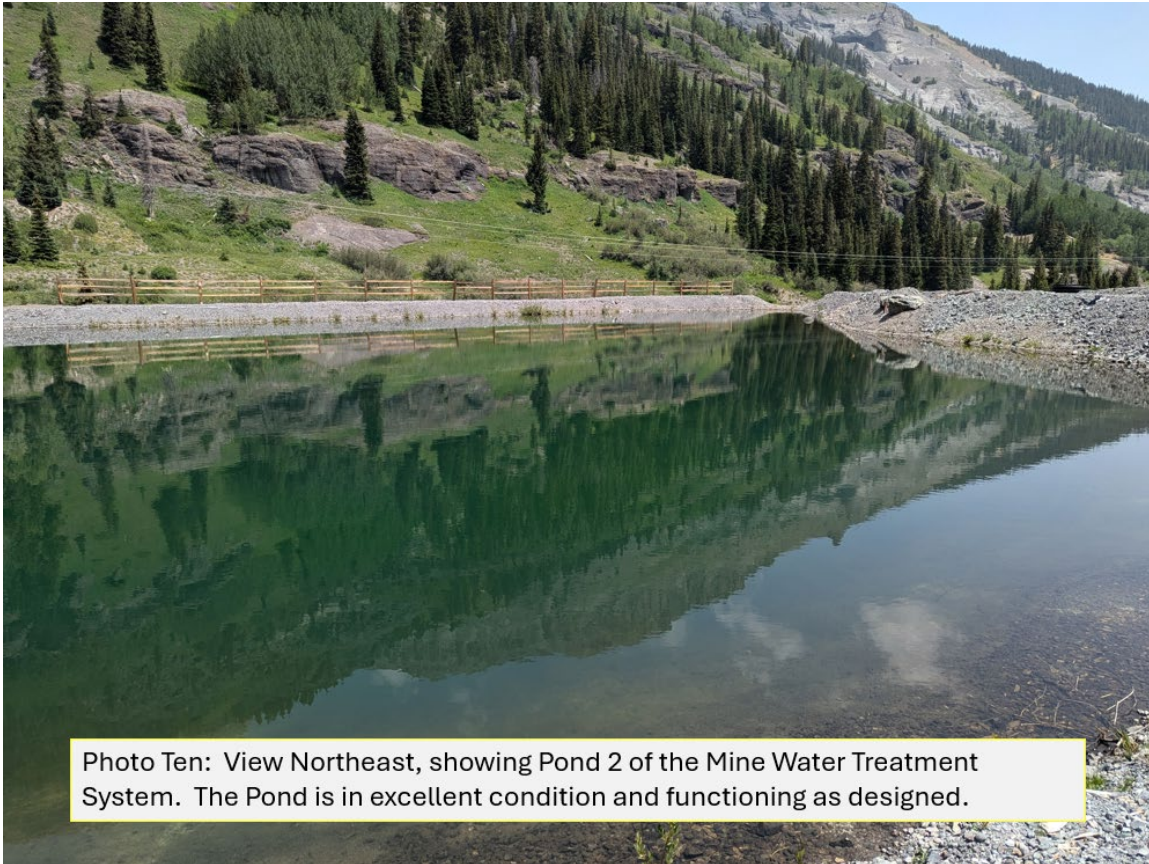
The Passive Mine Water Treatment system was flowing and functioning as designed at the time of the inspection. Pond One was slightly more turbid in the first cell, upstream of the first baffle curtain, however the curtains are functioning as designed and the water settles to its original color and turbidity prior to discharge into Pond Two. Ponds Two and Three are in excellent condition and appeared to be functioning as designed. Examples of the various ponds can be seen in Photos Nine and Ten.

Photo Ten: View Northeast, showing Pond 2 of the Mine Water Treatment System. The Pond is in excellent condition and functioning as designed.

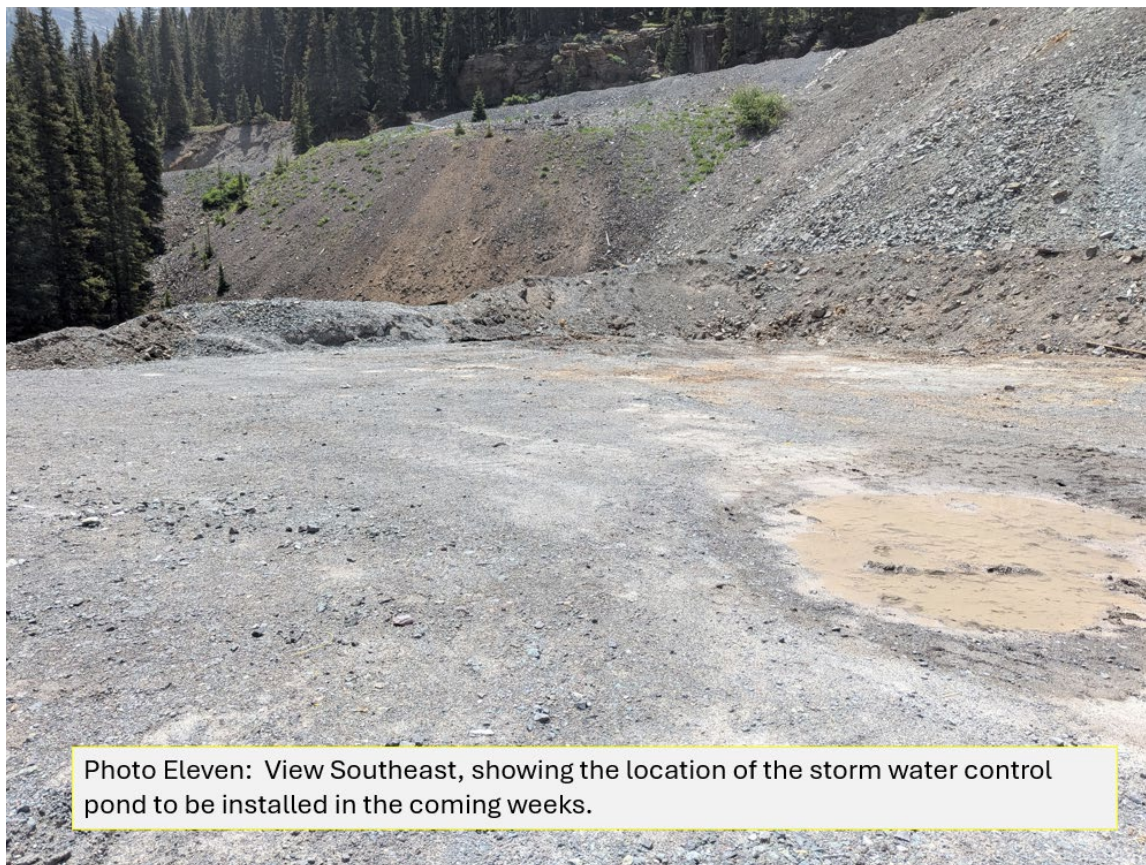
With the Approval of AM-2, the Operator committed to installing a new Groundwater Monitoring Well and Storm Water Pond near the entrance to the site. Those commitments carry forward to the new Operator and at the time of the inspection had not been completed. The Operator is reminded that prior to any production related activities on site, both features must be completed with as built completion reports supplied to the Division. Photo Eleven shows the location of the storm water pond to be constructed.

Photo Eleven: View Southeast, showing the location of the storm water control pond to be installed in the coming weeks.
