MINERALS PROGRAM INSPECTION REPORT
PHONE: (303) 866-3567

MINE NAME: Upper Mountain Top	MINE/PROSPECTING ID#: P-2011-003	MINERAL: Silver	COUNTY: Ouray
INSPECTION TYPE: Surety Release Inspection	WEATHER: Clear	INSP. DATE: July 23, 2024	INSP. TIME: 14:25
OPERATOR: The Mining Company, Inc.	OPERATOR REPRESENTATIVE: None	TYPE OF OPERATION: MP - Mineral Prospecting	
REASON FOR INSPECTION: Surety Release Requested	BOND CALCULATION TYPE:	BOND AMOUNT: \$2,552.00	
DATE OF COMPLAINT: NA	POST INSP. CONTACTS: None	JOINT INSP. AGENCY: None	
INSPECTOR(S): Lucas West Amber Gibson Hunter Ridley	INSPECTOR'S SIGNATURE:

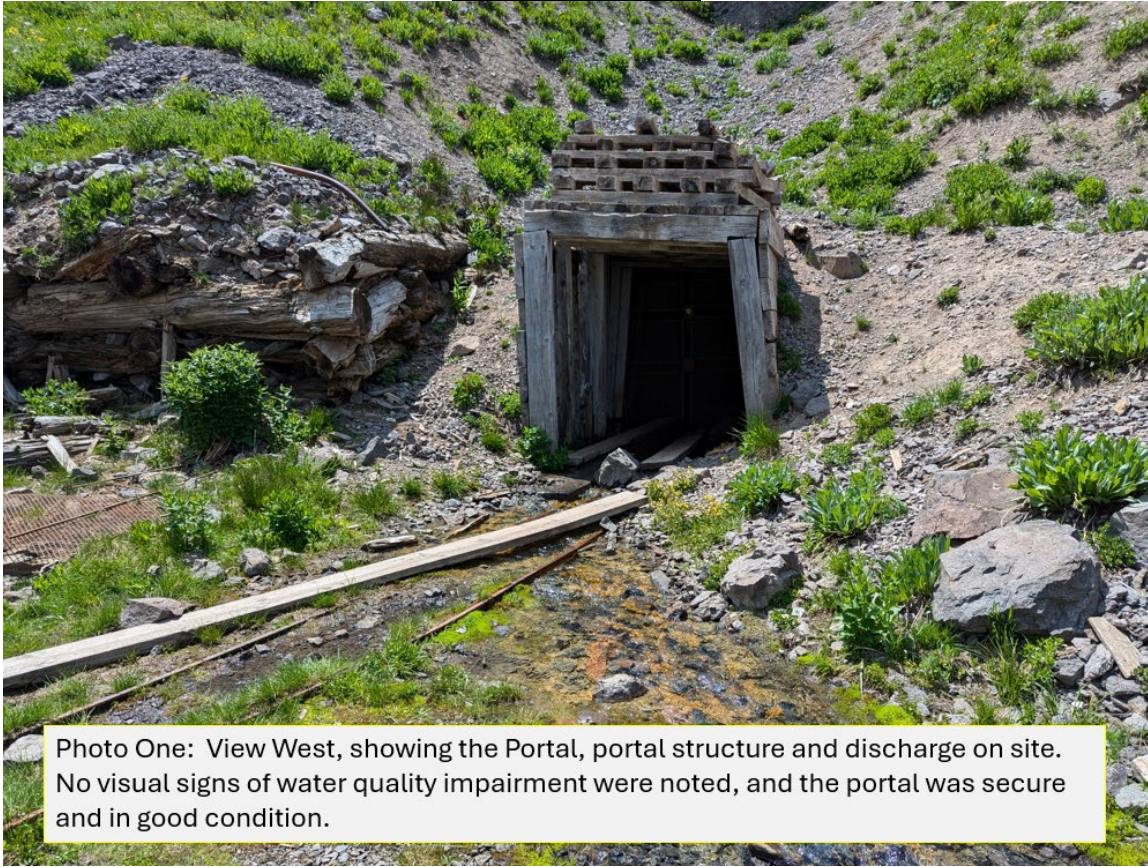
Photo One: View West, showing the Portal, portal structure and discharge on site. No visual signs of water quality impairment were noted, and the portal was secure and in good condition.

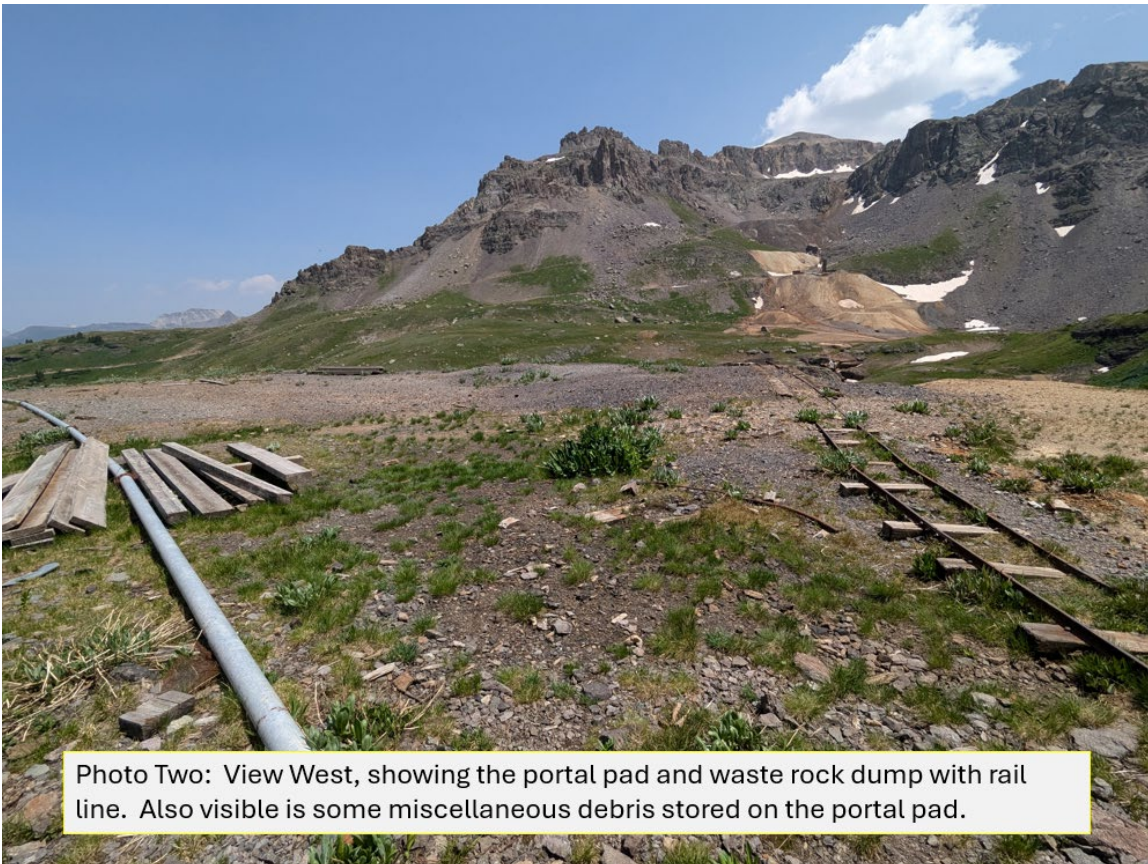
The access road is an existing claim road that branches off of Forest Service Road 853.1C, the locked gate lies along the access road near the boundary of the claim. No identification sign was posted on site at the time of the inspection. Due to the high volume of recreational travel in the area and the likelihood of theft the lack of identification signage is not considered a problem at this time. The access road is in good condition and no signs of settling, slumping or erosion of the road was noted. At the end of the access road is the portal pad, waste rock dump and portal. The portal was observed and secured with a locking metal gate, no evidence of vandalism or attempted unauthorized entry was noted. The portal was discharging at the time of the inspection and was visually estimated to be flowing at a rate of 20-25 Gallons Per Minute. The flow was following a preferential flow path and showed no visual signs of impaired water quality. The portal and it's discharge can be seen in Photo One. Leading away from the portal is a historic mine rail spur leading to the edge of the waste rock dump. The dump itself is in good condition and appeared stable at the time of the inspection and can be seen in Photo Two.

Photo Two: View West, showing the portal pad and waste rock dump with rail line. Also visible is some miscellaneous debris stored on the portal pad.

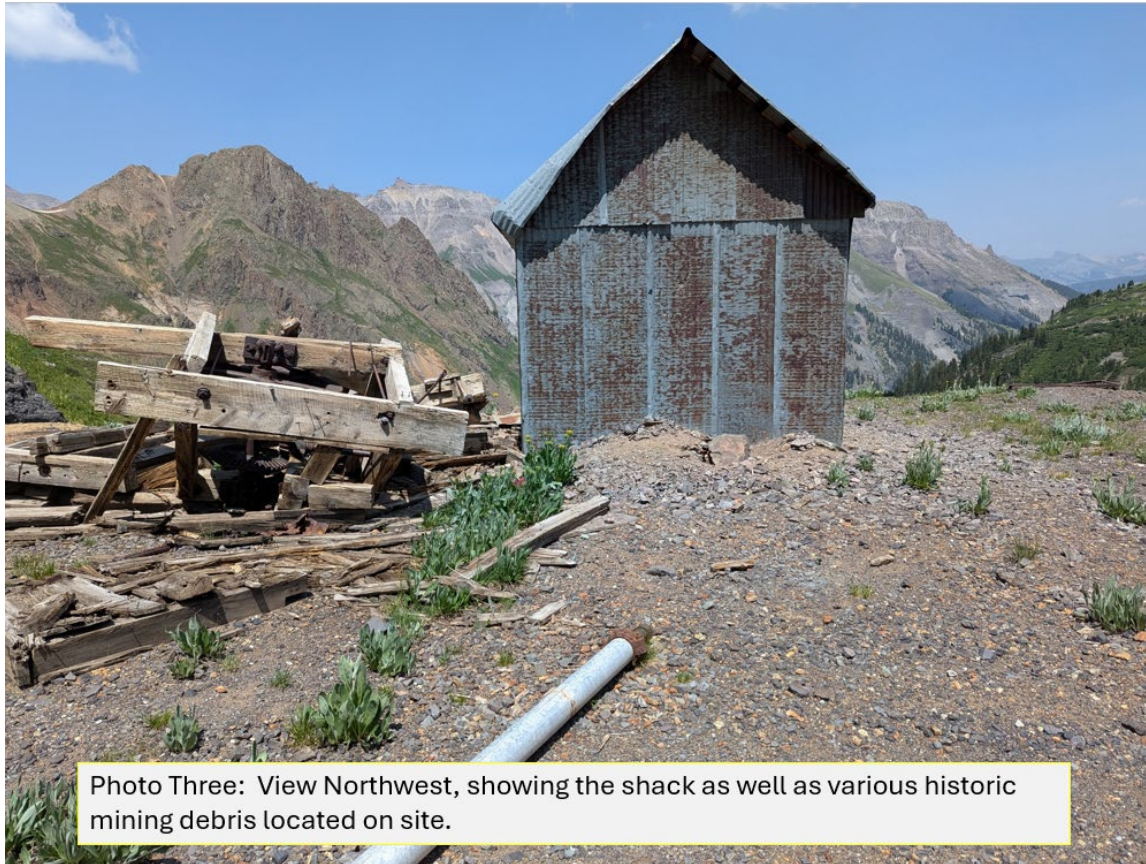
Across the portal pad, a mixture of historic and semi-modern mining related debris is scattered. The debris appears to be being stored for potential future use and is somewhat neat and orderly. Adjacent to the stored materials is a small shack that was in good condition. The shack was secured and no signs of attempted unauthorized entry or vandalism was noted. The shack and various debris can be seen in Photo Three.
