Foidel Inspection report

Miranda and Mike,
Attached is the August 2024 inspection report for the Foidel Creek Mine, C-1982-056.
Brock

Permit Number: C-1982-056 Mine Name: Foidel Creek Mine Operator: Twentymile Coal, LLC Operator Address: Ms. Miranda Kawcak 29515 Routt County Road No. 27 Oak Creek, CO 80467	County: Routt Operation Type: Underground Permit Status: Active Ownership: Private
	Operator Representative Present: Michael Howard
Operator Representative Signature: (Field Issuance Only)

Inspection Start Date: August 20, 2024 Inspection Start Time: 08:00 Inspection End Date: August 21, 2024 Inspection End Time: 10:30	Inspection Type: Coal Partial Inspection Inspection Reason: Normal I&E Program Weather: Clear
Joint Inspection Agency: None	Joint Inspection Contacts:
Post Inspection Agency: None	Post Inspection Contacts:
Inspector(s): Brock Bowles Ben Hammar	Inspector's Signature:

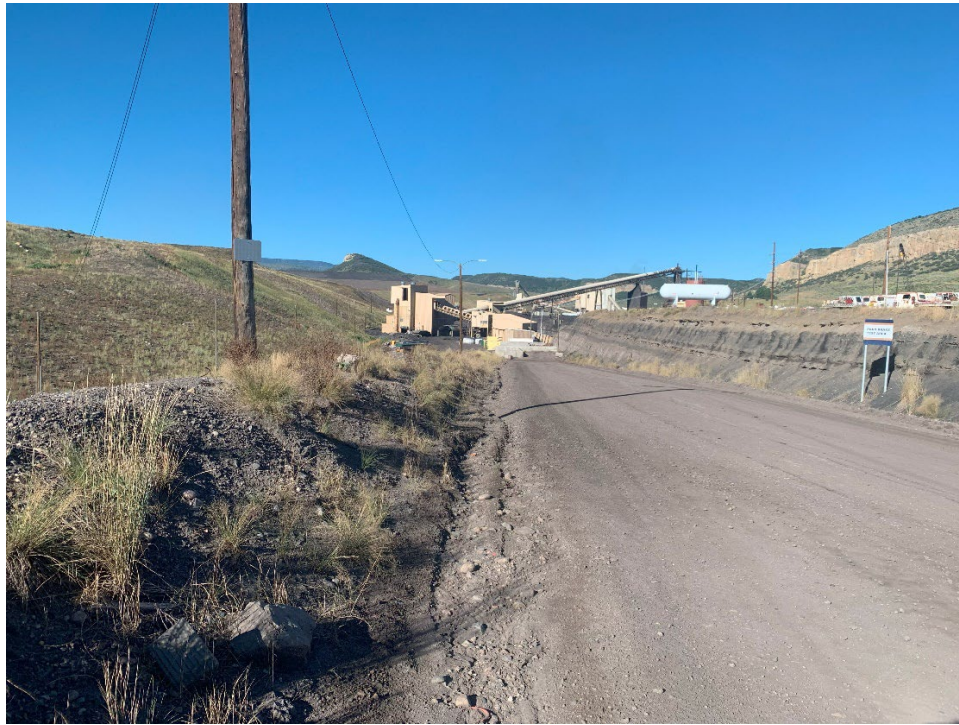
Ditch D-6 (A-B) between the bathhouse and non-coal waste area was clear of obstructions (photo 1). The culvert shown on Map 24 by the non-coal waste area was not seen on the ground. TC is investigating if it was ever installed.

Photo 1 – Ditch D6 from bathhouse to non-coal waste area.

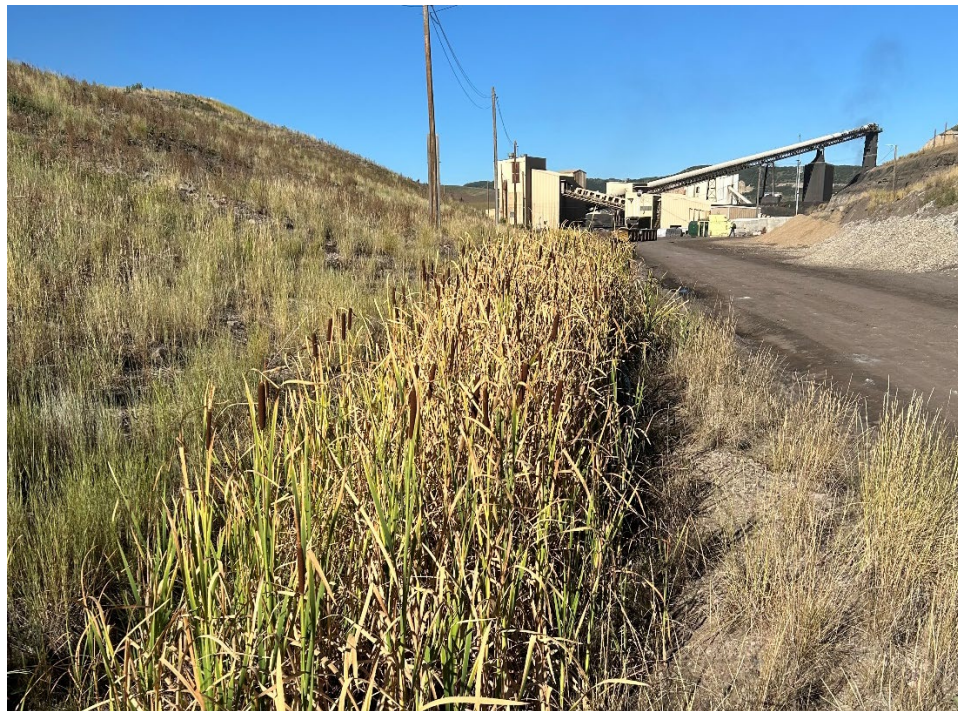
Ditch D-4 between the employee parking lot and the non-coal waste area contained cattails that are obstructing the flow of the ditch and need to be removed (photo 2).

Photo 2 – Cattails obstructing Ditch D4

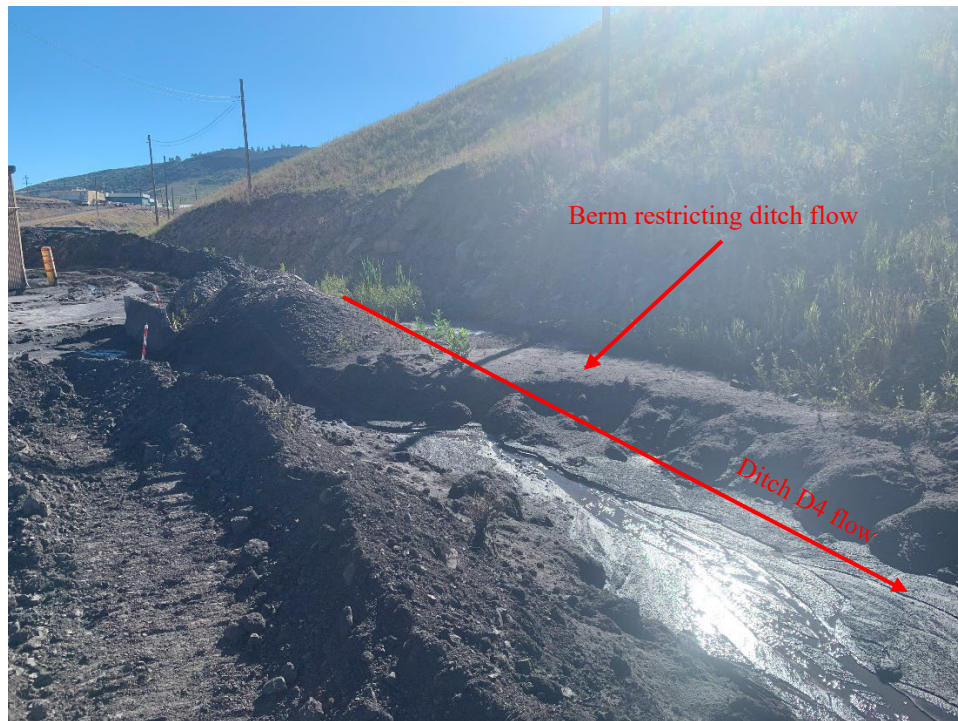
The area around the transfer building drains into Ditch D-4. At this intersection, a sediment berm has formed restricting the flow of D-4 and needs to be cleaned (photo 3).

Photo 3 – Transfer building area draining into Ditch D4

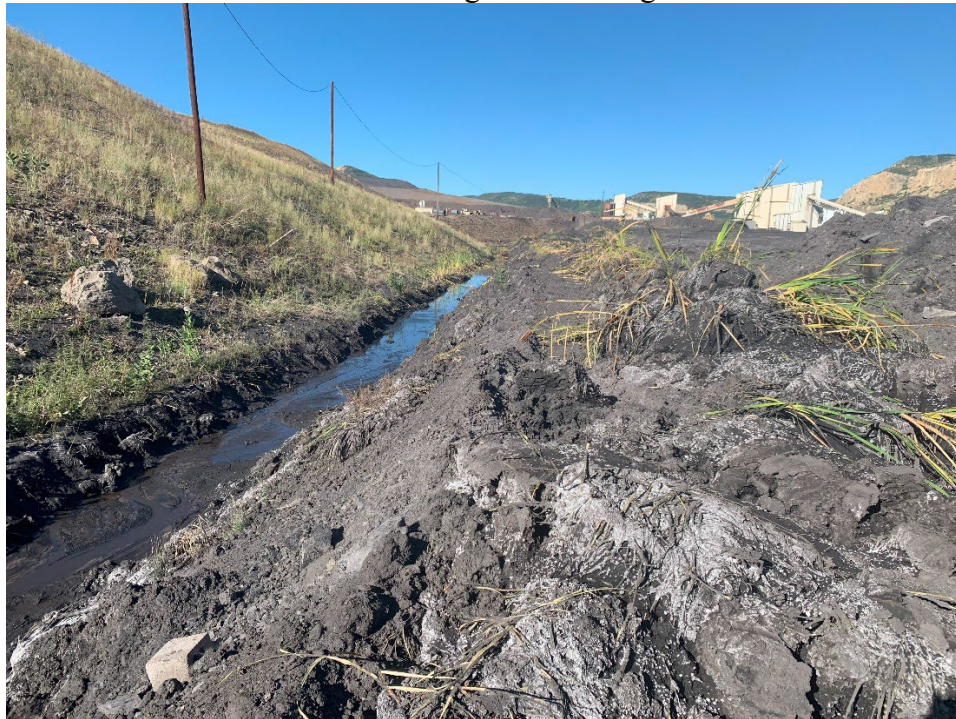
Map 24 shows Ditch D-4 going through a culvert between the transfer building and the first sump. This section of D-4 is actually an open ditch on the ground. The cattails in this section of ditch have recently been cleaned (photo 4).

Photo 4 – Ditch D4 between transfer building and first sump

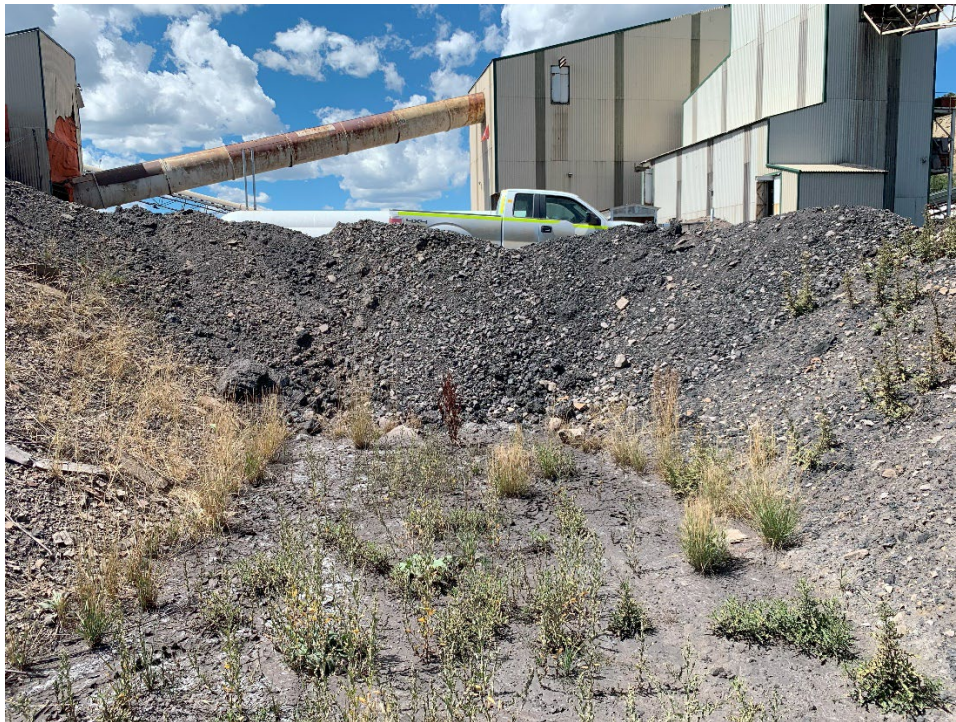
Continuing to follow the water path of Ditch D-4, the dual culverts shown on Map 24 direct the water to a third sump. The east end of the third sump has one culvert where Map 24 shows there should be two culverts. The water is directed out of the third sump by a set of dual culverts. These culverts were not located, most likely due to road maintenance pushing material into the third sump and covering the culvert openings (photo 5).

Photo 5 – West end of third sump where culverts are most likely buried.

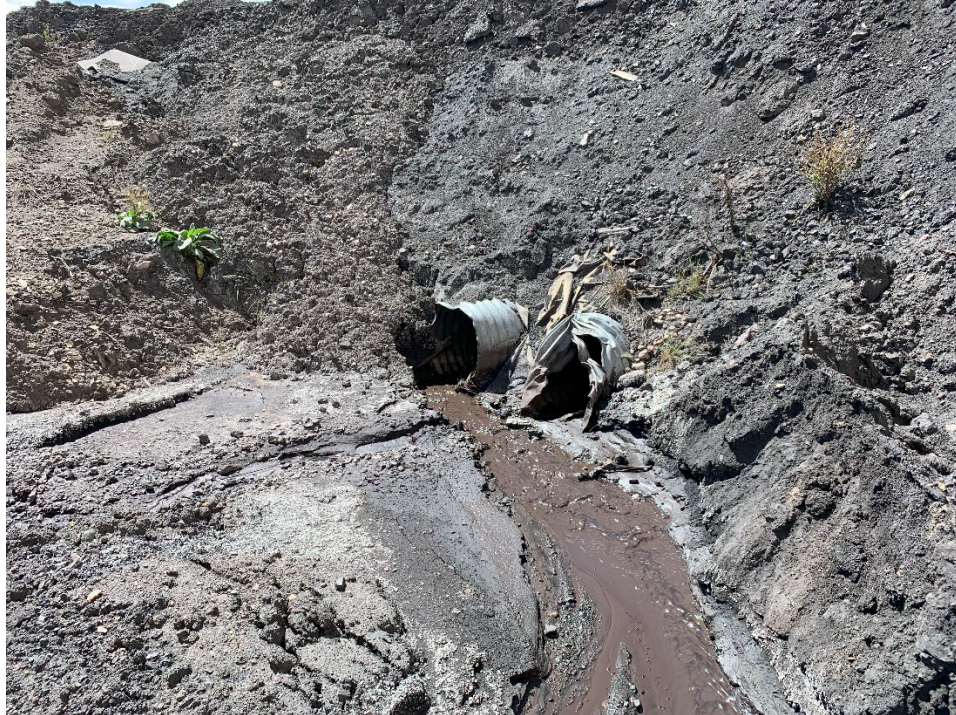
The dual culverts under the 48" Refuse Conveyor belt were in operation, although the northern culvert opening has been damaged and needs to be repaired (photo 6).

Photo 6 – Culverts under the Refuse Conveyor belt need to be repaired.

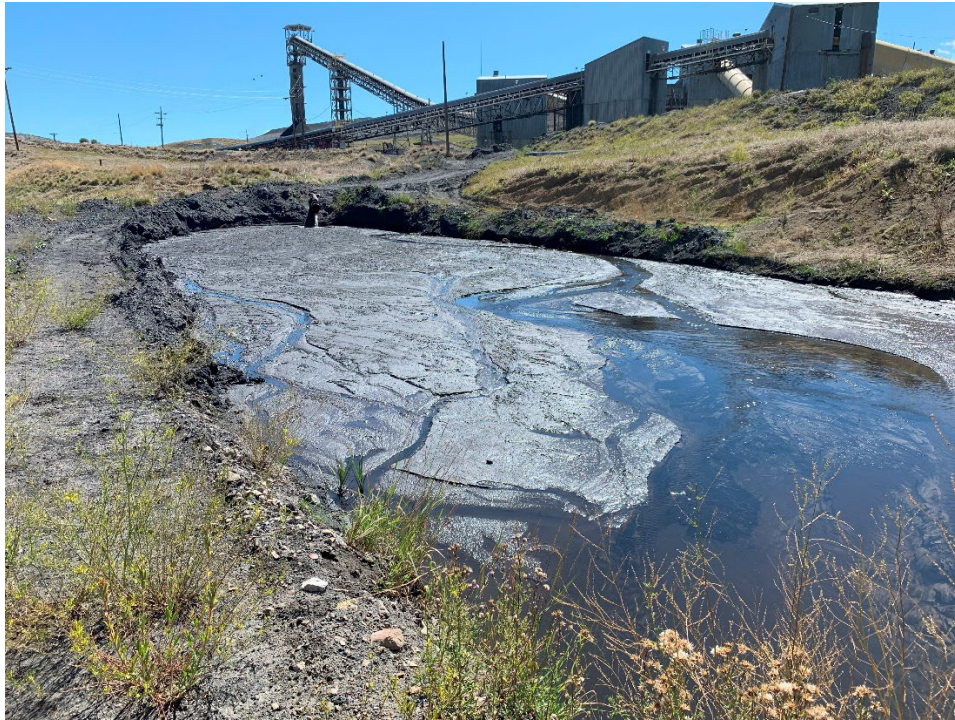
Pond B water contained water. The sump above Pond B appear to be at capacity and needs to be cleaned (photo 7). The ditches and culverts under the train tracks draining into Pond B were clear of obstructions.

Photo 7 – The sump above Pond B appears to be at capacity.

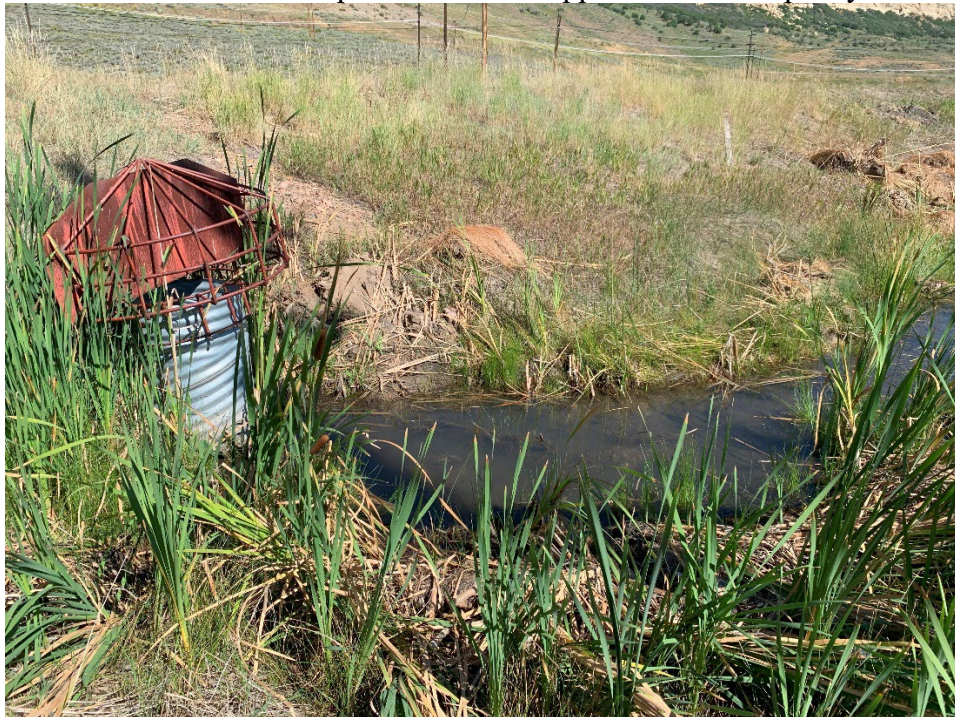
Pond E contained water and was discharging. The cattails have been removed from around the discharge structure to allow for unrestricted water movement (photo 8). The culvert under the road leading to Pond E has been cleaned.

Photo 8 – Cattails removed from around the Pond E discharge.

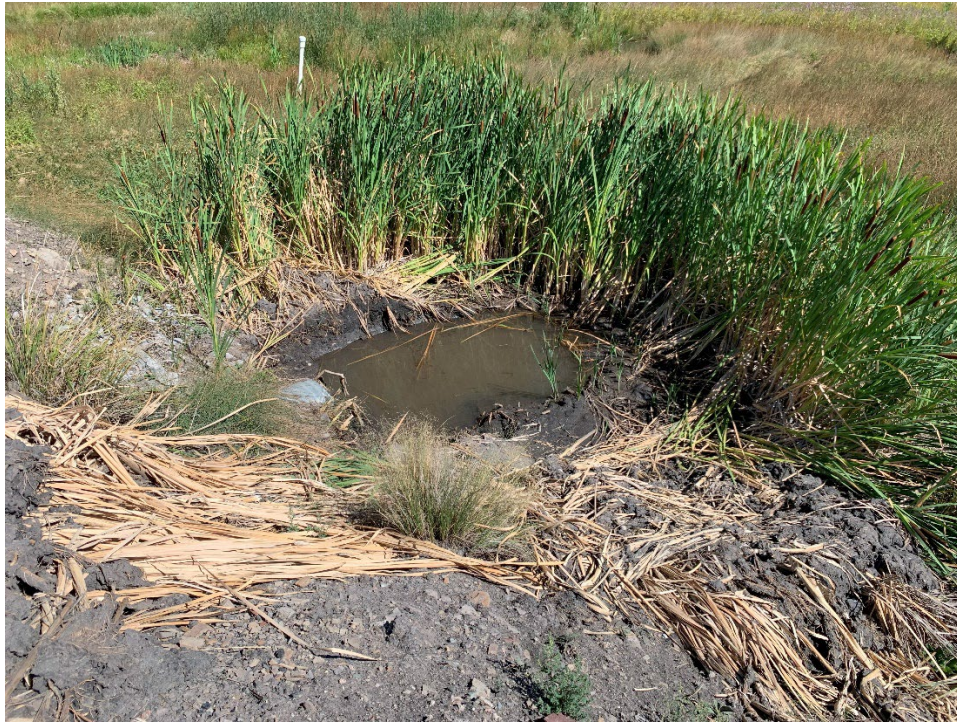
The cattails were removed from the outlet side of the culvert under the batch weigh loadout road (photo 9).

Photo 9 – Cattails removed from culvert under the batch weigh loadout road.

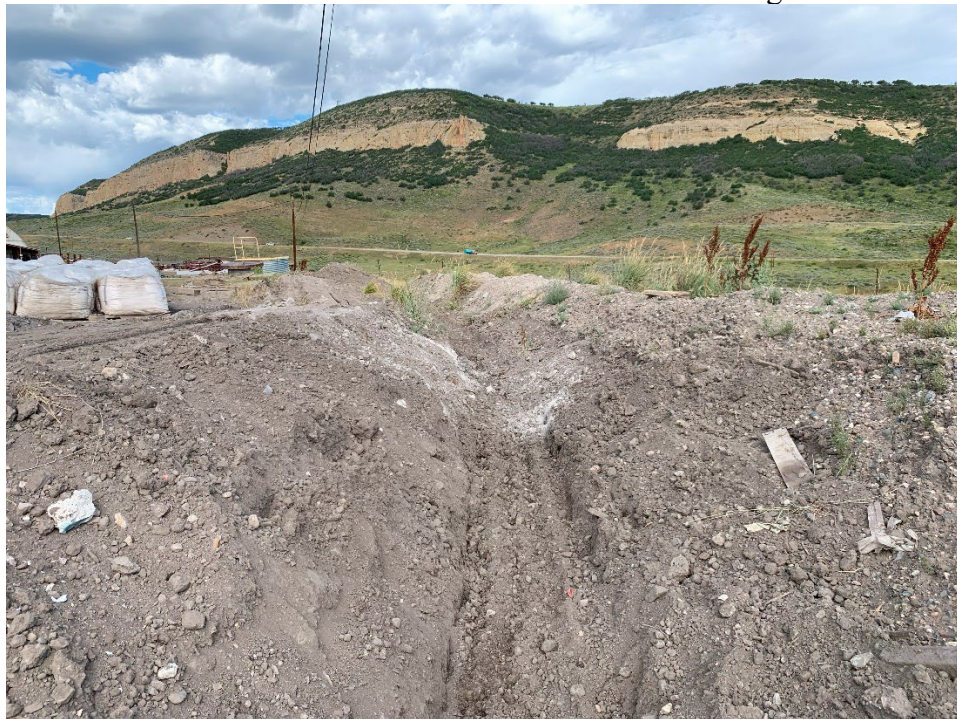
The debris in the E-1 ditch behind the maintenance shop has been removed (photo 10). The second partial obstruction that was approximately 100 feet to the west, has also been removed.

Photo 10 – Debris removed from Ditch E-1

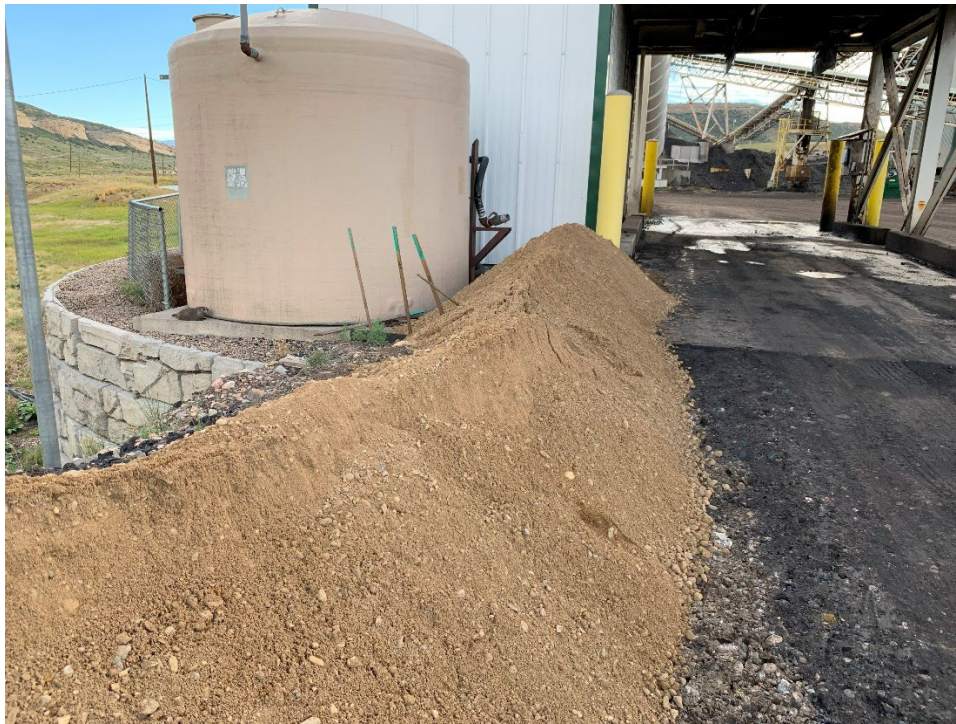
The area to the west of the stoker coal loadout building has been cleaned up. The loose coal has been removed from the area and a large earthen berm has been put in place (photo 11). The berm directs water away from the retaining wall and towards Pond D where it can be treated through a sediment control structure.

Photo 11 – Berm installed at stoker coal loadout

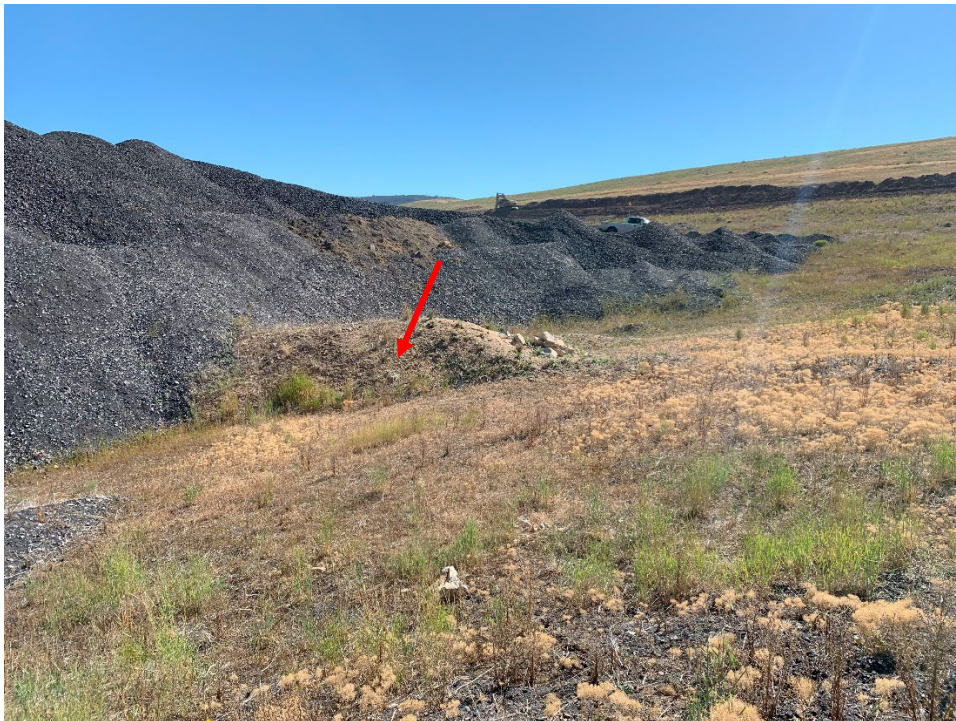
The wash plant was in operation and waste was being hauled to the top of the waste pile. The west end of the coal waste pile underdrain appears to be in operating condition (photo 12). There were no signs of standing water. The location of the underdrain as depicted on Map 24 is incorrect. The downhill side of the underdrain was discharging water into the Pit Pond.

Photo 12 – Coal waste pile underdrain
