## Hayden Gulch LO inspection report

<b>Permit Number:</b> C-1992-081 <b>Mine Name:</b> Hayden Gulch Loadout <b>Operator:</b> Hayden Gulch Terminal, LLC <b>Operator Address:</b> Ms. Miranda Kawcak 29515 Routt County Road 27 Oak Creek, CO 80467	<b>County:</b> Routt <b>Operation Type:</b> Loadout <b>Permit Status:</b> Active <b>Ownership:</b> Private
	<b>Operator Representative Present:</b>  N/a
<b>Operator Representative Signature: (Field Issuance Only)</b>

<b>Inspection Start Date:</b> August 20, 2024 <b>Inspection Start Time:</b> 14:15 <b>Inspection End Date:</b> August 20, 2024 <b>Inspection End Time:</b> 15:15	<b>Inspection Type:</b> Coal Partial Inspection <b>Inspection Reason:</b> Normal I&E Program <b>Weather:</b> Clear
<b>Joint Inspection Agency:</b>  None	<b>Joint Inspection Contacts:</b>  
<b>Post Inspection Agency:</b>  None	<b>Post Inspection Contacts:</b>  
<b>Inspector(s):</b>  Brock Bowles  Ben Hammar	<b>Inspector's Signature:</b>

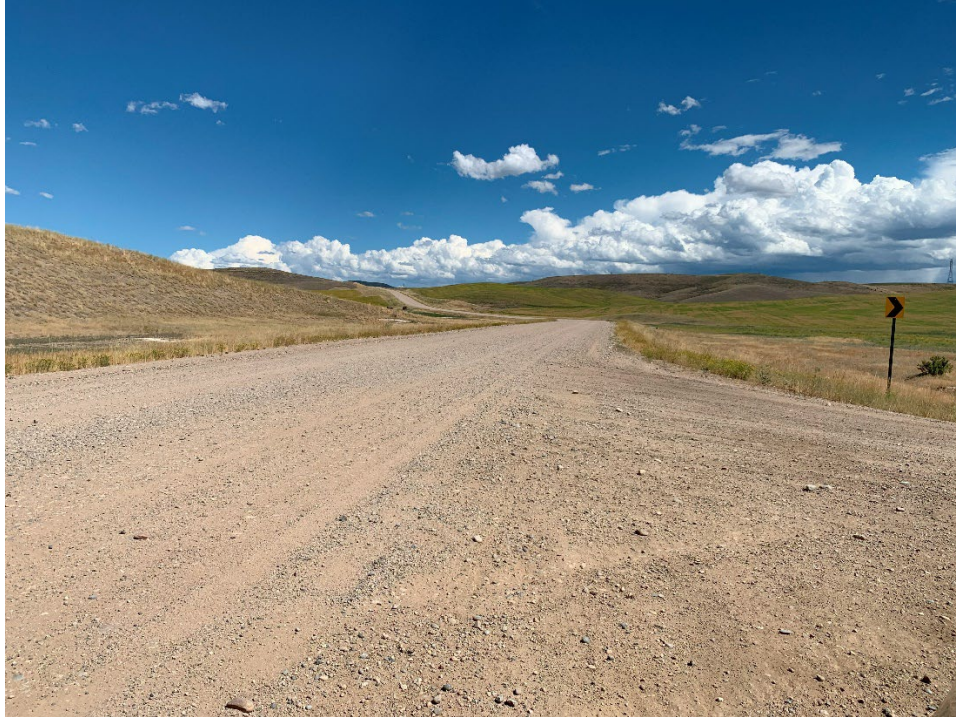
The tie-across haul road was well maintained and in good condition (photo 1).

Photo 1 – Tie-across haul road facing east.

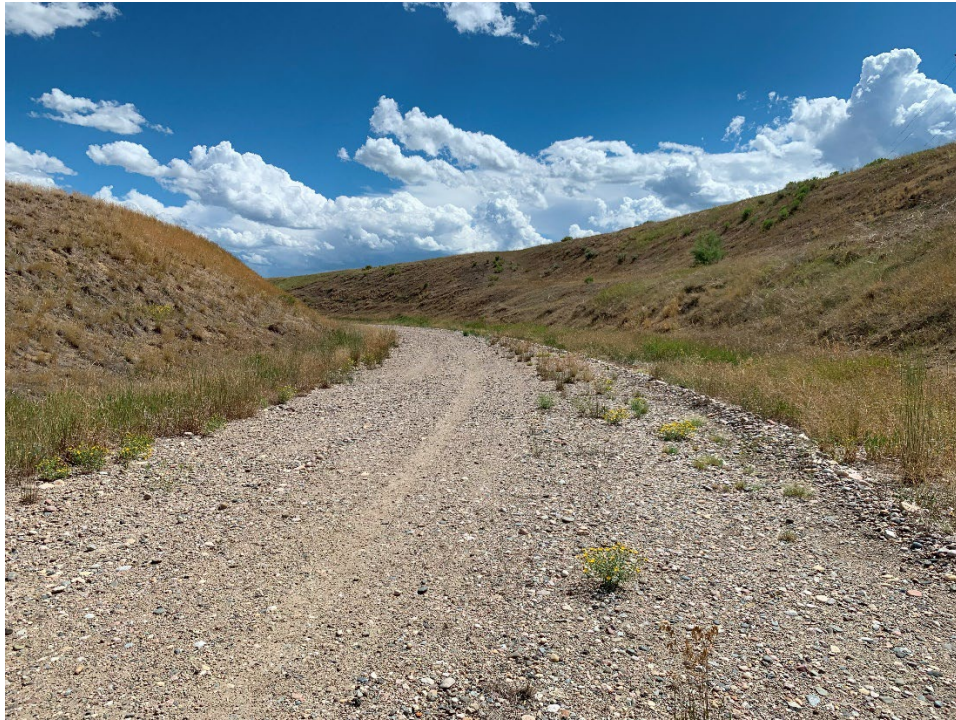
The hillsides through the cut area of the rail loop appeared to be well vegetated and stable (photo 2).

Photo 2 – Hillsides along the former train loop.

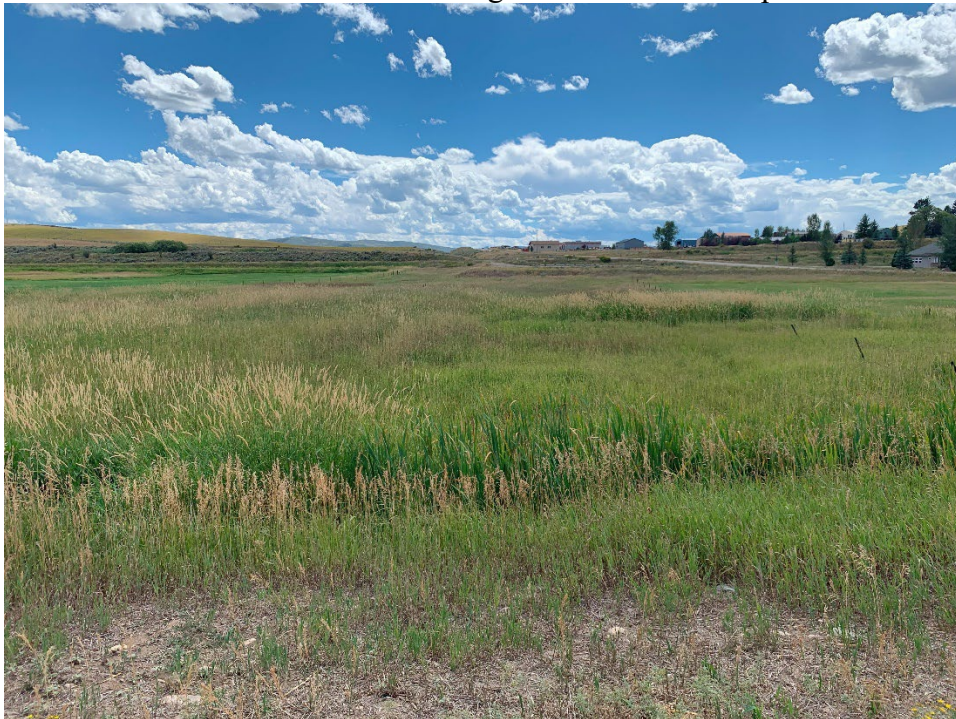
The vegetation between the trailhead parking lot and Hwy 40 is doing well (photo 3). It is well established and has matured seedheads indicating it is self-sustaining.

Photo 3 – Area of reclamation between the tailhead parking lot and the City of Hayden sewer line.
