MINERALS PROGRAM INSPECTION REPORT
PHONE: (303) 866-3567

MINE NAME: Ouray County Road 9 / Double RL Ranch	MINE/PROSPECTING ID#: M-2024-036	MINERAL: N/A	COUNTY: Ouray
INSPECTION TYPE: Illegal(Unpermitted Operation)	WEATHER: Clear	INSP. DATE: July 10, 2024	INSP. TIME: 10:26
OPERATOR: Double RL Company	OPERATOR REPRESENTATIVE: Oakley Kelly	TYPE OF OPERATION: ILL – Illegal (Possible)	
REASON FOR INSPECTION: Citizen Complaint	BOND CALCULATION TYPE:	BOND AMOUNT: NA	
DATE OF COMPLAINT: NA	POST INSP. CONTACTS: None	JOINT INSP. AGENCY: None	
INSPECTOR(S): Lucas West	INSPECTOR'S SIGNATURE:

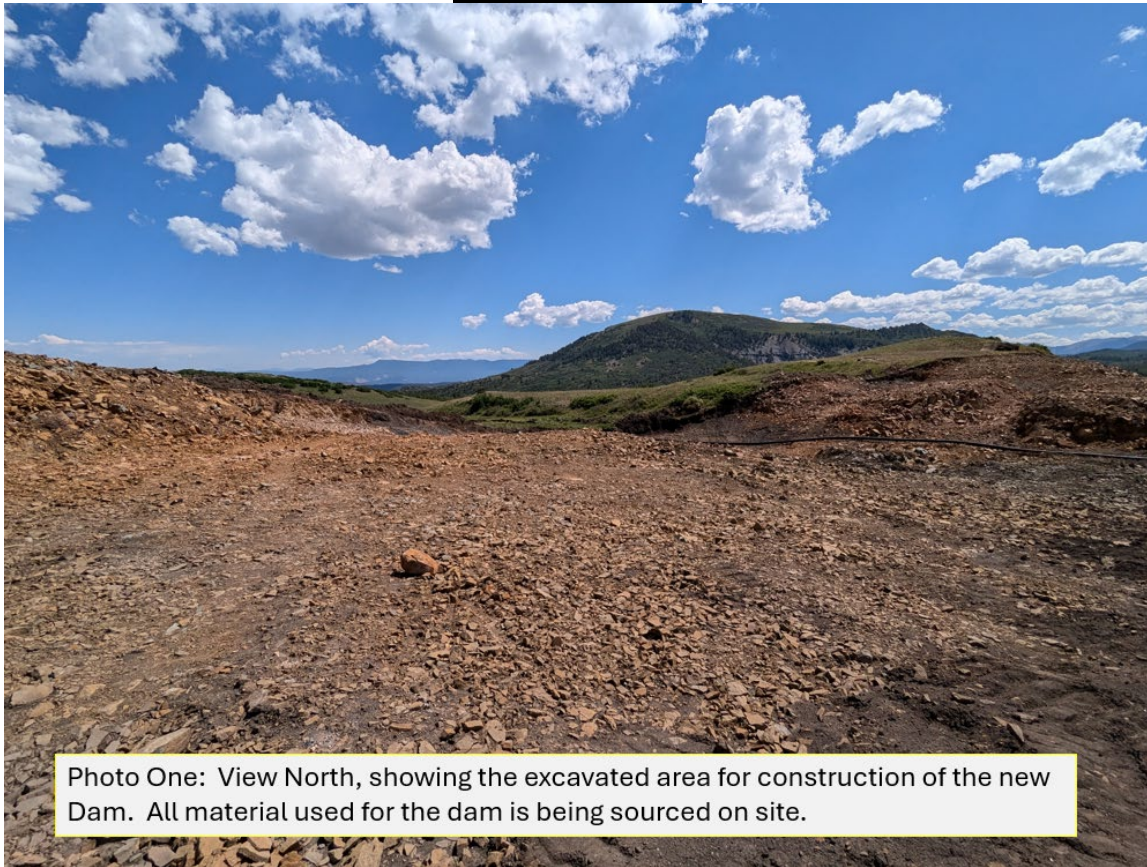
Photo One: View North, showing the excavated area for construction of the new Dam. All material used for the dam is being sourced on site.

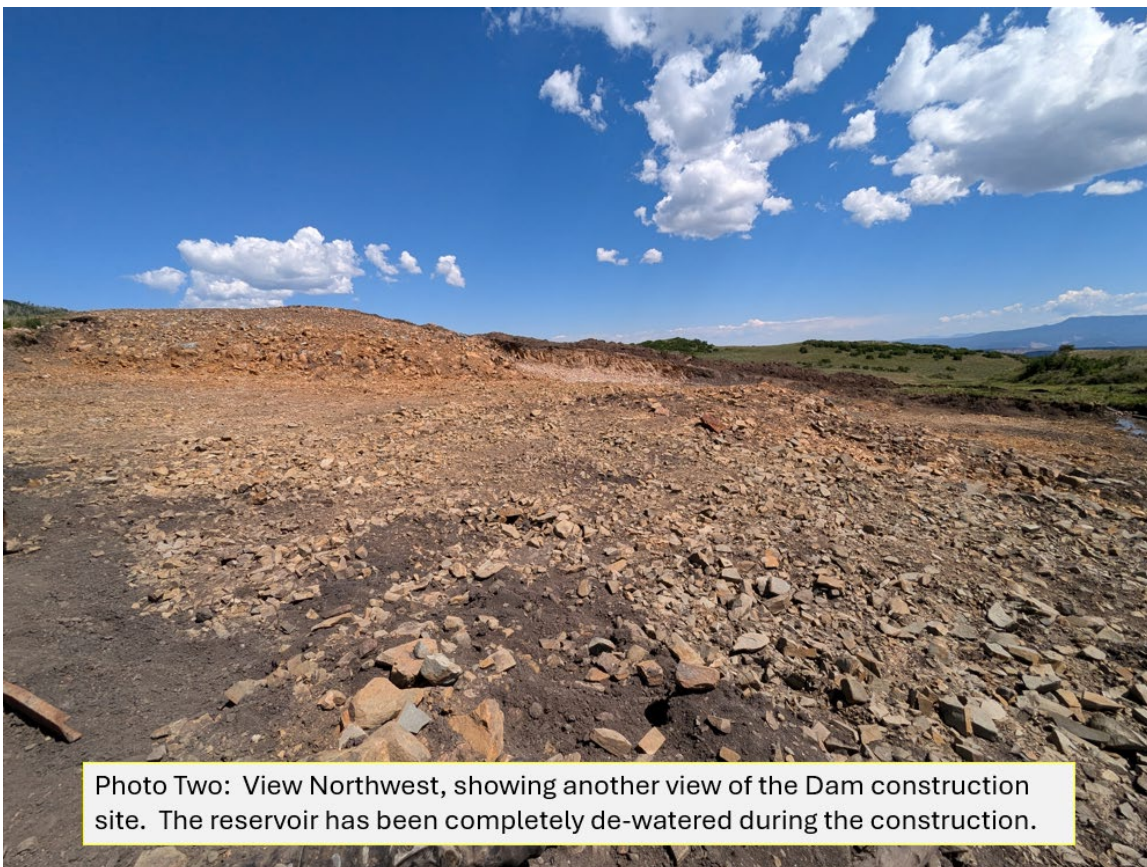
Photo Two: View Northwest, showing another view of the Dam construction site. The reservoir has been completely de-watered during the construction.

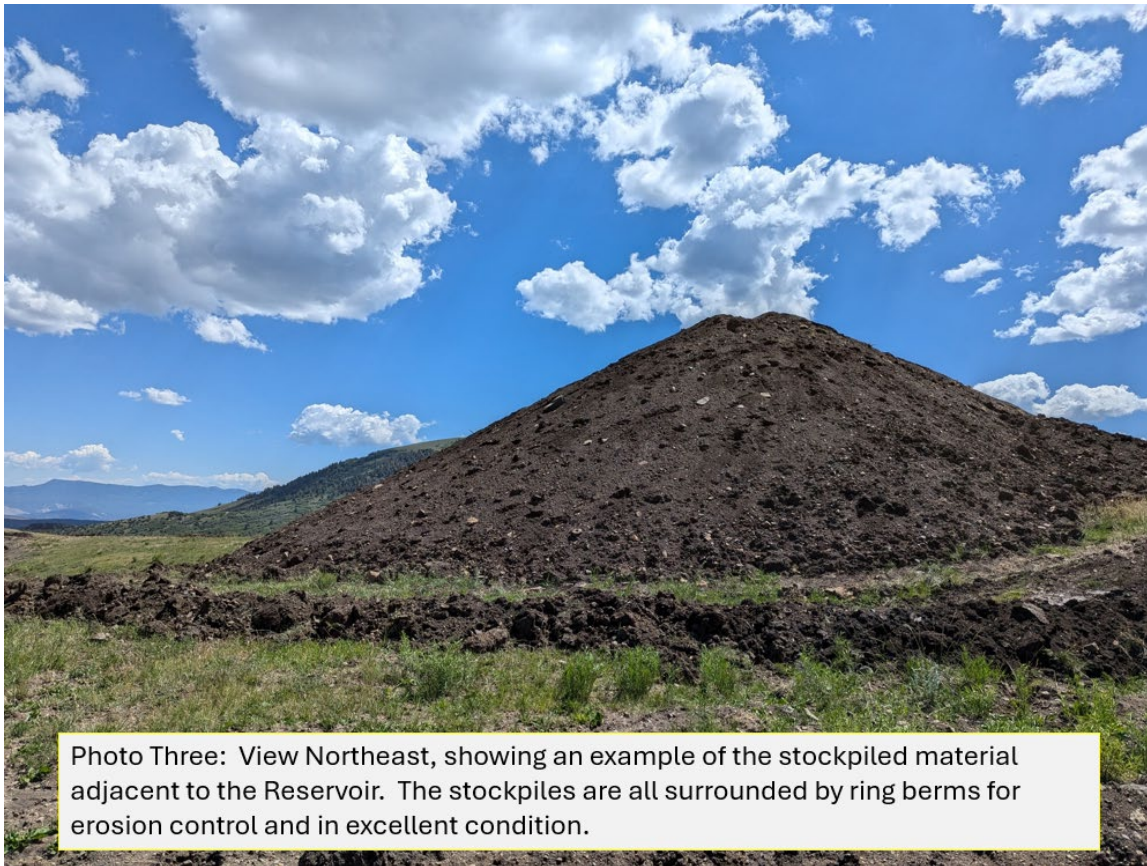
Photo Three: View Northeast, showing an example of the stockpiled material adjacent to the Reservoir. The stockpiles are all surrounded by ring berms for erosion control and in excellent condition.

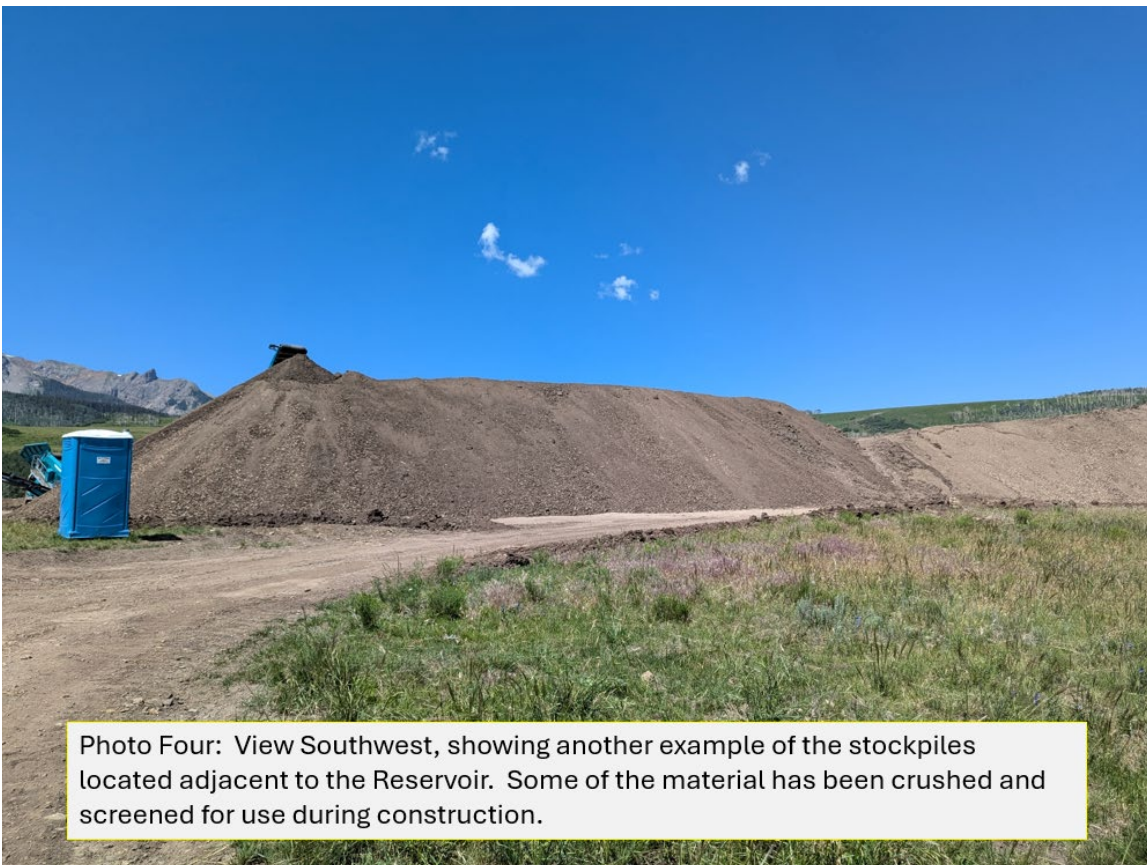
Photo Four: View Southwest, showing another example of the stockpiles located adjacent to the Reservoir. Some of the material has been crushed and screened for use during construction.

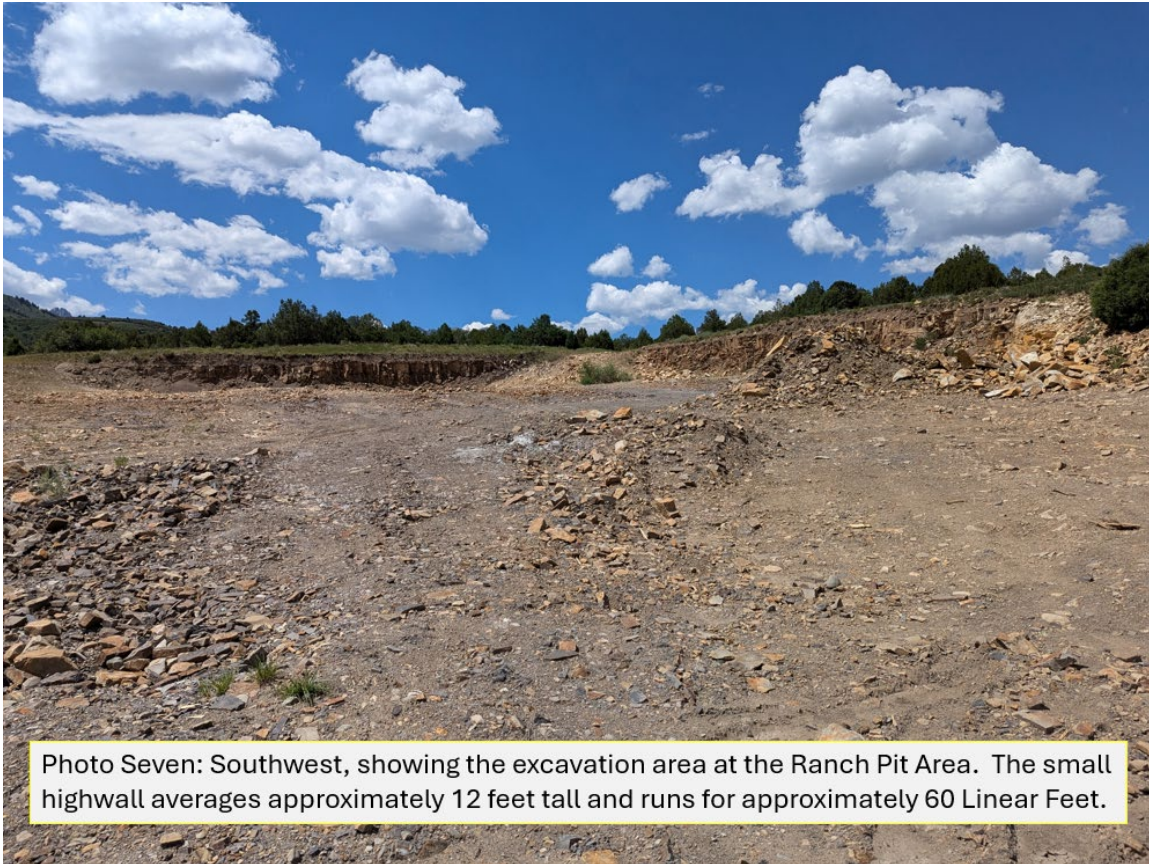
The excavation area is a small area that contains an L-shaped "highwall" that is approximately 12 feet tall and spans approximately 60 Linear Feet. The "highwall" appeared stable at the time of the inspection and no evidence of settling or sloughing was noted. Various small stockpiles of broken rock were noted around the "Highwall", but overall, the excavation area is in excellent condition. The area can be seen in Photos Seven and Eight.

Photo Seven: Southwest, showing the excavation area at the Ranch Pit Area. The small highwall averages approximately 12 feet tall and runs for approximately 60 Linear Feet.

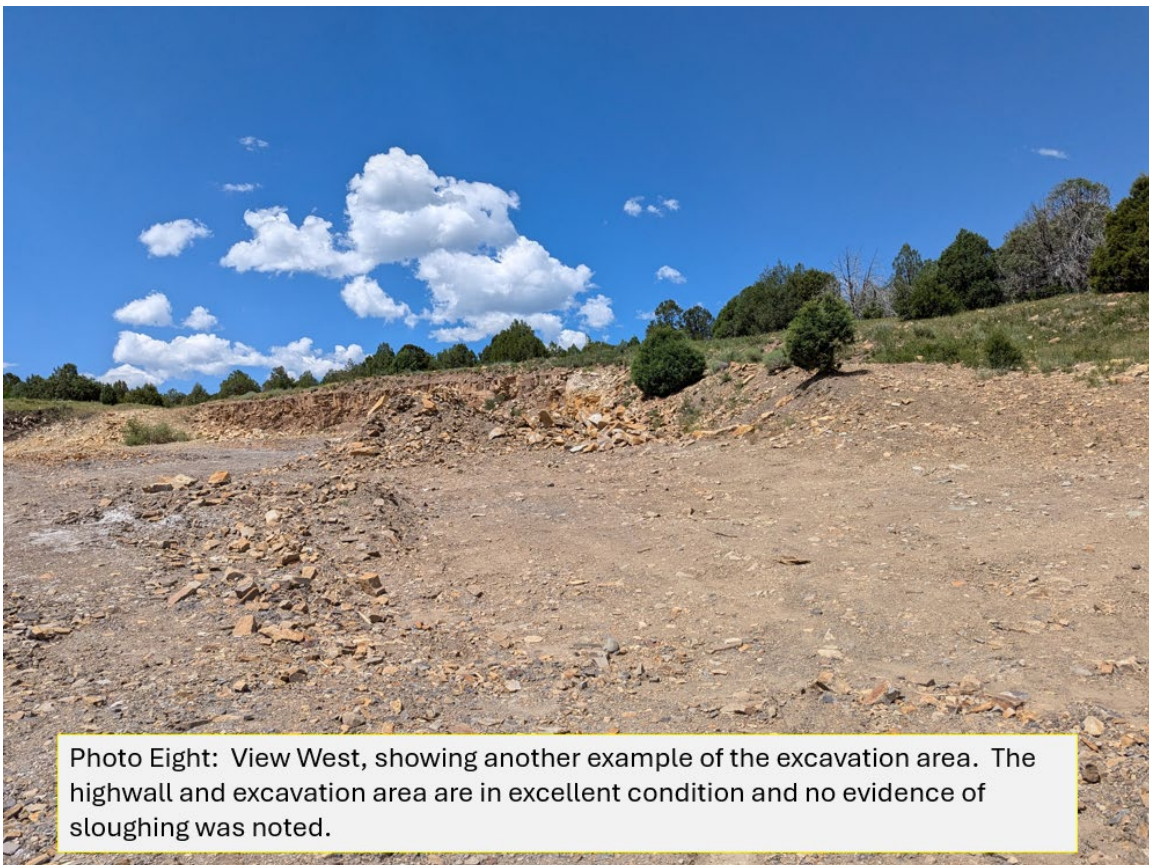
Photo Eight: View West, showing another example of the excavation area. The highwall and excavation area are in excellent condition and no evidence of sloughing was noted.
