Inspection report for Bowie #1

Permit Number: C-1981-038 Mine Name: Bowie No. 1 Mine Operator: Bowie Resources, LLC Operator Address: Mr. Basil R. Bear P.O. Box 1488 Paonia, CO 81428	County: Delta Operation Type: Underground Permit Status: Active Ownership: Private
	Operator Representative Present: Basil Bear, Ryan Wilson
Operator Representative Signature: (Field Issuance Only)

Inspection Start Date: August 28, 2024 Inspection Start Time: 12:10 Inspection End Date: August 28, 2024 Inspection End Time: 13:30		Inspection Type: Coal Partial Inspection Inspection Reason: Normal I&E Program Weather: Clear	
Joint Inspection Agency: None		Joint Inspection Contacts:	
Post Inspection Agency: None		Post Inspection Contacts:	
Inspector(s): Robert Zuber, P.E.	Inspector's Signature:

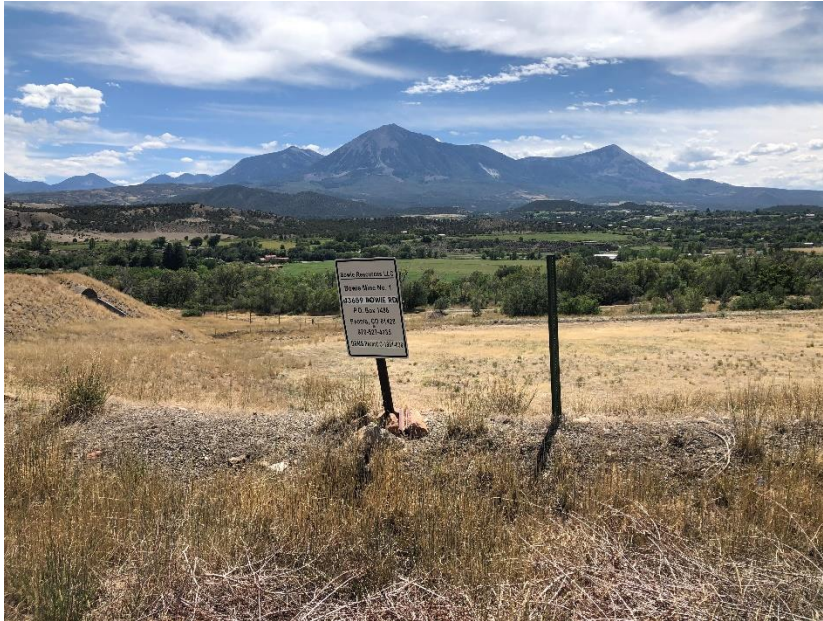
Coal Storage by Highway

No erosion or other problems were seen with the Coal Storage Area beside the intersection of Highway 133 and Black Bridge Road.

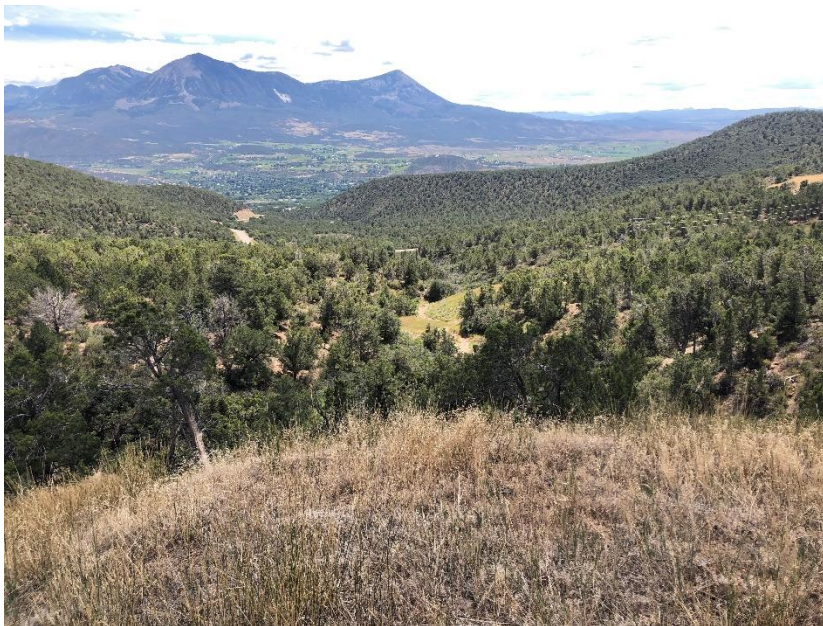
The reclamation in the area of Ponds 1, 2, 3, and 4 (East Mine) appeared to be good, as viewed from afar (the Old Waste Disposal Area).

Lower reclaimed ponds at East Mine (Ponds 3 and 4), viewed from above

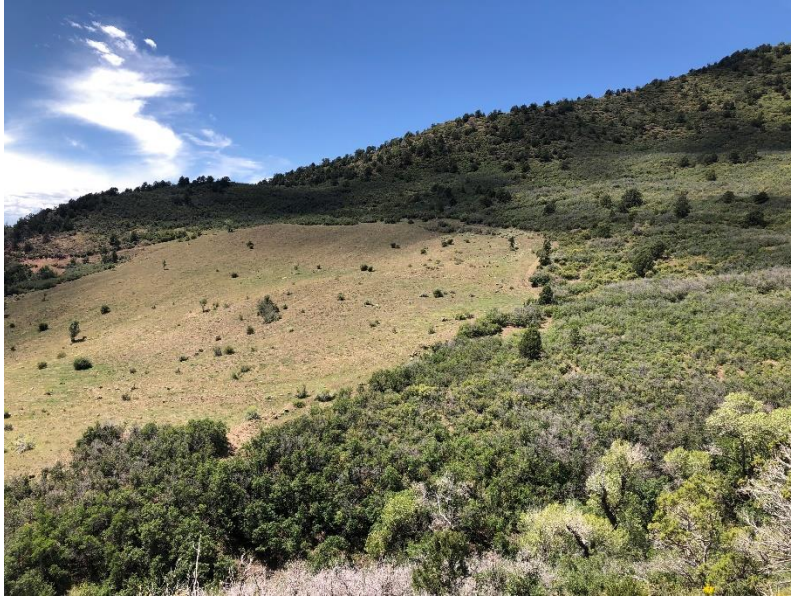
No erosion was seen at the West Mine, including the reclaimed road.

Reclaimed road at West Mine

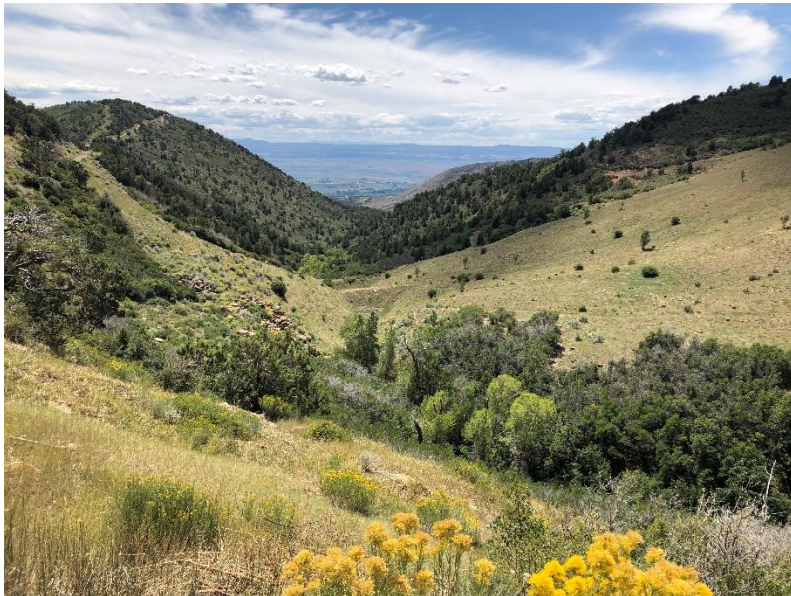
The ponds at the loadout, the Coal Storage Area (near Black Bridge Road), and the West Mine contained no water, and no problems were identified with these ponds.

Ponds at West Mine
