Bowie #2 inspection report

Permit Number: C-1996-083 Mine Name: Bowie No. 2 Mine Operator: Bowie Resources, LLC Operator Address: Mr. Basil Bear P.O. Box 1488 Paonia, CO 81428	County: Delta Operation Type: Underground Permit Status: Active Ownership: Private
	Operator Representative Present: B. Bear, K. Pitt, R. Wilson
Operator Representative Signature: (Field Issuance Only)

Inspection Start Date: August 28, 2024 Inspection Start Time: 07:00 Inspection End Date: August 28, 2024 Inspection End Time: 12:00		Inspection Type: Coal Partial Inspection Inspection Reason: Normal I&E Program Weather: Clear	
Joint Inspection Agency: None		Joint Inspection Contacts:	
Post Inspection Agency: None		Post Inspection Contacts:	
Inspector(s): Robert Zuber, P.E.	Inspector's Signature:

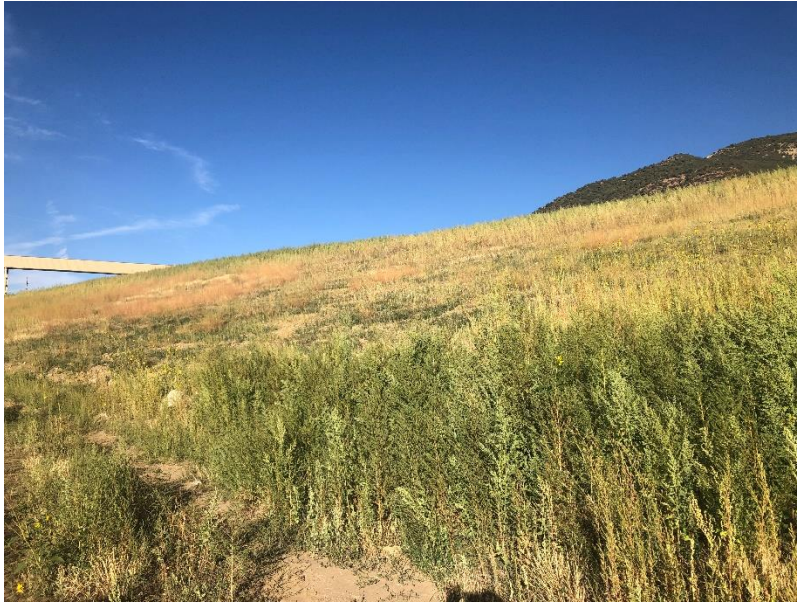
- On the west end, the depth was 36 inches.
- On the north end (towards the west), the depth was 44 inches.
- On the north end (towards the east), the depth was 43 inches.
- On the east end, the depth was 39 inches.
- On the south end (towards the east), the depth was 40 inches.
- On the south end (towards the west), the depth was 39 inches.

The slopes on Gob Pile #3 were checked at several locations (see table below), and almost all were flatter than 3H:1V. Two exceptions were on the south side. However, these slopes are only slightly steeper than 3H:1V (34% and 35%), and the measurements were on the lower portions; slopes are flatter on the higher portions. Also, another slope was measured on the south side, and this slope was much flatter than 3H:1V (13%). The Division does not find the exceptions to be a problem.

South side of Gob Pile #3

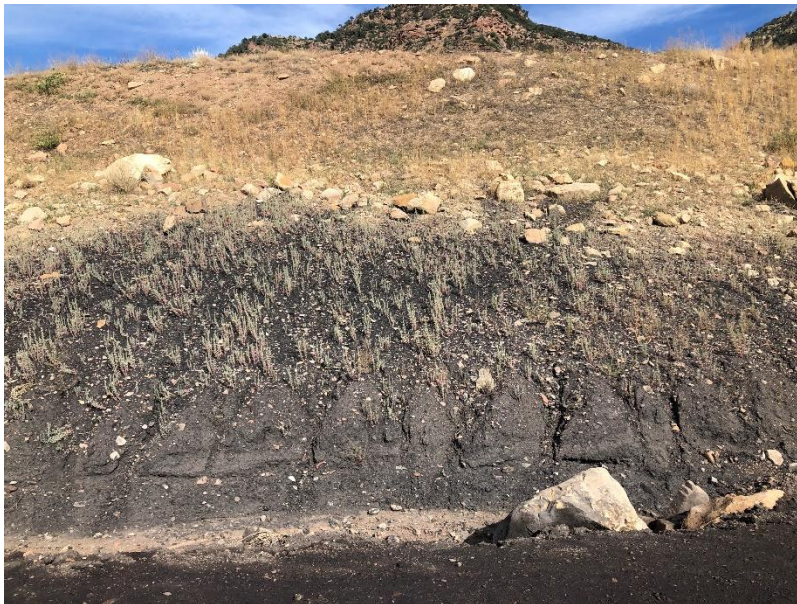
Some weeds were seen in some location: cheat grass and halogeton along the road to Gob Pile #2, mullein by Topsoil Stockpile A, halogeton at the B Portal bench, and thistle at Curve 10.

Halogeton on Gob Pile #2

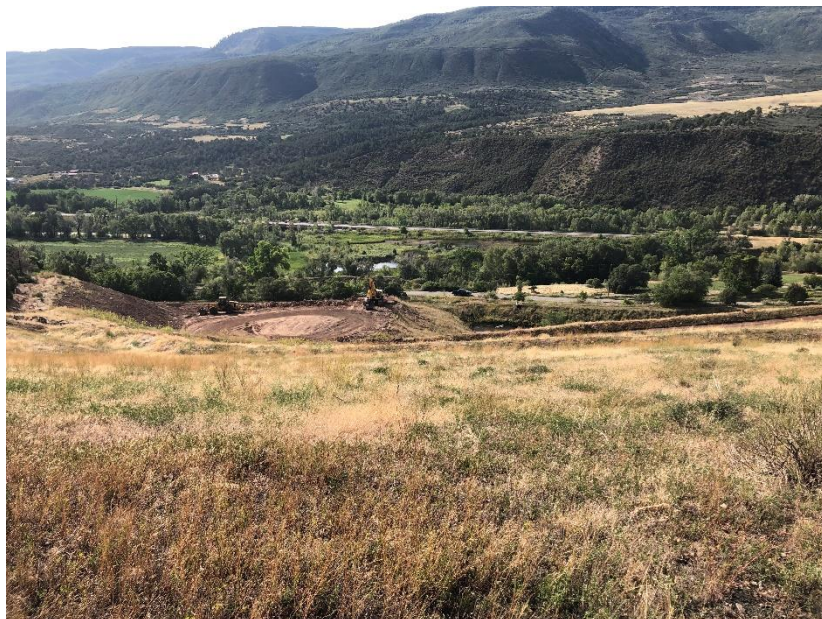
Soil pile that has been used for Gob Pile #2 reclamation

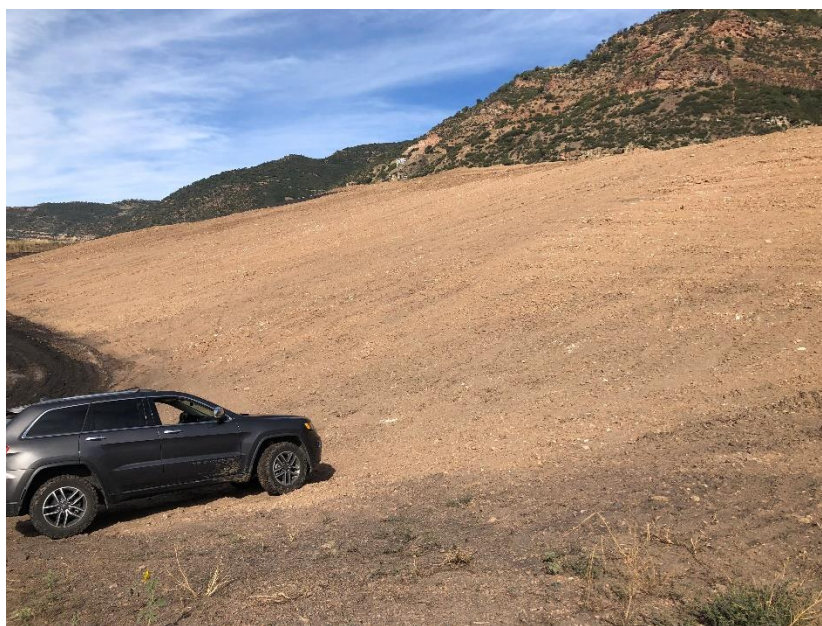
Placement of coverfill on Gob Pile #2 is still in progress. A riprap channel has been constructed on this pile, and appears to be constructed well, with large rocks (D50 greater than 12 inches) and good gradation of rock. Per BRL managers, this channel was tested by large storms in 2024, and it has held up well.

Reclamation on Gob Pile #2

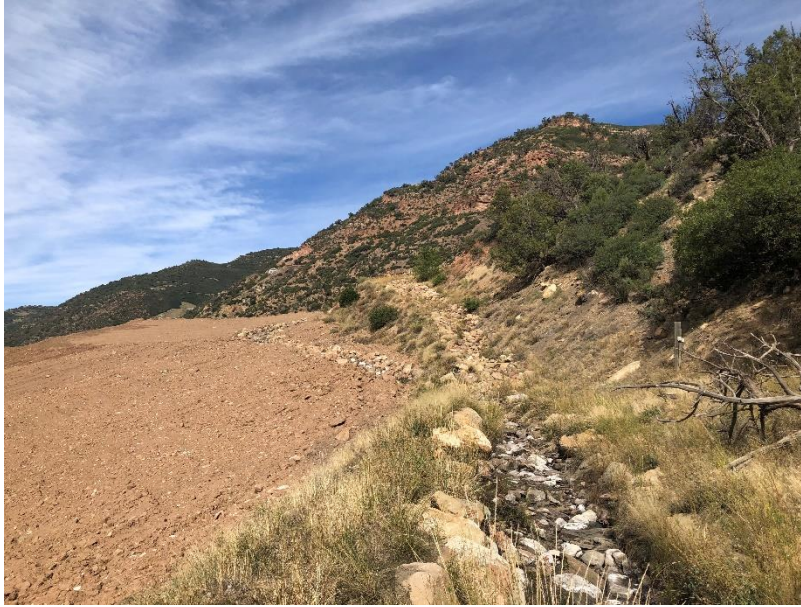
No problems were seen with the upper (flat) portion of Gob Pile #2. It is graded for water to flow to the east side and off the pile. No erosion or low spots were identified. BRL management indicated that small ditches will be cut in this area (that were removed in recent weeks by grading) and sediment control structures will be added, including rocks and silt fence made of HDPE. The previous sediment control sump was removed while the slope was graded and channel reconstructed.

Channels at east end of Gob Pile #2

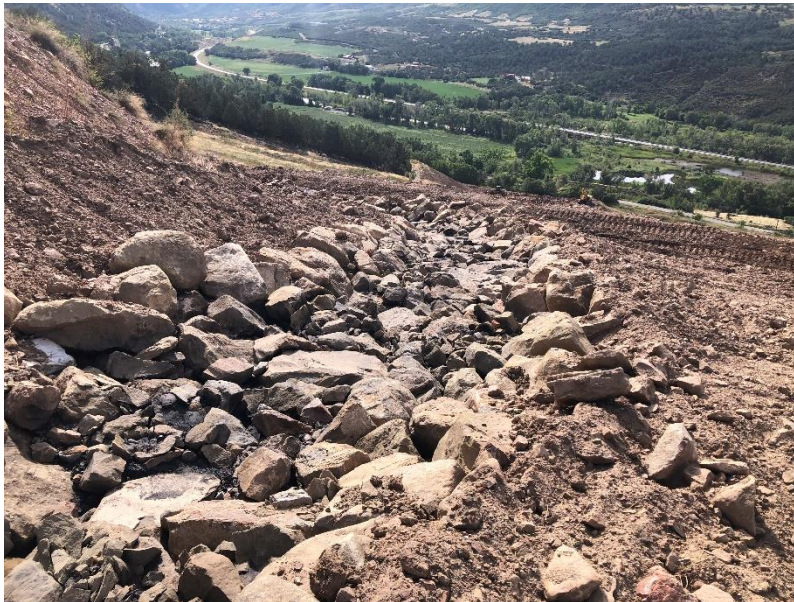
New channel on Gob Pile #2

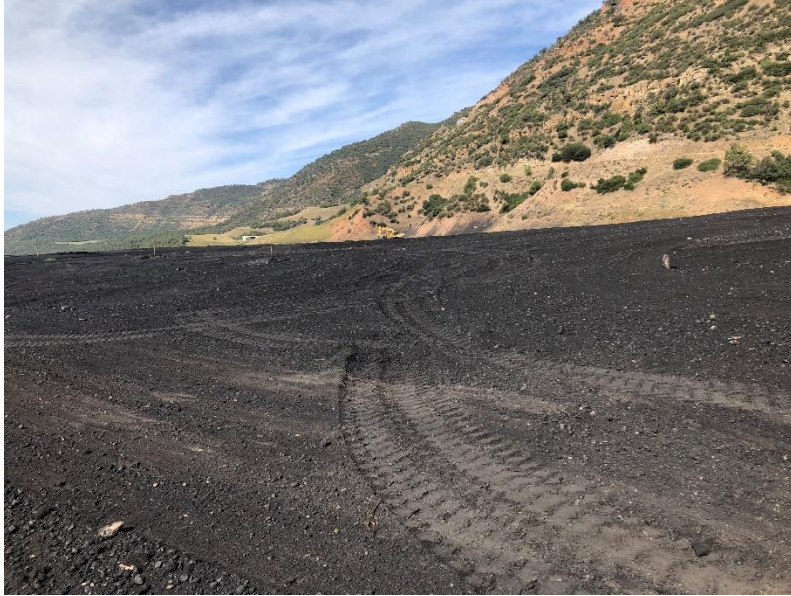
Upper portion of Gob Pile #2

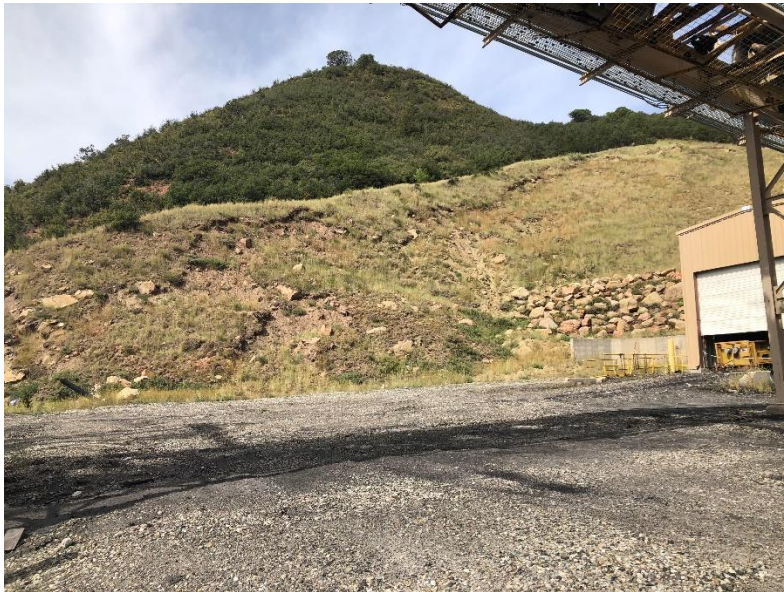
No problems were seen on the slopes above and below the benches. The slides above the B Portal Bench and Curve 11 (noted in the past) look stable. The slide above Curve Number 10 appears to have not moved a large amount since June. This is an ongoing project for BRL.

West slope above B Portal bench

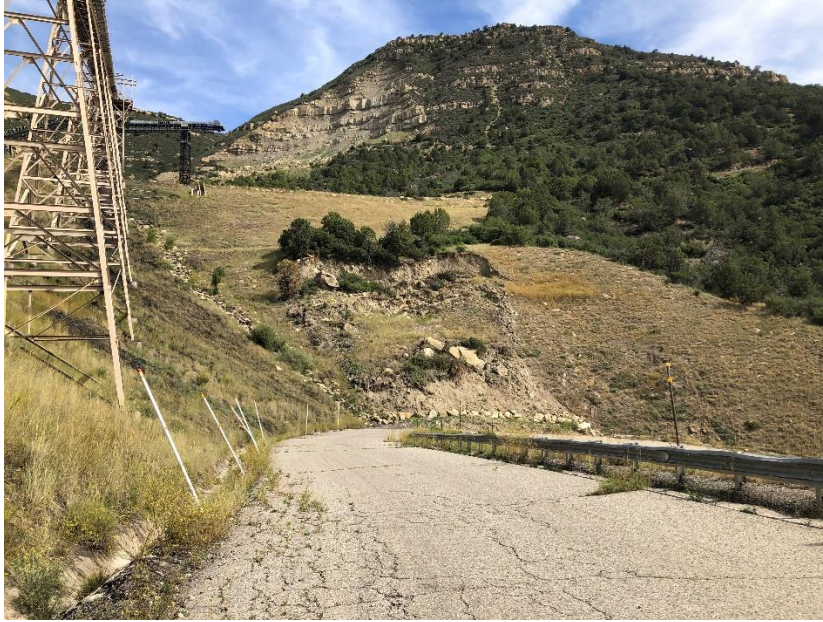
The road to the portals was in adequate condition. The slopes adjacent to this road are generally stable, except for the slide at Curve 10 (see Slides and Other Damage section).

Slide at Curve 10

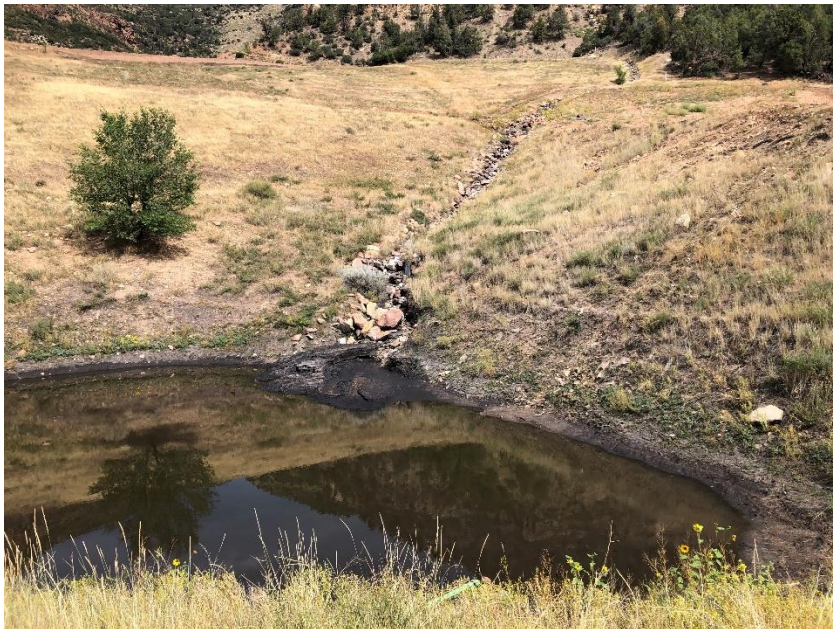
A delta of sediment was seen at the eastern inlet to Pond F (northeast corner), which is to be expected given the dirt work at Gob Pile #2. The elevation differences between the approximate sediment levels of the two ponds and the emergency spillways were measured with a laser device. Both ponds appear to have sufficient capacity with the measurements being ten feet or greater.

Sediment delta at inlet to Pond F
