MINERALS PROGRAM INSPECTION REPORT
PHONE: (303) 866-3567

MINE NAME: Legacy	MINE/PROSPECTING ID#: P-2023-017	MINERAL: Gold and rare earths	COUNTY: Moffat
INSPECTION TYPE: Monitoring	WEATHER: Clear	INSP. DATE: August 19, 2024	INSP. TIME: 15:00
OPERATOR: Legacy Mining LLC	OPERATOR REPRESENTATIVE: Cheryl Monger	TYPE OF OPERATION: MP - Mineral Prospecting	
REASON FOR INSPECTION: Normal I&E Program	BOND CALCULATION TYPE: Partial Bond	BOND AMOUNT: \$10,000.00	
DATE OF COMPLAINT: NA	POST INSP. CONTACTS: None	JOINT INSP. AGENCY: None	
INSPECTOR(S): Hunter Ridley	INSPECTOR'S SIGNATURE:

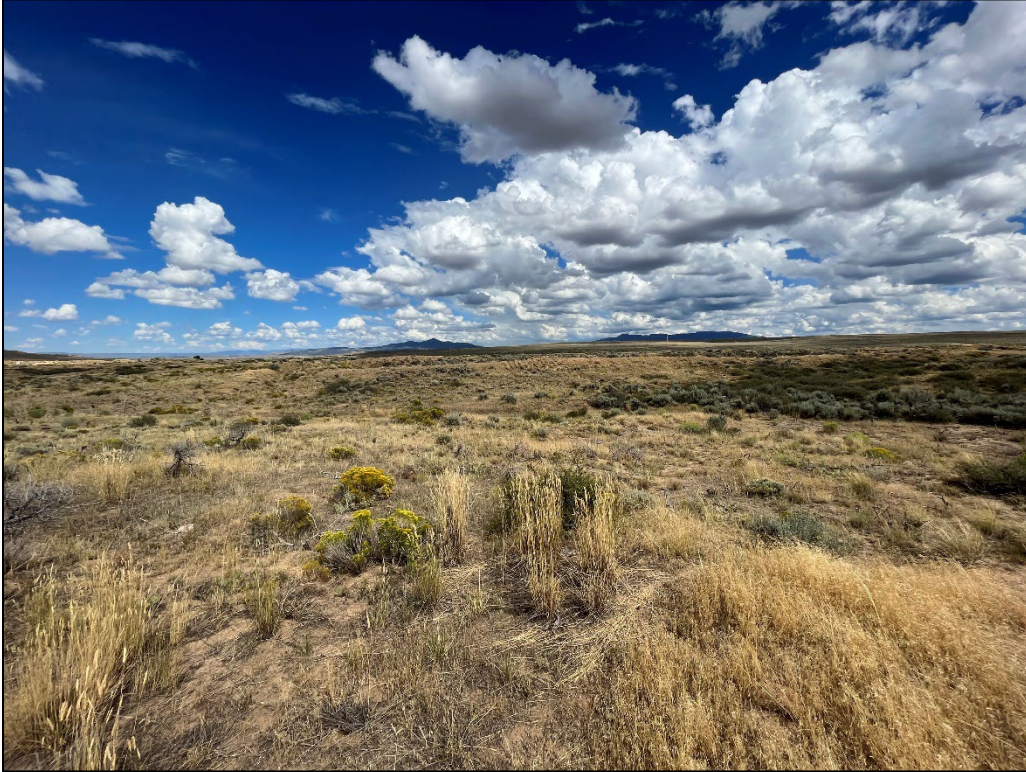
Revegetation: Current vegetation on this undisturbed site is usual rangeland habitat which includes cacti, rabbitbrush, sagebrush, wheatgrasses, etc. (Photo 1).

Photo 1: Area of representative vegetation and topography of where test pits will eventually be dug.
