MINERALS PROGRAM INSPECTION REPORT
PHONE: (303) 866-3567

| MINE NAME: Lyster Pit | MINE/PROSPECTING ID#: M-2008-009 | MINERAL: Sand and gravel | COUNTY: Moffat |
| INSPECTION TYPE: Monitoring | WEATHER: Clear | INSP. DATE: August 21, 2024 | INSP. TIME: 09:00 |

Lyster Pit M-2008-009 - Hydrology Report

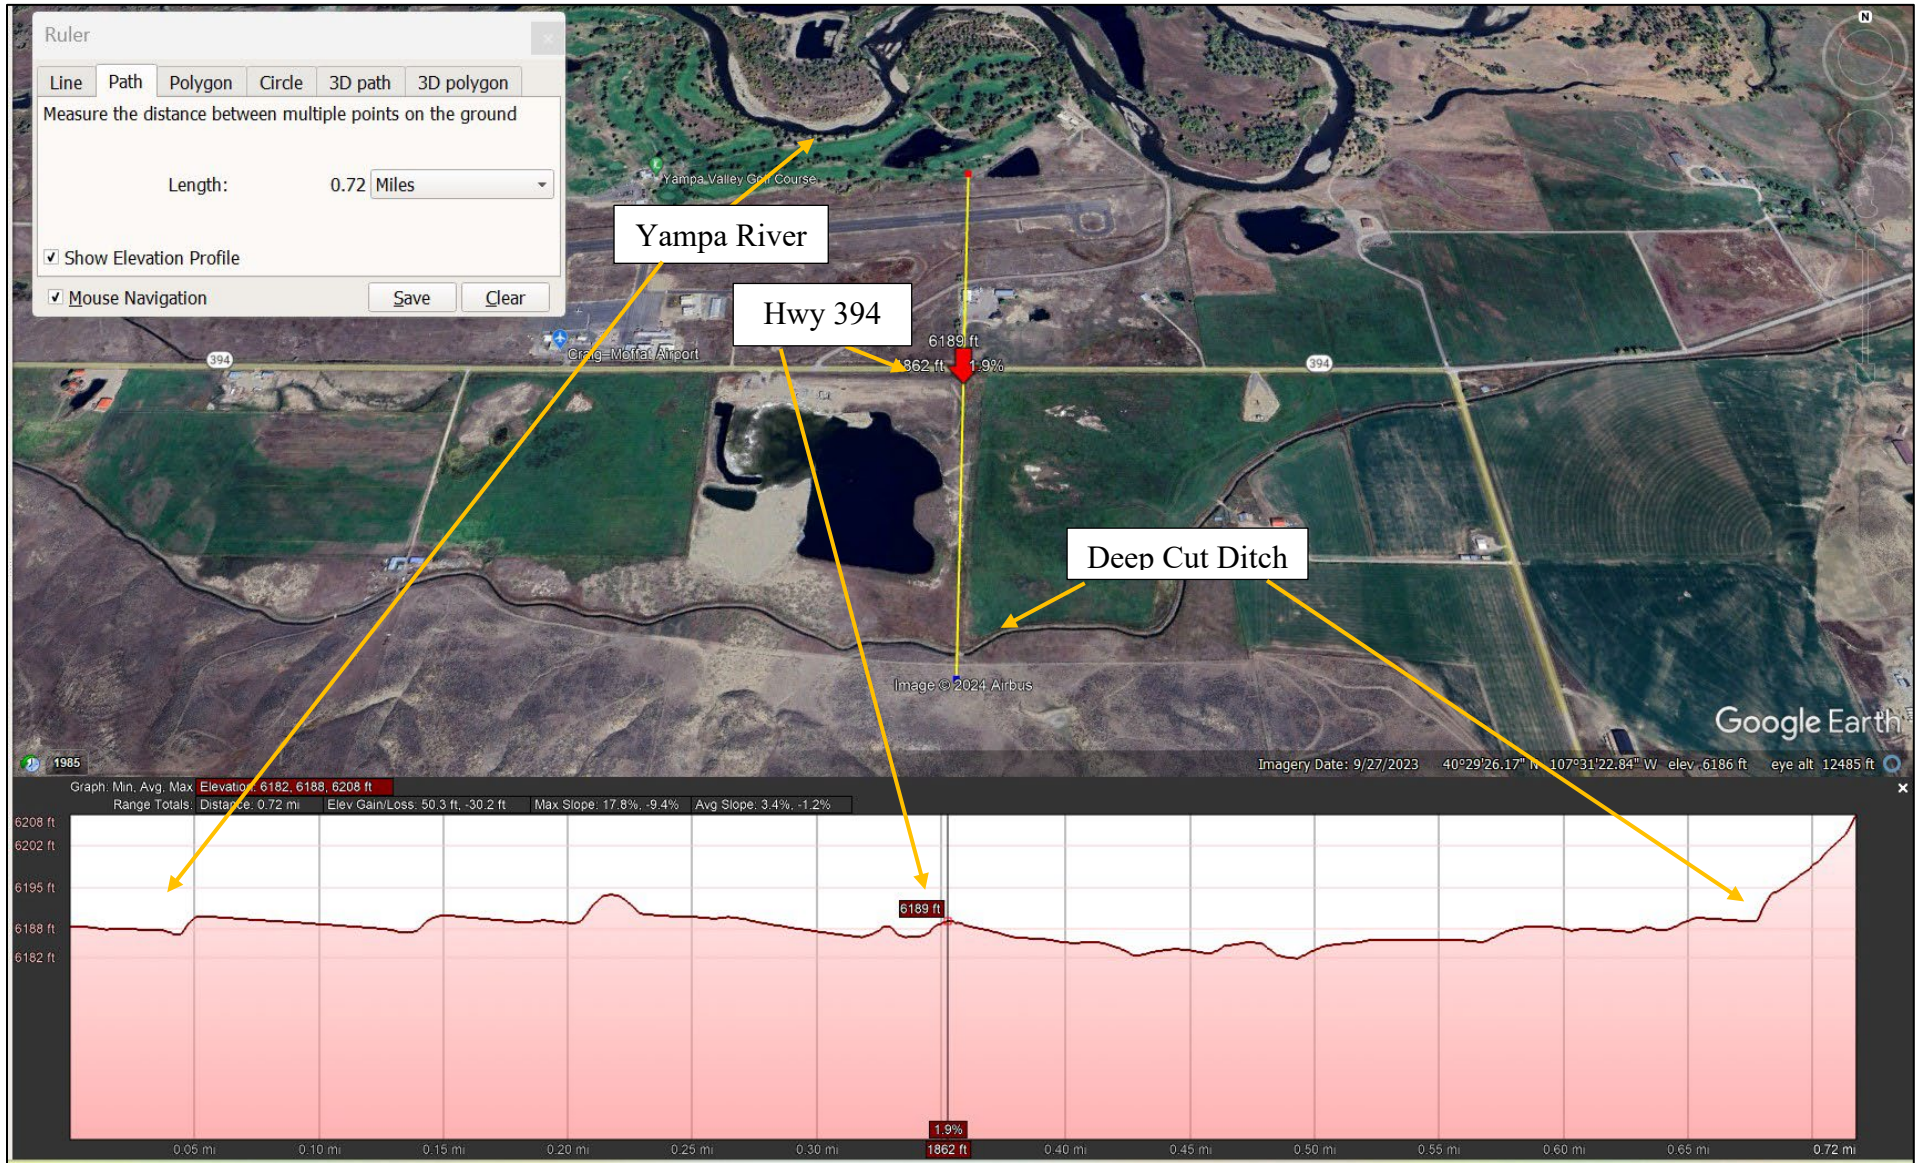
An elevational cross section of the mine site and surrounding area was extracted using Google Earth software (Figure 3). This figure shows the elevational profile of the land beginning from the Yampa River and ending at the southernly foothills in the area. This cross section suggests that the area in which the mine site and Mr. Ocker property is located acts effectively as a large basin which captures surface water runoff from the southernly foothills towards Hwy 394 where the elevational profile rises sharply. Hwy 394 has been built up higher from the adjacent topography, likely to protect the road from flood conditions. A ditch is also located along Hwy 394 and carries water under the Hwy and out towards the river. This built-up road feature effectively acts as a barrier to surface water flows heading from the southernly foothills, across the mine and Mr. Ocker's property, and towards the river. During the inspection, it was noted among the Division, the Operator, the mine site landowner, and complainant that while digging the two ditches east of the mine site slightly deeper would help with the movement of stormwater during saturated conditions, the elevation of the Hwy 394 ditch limits this activity and thus exacerbates saturated conditions in times of excess stormwater.

Figure 3: Elevational cross section data north to south (left to right) encompassing the southerly foothills towards the Yampa River. The red arrow represents the elevational location of Hwy 394 within the cross section.

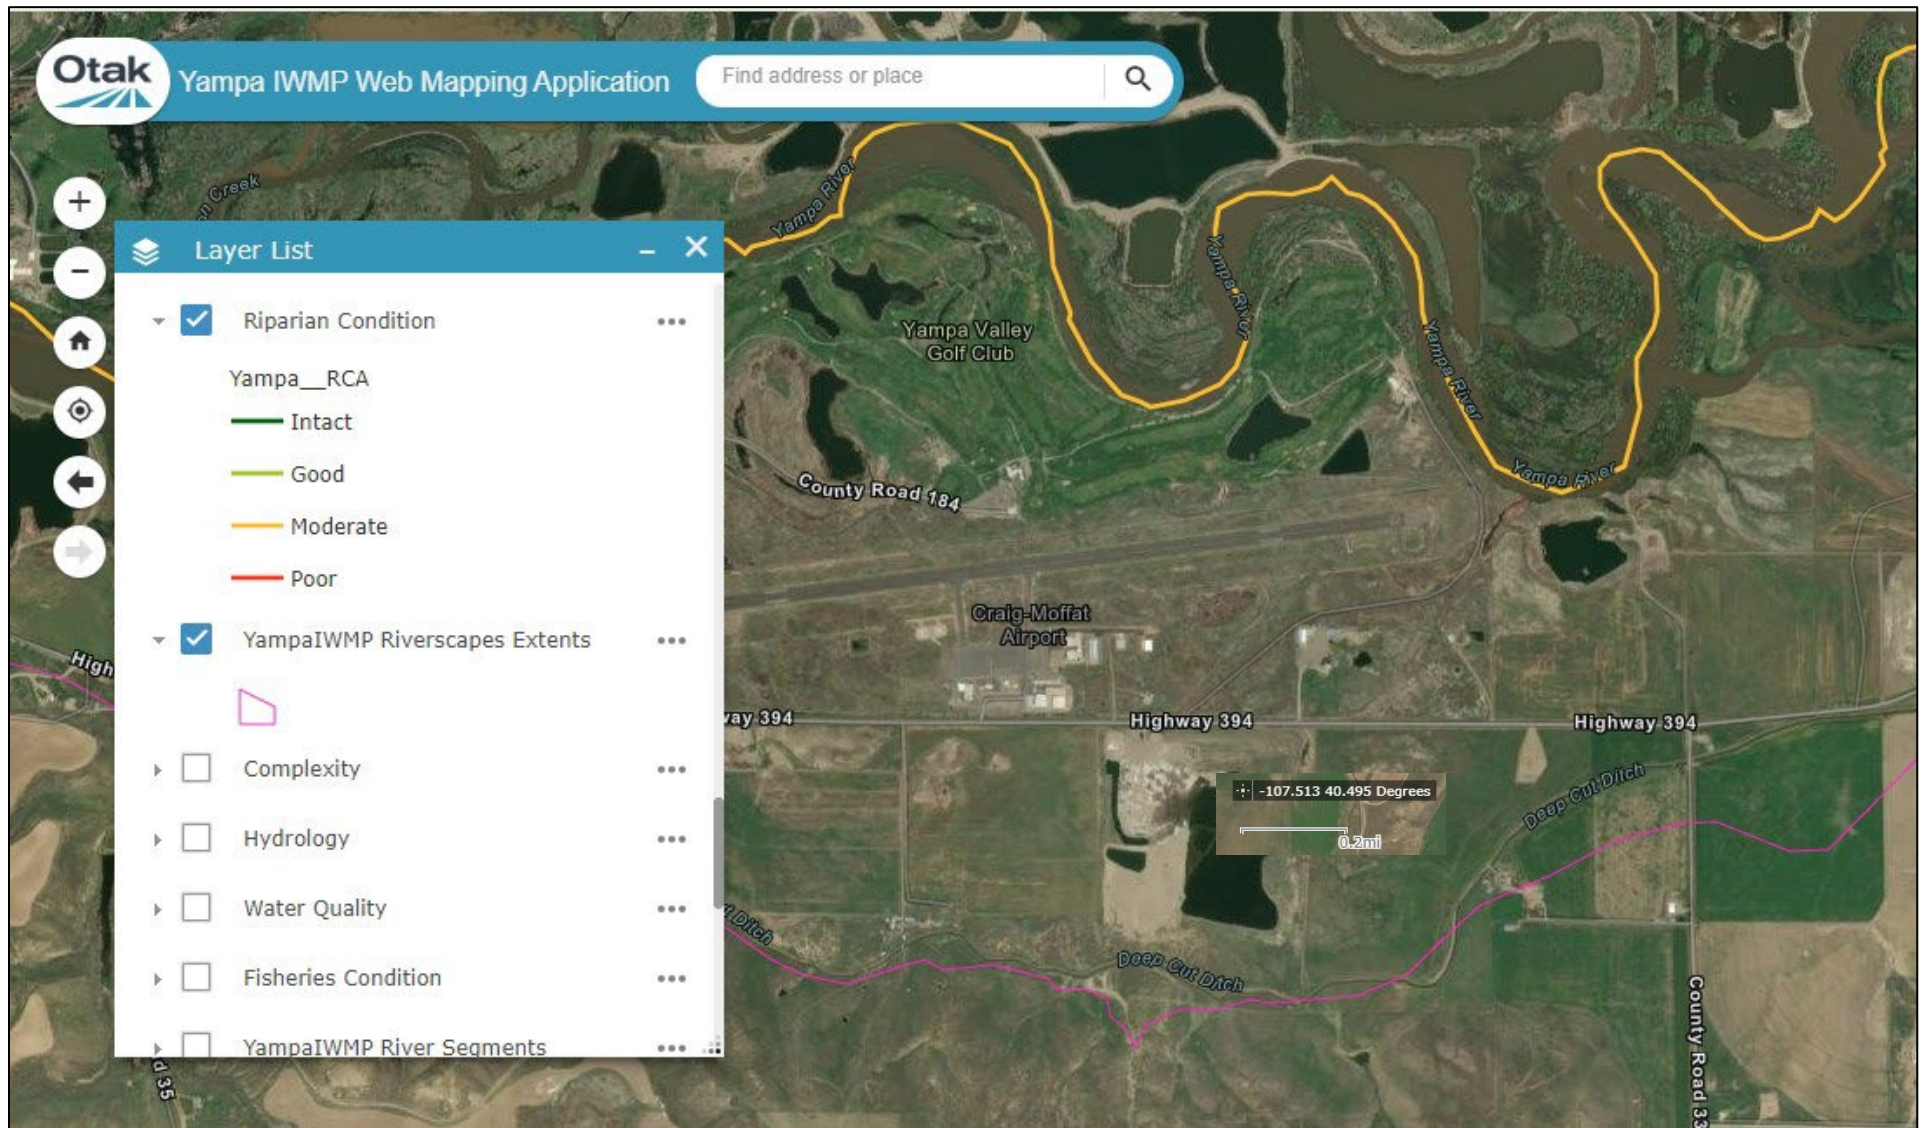
In the absence of widely available floodplain mapping data in this portion of the State, the Division has located a GIS-based tool formulated by Yampa White Green Basin Roundtable (YWGBR). This group is a combination effort from those work and live in the Yampa Valley to develop an Integrated Water Management Plan (IWMP) for the Yampa River. The YWGBR has used engineering and ground-based data assessment to more accurately characterize the physical and biological traits of the Yampa River Basin. OTAK is the environmental consulting group working in support of this project. As part of this effort, the YWGBR supports the display of these assessments through a GIS-based virtual web map application. A screenshot from this web mapper is shown below in Figure 5. Two colored lines are shown on this Figure. The yellow line layer has been toggled on to outline the midpoint line of the Yampa River. The pink line represents the 'Yampa IWMP Riverscapes Extents'. In this context, a riverscape defines an area within a river's alluvial plain whose hydrology is directly controlled by the river itself. Riverscapes are often characterized by flat or gently sloping topography, much like the area of Mr. Ocker's property and the mine site. This pink line feature shows that the extent of the Yampa River riverscape in this particular area extends all the way south towards the foothills located south of the mine site and Mr. Ocker's property. This further suggests that groundwater levels and conditions are predominantly

and directly influenced by the Yampa River and its natural fluctuation of water levels rather than by nearby mining activity.

Figure 3: Screenshot from the Yampa White Green Basin Roundtable's Web Mapping Application.

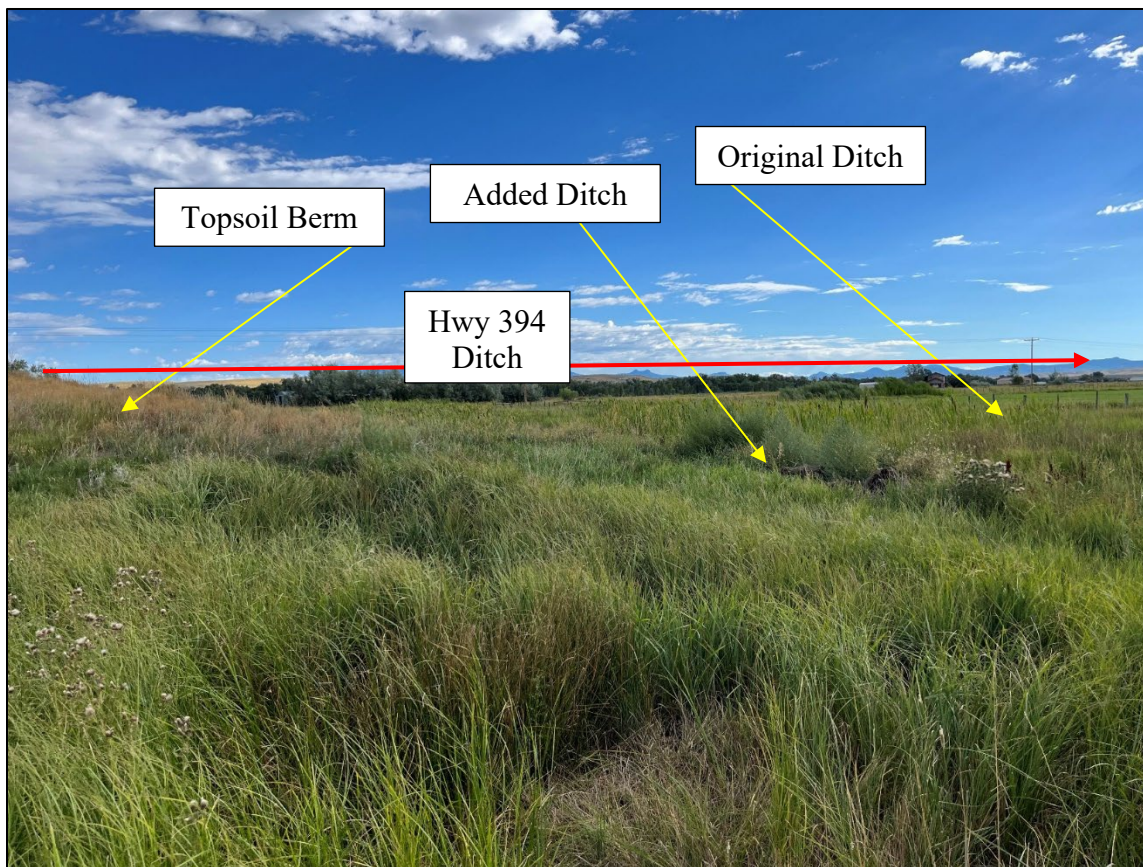
The northeastern corner of the released permit boundary and the northwest corner of Mr. Ocker's property was the area investigated during this inspection (Photo 1). This area was never disturbed by mining operations but was part of the permitted operation's acreage. General topography of the surrounding area is a very gradual slope northwest towards the river from the more southernly foothills. There is a pre-existing ditch located along the property line fence, which was in place prior to the permitting of the mine site. In the fall of 2023, Mr. Ocker and the mine site landowner Chris Martin installed another ditch parallel to the original ditch (Photos 1, 4, and 5; Figure 2) with the intent of encouraging stormwater flows towards the ditch located along Hwy 394. This added ditch curves around the eastern side of the topsoil berm and towards the Hwy 394 ditch (Figure 3 and Photo 1). At the time of inspection, the northern end of this ditch was heavily vegetated with cattails and other grassy debris (Photo 4). Three groundwater monitoring wells are located in and around the mine site and began being monitored by the original permittee a few months before the site's permitting in 2008 (Figure 2). At the very southern extent of both Mr. Martin and Mr. Ocker field's is the Deep Cut Ditch. The Yampa River is located ~0.5 mile north of the Lyster Pit's northern permit boundary (Figure 3).

At the time of the inspection, the northeast corner area under investigation was not saturated with water. Mr. Ocker stated that his adjacent field was not experiencing any excess of water this year but stated that this area had experienced saturated conditions in years prior. Dewatering of the adjacent Lyster Pit mine site has been occurring off and on throughout the life of the mine but was last conducted at the site in April of 2024. As a result, the surrounding area has likely experienced artificially low groundwater levels in times of dewatering. As dewatering ceases and groundwater in the area slowly begins to recharge, the natural state of high groundwater levels can be expected to reestablish.

Photo 1: View northeast of the area of concern which has seen prior stormwater saturation. The edge of the topsoil berm is visible to the west.

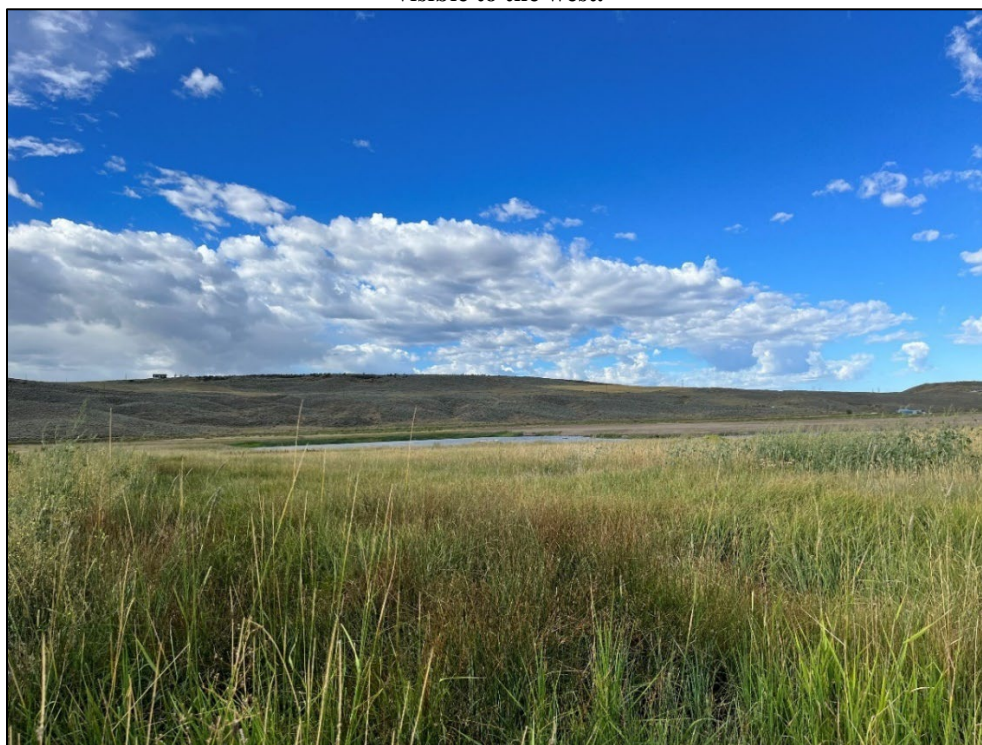
Hydrologic Balance: As per the approved reclamation plan, a groundwater pond has been created in the eastern half of the released permit area. The pond and surrounding vegetated area (37.10 acres) were approved to be released by the Division under AR-2 and were observed to still be well vegetated and stable (Photo 2). The pond was not at full capacity but contained exposed groundwater at the time of inspection. Since this is an unlined pond feature which is approved to expose groundwater, the water level of the pond is generally representative of surrounding groundwater levels. A topsoil berm is located in the northeastern portion of the released acreage and is well vegetated. The edge of this berm begins ~85 feet from the western boundary of Mr. Ocker's field and continues along the edge of the permit boundary and Hwy 394 until it reaches the mine site entrance gate (Figure 4). The berm is a surface feature and is not a barrier to groundwater flows. The groundwater pond located to the southwest of the saturated water area is unlined. Thus, with no slurry wall or clay liner to impede groundwater flows, the pond does not create a barrier to groundwater flows.

Photo 2: View southwest of the exposed groundwater pond in the released area of the permit.

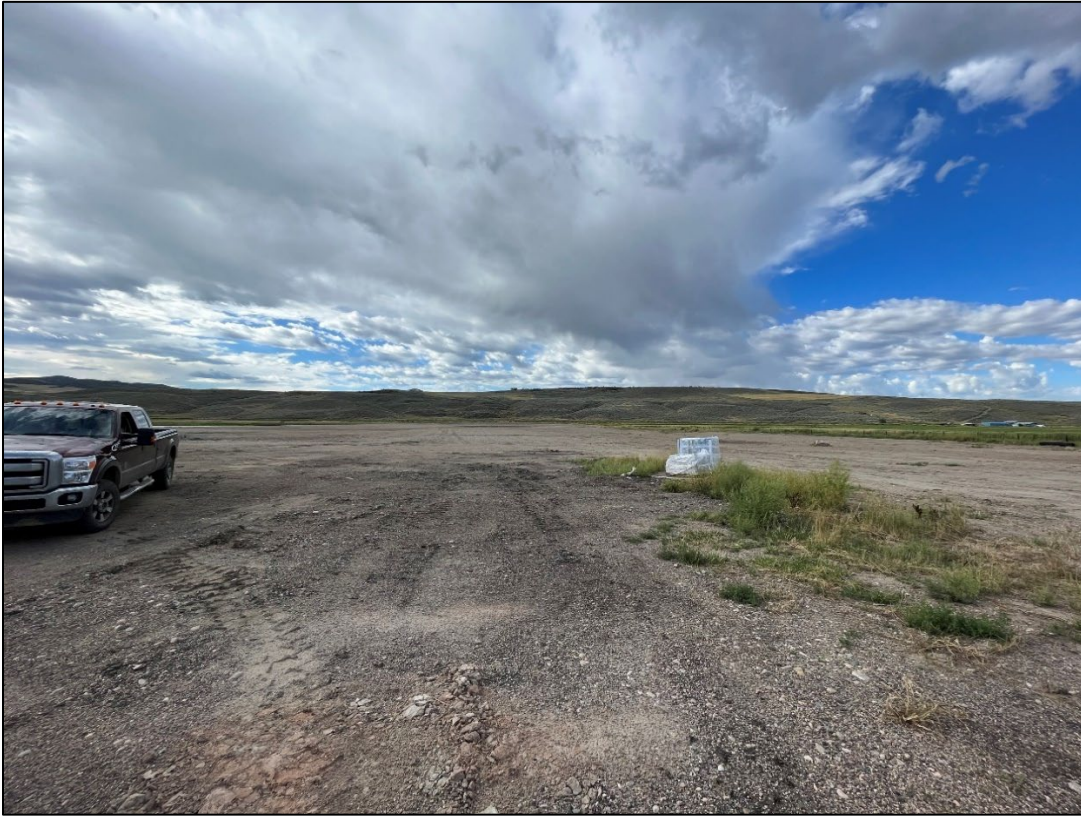
contains a smaller graded pond adjacent to the larger, released groundwater pond. This smaller pond is not currently approved as part of the mine's reclamation plan. If the intention is for this feature to remain in final reclamation, a technical revision will be necessary to update the Exhibit F Reclamation Plan to show the smaller pond remaining and update Exhibit G Water information to account for increased acreages of exposed groundwater.

Photo 3: View south of the graded, unreleased permit area.

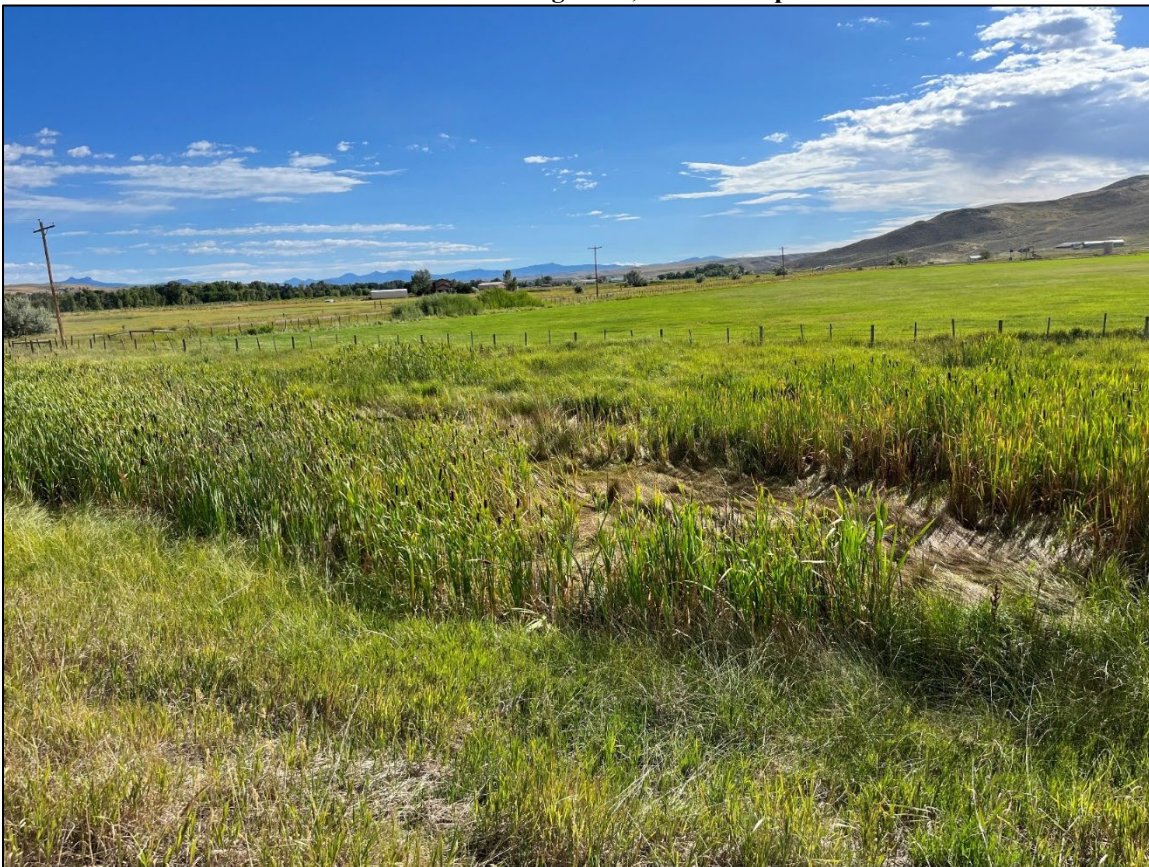
Photo 4: View northeast of the ditch installed by Mr. Ocker and the landowner Mr. Martin.

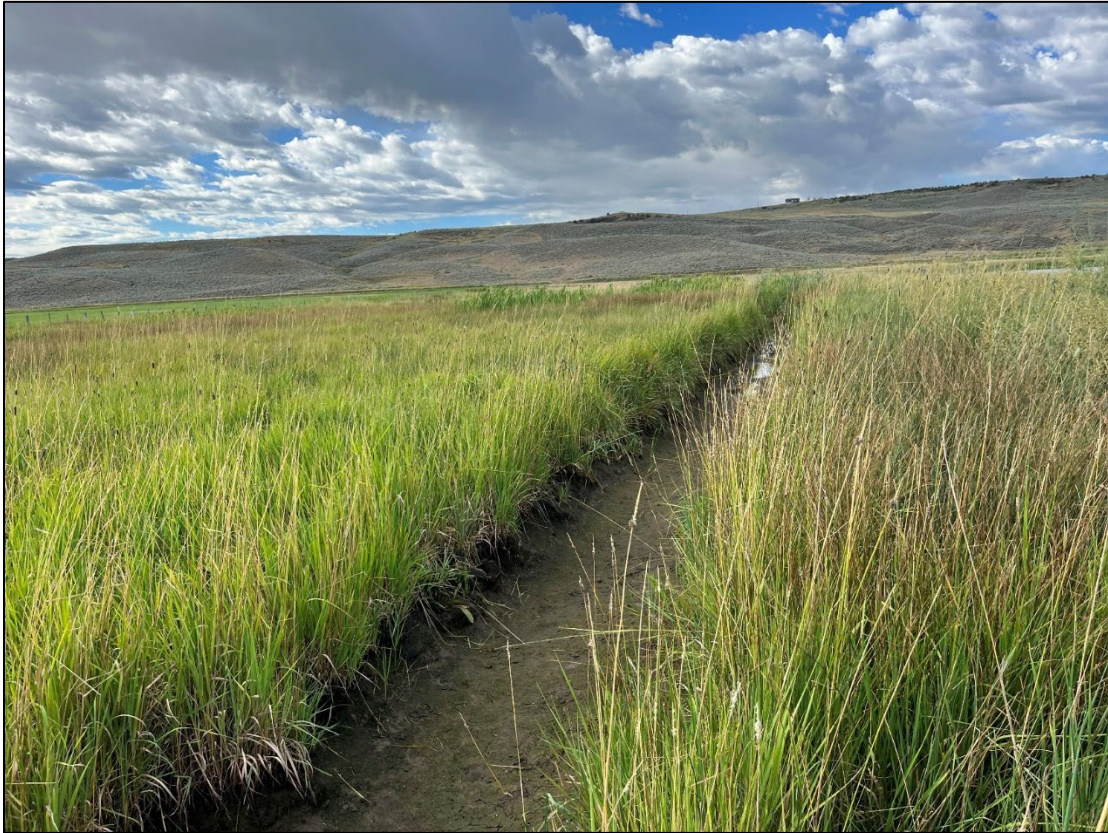
Photo 5: View south of the ditch installed by Mr. Ocker and the landowner Mr. Martin.

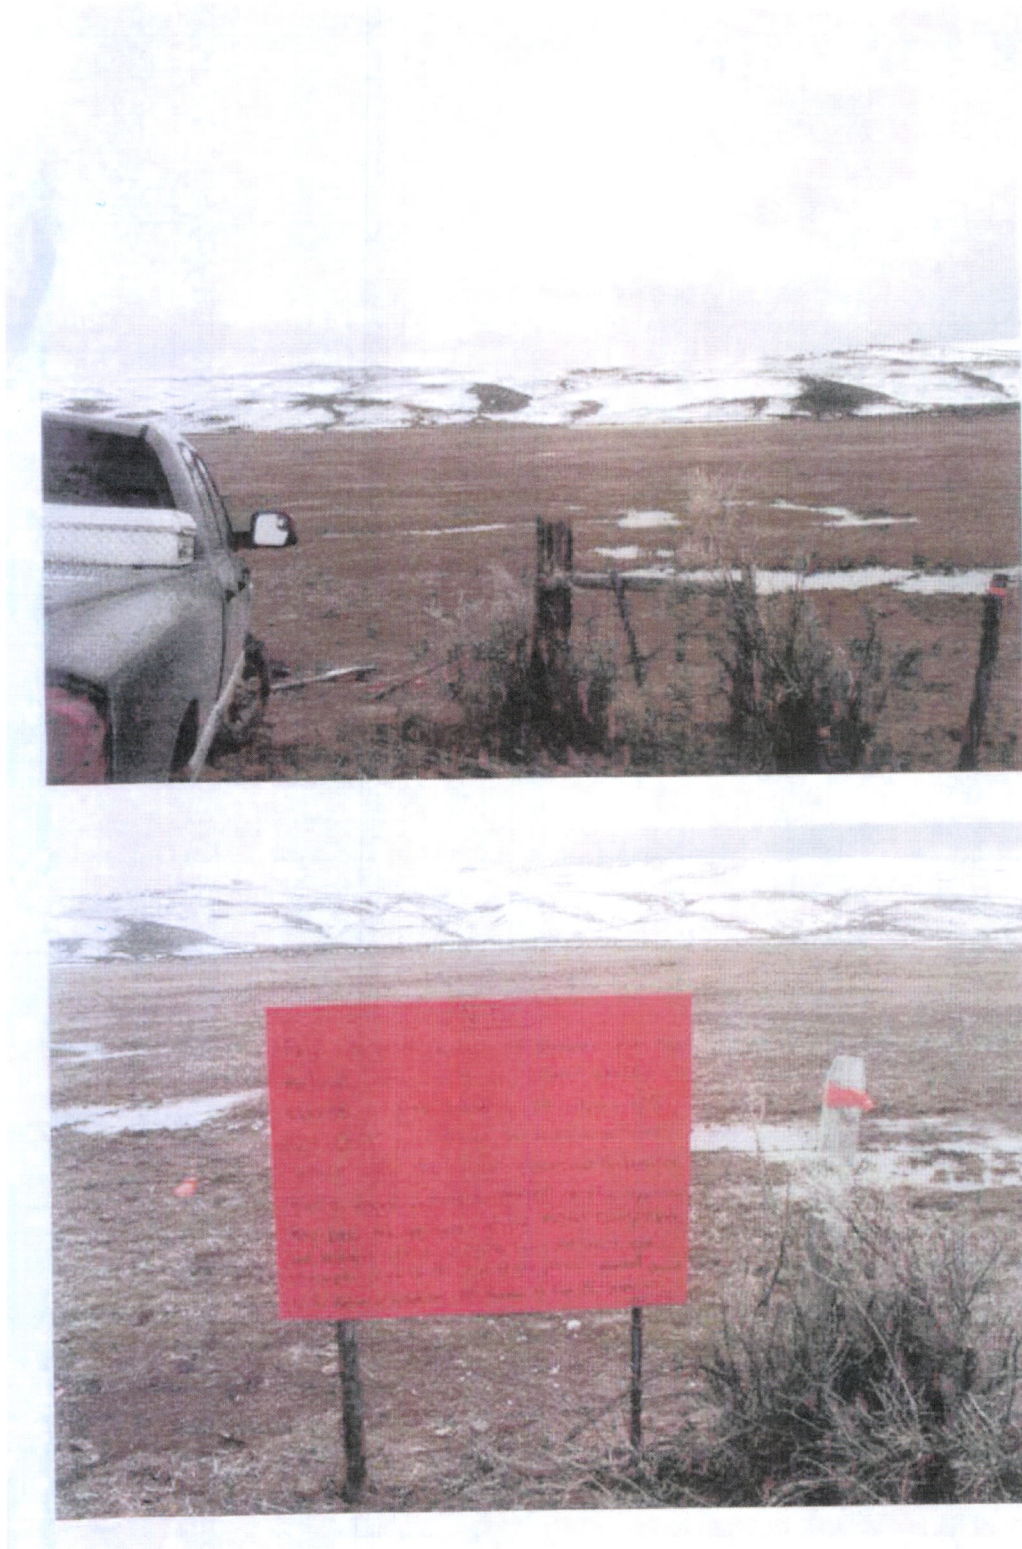
The Lyster Pit was permitted in 2008. During the April 10, 2008 pre-op inspection conducted by Travis Marshall (DRMS), the site had naturally “swampy” conditions including the presence of standing water, as seen in the Division site inspection photographs (Figure 1). Historical aerial photos available through Google Earth also show the standing water condition on the Lyster site and neighboring properties back in 2004 (Figure 2). The Lyster Pit was operated by Connell Resources prior to its current operator United Companies. Connell personnel informed GLA that in 2012 and 2013 there were times that the dewatering pump was not operating and standing water conditions were experienced during both pumping and non-pumping time periods.

Figure 1 – Photos Showing Standing Water from the 2008 DRMS Pre-Op Inspection conducted on 04/10/08 by Travis Marshall. Photo taken on 04/10/08, view to the south.

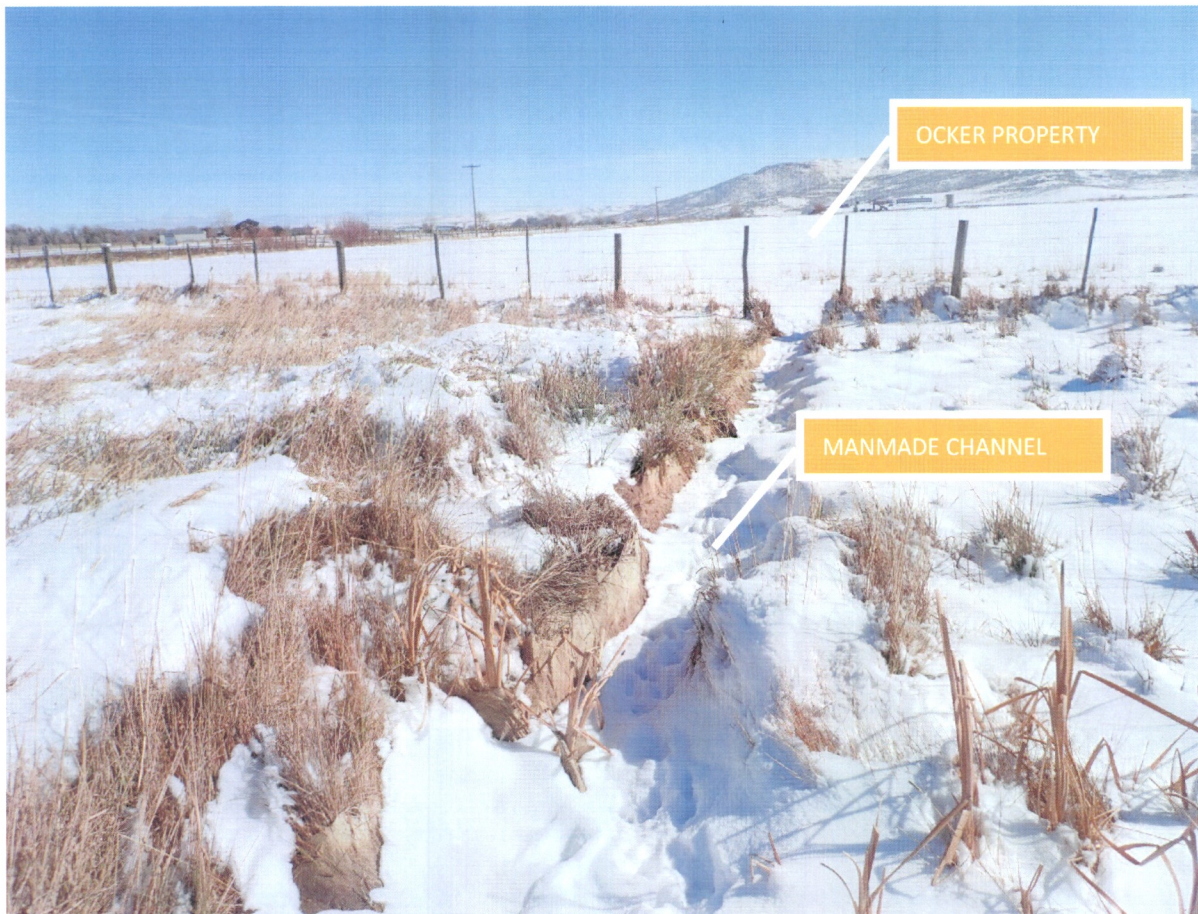
Surface water flows at the Lyster Pit and Ocker property consist of seasonal runoff and flood irrigation water. The surface water runoff flows clearly move from east to west across the Ocker property. At the fence line between the Lyster and Ocker sites, there is a ditch (Drainage Ditch) parallel to and west of the property line that generally drains to the north (Figure 3). Site investigation by GLA shows that the Drainage Ditch slope almost completely flattens at a small low point roughly 150 feet south of the CO-394 road ditch (Map 1 – NW corner). This low point area is thick with vegetation, as is the Drainage Ditch that flows into it. A connection point from the Ocker property to the Drainage Ditch and low point can be seen along the east fencelines; it is clear that at some point in the past, a manmade channel was dug to facilitate additional draining of some of the Ocker fields into the east side ditch (Figure 4). The low area and manmade channel are shown by the November 2020 topographic data collected via drone imagery shown on Map 1 – NW Corner. However, neither Connell Resources nor United Companies has ever conducted earthwork in this area. It is possible that the Ockers or previous owners of that property carved this connecting channel in themselves.

Figure 4 – Connection Point (Manmade Channel) Between Ocker Property and Drainage Ditch. Photo captured on 10/28/20, view to the east-northeast.

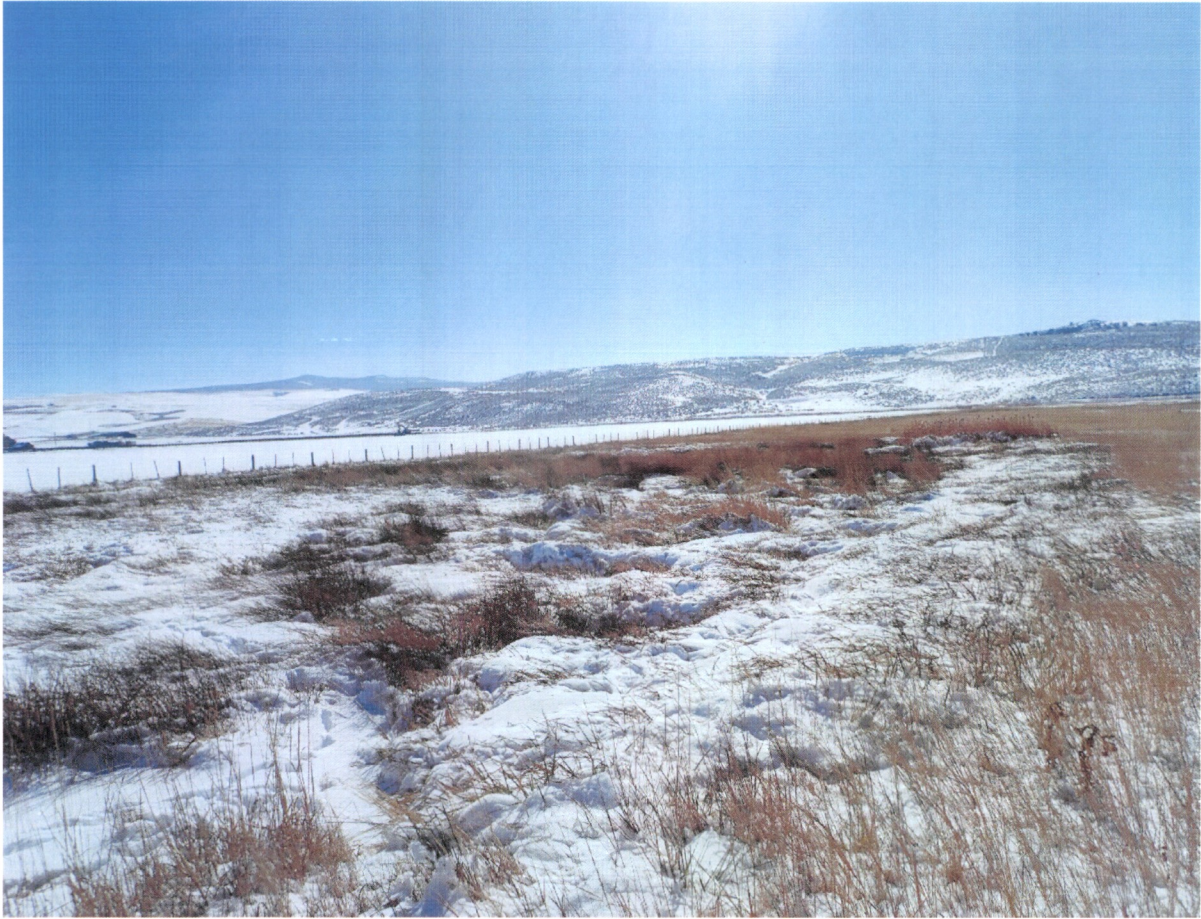
Northwest low area, looking east towards Ocker property.

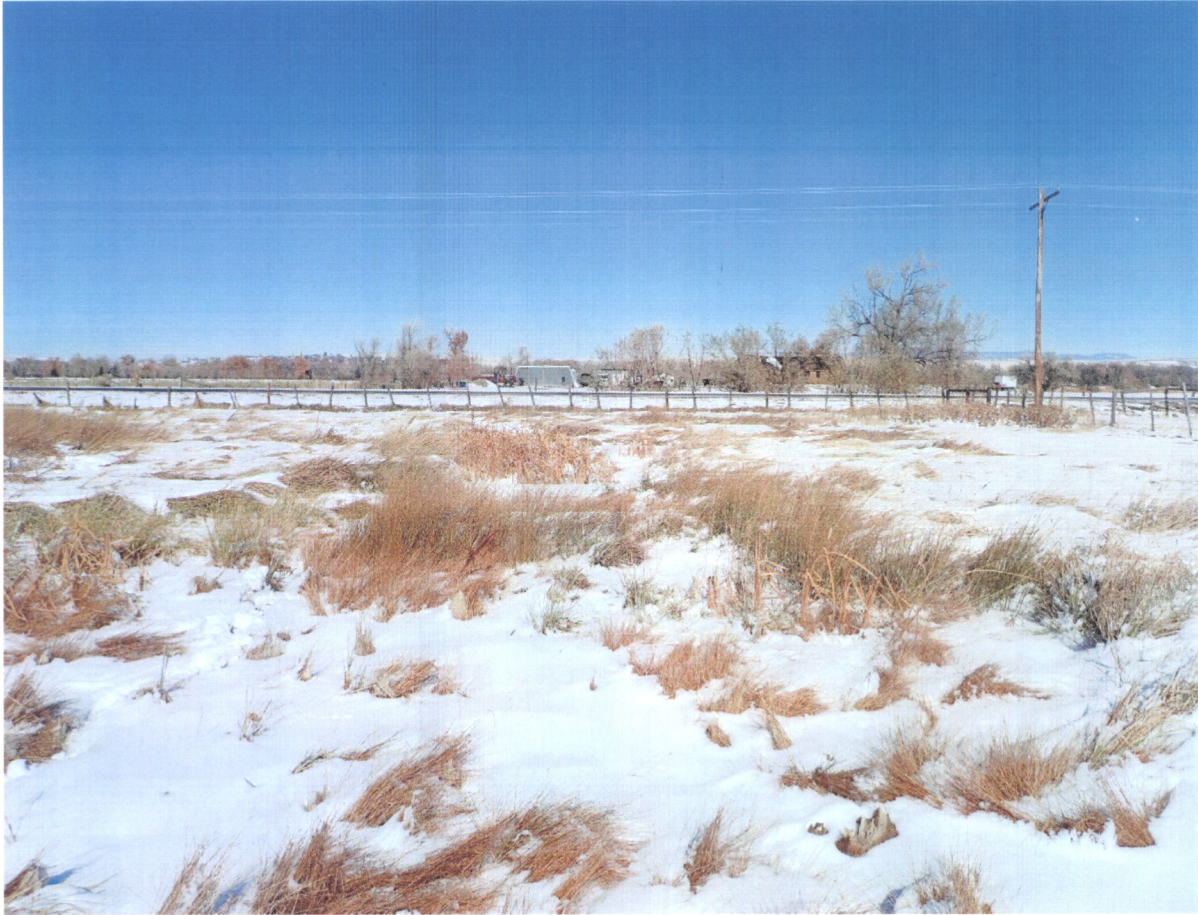
Northwest low area, looking north towards to CO-394.

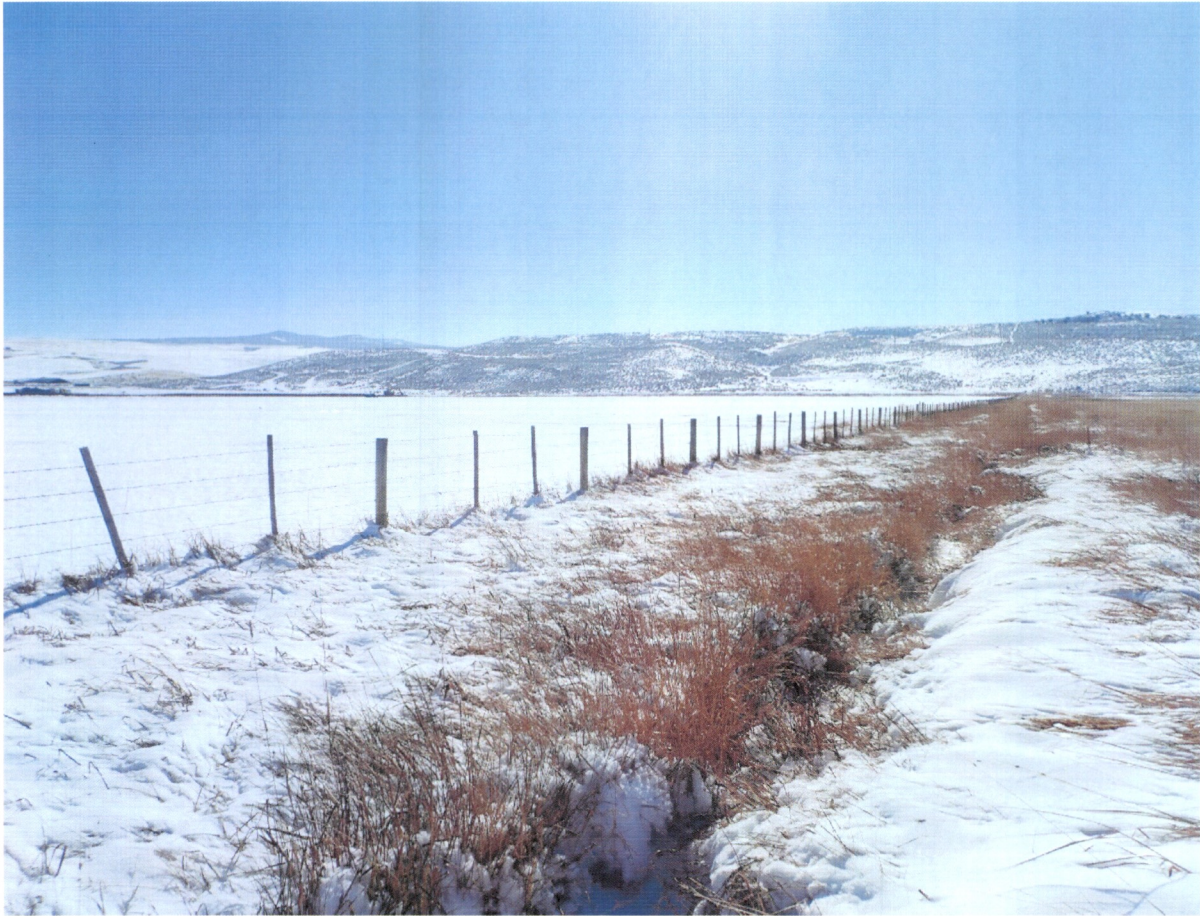
The Drainage Ditch is thick with vegetation to the point that surface water flows into and through said ditch would be significantly affected. Connell Resources noted that they mowed that area when they operated the pit prior 2017. It is likely that this mowing helped with smooth water flows off the Ocker property given the gentle slope from the east to the west.

Drainage Ditch, looking south from northeast low area.

While the activities at the Lyster Pit are not the cause of standing water on the Ocker property, the permittee understands Mr. Ocker's desire to ensure maximum drainage of his fields following flood irrigation. Therefore, the permittee commits to mow the vegetation along the Drainage Ditch parallel to and just west of the Lyster/Ocker property line. This will improve runoff flow conditions for Mr. Ocker and will likely lead to a noticeable reduction in standing water. It should be noted that due to the natural hydrologic conditions of the site, there will likely always be some standing water in the northeast corner of the Lyster Pit during portions of the irrigation season.

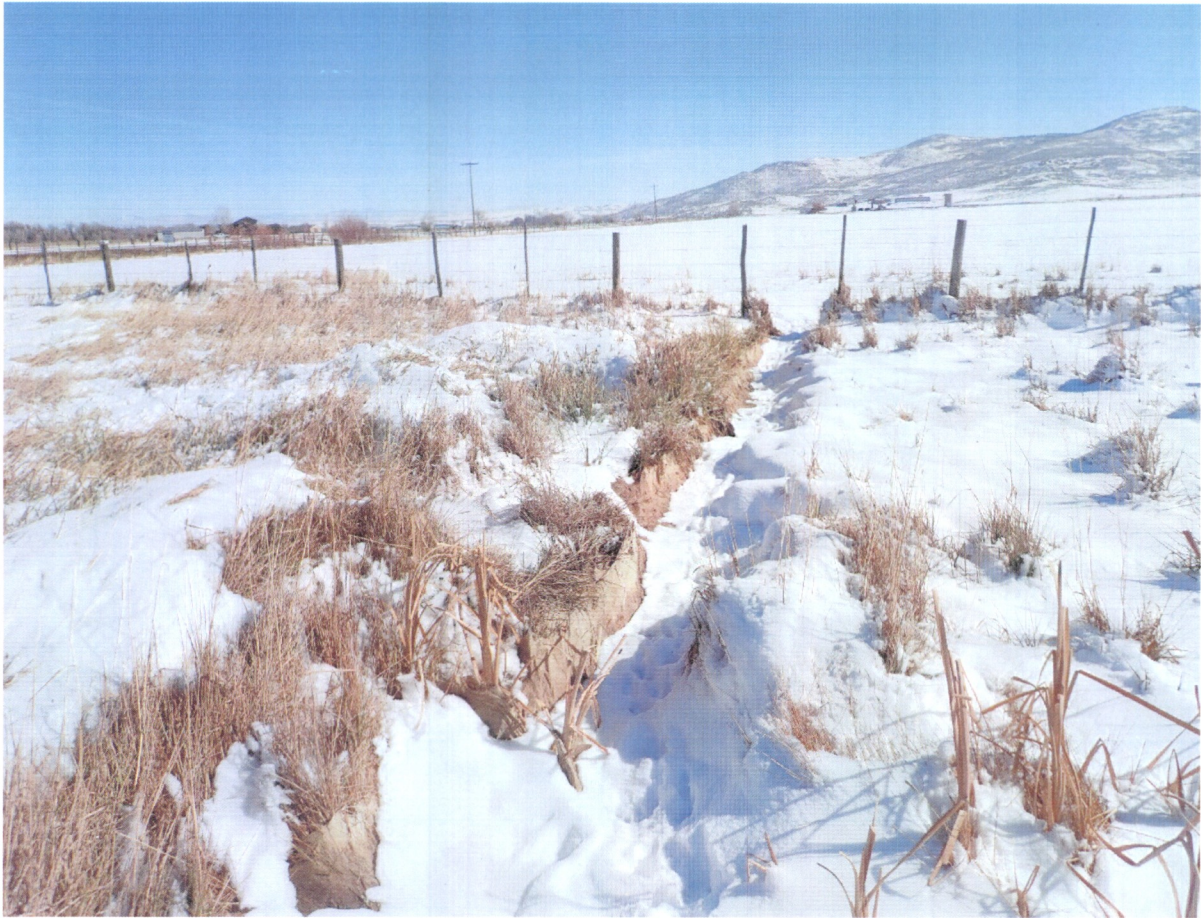
Ocker property manmade channel to low area, view to the east-northeast.

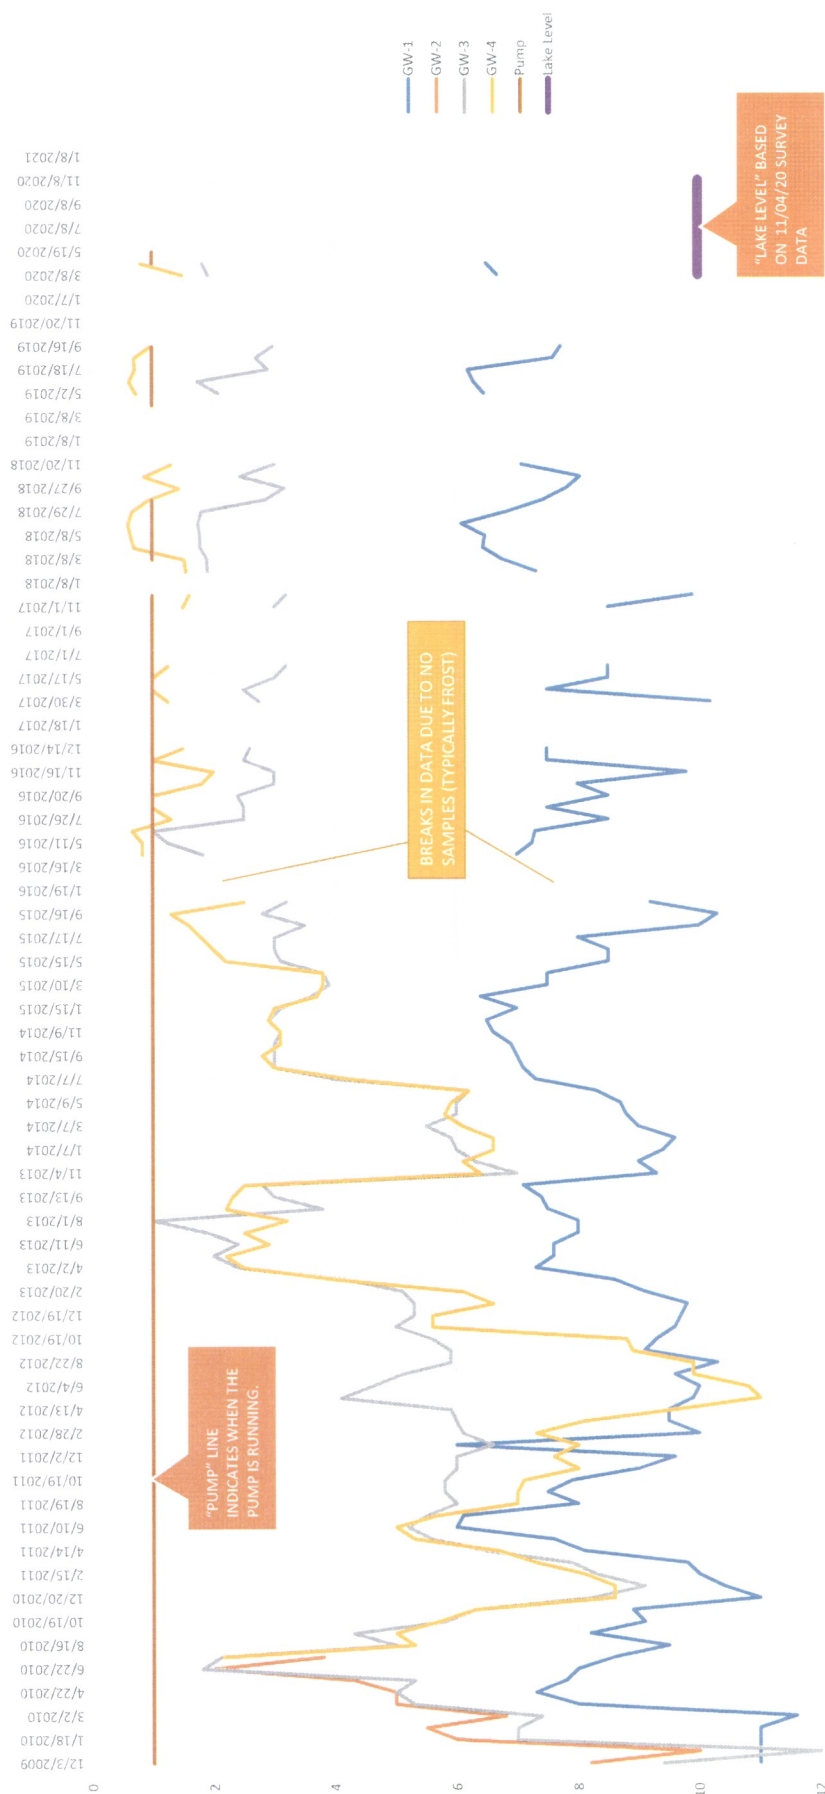
Groundwater Depth from Piezometers.

Piezometer data gathered from four groundwater monitoring wells onsite over many years, going back at least to 2016, shows that the natural groundwater table is close to the surface (Figure 3). This includes periods of time when the dewatering pump is running. GW-3 and GW-4 (northeast corner of the permit area) both show groundwater levels very near the surface (Map 1 – NW Corner). GW-2, which was abandoned in 2010, shows groundwater levels very near the surface as well (Figure 3). GW-2 was located east of the Lyster Pit on the Ocker Property.

Adjusting for piezometer casing height, the ground water elevation in the northeast corner of the permit area, adjacent to Mr. Ocker property, is within a foot of the surface (Appendix 1). This includes during periods when the dewatering pump is running. In fact, the recharge flow from the east of the site clearly prevents the dewatering activities to the west of GW-3 and GW-4 from having a significant effect on the groundwater level. This can be seen in Appendix 2 – Groundwater Data which shows the depth to water measured by each piezometer along with if the dewatering pump was either running or not running. GW-3, the furthest north and closest to CO-394 groundwater monitoring well, shows water levels within two to three feet of the top of the casing. Accounting for casing height of roughly a foot, this leads to a groundwater table typically within 12 inches of the ground. GW-4 frequently measures a groundwater level above the local topography. Such a close groundwater table will not facilitate substantial surface water infiltration.
