MINERALS PROGRAM INSPECTION REPORT
PHONE: (303) 866-3567

MINE NAME: Pandora South Exploration Core Drilling	MINE/PROSPECTING ID#: P-2021-015	MINERAL: Silver and gold	COUNTY: Boulder
INSPECTION TYPE: Monitoring	WEATHER: Clear	INSP. DATE: August 30, 2024	INSP. TIME: 10:00
OPERATOR: Grand Island Resources LLC	OPERATOR REPRESENTATIVE: Je' An-Paul Brewer	TYPE OF OPERATION: ME - Mineral Exploration	
REASON FOR INSPECTION: Normal I&E Program	BOND CALCULATION TYPE: None	BOND AMOUNT: \$27,290.00	
DATE OF COMPLAINT: NA	POST INSP. CONTACTS: None	JOINT INSP. AGENCY: None	
INSPECTOR(S): Patrick Lennberg	INSPECTOR'S SIGNATURE:

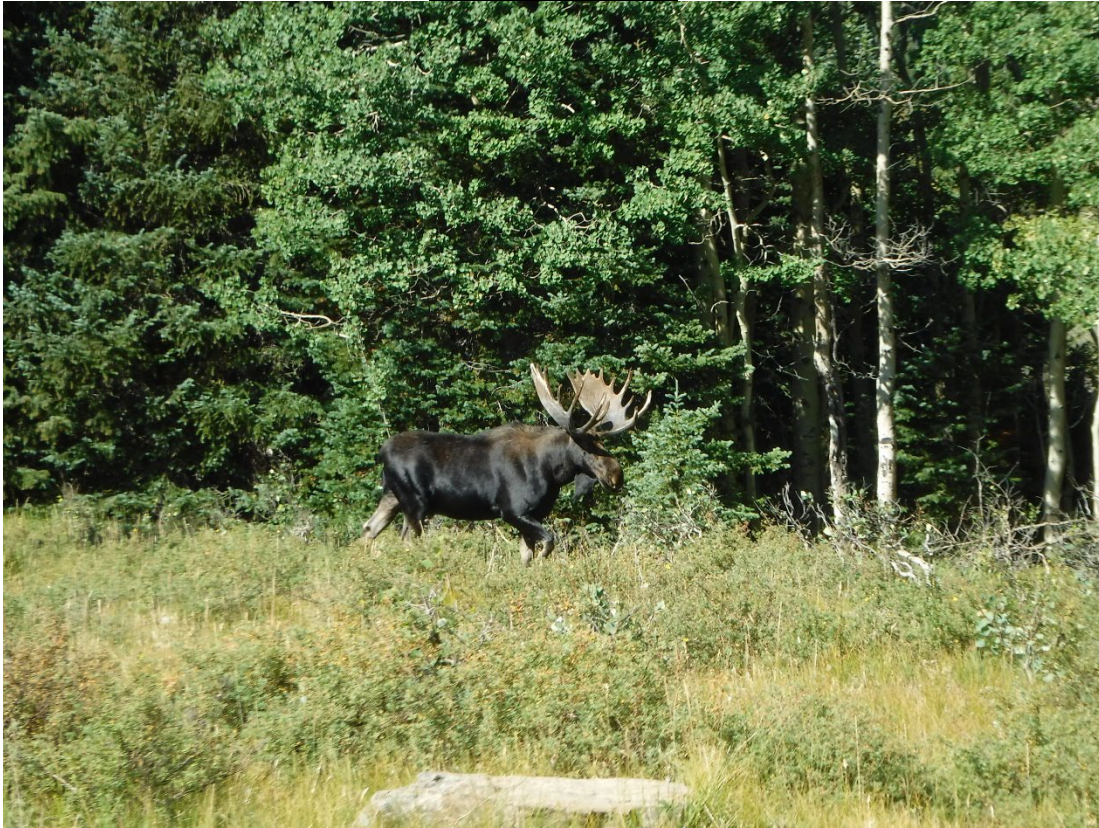
Photo 1: Bull Moose #1

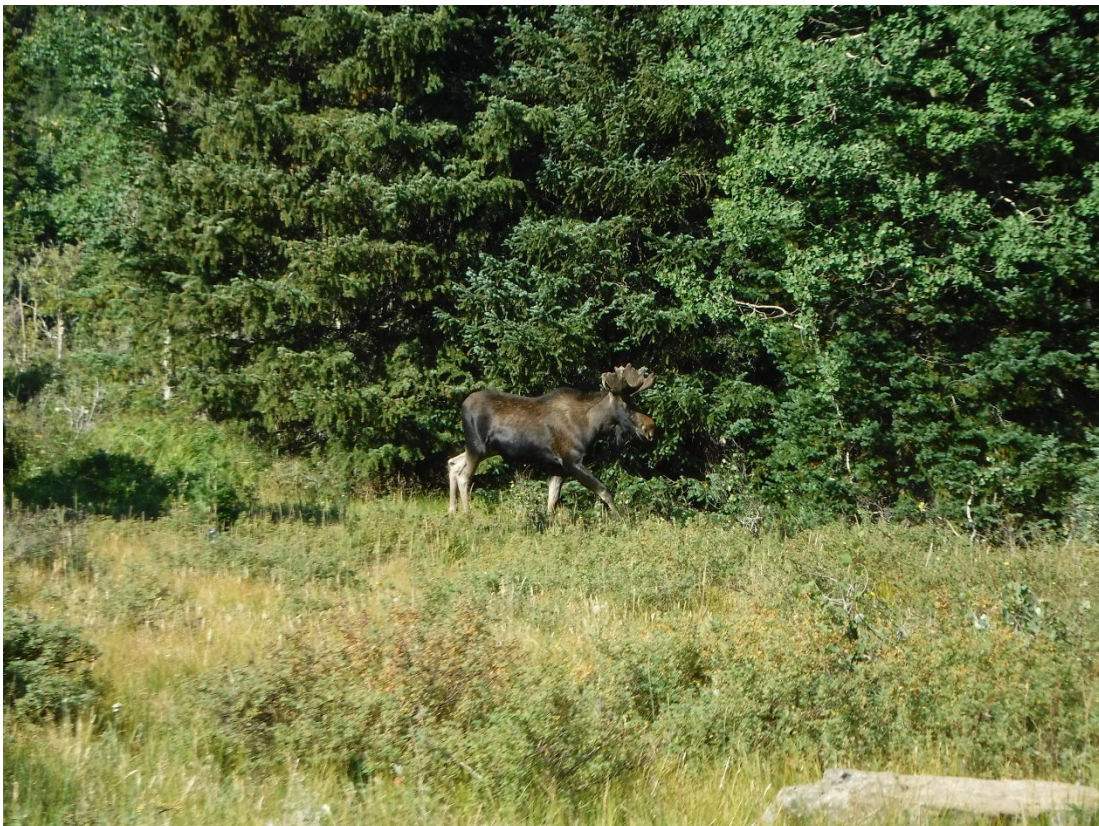
Photo 2: Bull Moose #2

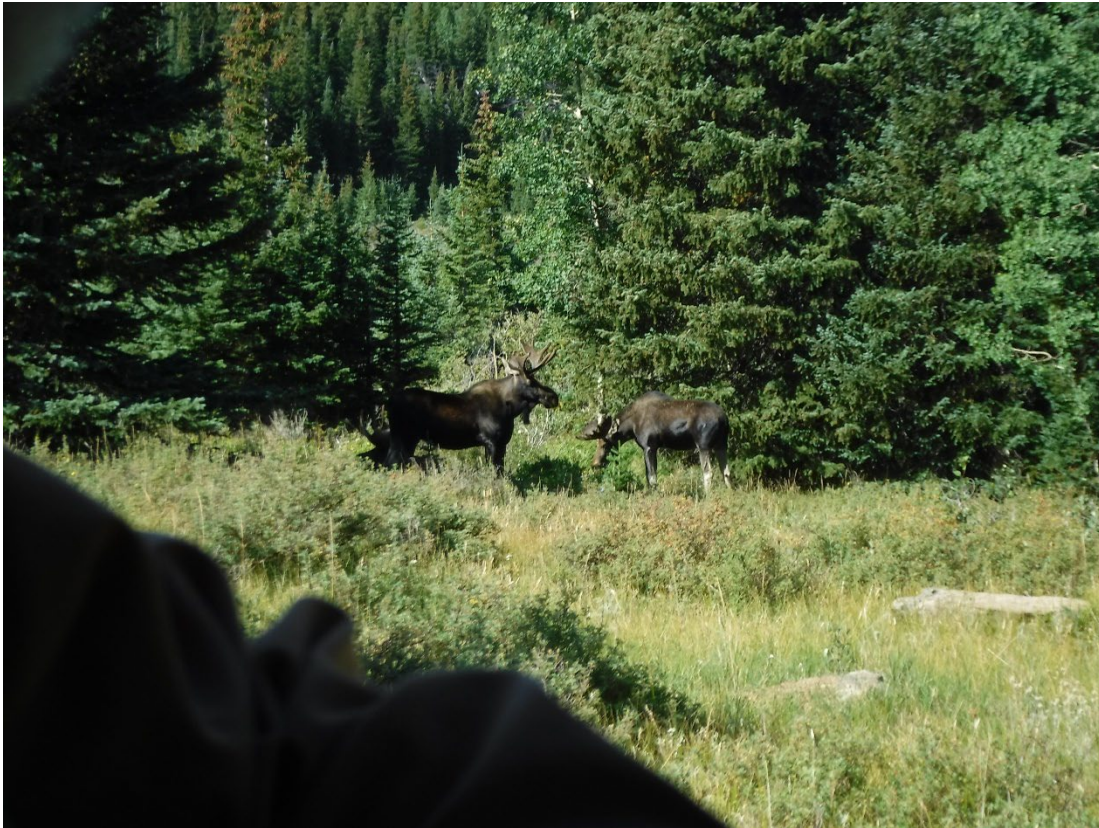
Photo 3: Bull Moose #3 (left) with Moose #2 (right)

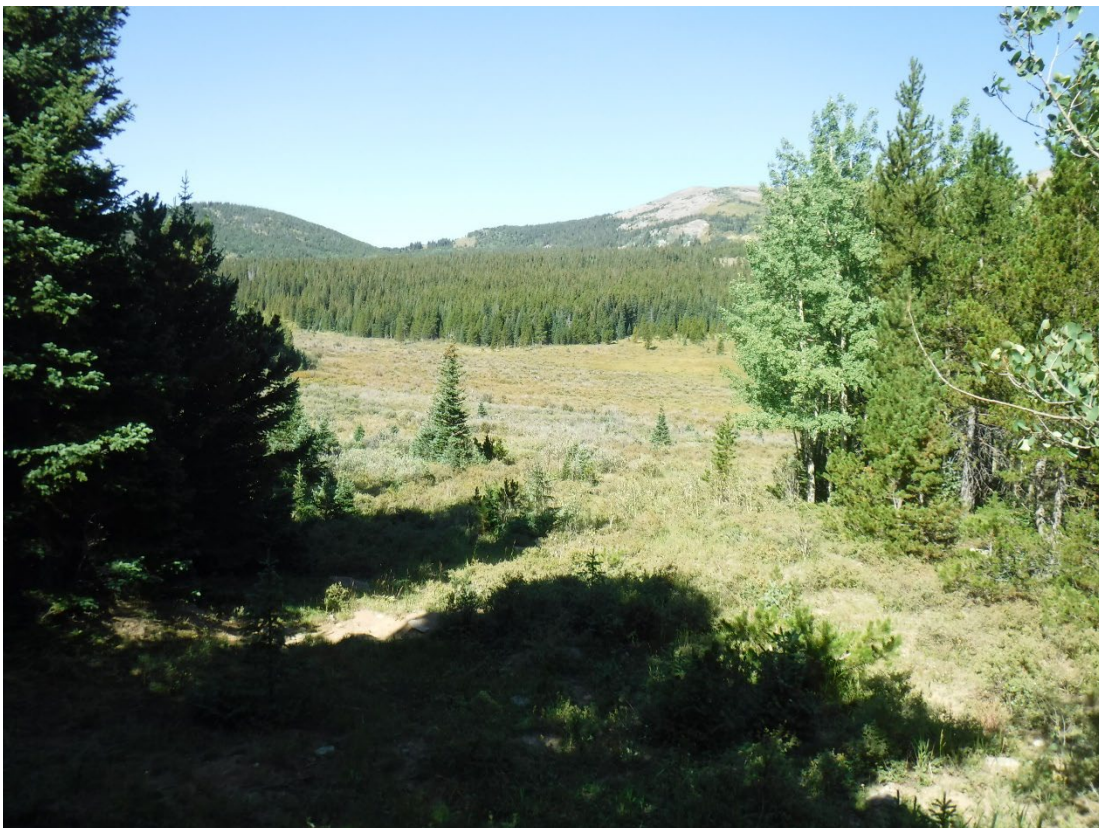
To date no activity has taken place at the site. The Division was unable to go beyond the road because of wildlife, three bull moose, nearby.

Photo 4: Looking southeast from where the access road is towards drill location, no activity

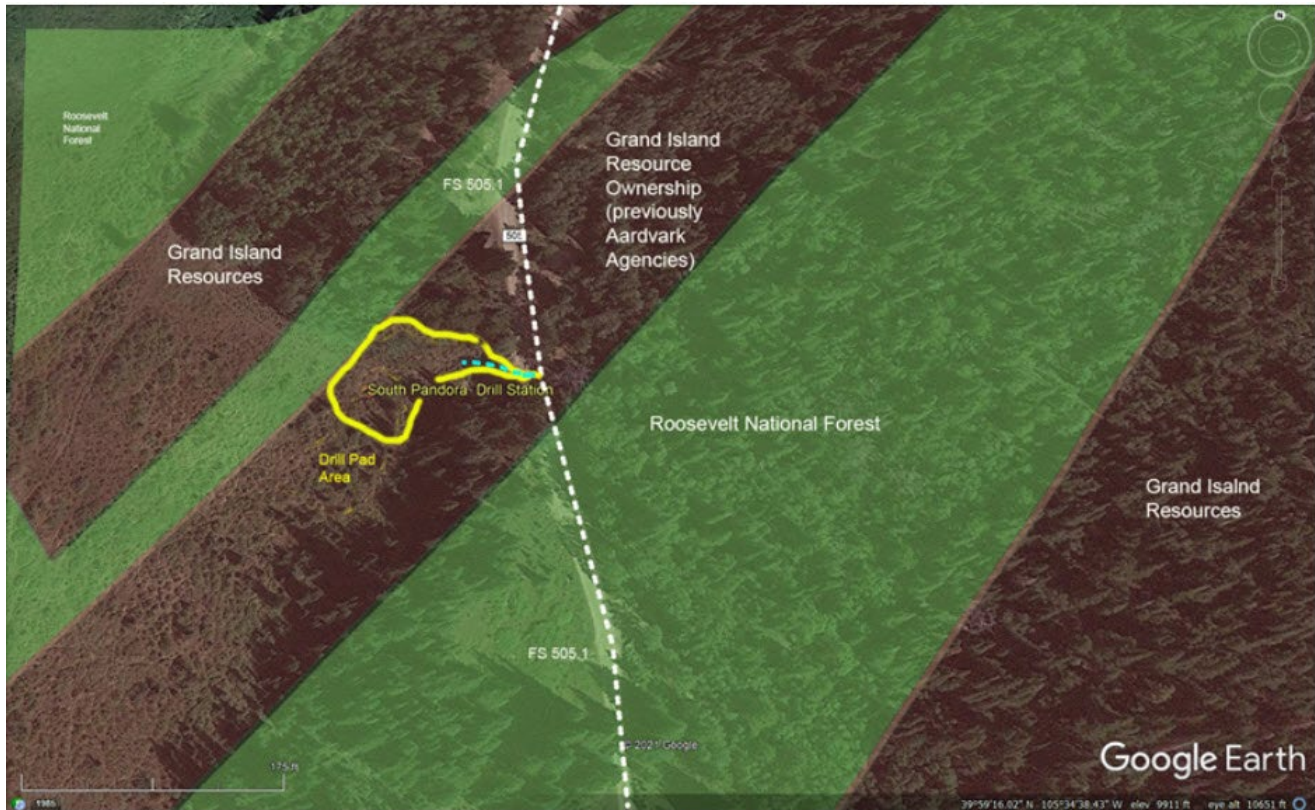
Figure 2.. Outline of Future Drill Pad on Permit P-2021-015
