MINERALS PROGRAM INSPECTION REPORT
PHONE: (303) 866-3567

MINE NAME: Liberty Project	MINE/PROSPECTING ID#: P-2007-058	MINERAL: Gold	COUNTY: Ouray
INSPECTION TYPE: Monitoring	WEATHER: Clear	INSP. DATE: July 23, 2024	INSP. TIME: 15:10
OPERATOR: The Mining Company, Inc.	OPERATOR REPRESENTATIVE: None	TYPE OF OPERATION: MP - Mineral Prospecting	
REASON FOR INSPECTION: Normal I&E Program	BOND CALCULATION TYPE: None	BOND AMOUNT: \$17,962.00	
DATE OF COMPLAINT: NA	POST INSP. CONTACTS: None	JOINT INSP. AGENCY: None	
INSPECTOR(S): Lucas West Amber Gibson Hunter Ridley	INSPECTOR'S SIGNATURE:

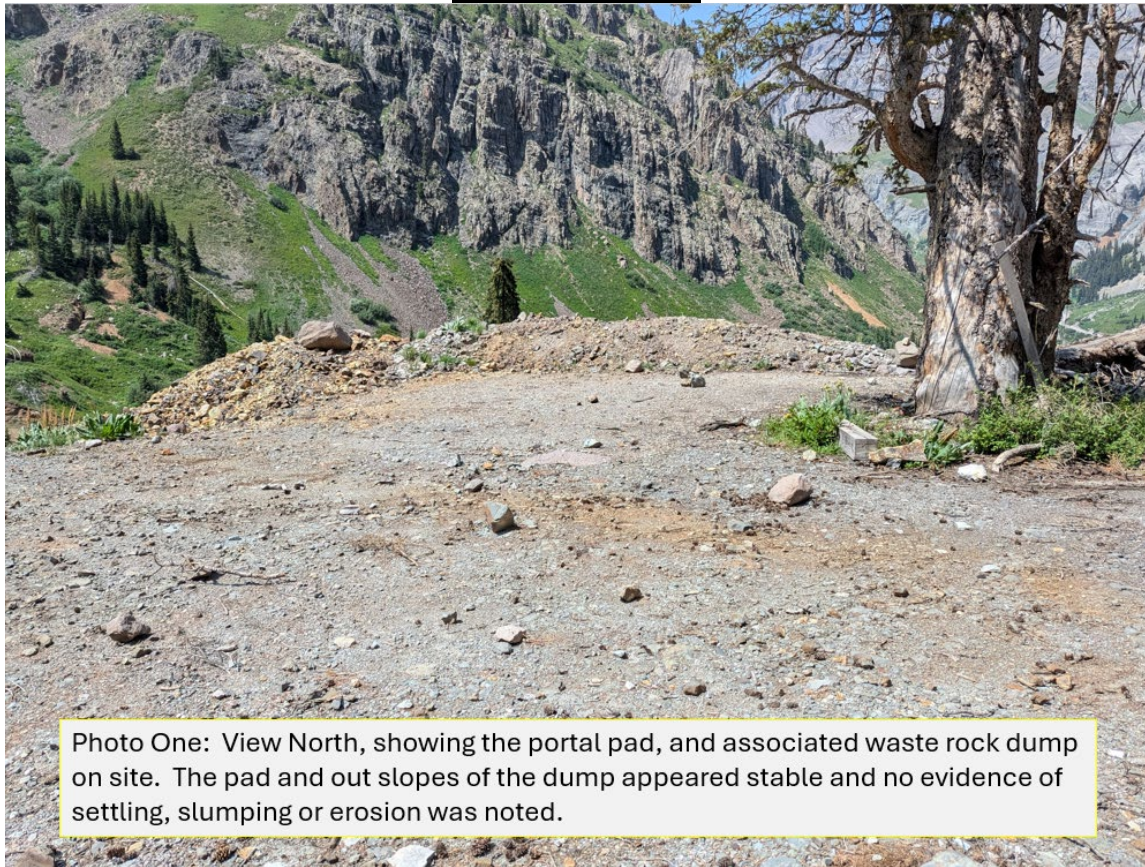
Photo One: View North, showing the portal pad, and associated waste rock dump on site. The pad and out slopes of the dump appeared stable and no evidence of settling, slumping or erosion was noted.

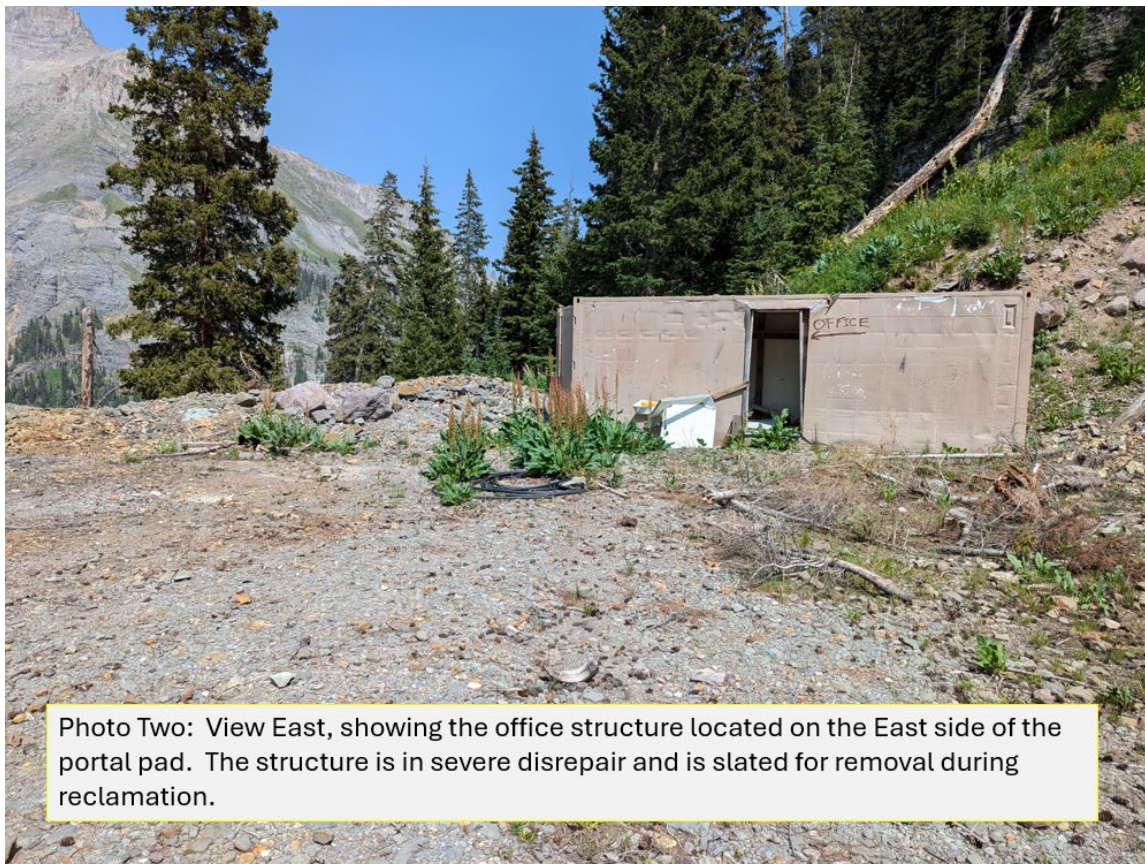
Photo Two: View East, showing the office structure located on the East side of the portal pad. The structure is in severe disrepair and is slated for removal during reclamation.

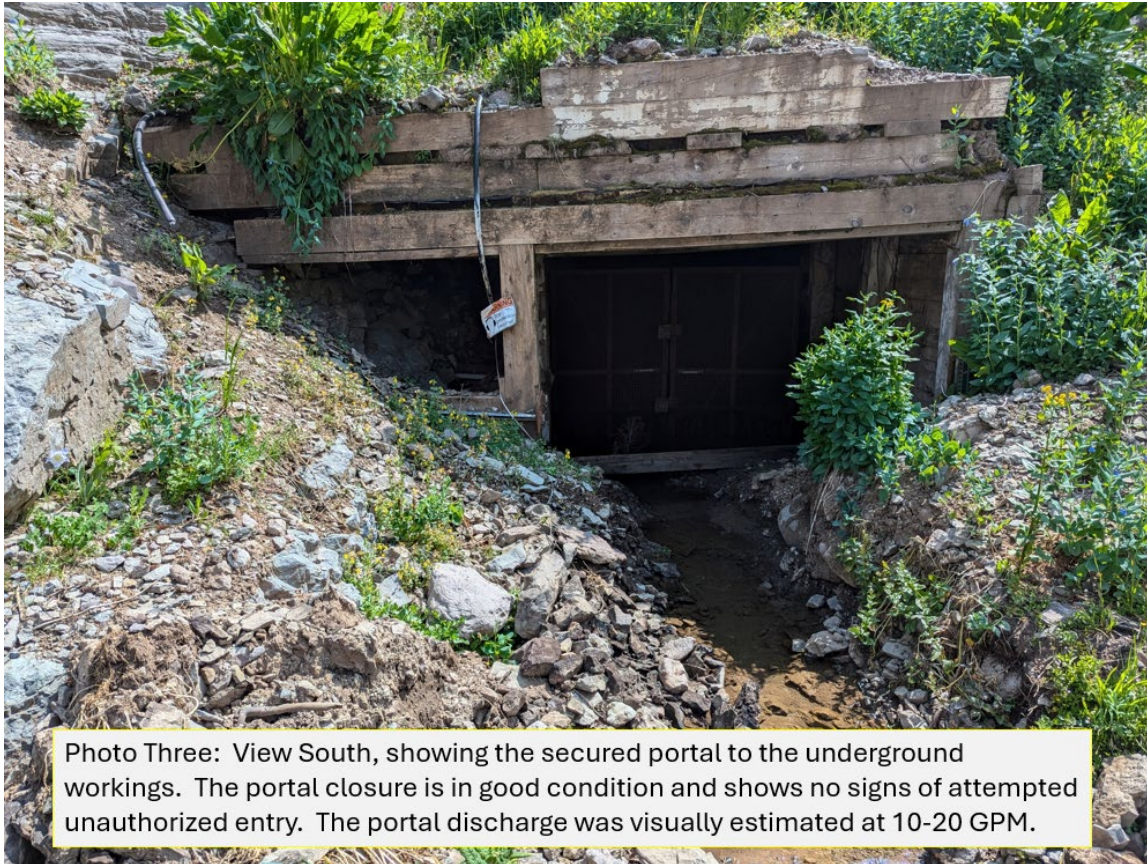
Located on the south side of the pad is the portal to the underground workings. The portal is secured by a locking steel gate which can be seen in Photo **Three**. Material has sloughed off the adjacent hillside and partially blocked the access to the Portal. At the time of the inspection the portal was observed to have a discharge of approximately 10-20 gallons per minute. The discharge has been routed into a ditch along the access road, flowing into a wetland like area offsite, and ultimately into the adjacent creek.

Photo Three: View South, showing the secured portal to the underground workings. The portal closure is in good condition and shows no signs of attempted unauthorized entry. The portal discharge was visually estimated at 10-20 GPM.
