Inspection Report, Colowyo, C-1981-019

PERMIT INFORMATION

Permit Number: C-1981-019 Mine Name: Colowyo Coal Mine Operator: Colowyo Coal Company L.P. Operator Address: Mr Tony Tennyson 5731 State Highway 13 Meeker, CO 81641	County: Moffat, Rio Blanco Operation Type: Surface Permit Status: Active Ownership: Private
	Operator Representative Present: Tony Tennyson
Operator Representative Signature: (Field Issuance Only)

Inspection Start Date: August 20, 2024 Inspection Start Time: 07:30 Inspection End Date: August 20, 2024 Inspection End Time: 11:45		Inspection Type: Coal Partial Inspection Inspection Reason: Normal I&E Program Weather: Clear	
Joint Inspection Agency: None		Joint Inspection Contacts: 	
Post Inspection Agency: None		Post Inspection Contacts: 	
Inspector(s): Hunter Ridley	Inspector's Signature: <i>Hunter Ridley</i>		Signature Date: August 28, 2024

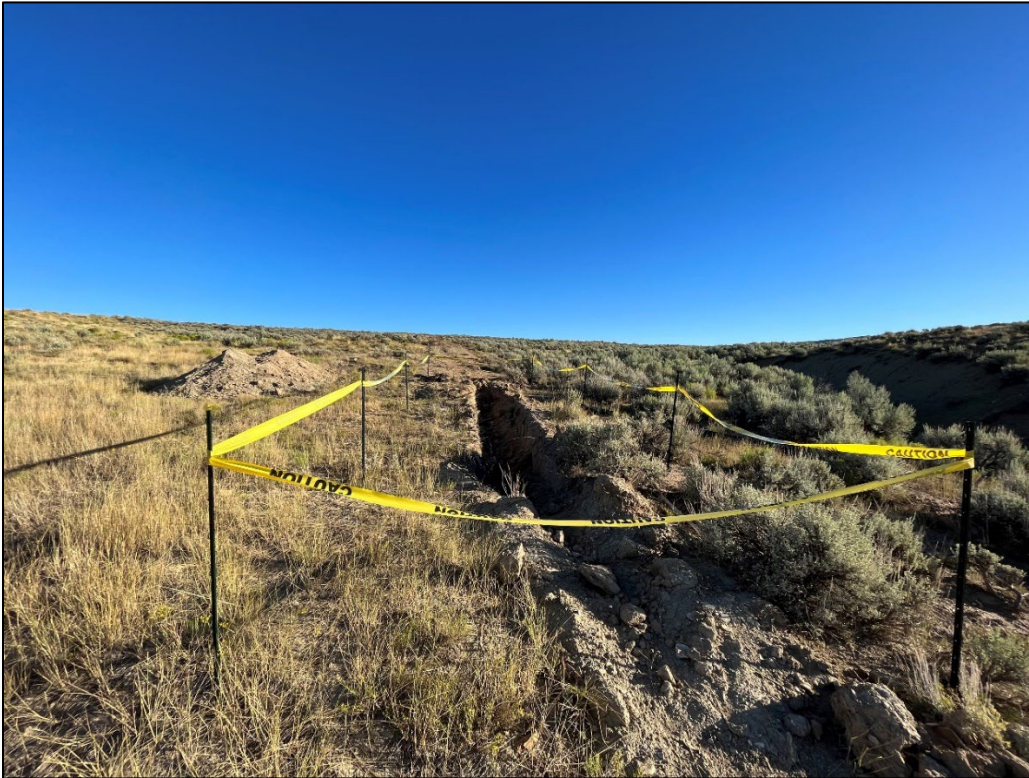
An application for Minor Revision 257 (MR-257) was received by the Division on August 12, 2024. MR-257 documented ground disturbance activities that occurred within Colowyo's permit boundary from an adjacent solar construction project (Photo 1). The ground disturbance is not associated with Colowyo and is minimal. A proposed decision to approve the MR was issued by the Division on August 22, 2024. The solar construction project will continue through this area of Colowyo's permit boundary and will be reclaimed following the conclusion of disturbance.

Photo 1: View north of the solar project disturbance within Colowyo's permit boundary, the disturbance is not mine related.

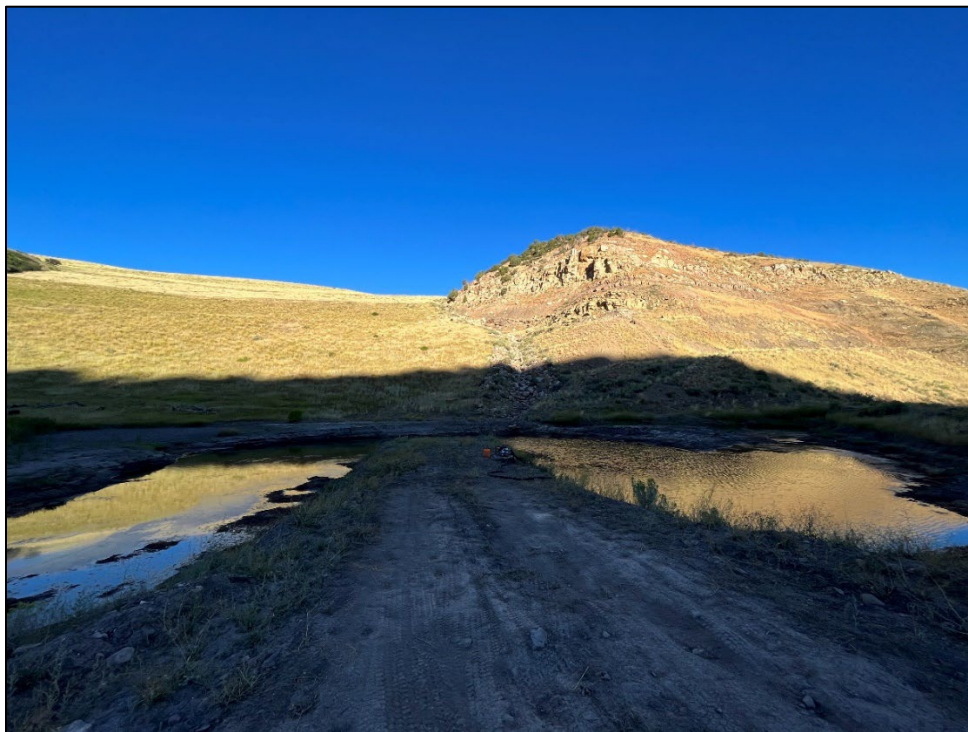
from Streeter Pond in support of reclamation operations being conducted by the State of Colorado Inactive Mines Program (IMP) to resolve the historic Axial Basin underground coal fire in this area (Photo 2). No issues were reported.

Photo 2: View west of the Streeter Pond, reclaimed valley fill, and the end of Streeter Ditch.

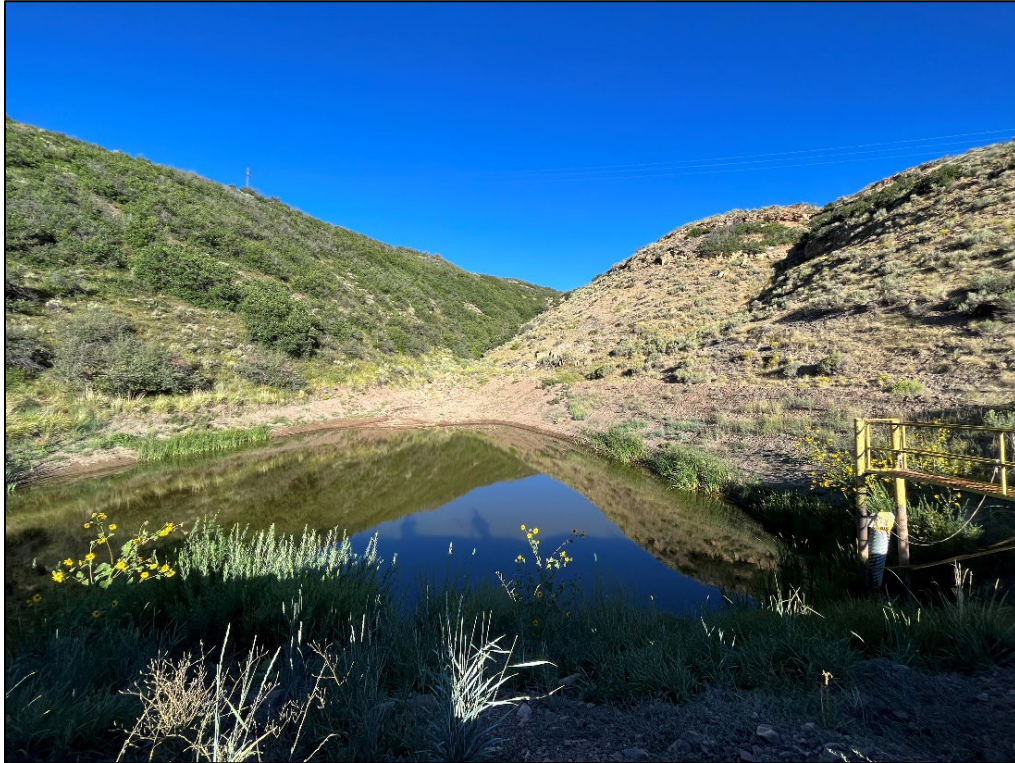
Photo 3: View west of Prospect Pond.

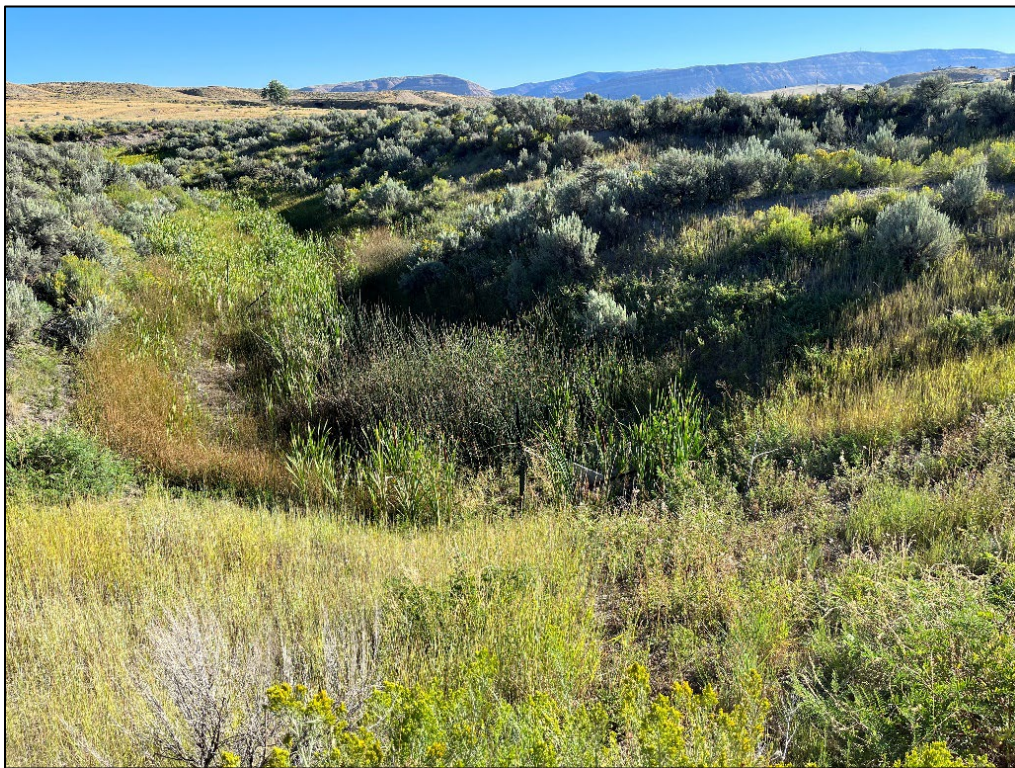
The following Ponds in the Loadout Area were inspected this month: Gossard Pond, Rail Loop Pond, Stoker Siding Pond (Photo 4 and 5). No problems or erosional concerns were noted. All ponds were noted to be holding water, though this was minimal at the Gossard and Rail Loop ponds (Photo 6). Mr. Tennyson stated that these two ponds will undergo routine cleaning maintenance in the near future. The Stoker Siding Pond is usually always full, likely due to a nearby natural spring in this area. Ditches in this coal loadout area were observed to be fully functioning.

Photo 4: View north of the discharge area above the Stoker Siding Pond.

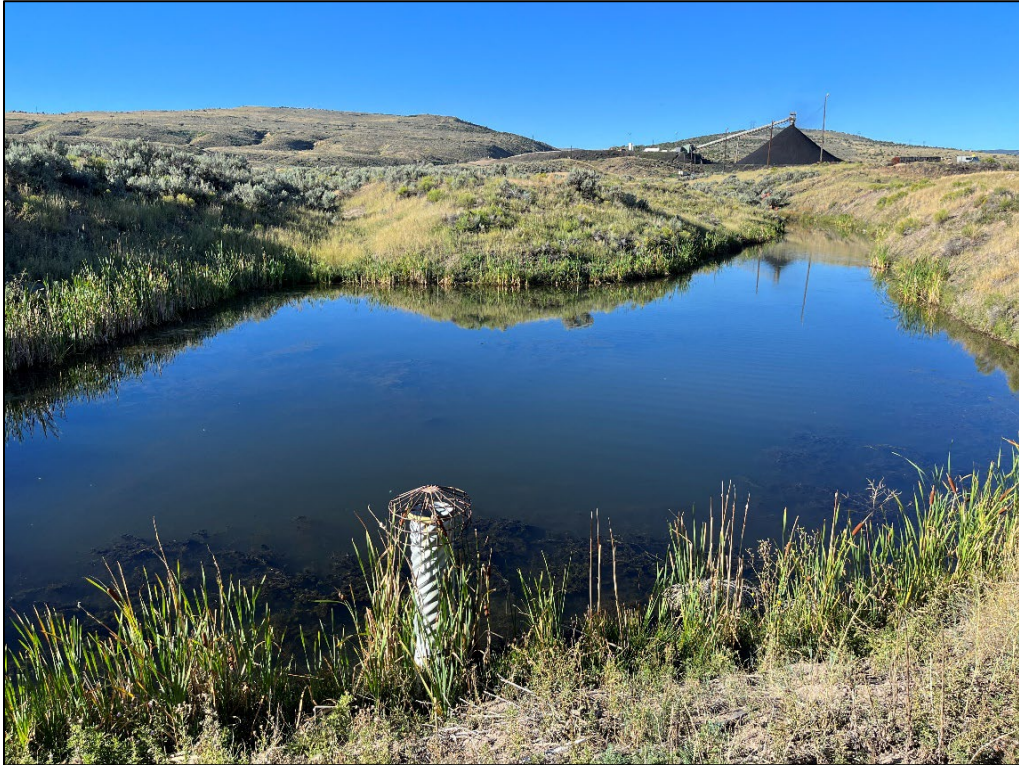
Photo 5: View south of the Stoker Siding Pond in the Rail Loop area.

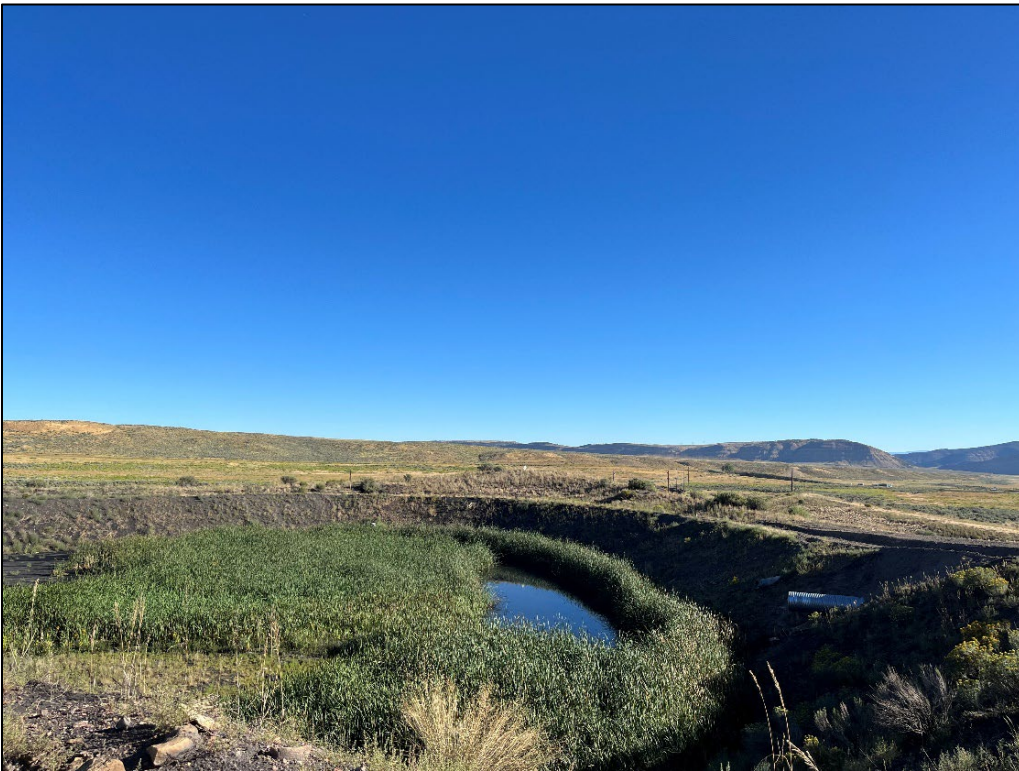
Photo 6: Rail Loop Pond, view north.

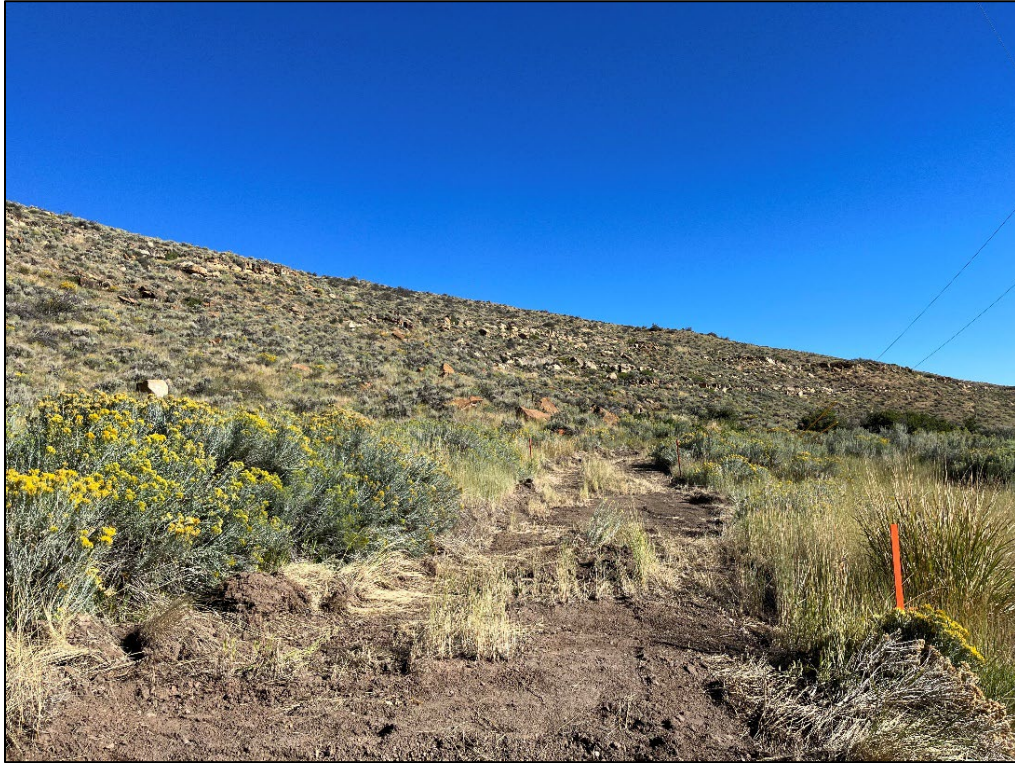
An application for Minor Revision 258 (MR-258) was received by the Division on August 15, 2024. MR-258 proposed additional ground disturbance related to the brushing of a light use road west of Taylor Creek (Photo 7). This additional 5.3 acres of disturbance is in addition to the disturbance approved under MR-255 also related to the brushing of this light use road. A proposed decision to approve the MR was issued by the Division on August 16, 2024.

Photo 7: View northwest of the light-use road brushing area approved in MR255 and MR258.

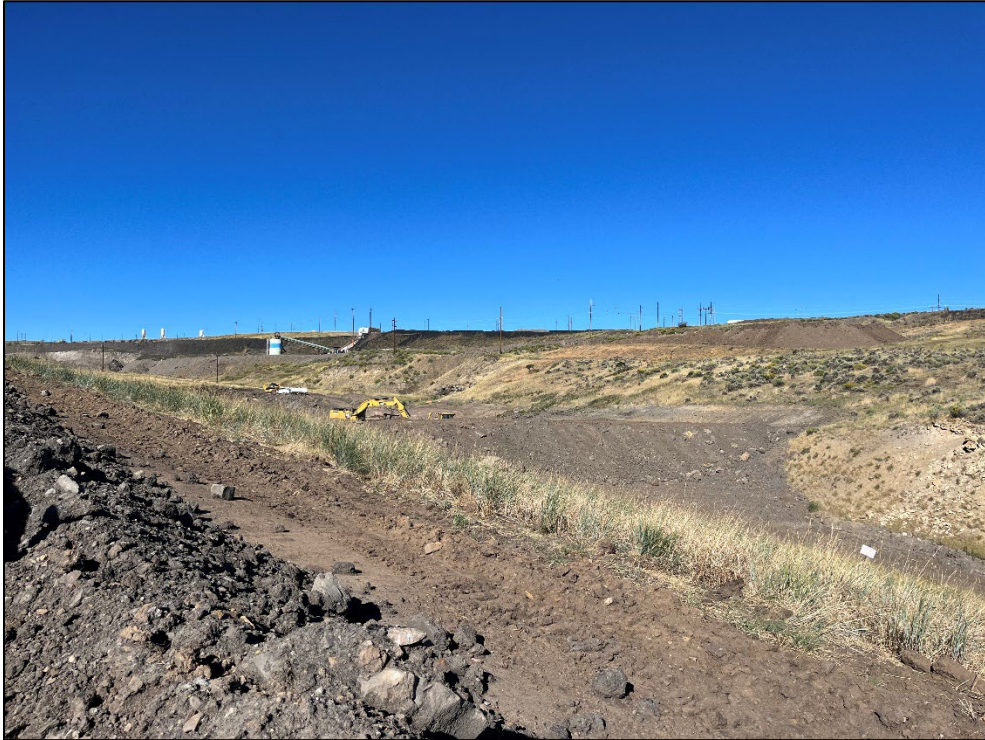
Observations in the East Pit included watching the continued development of the Upper and Lower Section 3 Ponds, located just below the primary crushing facility at the site (Photos 8 and 9). These are permitted to be non-discharging structures and are located within Streeter Ditch. An access road has been cut to aid in continued construction and future cleanout of these ponds. Topsoil has been stripped from this area. Material continues to be excavated from the pond area and rock has been hauled in for use in final design.

Photo 9: View west of the Upper Section 3 Pond in progress, active excavation in process.

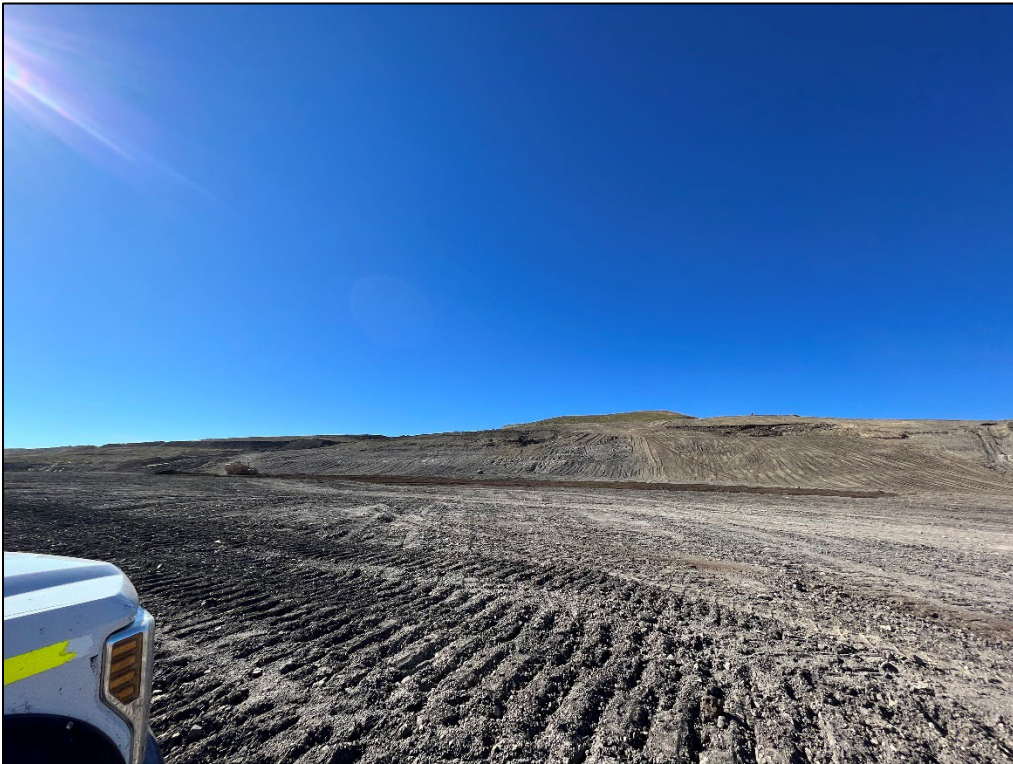
A majority of the West Pit is in final reclamation and is nearly entirely backfilled. A new area was undergoing reclamation in the southern portion of the West Pit at the time of inspection. This area was receiving final grading work and was being topsoiled (Photo 10). The slope noted in Photo 10 is nearly at final grade. However, small linear crack features were noted on this slope. Spoil is currently being removed from the top of this slope for backfill. Therefore, the site is going to delay the topsoiling and seeding of this particular slope until more weight can be removed from above. This allows linear features to be monitored more closely and will ensure that any topsoiling and seeding which occurs on this slope will have the best chance of success and stability.

Photo 10: View south of ongoing reclamation at the southern end of West Pit.

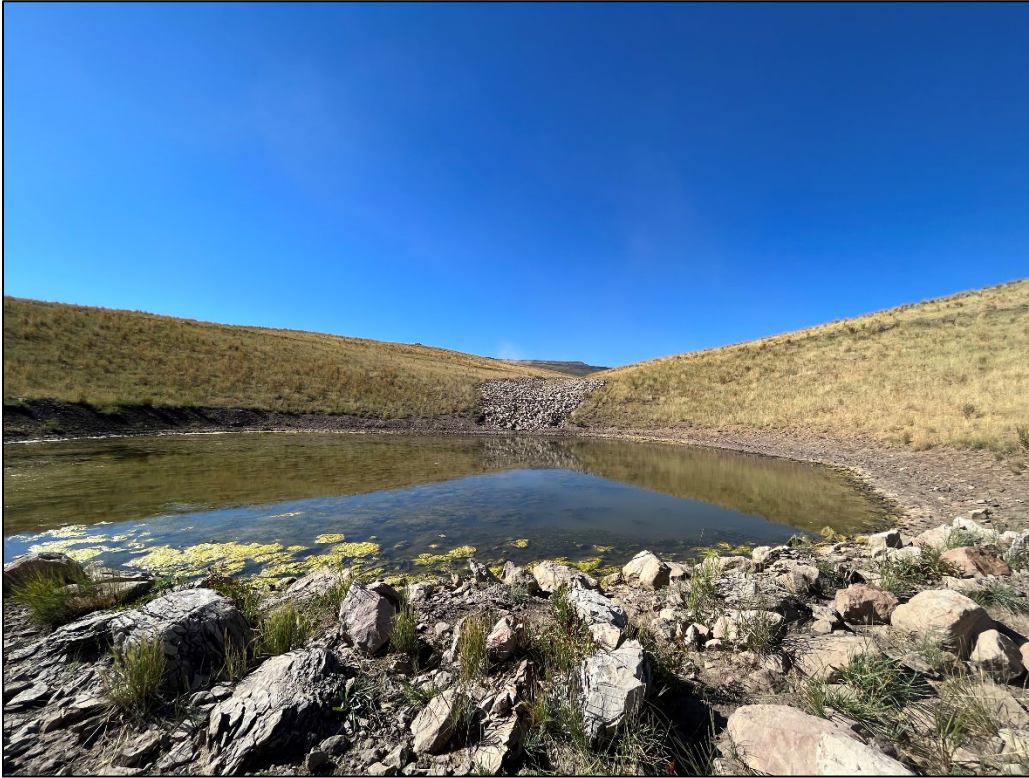
Stock ponds TD1 and TD2 in the West Pit reclamation area were inspected. These capture water which runs through Taylor Ditch. TD1 was holding water at the time of inspection (Photo 11). TD2, which is south of TD1, was dry at the time of inspection (Photo 12). Taylor Ditch was inspected from vantage points provided by TD1 and TD2 and was observed to be stable and mostly dry. TD2 is in need of maintenance but is not easily accessed by equipment and is surrounded by mature reclamation vegetation. Currently, the two stock ponds are approved to sediment in and remain in final reclamation. The Division and Mr. Tennyson discussed leaving TD2 as is and potentially creating another stock pond further south on Taylor Ditch to replace TD2. While mostly full of sediment, the last time sediment was removed from the TD2 was ~7 years ago. This suggests that while TD2 does collect runoff sediment from Taylor Ditch, it is not a crucial feature of sediment collection within the ditch. Additionally, the receiving East Taylor Pond is already designed to hold volumes assuming TD1 and TD2 are at capacity. Therefore, the Division has no concern with TD2 being left to begin to fill in naturally in the interest of not disturbing surrounding mature reclamation vegetation.

Vegetated areas in the West Pit reclamation parcels remain mature and free of issues (Photos 11 and 12). Native shrub and grass species have grown tall, and groundcover is established consistently across most of these reclaimed areas. There are a few smaller areas in the north of the West Pit where vegetation is slightly shorter, and groundcover is more irregular. There were no signs of erosion rills across these reclamation areas. Reclamation grasses in the East Pit and around the Final East Pit Ditch were also observed to be mature and stable (Photo 15).

Photo 11: View south of TD1 in West Pit.

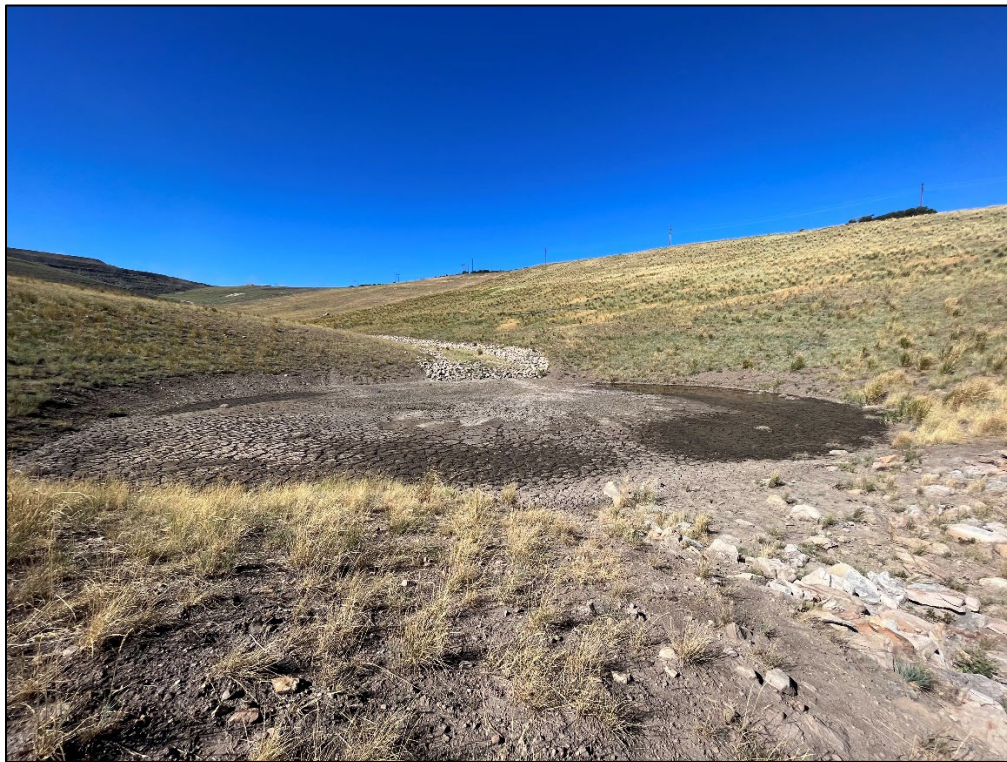
The West Pit Pond and the East Taylor Pond (Photo 12) were inspected this month. Both ponds were accessed via a small offroad trail along Taylor Creek. Both ponds were holding water at the time of inspection. Aquatic vegetation was visible in both ponds but was not causing any issues with discharge structures. The flume at the East Taylor Pond will undergo replacement, potentially with a new type of

Photo 12: View south of TD2 in West Pit, see maintenance items for more details.

- Monitor the slump area at Section 26 Pond
- Seed the topsoil pile in the northern section of Collom Pit when conditions allow
- Monitor the small erosional feature in D4, repairs will be necessary if conditions worsen

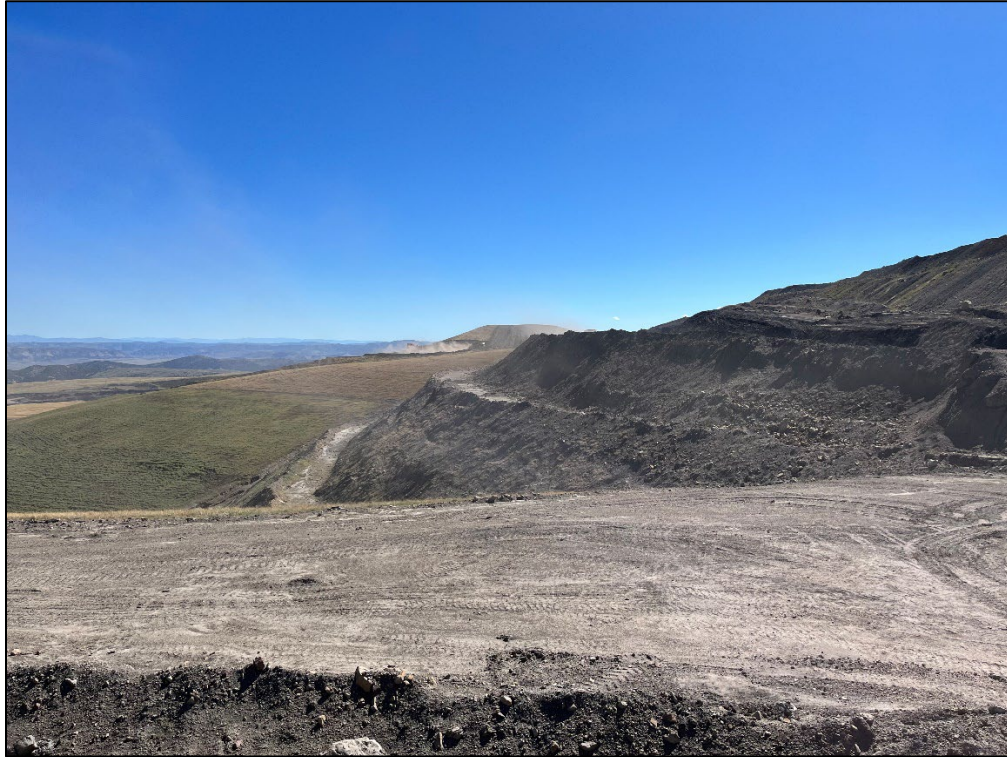
The active hauling and regrading of spoil along the southern extent of the West Pit was inspected (Photo 13). Mr. Tennyson stated that a revision for the post mining topography may be needed in this area as material is being moved around to complete the southern extent of Taylor Ditch and as backfill is still occurring in the South Taylor Pit.

Topsoil piles across the site contained appropriate markers. Topsoil was being actively hauled from the southern end of West Pit for use in final reclamation (Photo 13). Mr. Tennyson restated the site's intention to seed the Collom topsoil pile for stabilization as required by Rule 4.06 in the Fall of 2024. Mr. Tennyson also stated that the site will be reviewing vegetation data from areas of past reclamation to assess the success of the current topsoil replacement rate method. A revision may be submitted to the Division if the site determines that a change to this method is warranted to aid in reclamation success.

Photo 13: View east of the active hauling and grading area in the south of West Pit, active topsoil hauling is shown in the background.

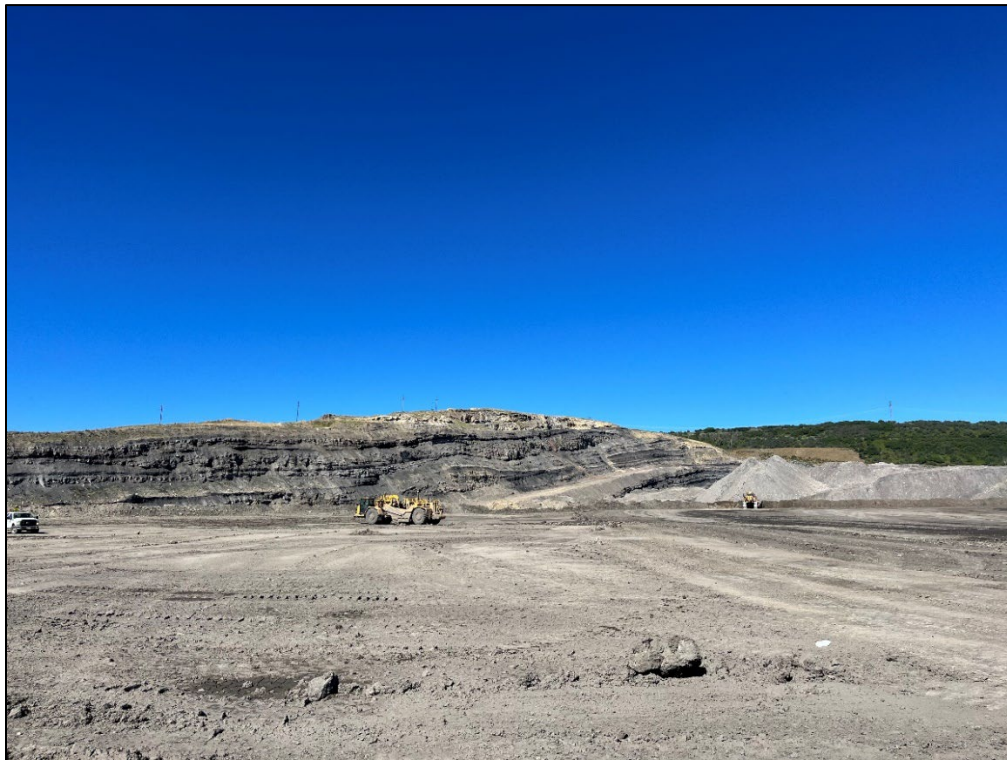
Active backfill operations were observed in the South Taylor Pit during the inspection. Material is excavated from a temporary spoil located just north of the pit and used to fill the pit (Photo 14). A highwall remains to the west for possible future mining.

Photo 14: View west of ongoing backfill activity in the South Taylor Pit.

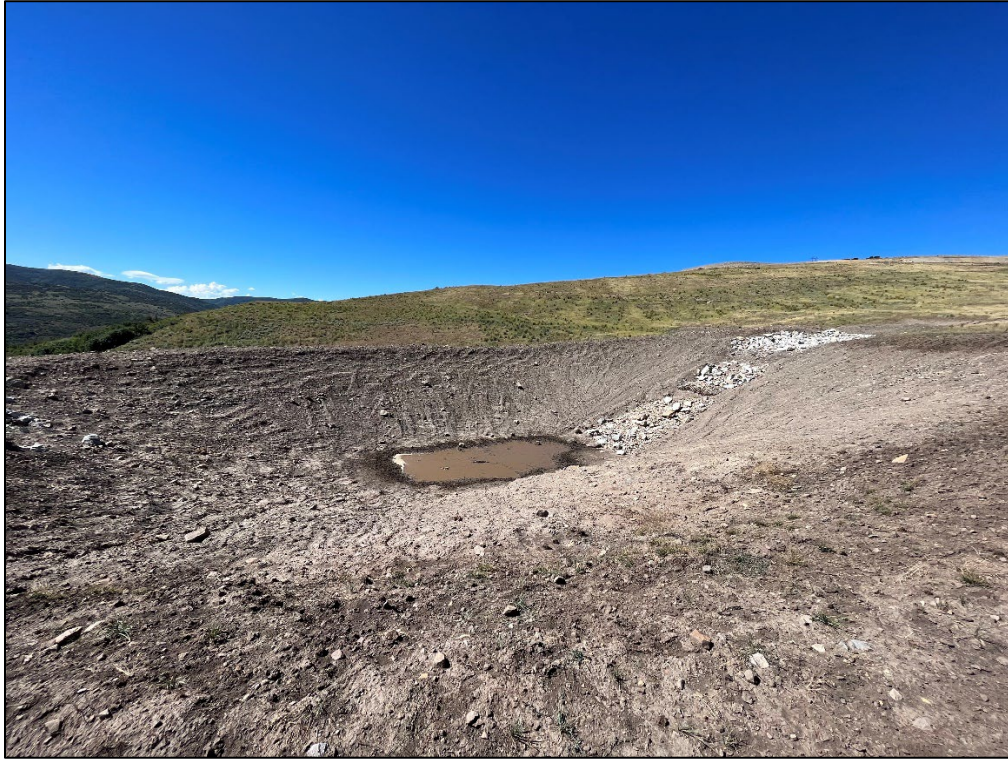
Photo 15: View south of EP2 in the East Pit area.

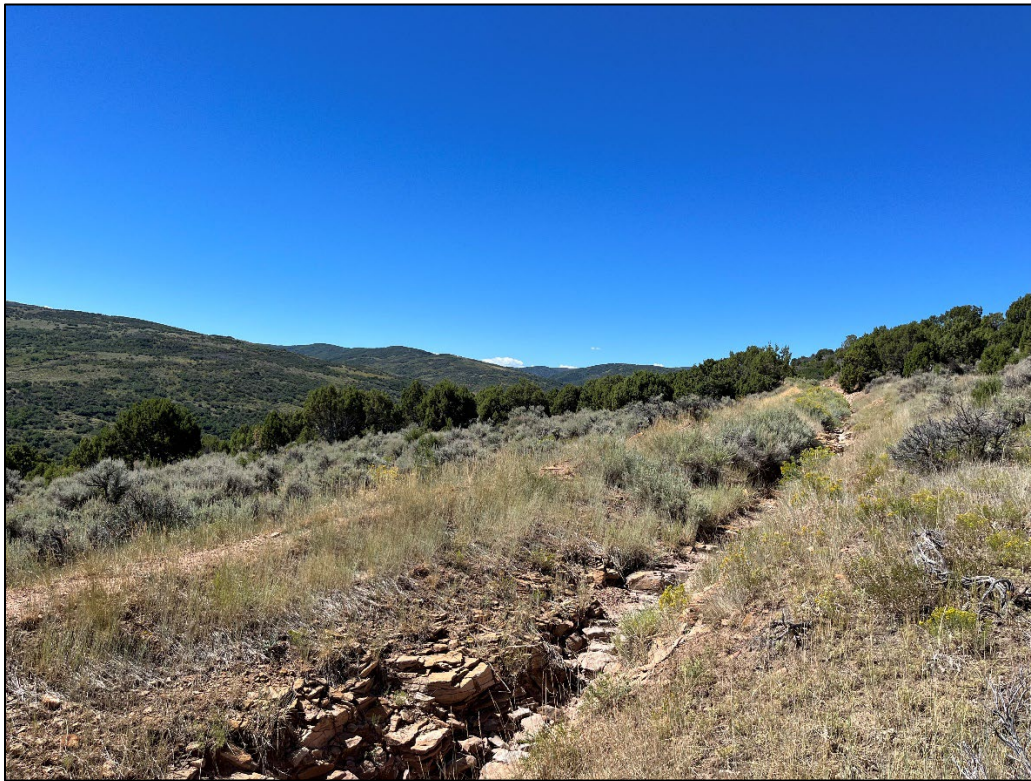
Photo 16: View southeast of the Prospect collection ditch.

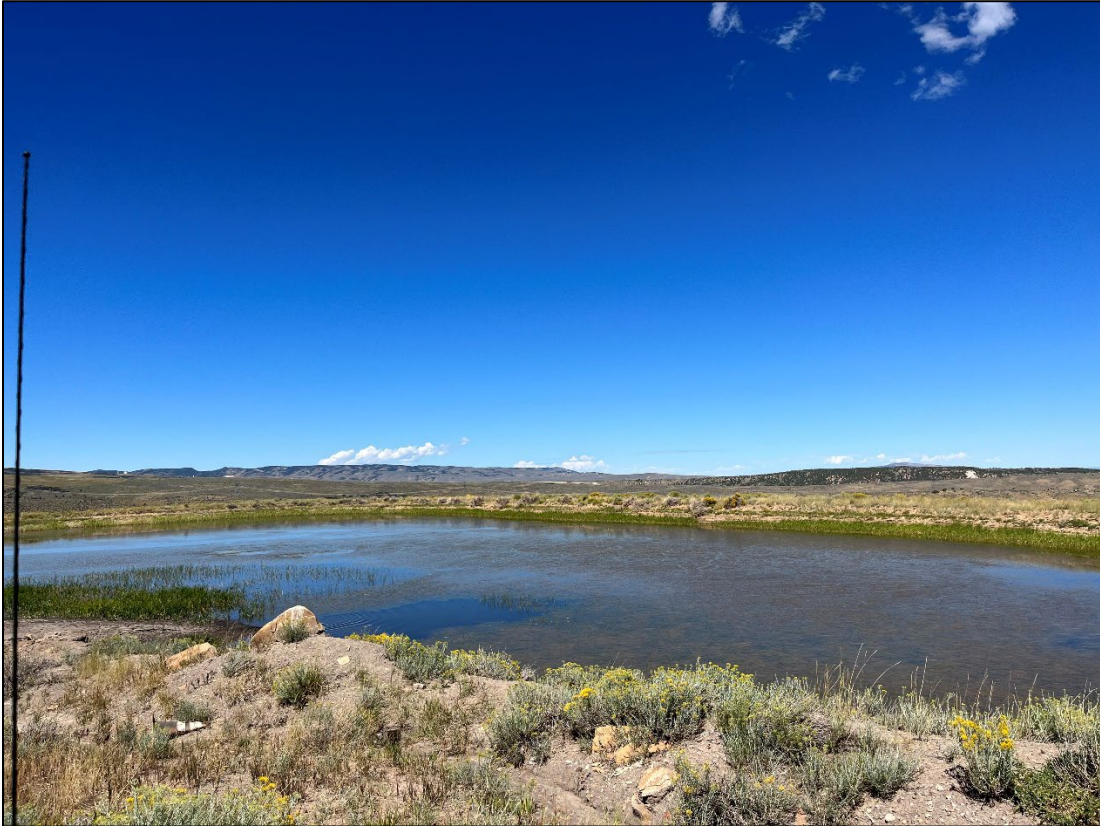
Throughout the summer season the Division has inspected perimeter ditches surrounding disturbances in the South Taaylor area and below Section 16 Pond. The remainder of the perimeter ditch below Section 15 Pond and above Prospect Pond was observed during this inspection. The ditch was found to be dry and stable. The Work Area Pond near the facilities area was also inspected (Photo 17). No issues are reported.

Photo 17: View northwest of the Work Area Pond in the facilities area.
