MINERALS PROGRAM INSPECTION REPORT
PHONE: (303) 866-3567

| MINE NAME: Pikeview Quarry | MINE/PROSPECTING ID#: M-1977-211 | MINERAL: Limestone (general), granite gneiss and do | COUNTY: El Paso |
| INSPECTION TYPE: Monitoring | WEATHER: Clear | INSP. DATE: August 29, 2024 | INSP. TIME: 10:00 |

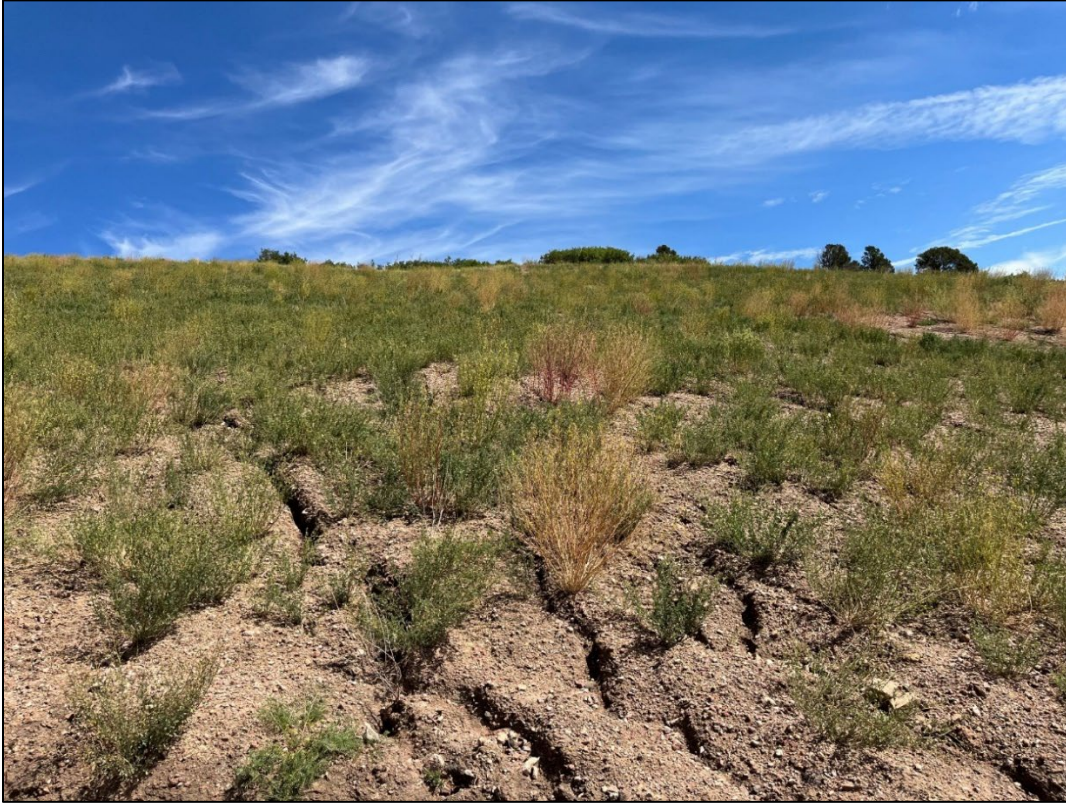
Photo 1: Representative view of northern, unmatted slopes of city property.

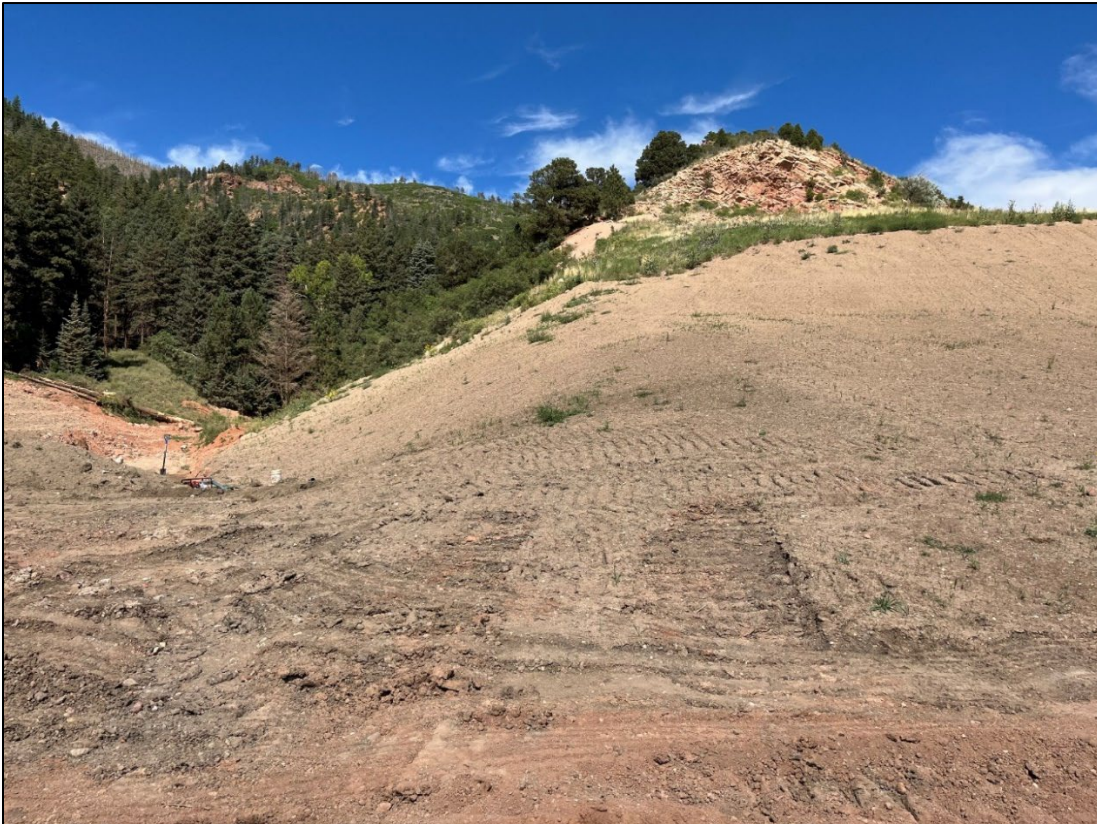
Photo 2: View northwest of U.S. Forest Service land in the northern portion of the site; this area is to be matted for revegetation.

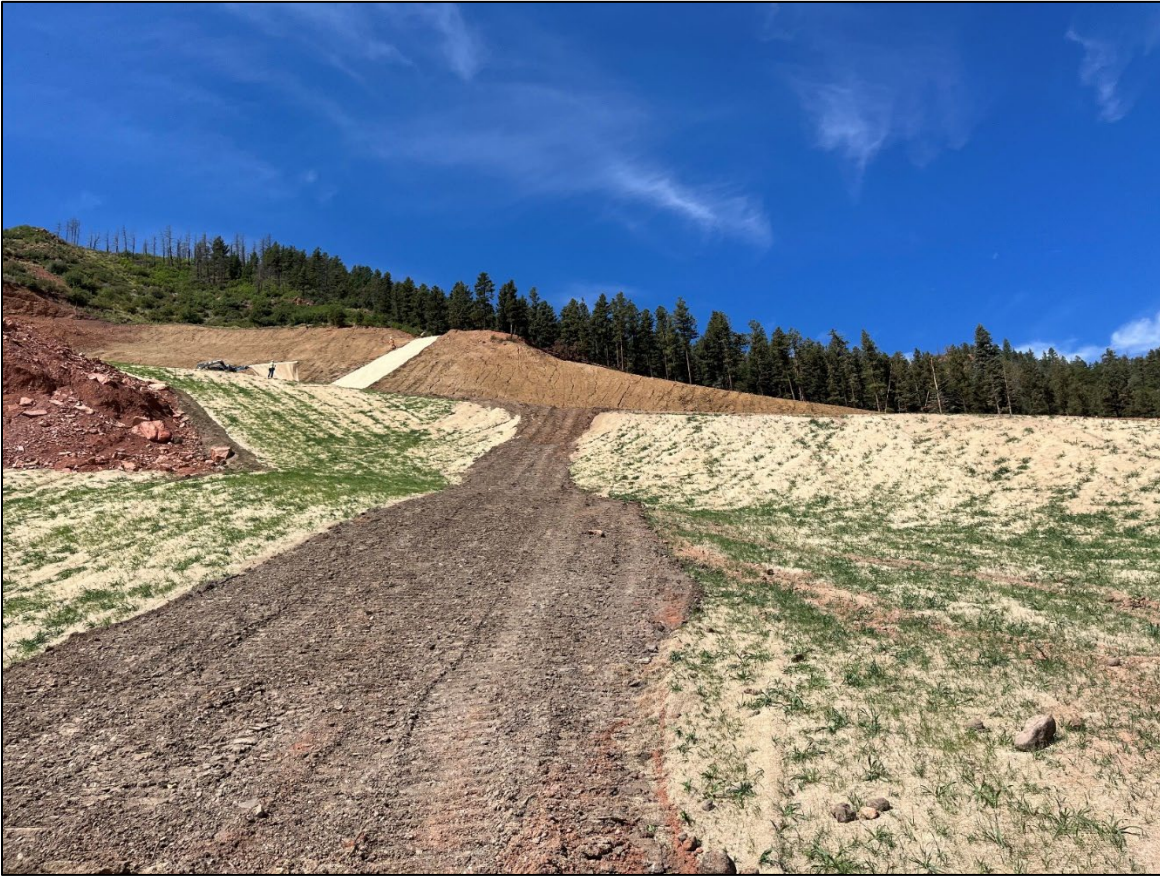
Hydroseeding of the upper peaks is partially complete and matting continues on benches just below this area (Photo 3). Irrigation tanks have been installed along the Level 1 bench, but tanks have yet to be placed on additional slopes. The Division and Mr. Schnabel discussed the advantages and disadvantages of irrigating the matted slopes. Irrigation will help to establish initial vegetative cover, but long-term exposure to irrigation may weaken / shorten the root system of vegetation, making it less resistant to the drier, more infrequent precipitation events usual of this geographic area. Instead, the site may use water trucks to simulate more realistic, infrequent but heavier precipitation events. This would allow root structures to grow stronger in the initial growth stages and adapt to the naturally sporadic precipitation events that will follow once irrigation stops. This will set vegetation up for success in final reclamation and create vegetated conditions that are in compliance with Rule 3.1.10(1).

Photo 3: View northwest from City property, matting is being applied to upper slopes.

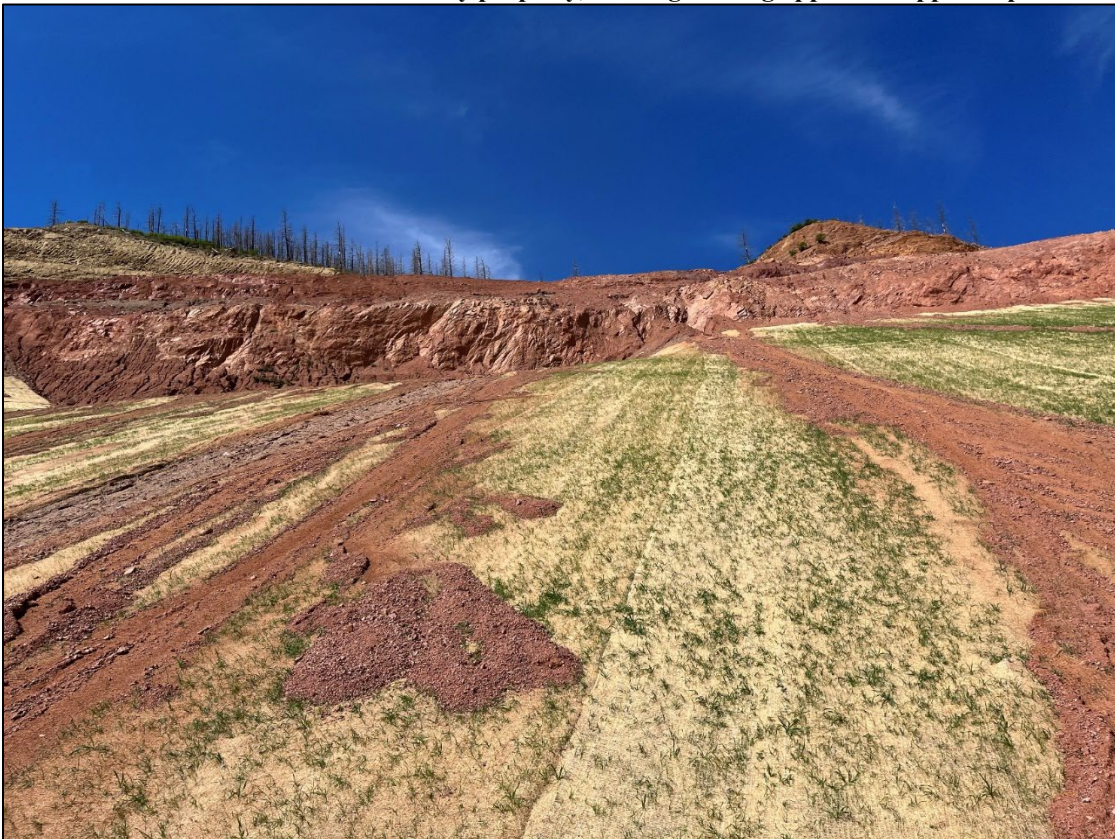
Maintenance on coconut matting impacted by storm events continues. A small amount of erosion and sedimentation can be seen on the middle benches (Photo 4). As benches above these areas are seeded and matted, erosion will decrease. Grass was observed to be growing through these small patches of deposited material.

Photo 4: View west near the BFR area, grass continues to grow through sedimented material.

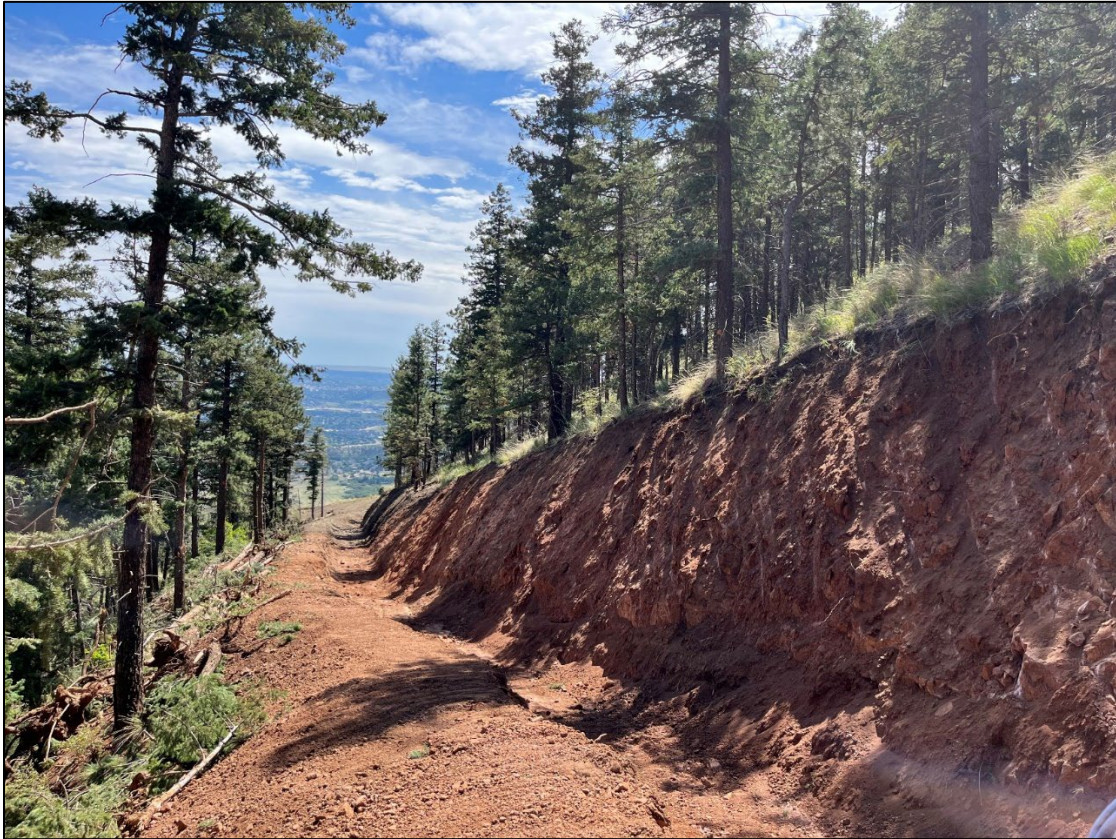
Roads: As stated in previous inspection reports, the Forest Service has requested that no formal roads are to remain on their portion of the property in final reclamation. The Forest Service inspected Pikeview's current work on road obliteration in the southern drainage channel area and approved the obliterated state of the western half of the channel area (Photo 5). The Forest Service had concerns about a portion of the channel designed to be slightly

Photo 5: View east of the southernmost drainage channel, site of road obliteration on U.S. Forest Service land.

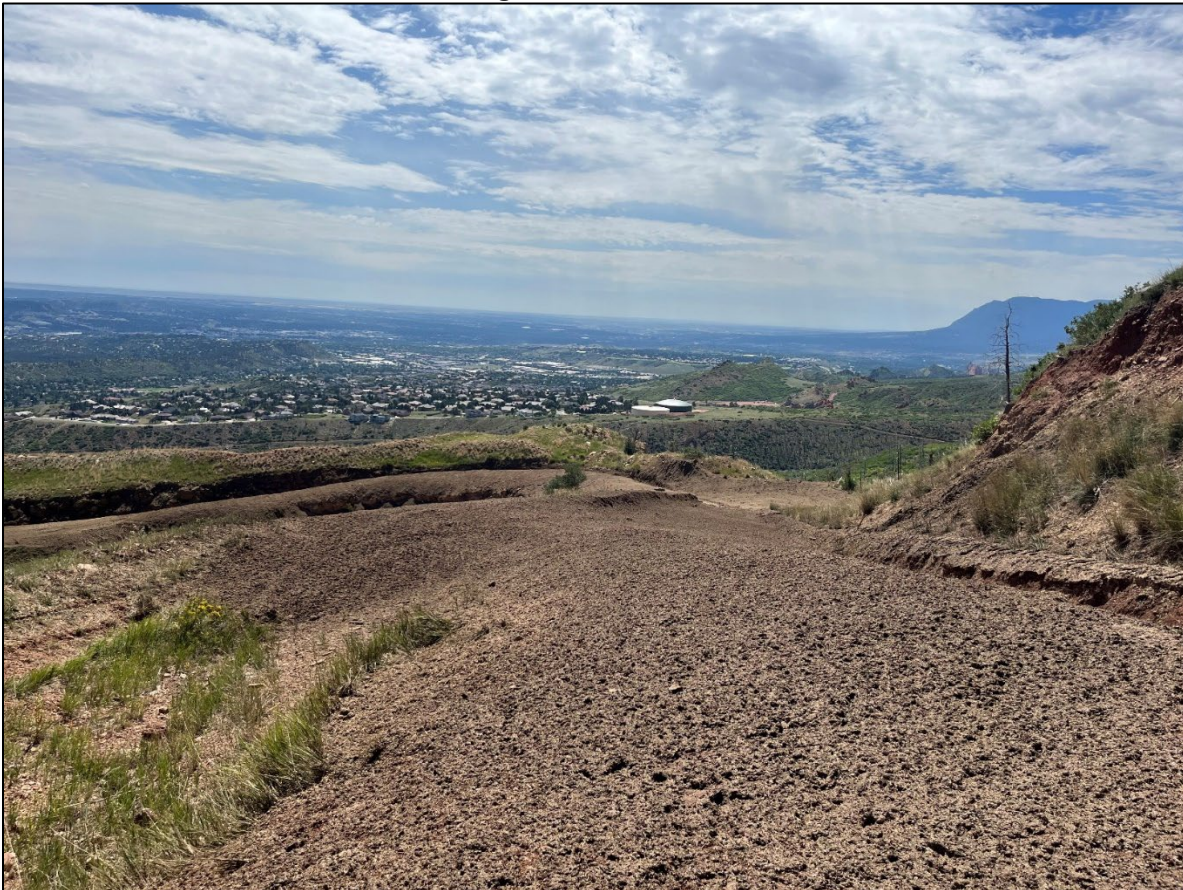
flattened (Photo 6) and the potential for erosion gullies and scouring of channel sides. Further discussion of this item can be found under the 'Sediment Control' section. The Forest Service also stated that if the widened, flat area of the channel is to remain, road obliteration further down the slope should ensure that the area is completely inaccessible via motorized vehicles. Further barriers will include large boulders and tree debris.

The City and Forest Service voiced their concern regarding construction of the southernmost drainage channel. While the channel is currently built to the DRMS approved design, on-site conditions suggest the potential for erosion gullies, scouring of channel sides, or stormwater overtopping the sides of the channel. The channel is steep in some areas, especially along the widened area (Photos 8 and 10) and the turn of the channel is relatively sharp cut (Photo 9). Meaning, stormwater could potentially run outside of the channel or erode the channel and impact function. While the armoring of the entire channel may not be necessary, the Division suggests that some type of

Photo 6: View southeast of a widened area of the southernmost drainage channel.

energy dissipating structure would be beneficial in this portion of the channel where steep grades will encourage fast flowing water. However, should the channel prove to function effectively as an unlined limestone and granite bedrock channel as per the approved design, then no additional armoring will be required by the Division.

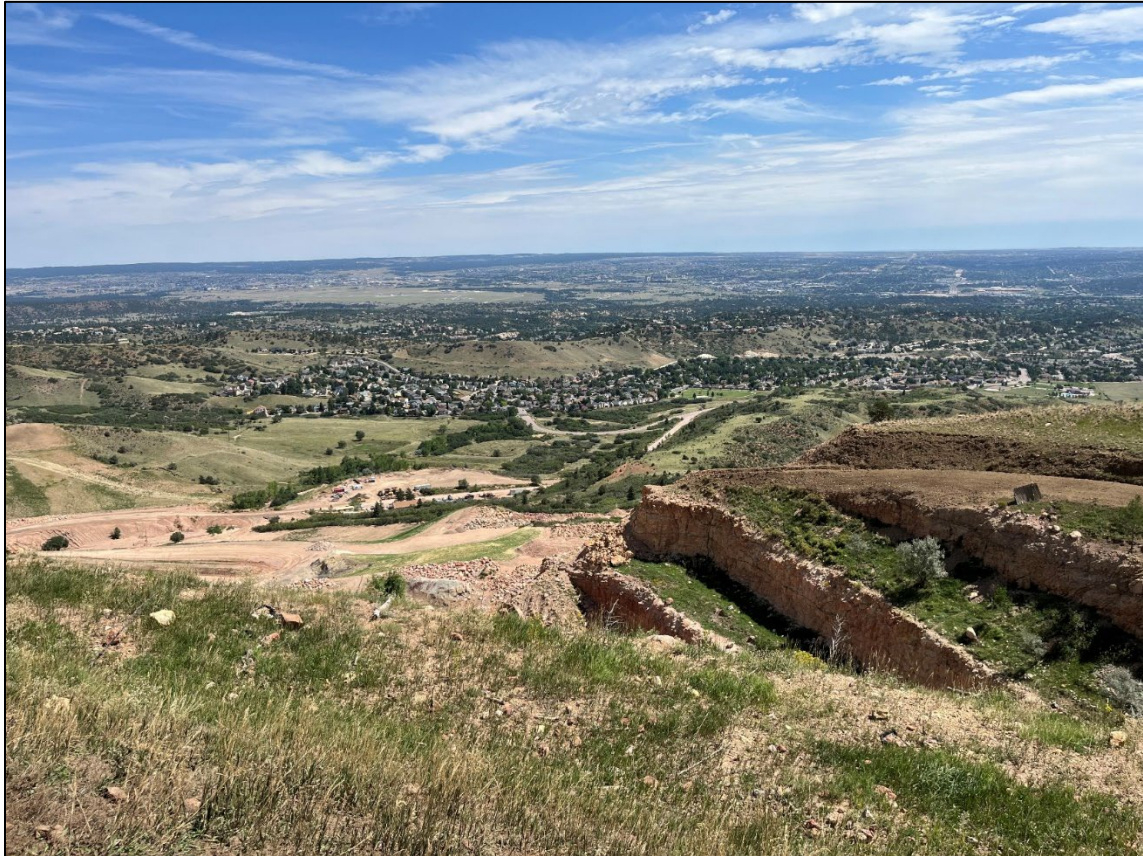
Photo 7: View east of the end of the southern drainage channel, water will be routed over the edge of this feature into a plunge pool.

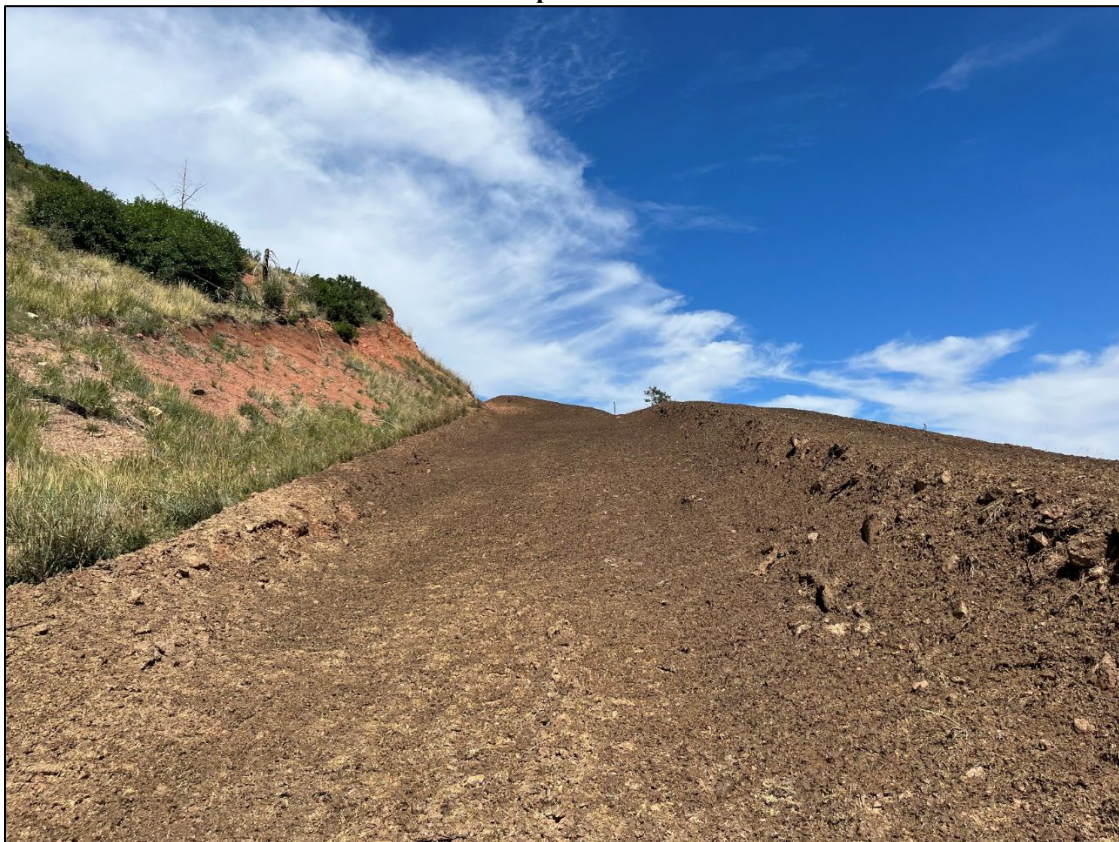
Photo 8: View looking up from the flattened area of the southern drainage channel.

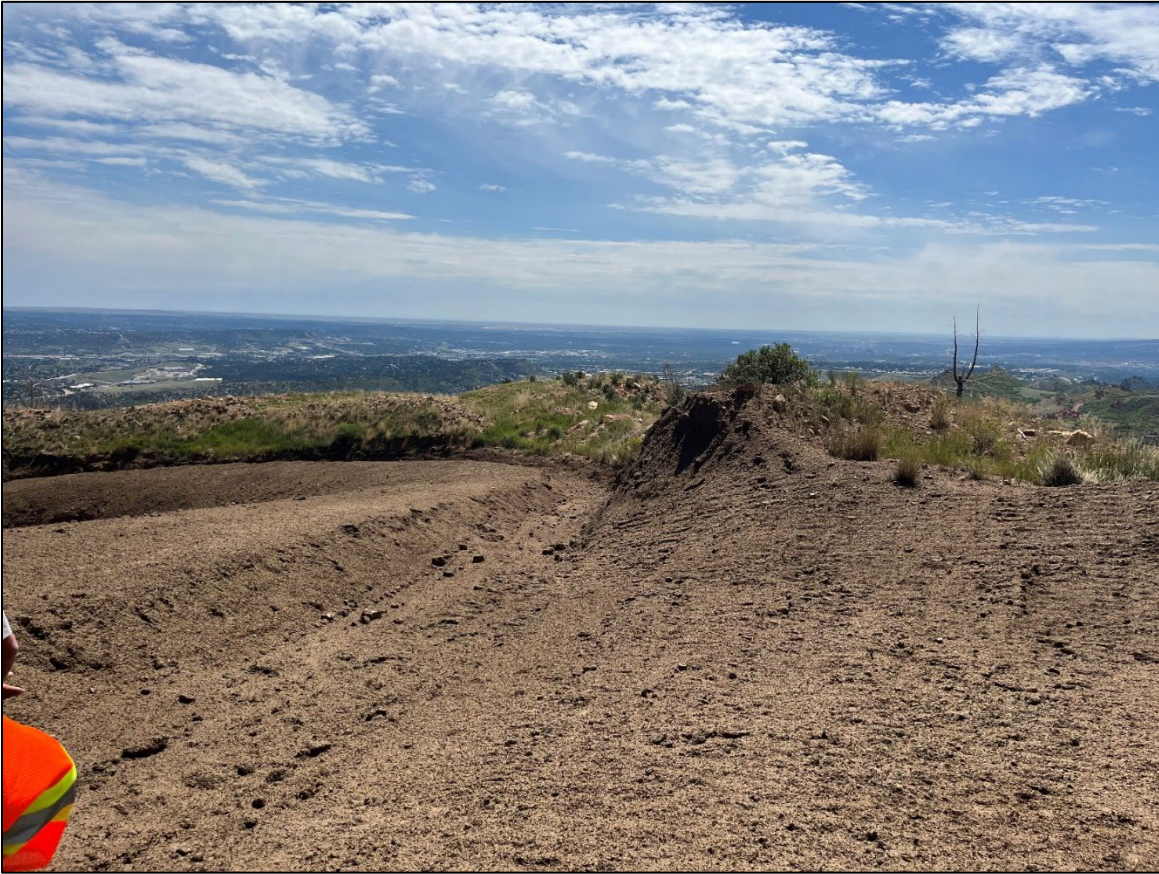
Photo 9: View south from the flat portion of the drainage channel.

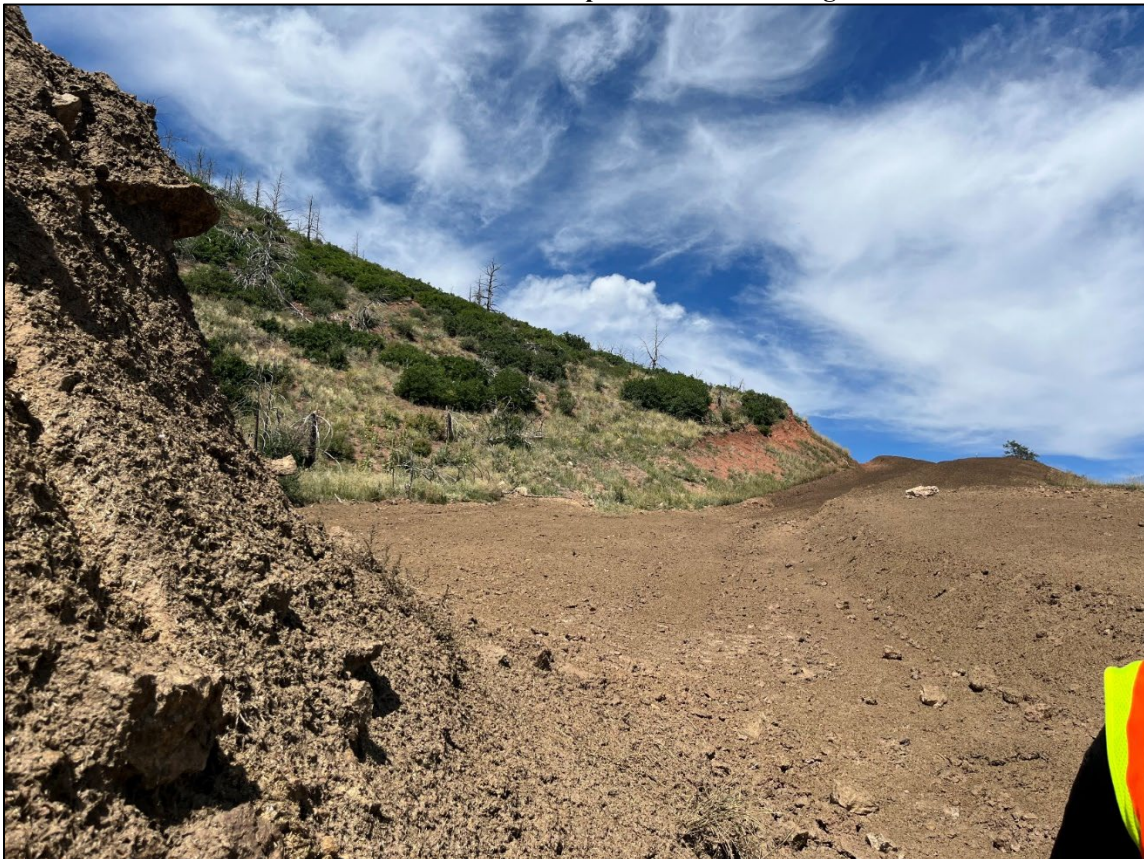
Photo 10: View northwest from the turn at the southern corner of the drainage channel.

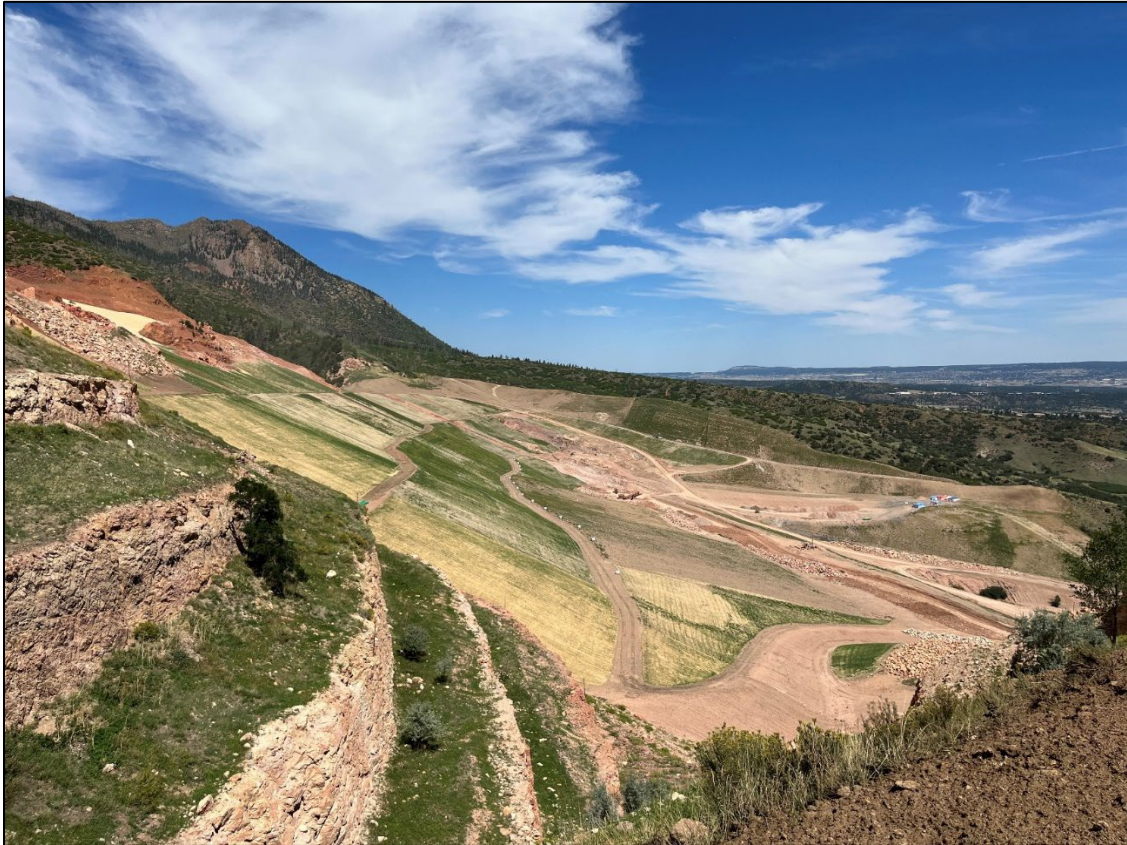
Photo 11: View north of the matted and buttressed slope.

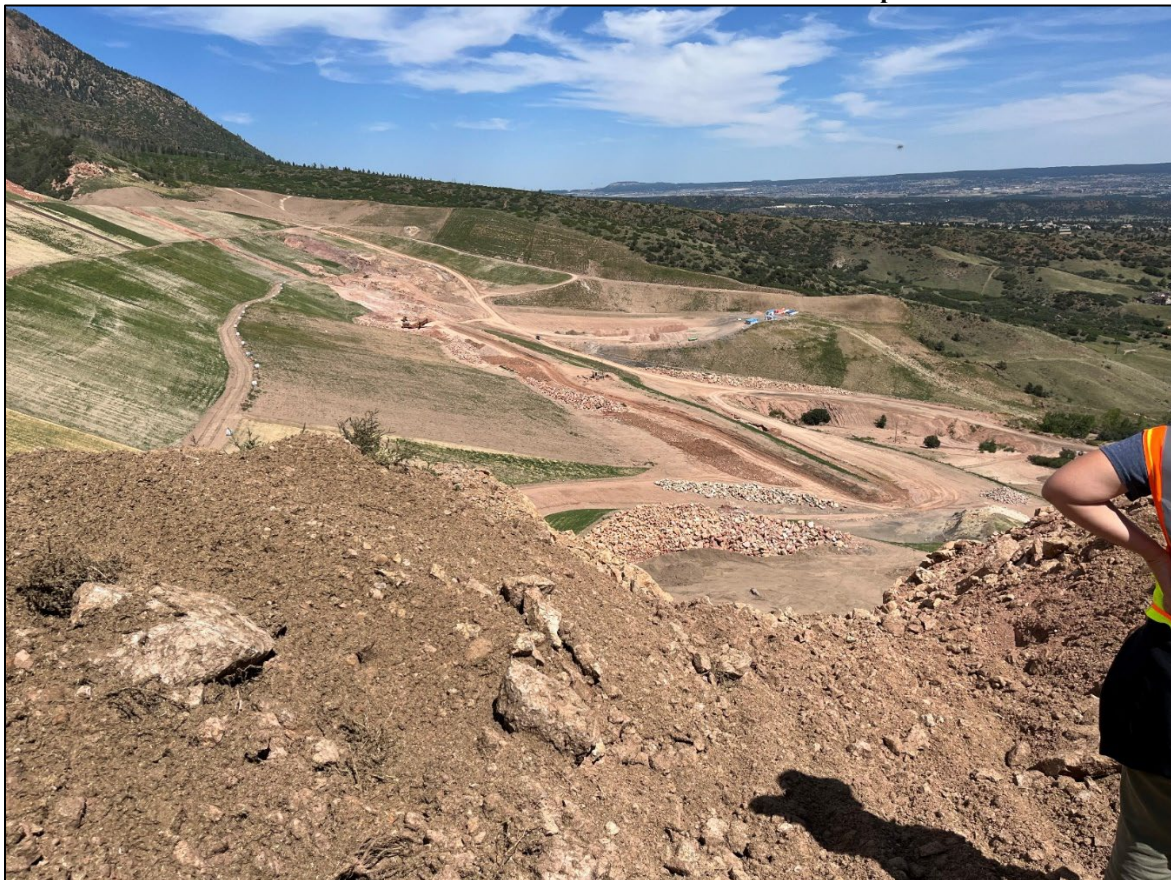
Photo 12: View of the lower benches of the buttressed slope.

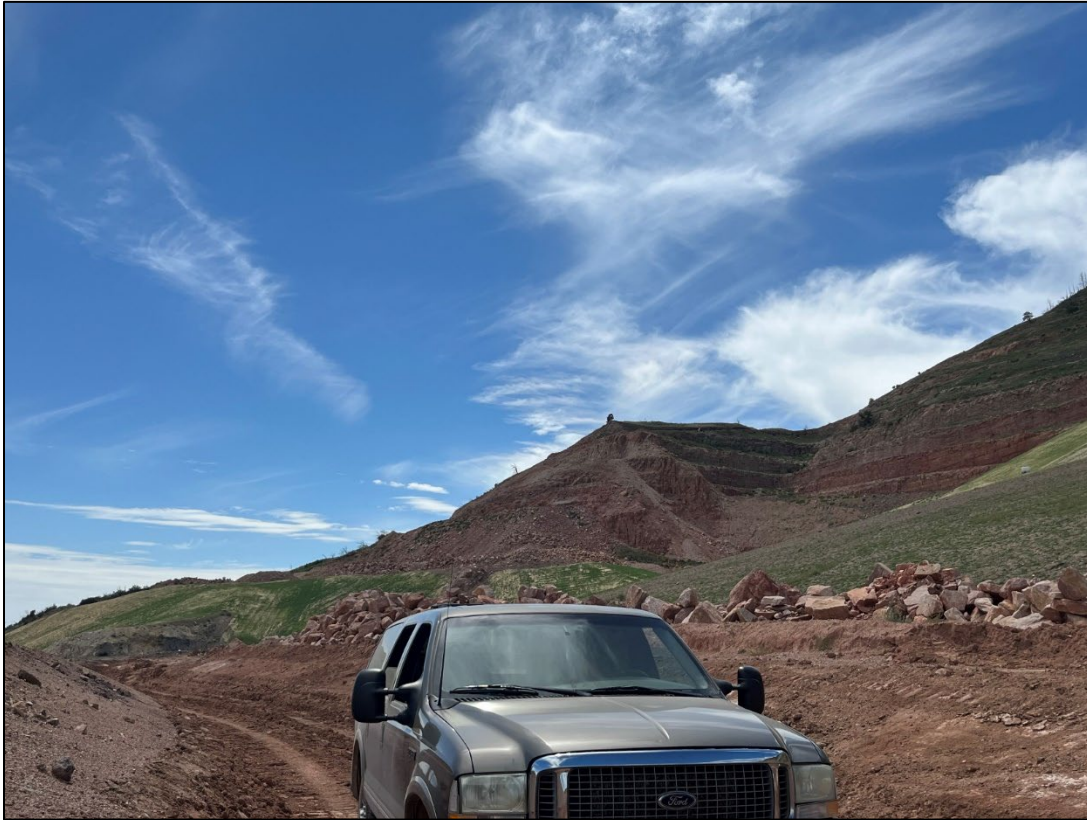
The Forest Service, Division, and site personnel also discussed plans for grading and revegetation of the north facing slope in the South Borrow area (Photo 13). This area is currently rocky and unvegetated but could potentially be partially vegetated using similar methods as used on the three peaks area. Discussion of this item has been included as a post-inspection follow up item.

Photo 13: View south of the rocky southern slope, revegetation of this area is currently being discussed.
