MINERALS PROGRAM INSPECTION REPORT
PHONE: (303) 866-3567

MINE NAME: Idarado Mining Co	MINE/PROSPECTING ID#: M-1977-403-HR	MINERAL: Lead, zinc, copper, c gold	COUNTY: San Miguel
INSPECTION TYPE: Monitoring	WEATHER: Foggy	INSP. DATE: July 25, 2024	INSP. TIME: 09:05
OPERATOR: Idarado Mining Company	OPERATOR REPRESENTATIVE: Devon Horntvedt	TYPE OF OPERATION: 112d-3 - Designated Mining Operation	
REASON FOR INSPECTION: Normal I&E Program	BOND CALCULATION TYPE:	BOND AMOUNT: \$226,600.00	
DATE OF COMPLAINT: NA	POST INSP. CONTACTS: None	JOINT INSP. AGENCY: None	
INSPECTOR(S): Lucas West Amber Gibson Hunter Ridley	INSPECTOR'S SIGNATURE:

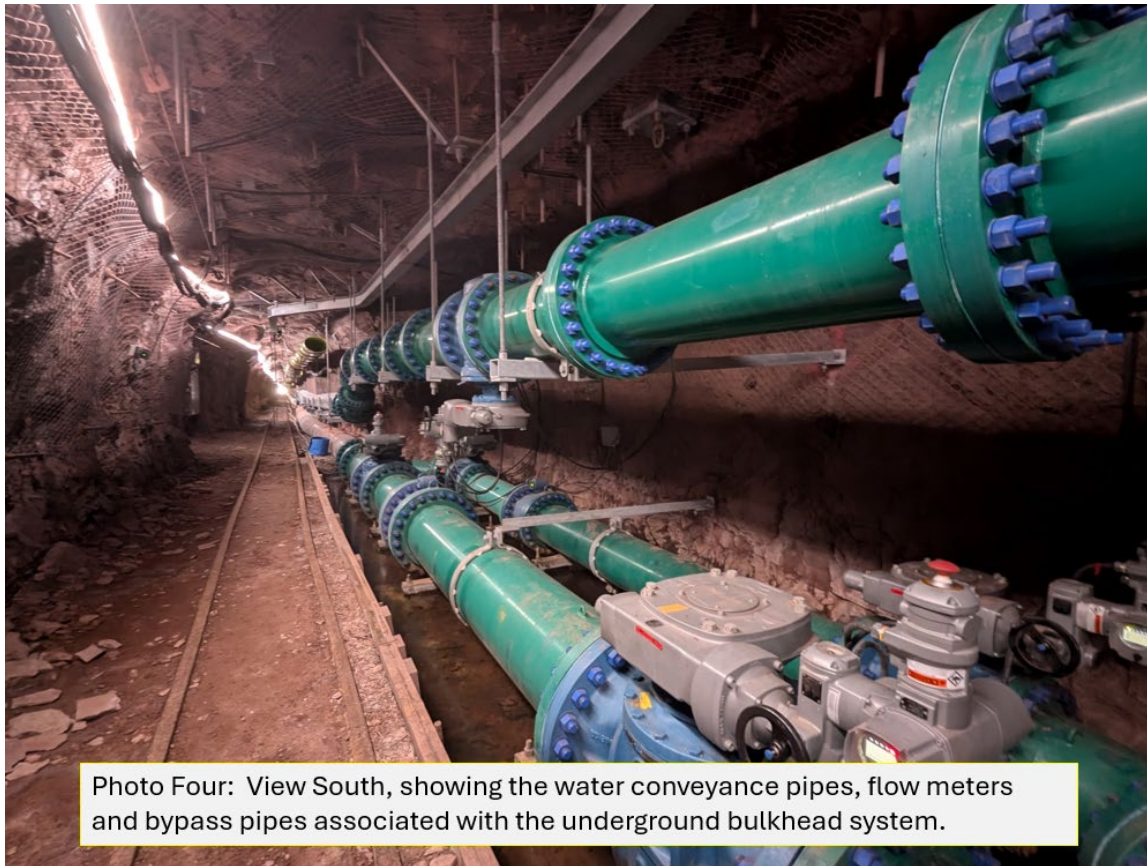
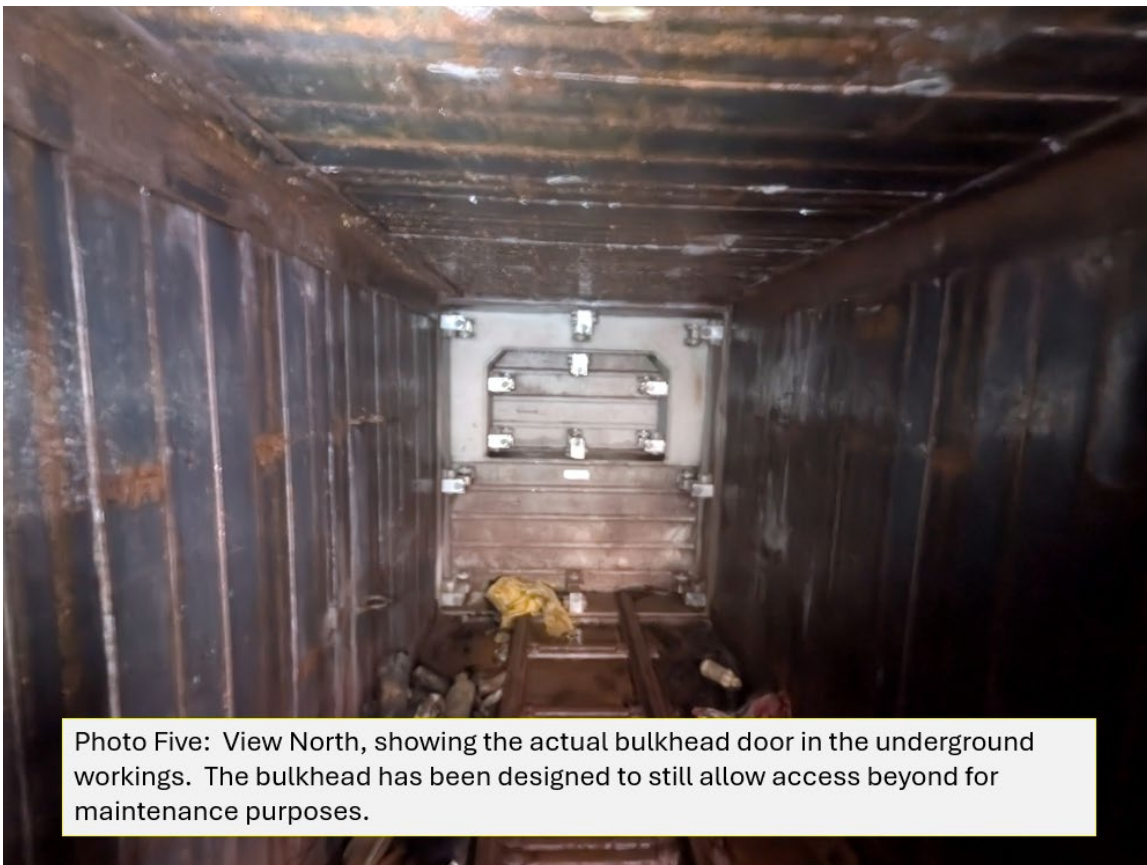
Telluride Facilities: The Telluride Facilities were not active during the inspection. This permitted area consists mostly of the Pandora Mill Building, Mill Level Portal, as well as various out structures and tailings impoundments. The Mill Building appears to be stable and in good condition. The train shed, shops and the various other outbuildings in the area are in similar condition as the previous inspection conducted by the Division. Examples of the various outbuildings and structures can be seen in Photos One and Two. The Mill Level Portal was observed to be secured at the time of the inspection and discharging to the lagoons. The gated closure, as seen in Photo Three, showed no signs of vandalism or attempted unauthorized entry. The recently completed flow through Bulkhead, associated water lines and telemetric systems, located in the underground working were inspected. The Bulkhead was designed and installed to meter the flow of the discharge out of the portal, using the underground workings as a storage reservoir to control the rate of flow into the treatment lagoons. All elements of the Bulkhead system are in excellent condition and functioning as designed at the time of the inspection. Examples of the system can be seen in Photos Four and Five.

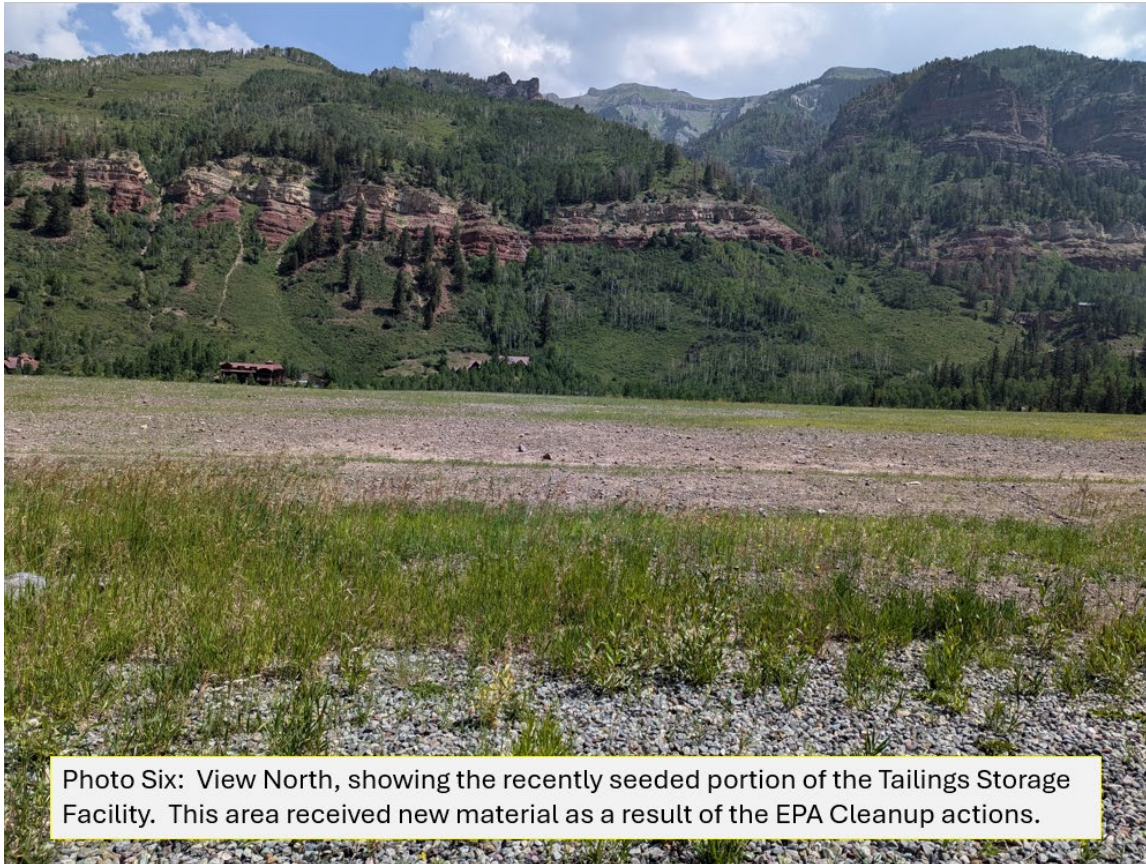
Photo Six: View North, showing the recently seeded portion of the Tailings Storage Facility. This area received new material as a result of the EPA Cleanup actions.

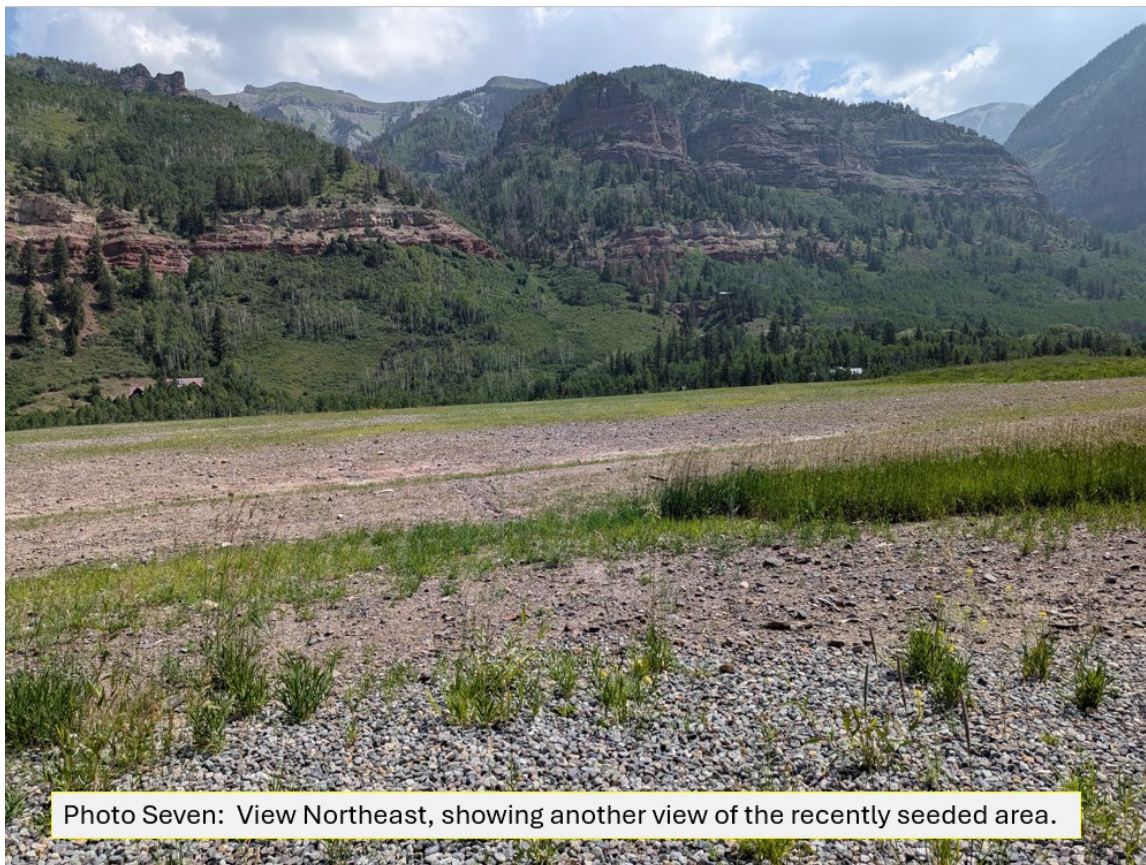
Photo Seven: View Northeast, showing another view of the recently seeded area.
