**MINERALS PROGRAM INSPECTION REPORT**  
**PHONE: (303) 866-3567**

<b>MINE NAME:</b> Logan Mill Site and Adjoining Lands	<b>MINE/PROSPECTING ID#:</b> P-1999-009	<b>MINERAL:</b> Gold and silver	<b>COUNTY:</b> Boulder
<b>INSPECTION TYPE:</b> Monitoring	<b>WEATHER:</b> Cloudy	<b>INSP. DATE:</b> September 4, 2024	<b>INSP. TIME:</b> 11:15
<b>OPERATOR:</b> Deward E. Walker Jr.	<b>OPERATOR REPRESENTATIVE:</b> Joe Ben Walker	<b>TYPE OF OPERATION:</b> MP - Mineral Prospecting	
<b>REASON FOR INSPECTION:</b> Normal I&E Program	<b>BOND CALCULATION TYPE:</b> Partial Bond	<b>BOND AMOUNT:</b> \$1,800.00	
<b>DATE OF COMPLAINT:</b> NA	<b>POST INSP. CONTACTS:</b> None	<b>JOINT INSP. AGENCY:</b> None	
<b>INSPECTOR(S):</b> Patrick Lennberg	<b>INSPECTOR'S SIGNATURE:</b>

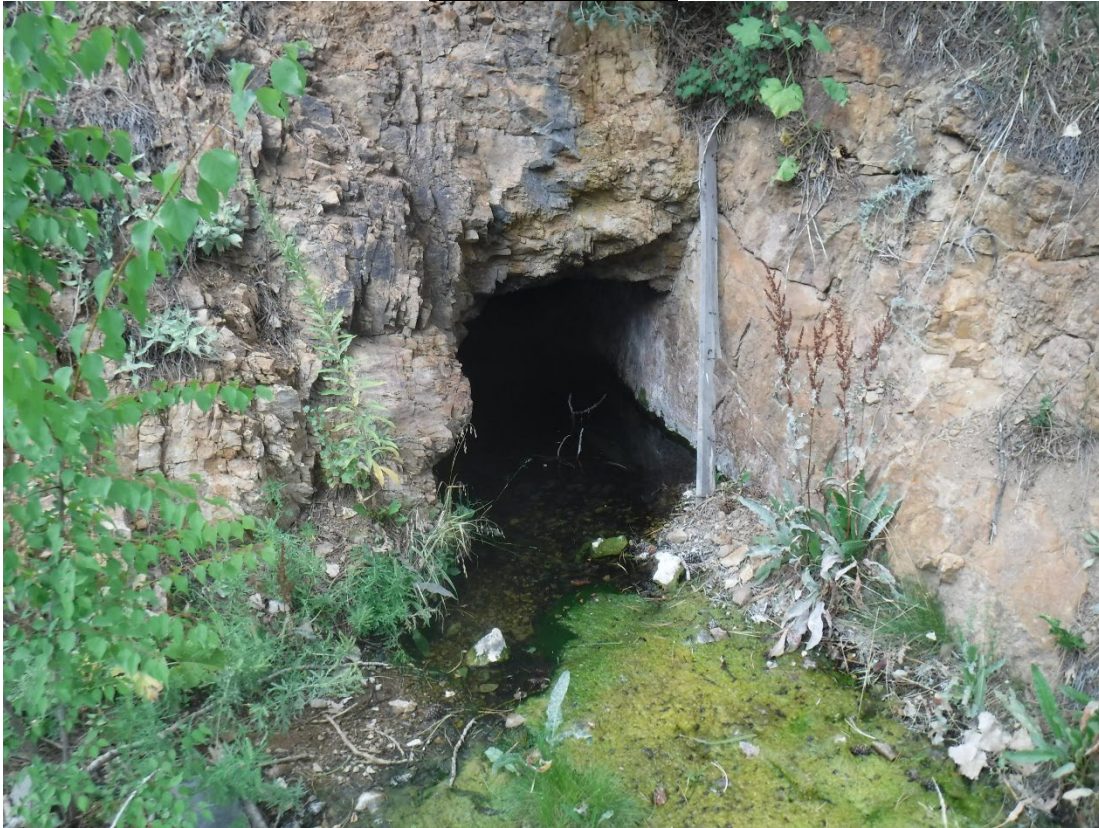
**Photo 1:** Cascade Portal across from primary residence

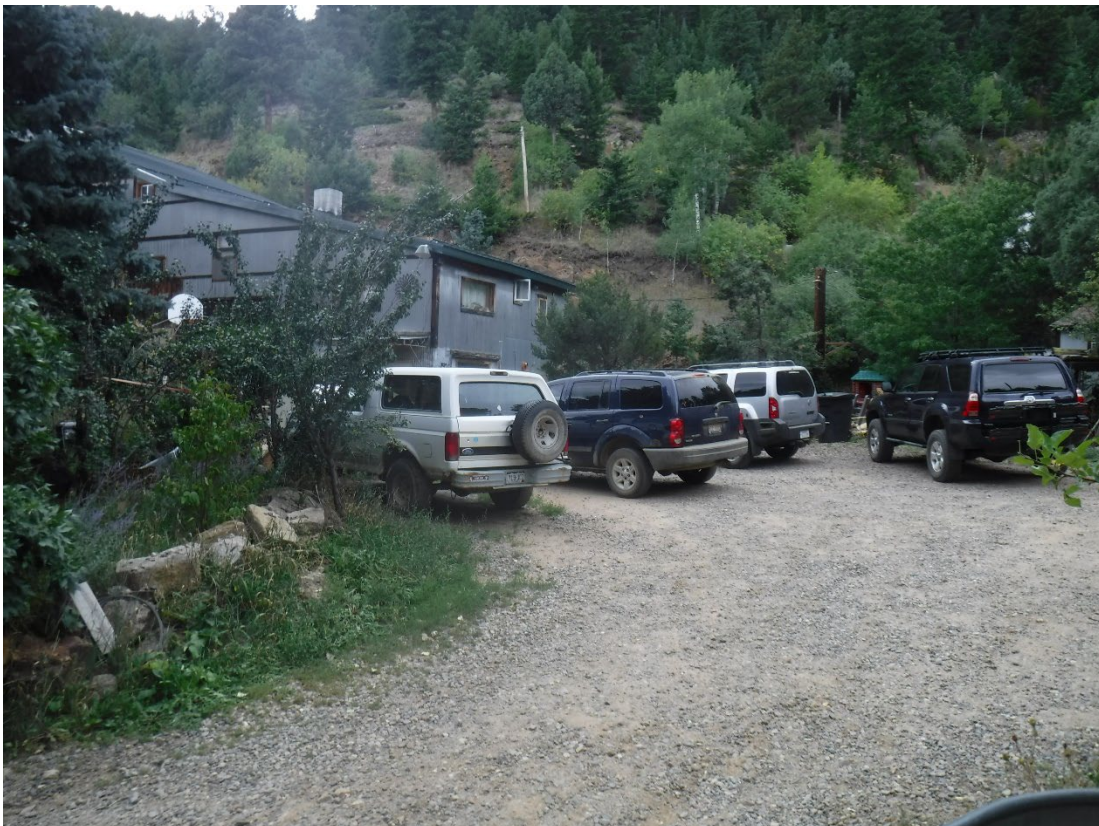
**Photo 2:** Primary residence, Logan Mine Portal(s) are located uphill from house

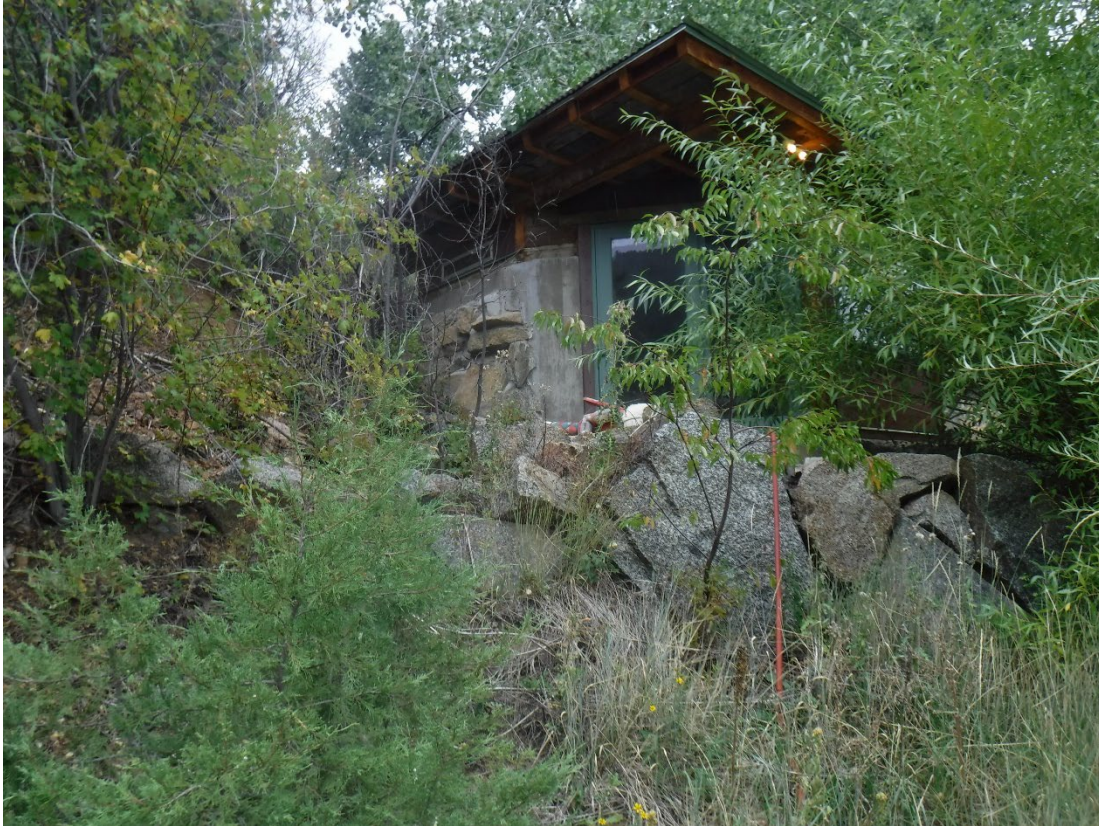
**Photo 3:** One of Logan Mine Portals

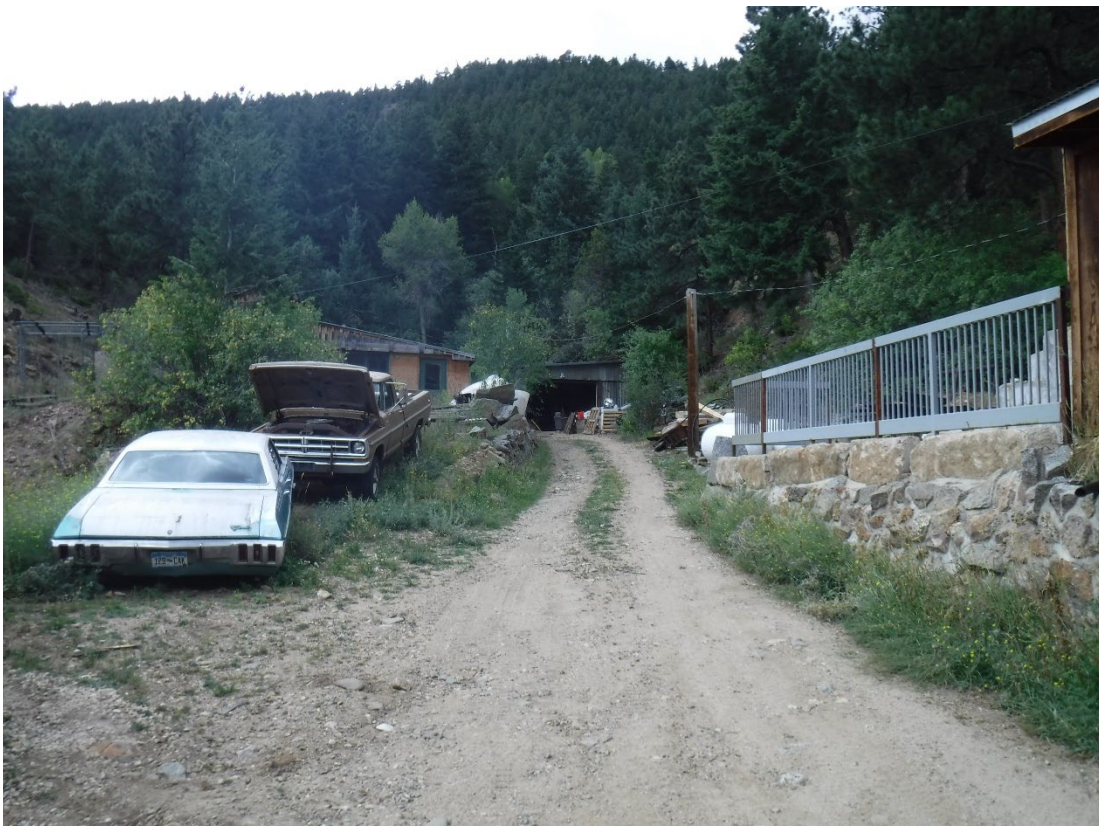
**Photo 4:** Looking south to the Clipper Portal from one of two rental houses.  
The second rental house is to the left of the portal entry and is vacant

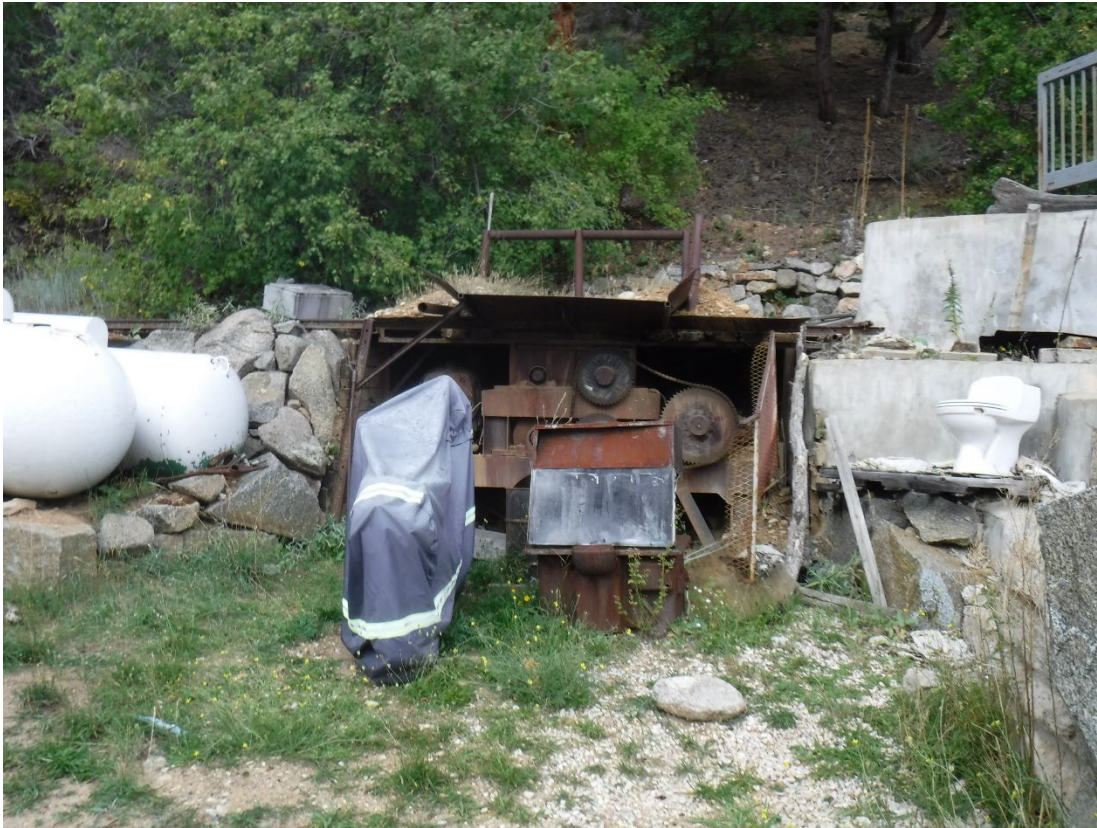
**Photo 5:** Rock crusher north of Clipper Portal.

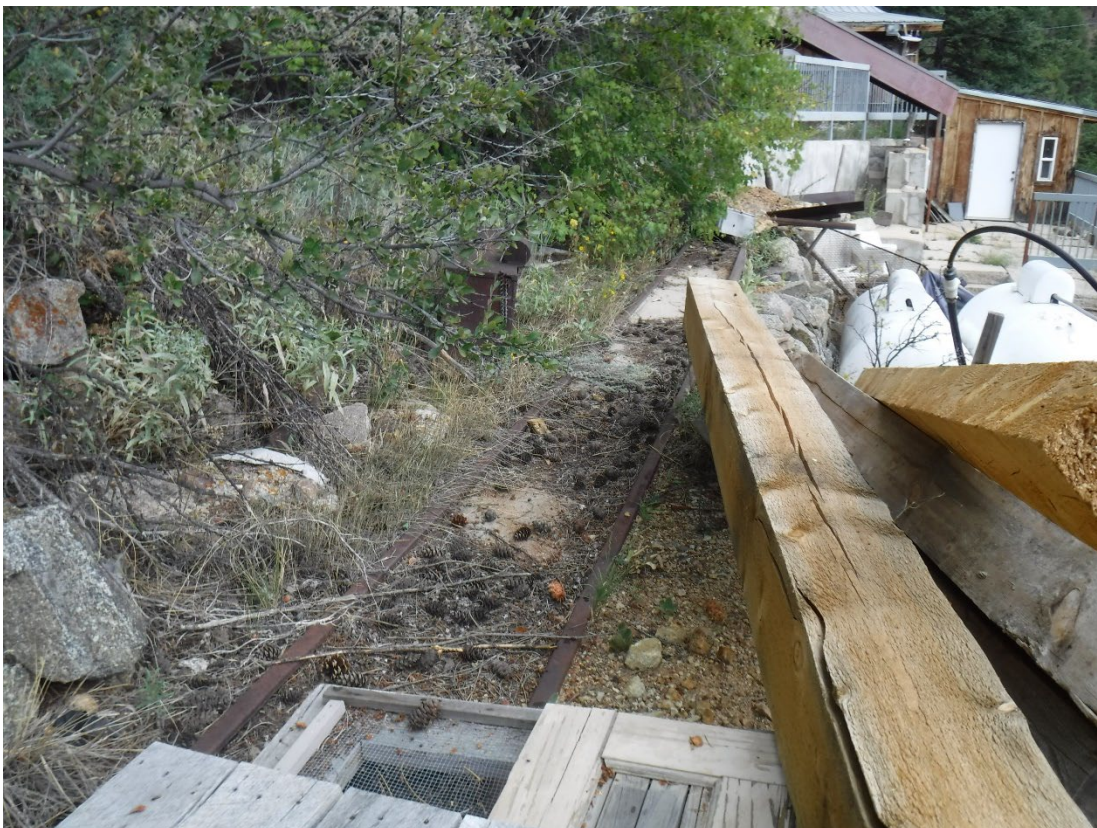
**Photo 6:** Tracks from Clipper Portal to rock crusher.

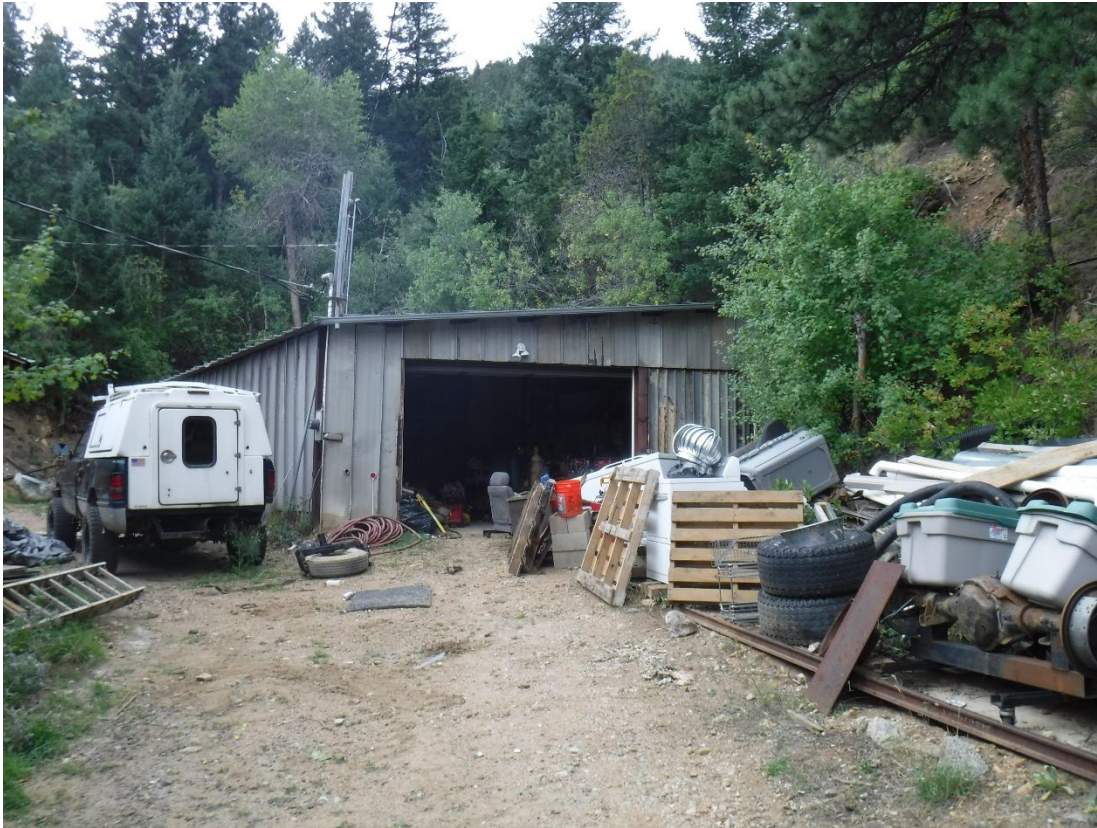
The site was not active at the time of inspection. The Division also viewed several of the old waste rock dumps. All dumps are in good condition and in stable condition. The Clipper portal was inspected, located just south of a residence. The operator plans on continuing to rehabilitate the shed that covers the portal entry along with getting the fire assay lab equipment up and running. The White Pine Portal, previously identified as the Clipper Portal, has collapsed over time and would need extensive rehabilitation to safely access. The Operator intends to evaluate the waste rock pile at the entrance of the portal. The Division reiterated if they do not plan on rehabilitating the portal entry, they may reach out to the Inactive Mine Program, 303-866-3567, to inquire if it was a candidate for their closure program.

**Photo 7:** Shed over Clipper Portal.

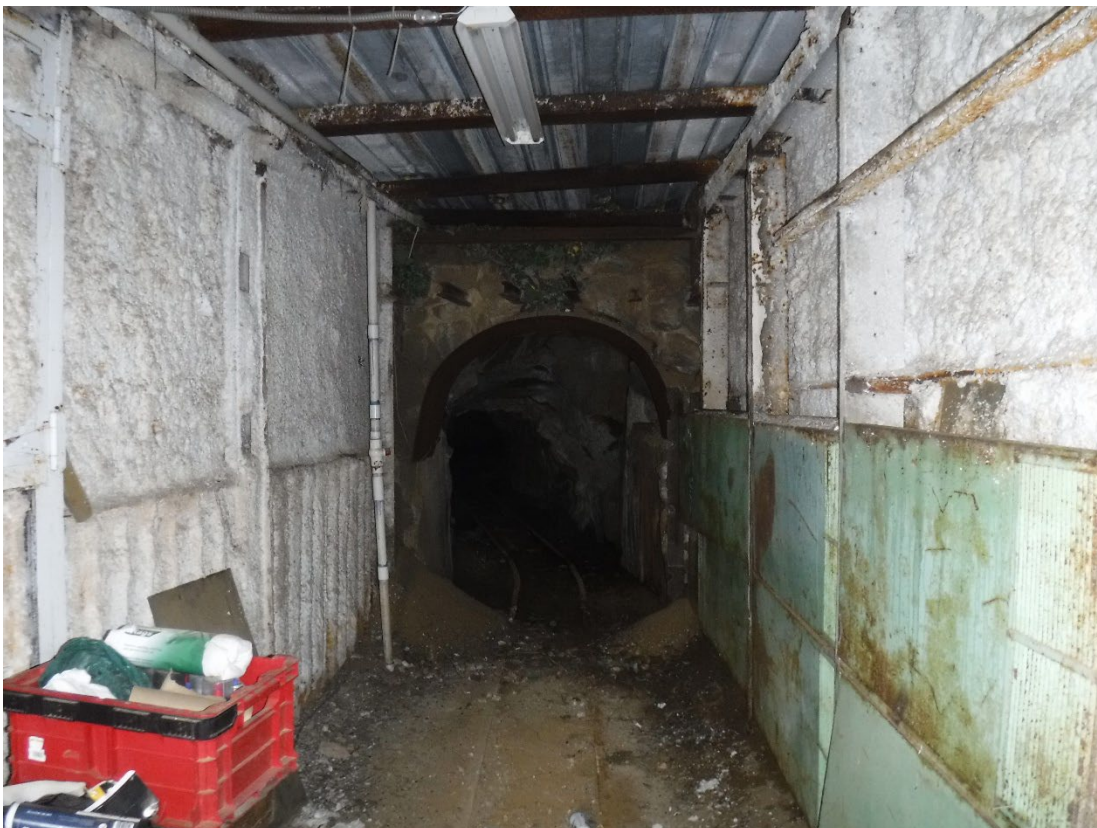
**Photo 8:** Clipper Portal.
