## C1981022, Elk Creek Mine, August Inspection Report

<b>Permit Number:</b> C-1981-022 <b>Mine Name:</b> Elk Creek Mine <b>Operator:</b> Oxbow Mining, LLC <b>Operator Address:</b> Mr Doug Smith 3737 Hwy 133 P. O. Box 535 Somerset, CO 81434	<b>County:</b> Delta, Gunnison <b>Operation Type:</b> Underground <b>Permit Status:</b> Active <b>Ownership:</b> Private
	<b>Operator Representative Present:</b>  N/A
<b>Operator Representative Signature: (Field Issuance Only)</b>

<b>Inspection Start Date:</b> August 27, 2024 <b>Inspection Start Time:</b> 12:00 <b>Inspection End Date:</b> <b>Inspection End Time:</b>	<b>Inspection Type:</b> Coal Partial Inspection <b>Inspection Reason:</b> Normal I&E Program <b>Weather:</b> Clear
<b>Joint Inspection Agency:</b>  None	<b>Joint Inspection Contacts:</b>  
<b>Post Inspection Agency:</b>  None	<b>Post Inspection Contacts:</b>  
<b>Inspector(s):</b>  Leigh Simmons	<b>Inspector's Signature:</b>

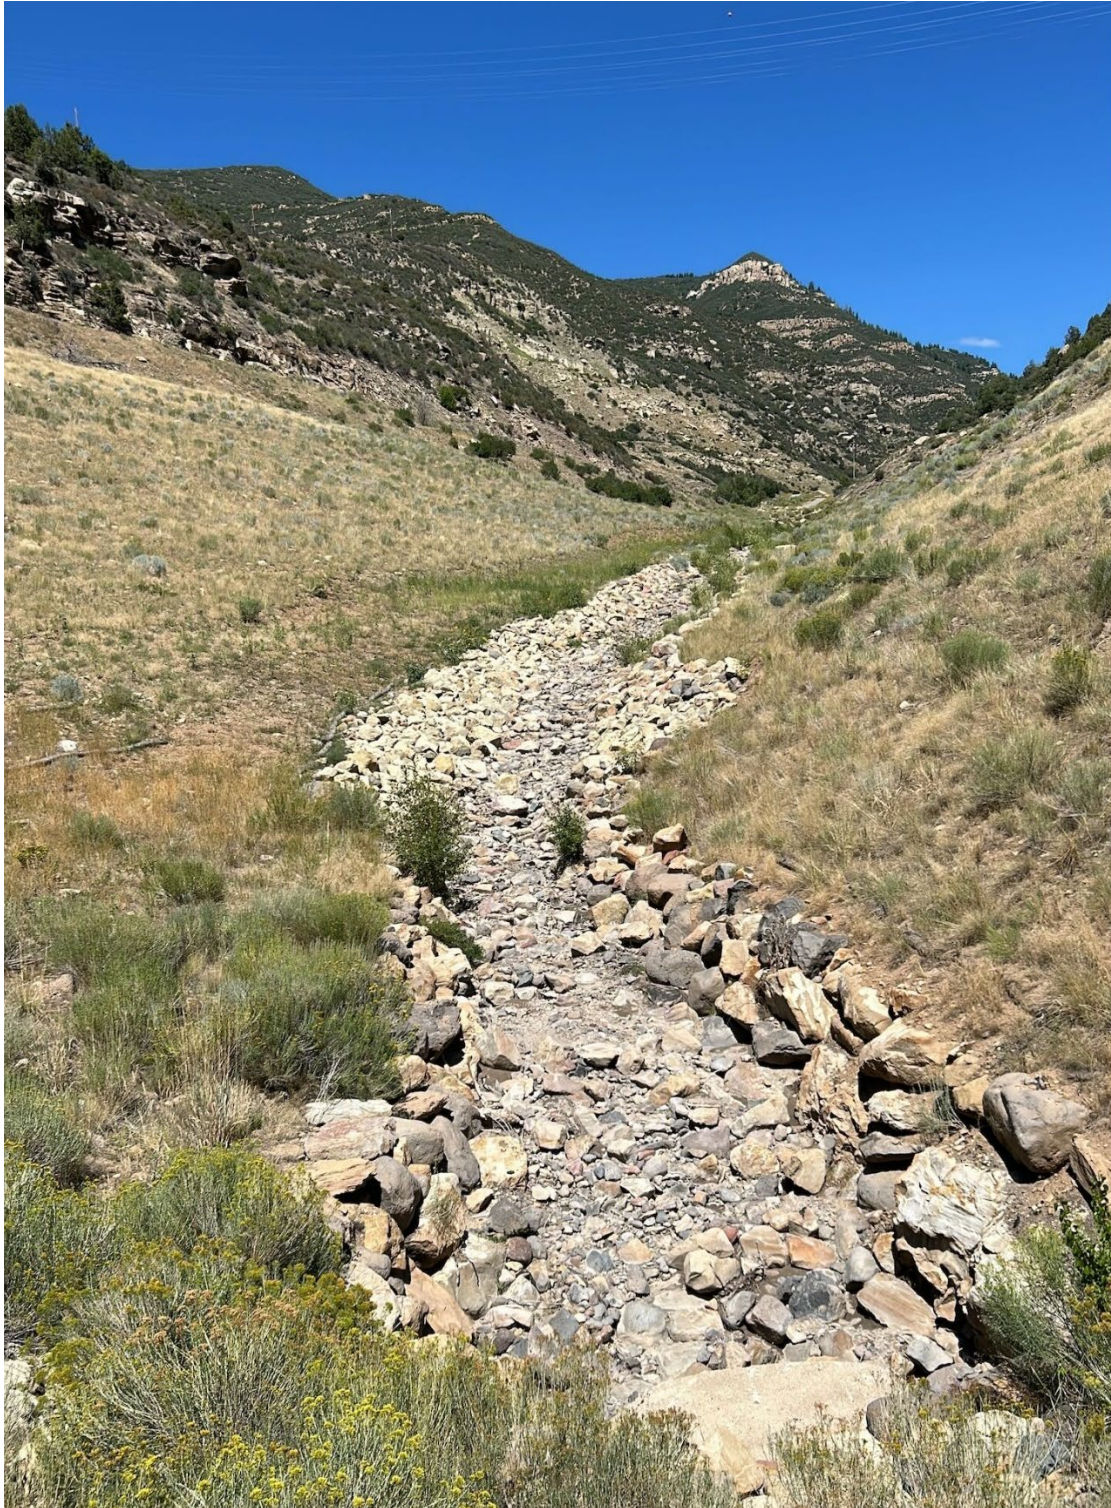
The water in the Elk Creek channel had completely dried up, despite recent stormy weather. The repaired sections of the channel were in good shape.

*Figure 1: Elk Creek Channel dry*

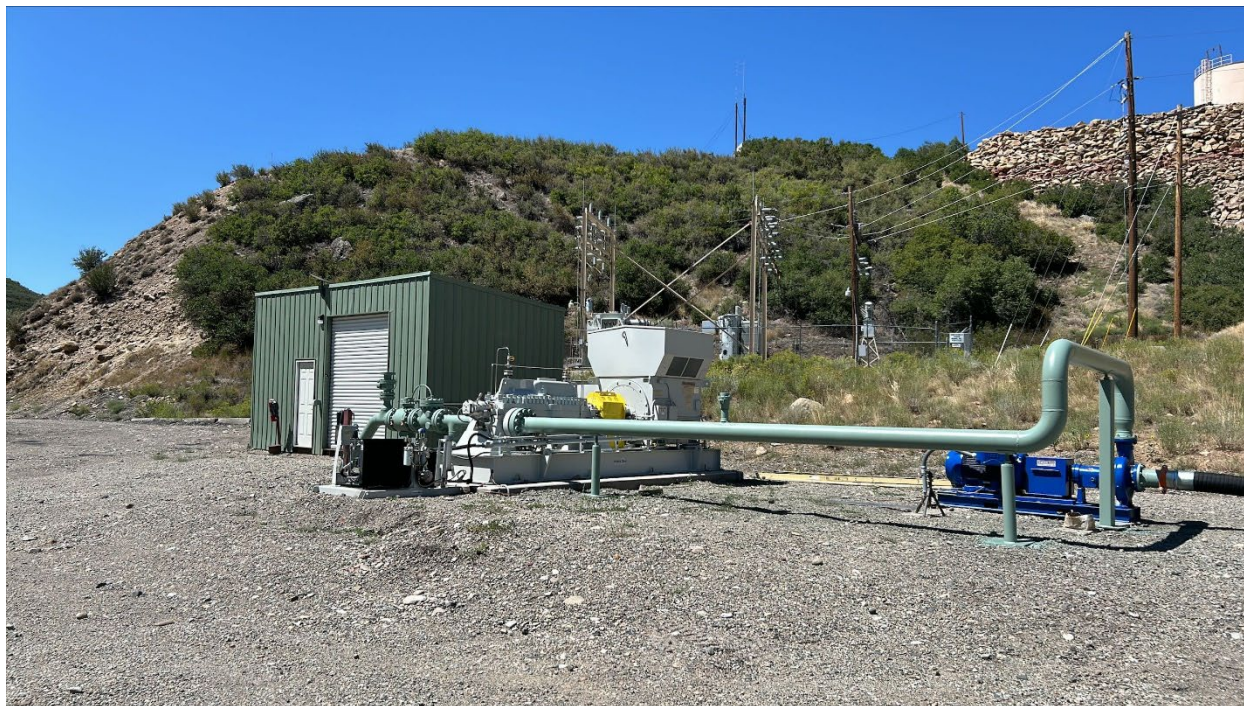
Facilities for the Gunnison Energy oil and gas project to the north of the permit area had been installed, and the hdpe water pipeline had been connected.

Figure 2: Gunnison Energy facility

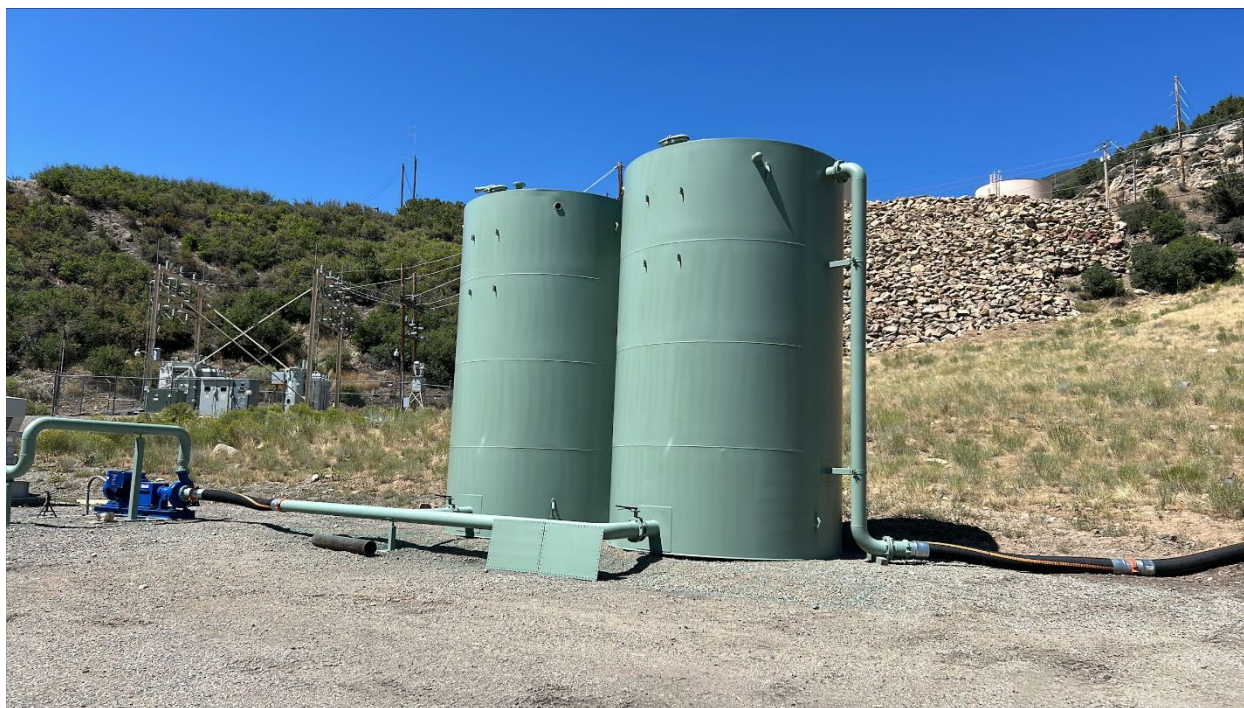
Figure 3: Gunnison Energy water tanks

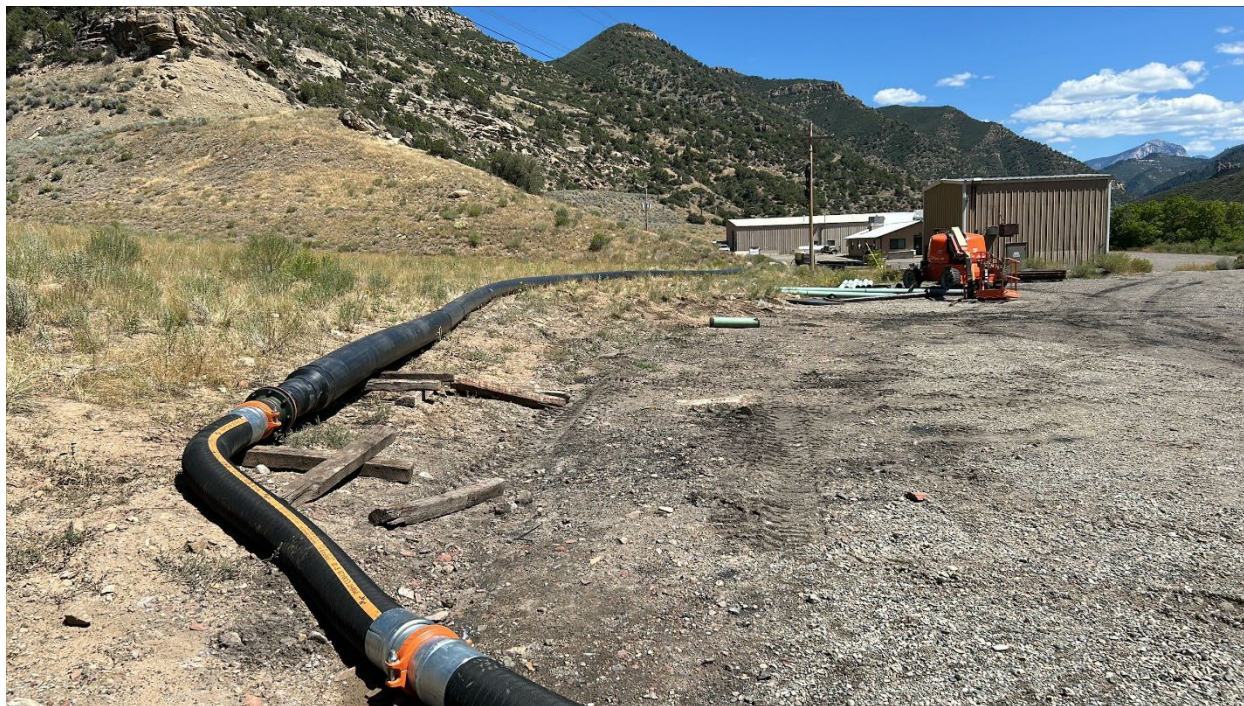
*Figure 4: Gunnison Energy pipeline*

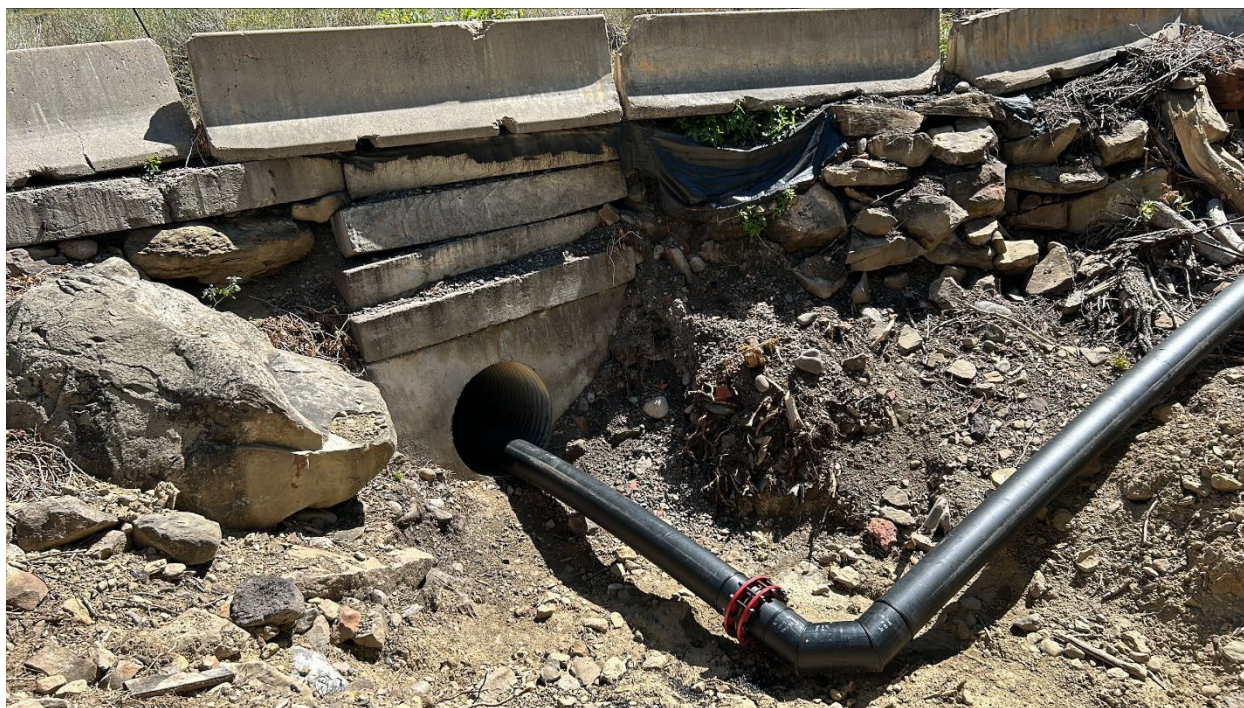
*Figure 5: Eastern end of Gunnison Energy pipeline*

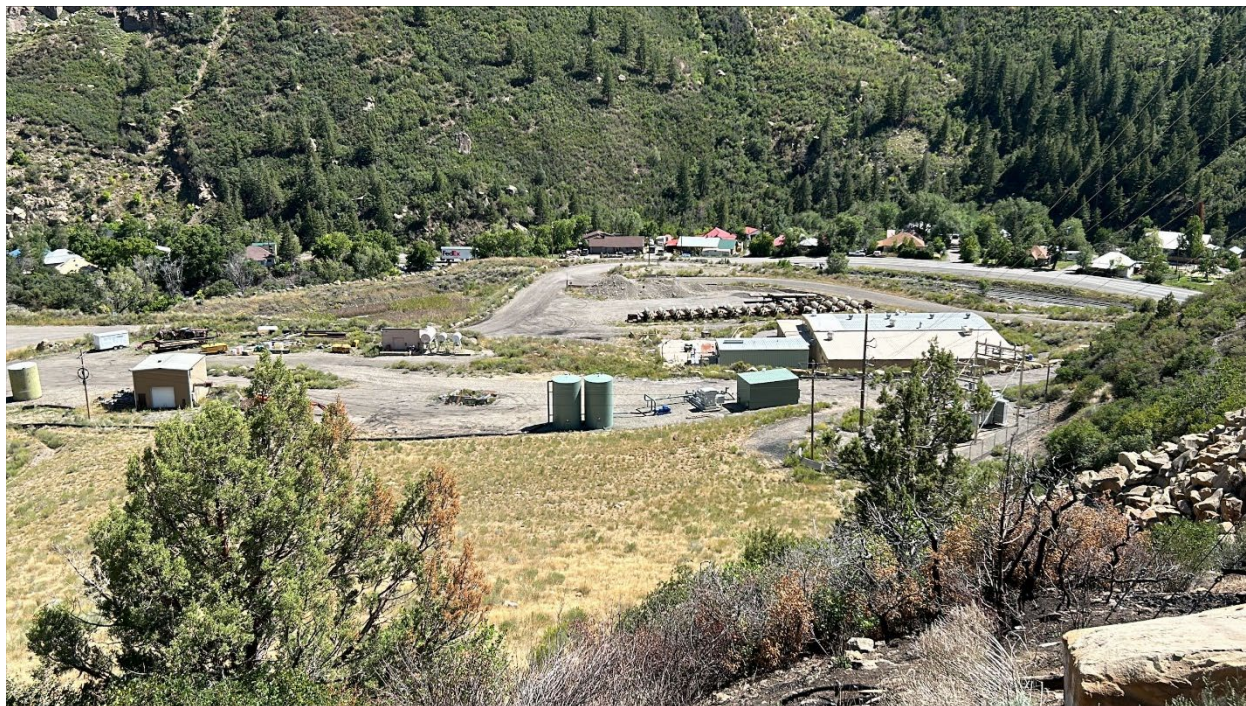
*Figure 6: Overview of Gunnison Energy facility*

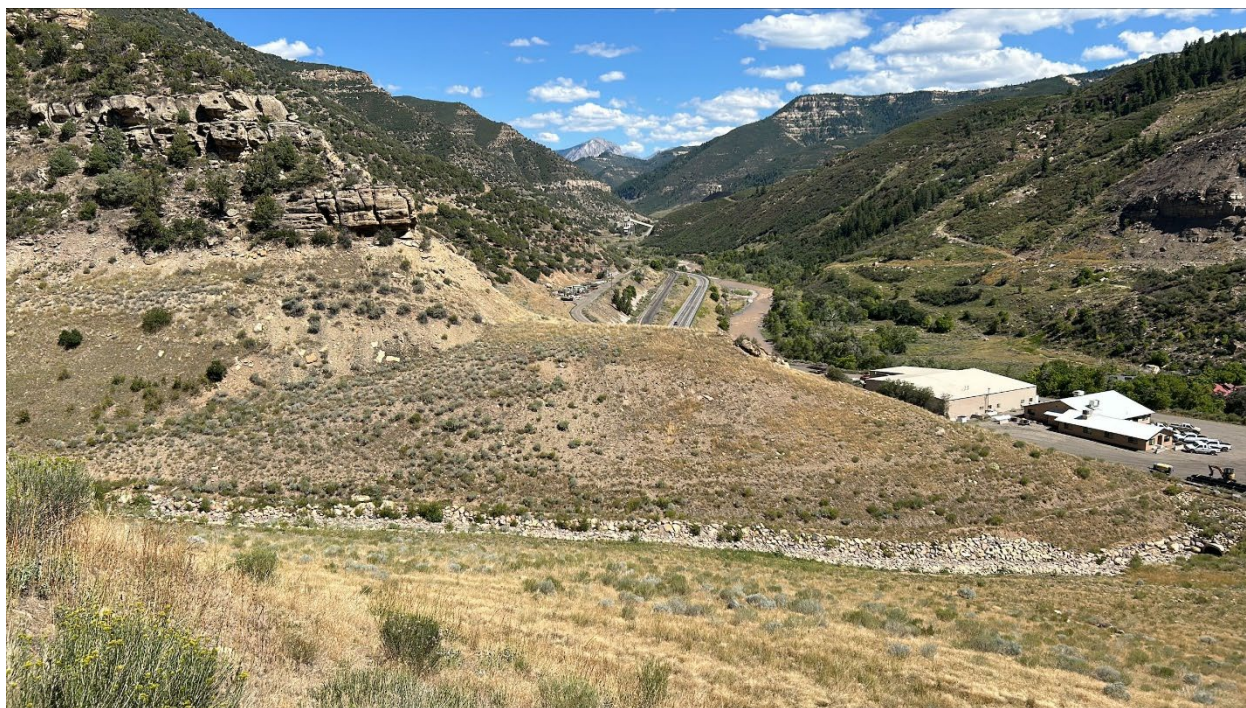
*Figure 7: Reclaimed Elk Creek channel*
