New Horizon Mine, C-1981-008, August Complete Inspection Report

PERMIT INFORMATION

Permit Number: C-1981-008 Mine Name: New Horizon Mine Operator: Elk Ridge Mining and Reclamation, LLC Operator Address: Mr. Tony Tennyson P.O. Box 628 27646 West 5th Avenue Nucla, CO 81424	County: Montrose Operation Type: Surface Permit Status: Active Ownership: Private
	Operator Representative Present: Mindy Sickels
Operator Representative Signature: (Field Issuance Only)

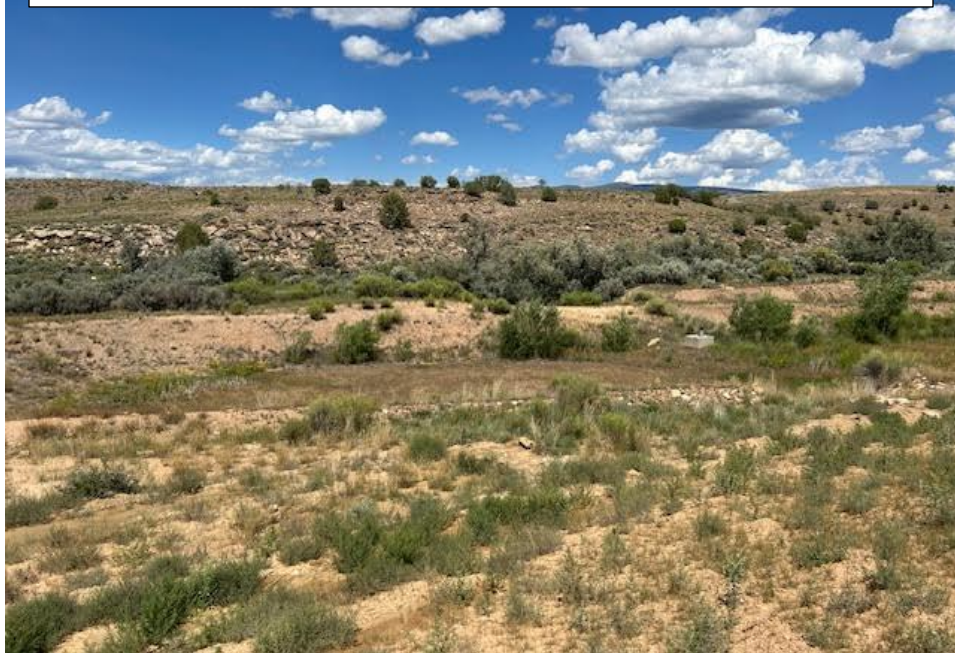
Photo 1: Pond 012.

Pond 012 is located in the northern portion of Section 36. Pond 012 was dry during the inspection (Photo 1). The primary outfall was observed to be clear of Debris. The embankment was stable with vegetative cover. No erosional features were identified.

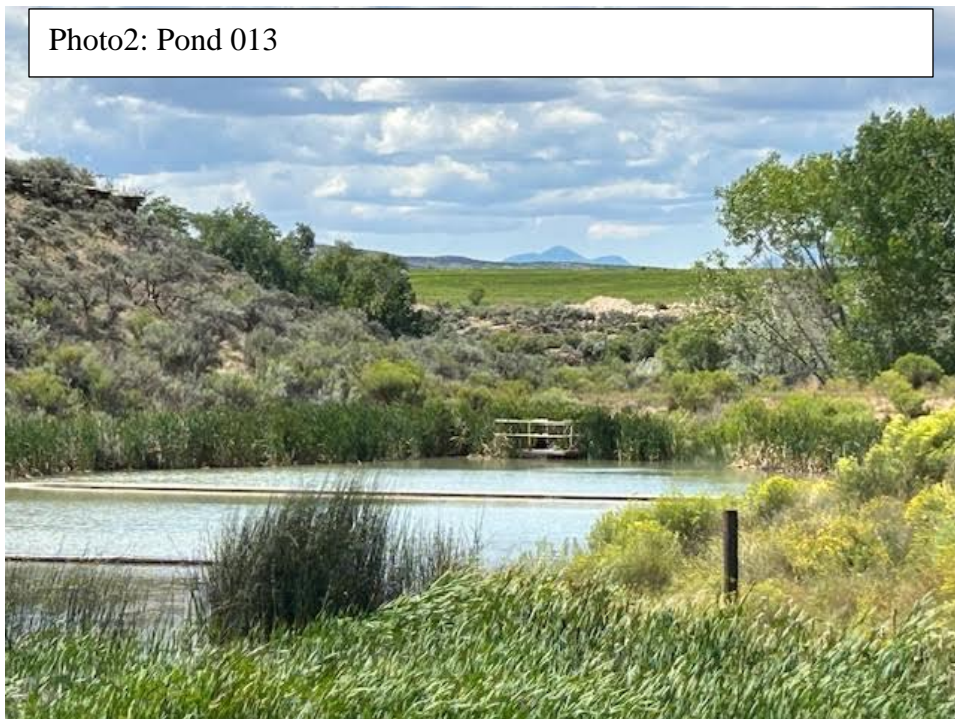
Photo2: Pond 013

Pond 013 is located within the northwest portion of the permit boundary in Section 36. Pond 013 was impounding water from the inlet pipes during the inspection. The pipe inlets discharge irrigation runoff and the water from a spoil spring. The water level in the pond was at the primary discharge outlet (Photo 2). The primary outlet was clear of blockages and discharge was occurring. The embankment for the pond was vegetated and stable. There

were no erosional features identified. Approximately a month before the inspection, the operator had tamarisk removed from the area surrounding Pond 013.

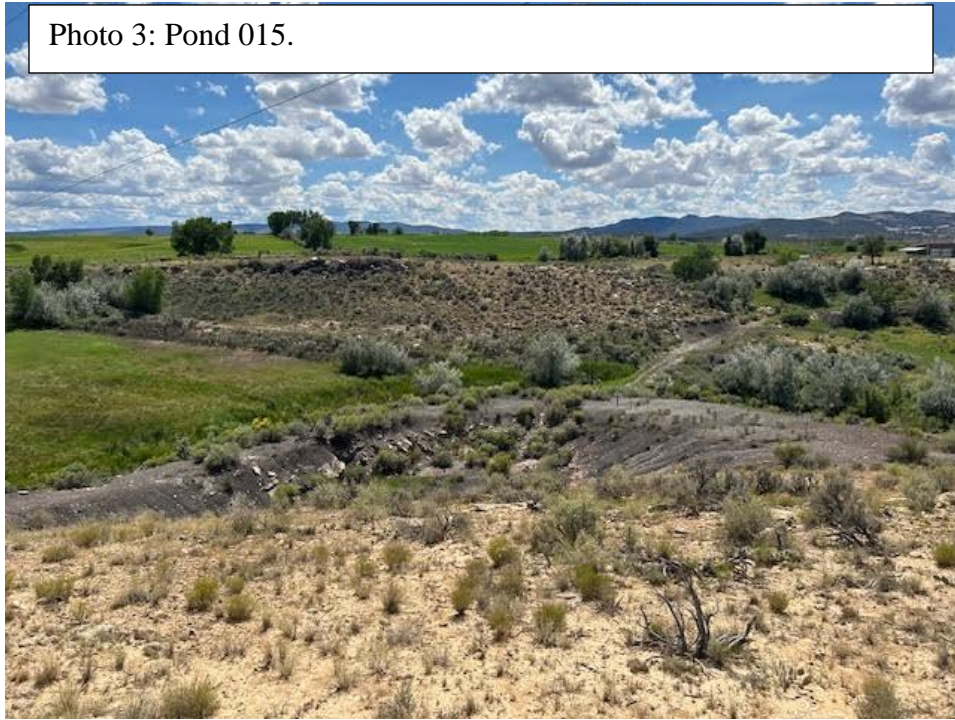
Photo 3: Pond 015.

Pond 015 is located within the southwest portion of the permit boundary in Section 36. Pond 015 was also dry at the time of the inspection (Photo 3). The outlet for the pond was clear. The embankment was stable and no new erosion was observed. Small rills have been documented during previous Division inspections on the pond's embankments. The rills have not enlarged and did not appear to affect the embankment's stability.

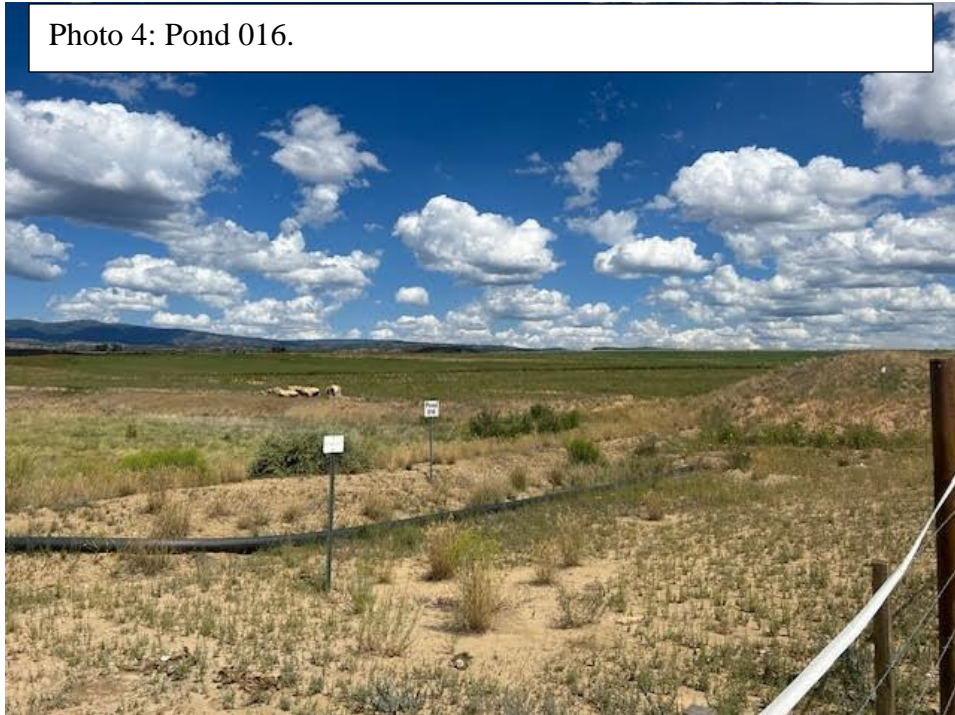
Photo 4: Pond 016.

Pond 016 is located within the southern portion of the permit boundary in Section 36. Pond 016 was observed to be dry (Photo 4). The embankment was stable and covered with vegetation. The primary discharge outlet was clear of debris. There were no indications of erosional features.

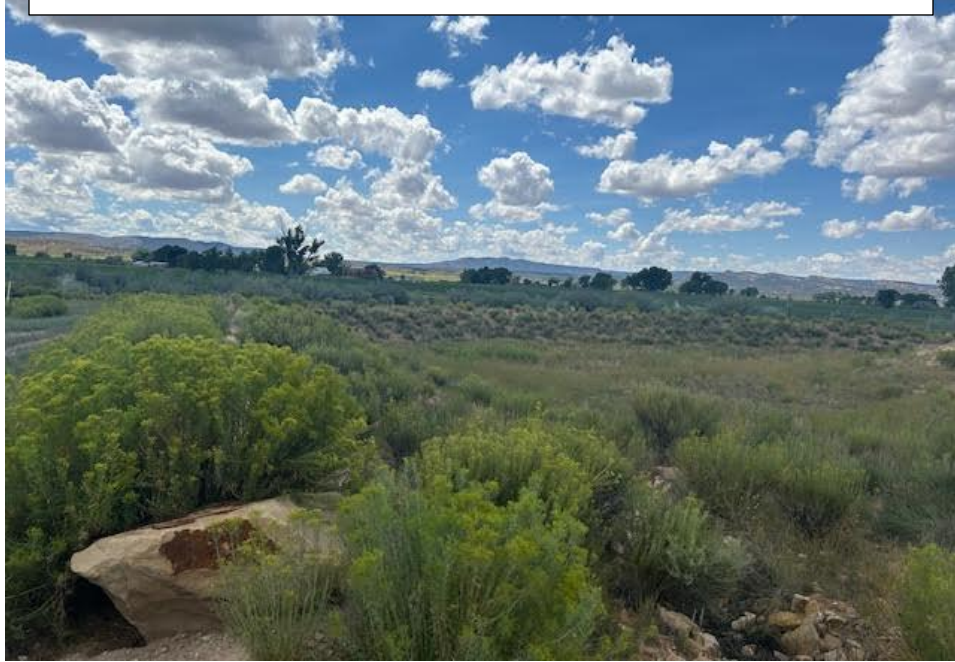
Photo 5: Pond 018.

Pond 018 is located within the southern portion of the permit boundary in Section 6. Pond 018 was observed to be dry (Photo 5). The embankment was vegetated and stable. There were no erosional concerns identified. The pond's outlet was unobstructed.

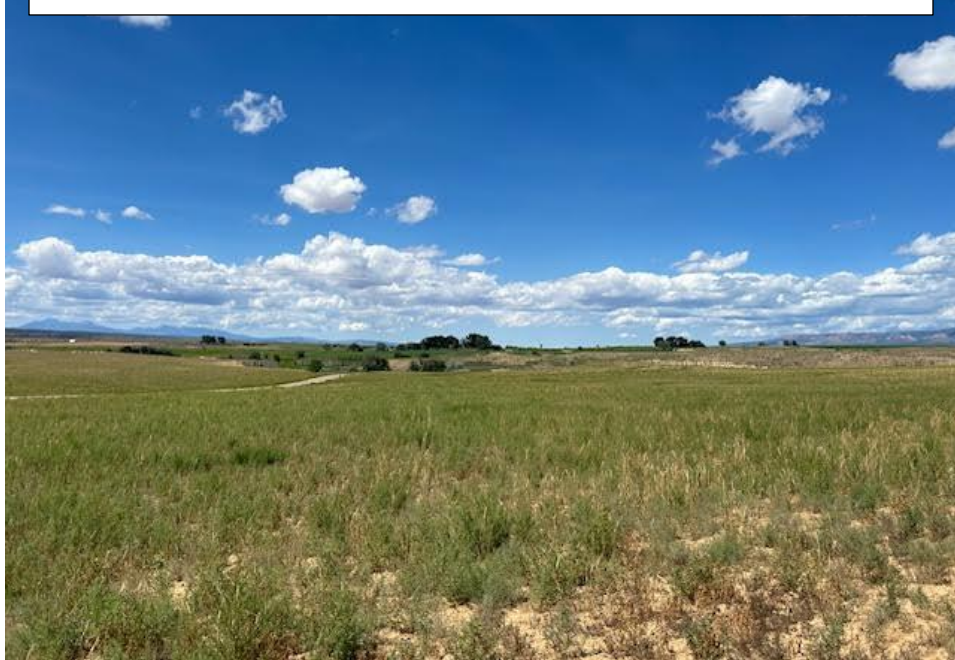
Photo 6: DP-20 and DP-21.

Dryland Pastures (DP-10, DP-11, DP-13, DP-14, DP-15, DP-18, DP-20 (Photo 7) and DP-21 are located in Section 36. DP-10 through DP-15 were stable with vegetative cover. There were no indications of erosion or differential settling. DP-18, DP-20 and DP-21 were reclaimed and seeded in 2023. The reclaimed areas were stable with vegetative cover. No signs of differential settling were observed. There were no erosional concerns identified.

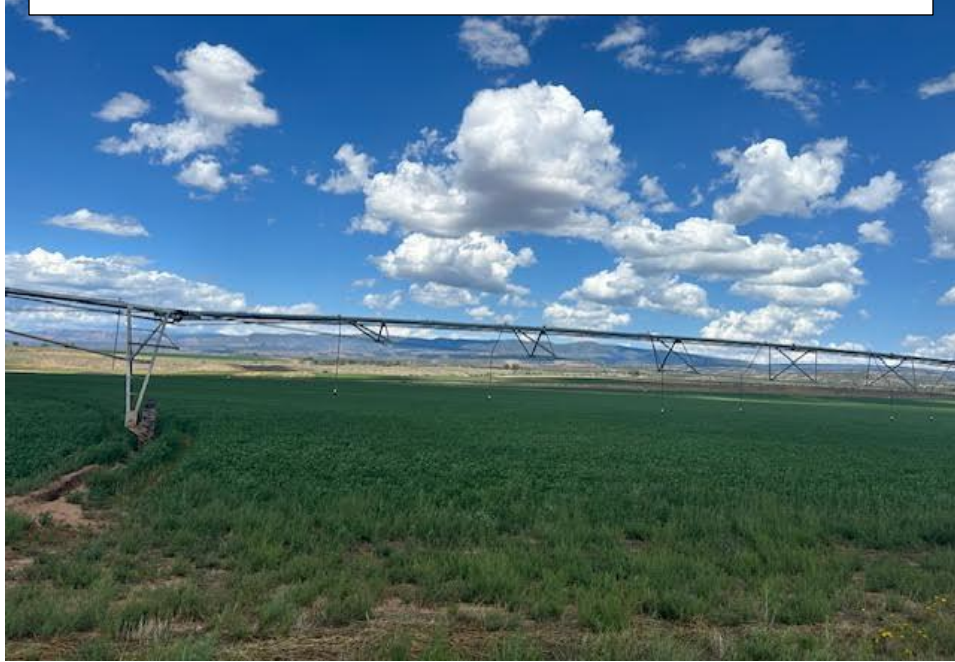
Photo 7: IC-1.

Irrigated Cropland (IC-1 is located in the northeast portion of Section 1 (Photo 6). The field was covered with what looked to be a hay crop. There were no indications of differential settling observed. No erosional concerns were identified.

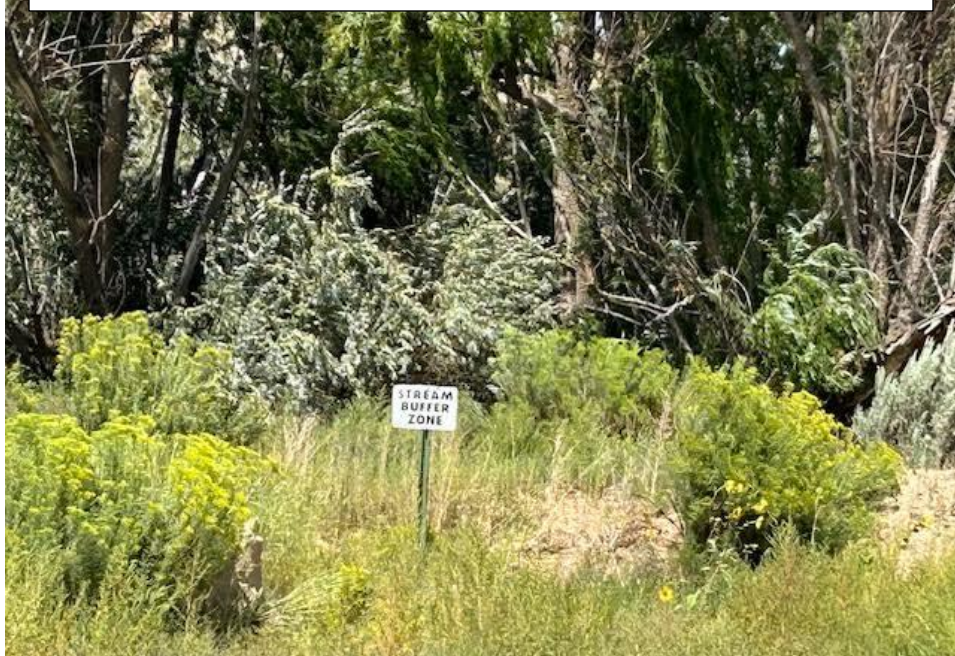
Stream Buffer Zone Markers were observed to be intact and posted in locations that were easy to spot (Photo 8).

Photo 8: Stream Buffer Zone Marker adjacent to Pond 013.

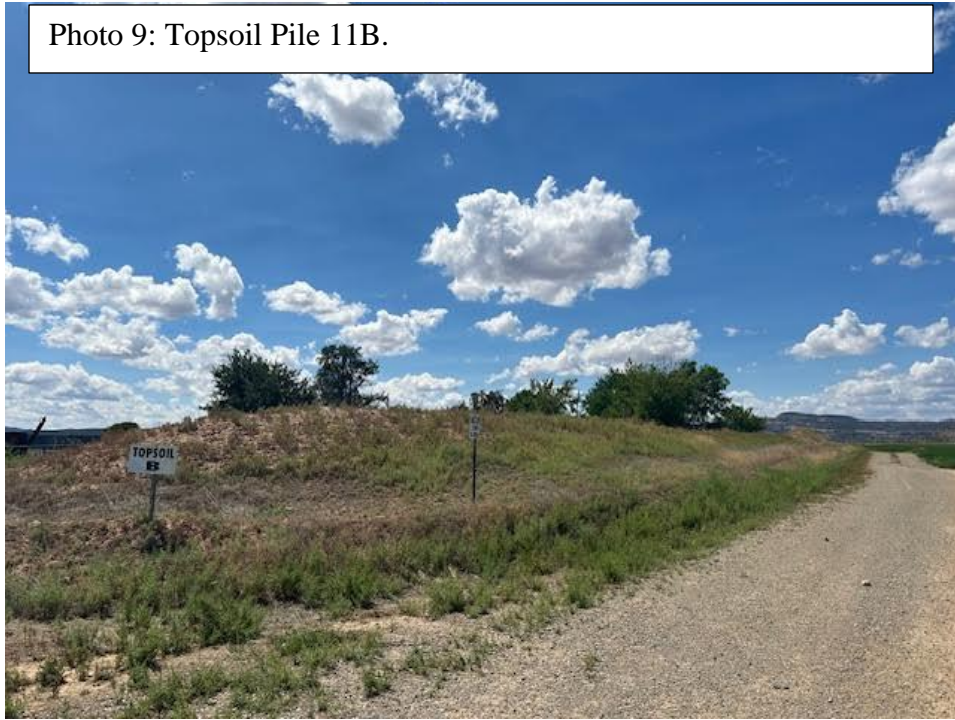
Photo 9: Topsoil Pile 11B.

Topsoil Piles 11A and 11B (Photo 9) are located in the southern part of the permit boundary in Section 1. The piles were observed to be stable with no erosion. There was no indication of the loss of topsoil resource.
