MINERALS PROGRAM INSPECTION REPORT
PHONE: (303) 866-3567

MINE NAME: Cross Gold Mine	MINE/PROSPECTING ID#: M-1977-410	MINERAL: Gold, copper, silver, lead	COUNTY: Boulder
INSPECTION TYPE: Monitoring	WEATHER: Clear	INSP. DATE: August 30, 2024	INSP. TIME: 09:00
OPERATOR: Grand Island Resources LLC	OPERATOR REPRESENTATIVE: Je' An-Paul Brewer	TYPE OF OPERATION: 110(2) - Hard Rock Limited Impact	
REASON FOR INSPECTION: High Priority	BOND CALCULATION TYPE: None	BOND AMOUNT: \$546,751.00	
DATE OF COMPLAINT: NA	POST INSP. CONTACTS: None	JOINT INSP. AGENCY: None	
INSPECTOR(S): Patrick Lennberg	INSPECTOR'S SIGNATURE:

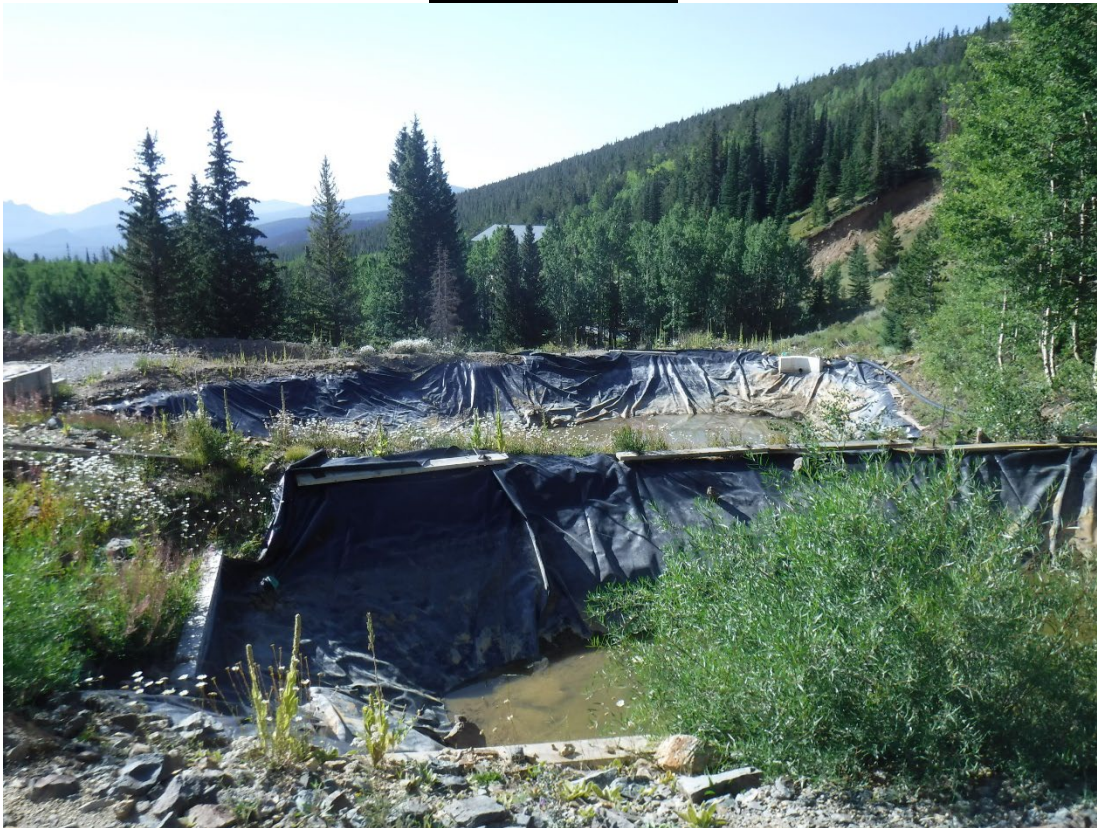
As noted in the previous inspection reports, the Operator is diverting the Idaho Tunnel effluent into a pipeline that bypasses the series 3 Ponds and discharges to Pond 1. The Operator then can direct water from Pond 1 to Joliet Raise for storage prior to being treated and released. The 3 series Ponds, 3a, 3b and 3c, were observed during this inspection. The ponds still contained some sediment and minor amounts of water. During the inspection the Division reiterated what steps were needed to abandon the ponds. The Division stated the Ponds could be abandoned through a Technical Revision that provided the details on the proper disposal of the sediment, as determined through chemical analysis, and the remaining geomembrane. Once the revision was approved the Operator could proceed. The Operator could collect sediment samples for TCLP, or similar analysis, to determine proper disposal of the residual sediment. Ultimately the Operator would like to use the current pond locations for equipment laydown and to allow better access to the tunnel.

Photo 1: Pond 3a in the foreground

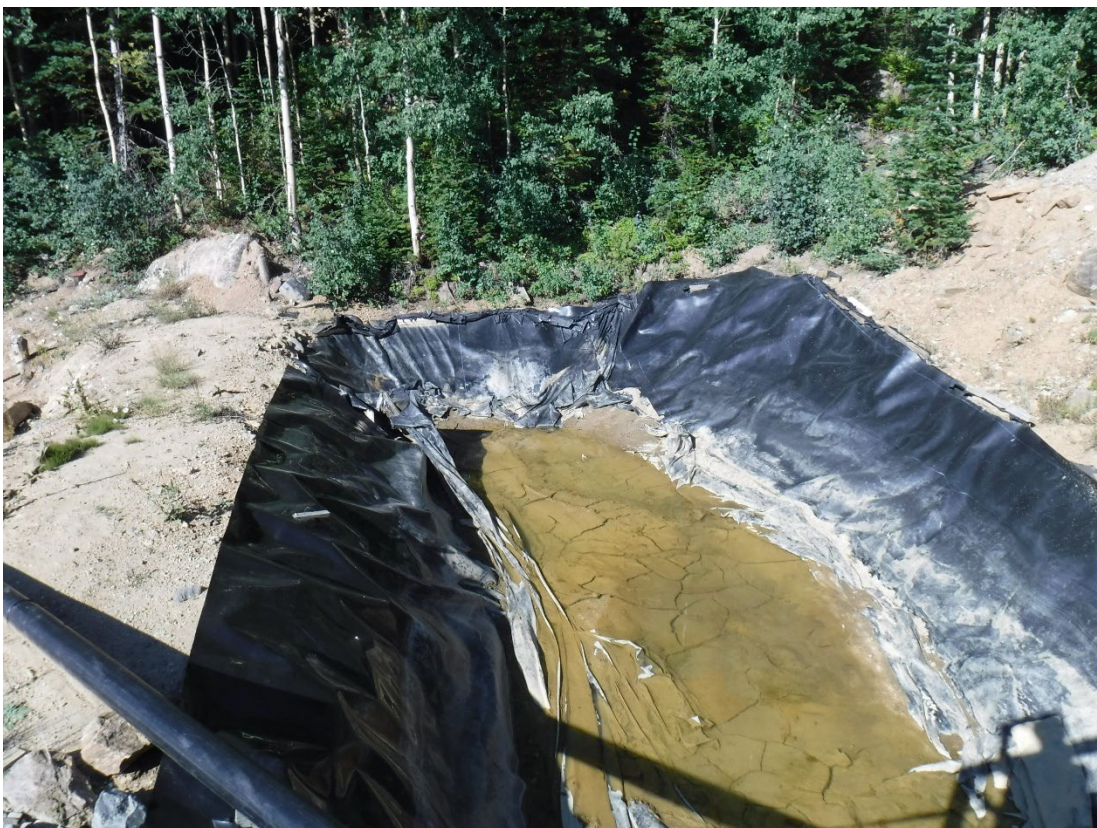
Photo 2: Pond 3b

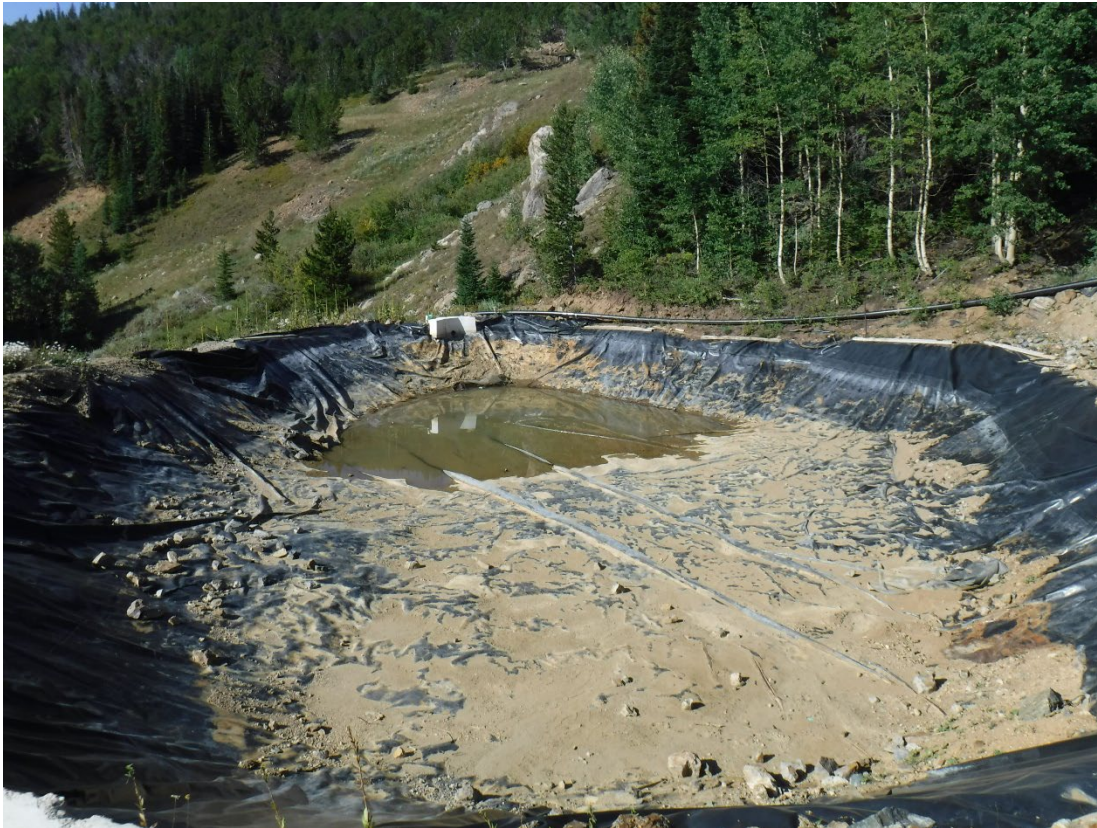
Photo 3: Pond 3c

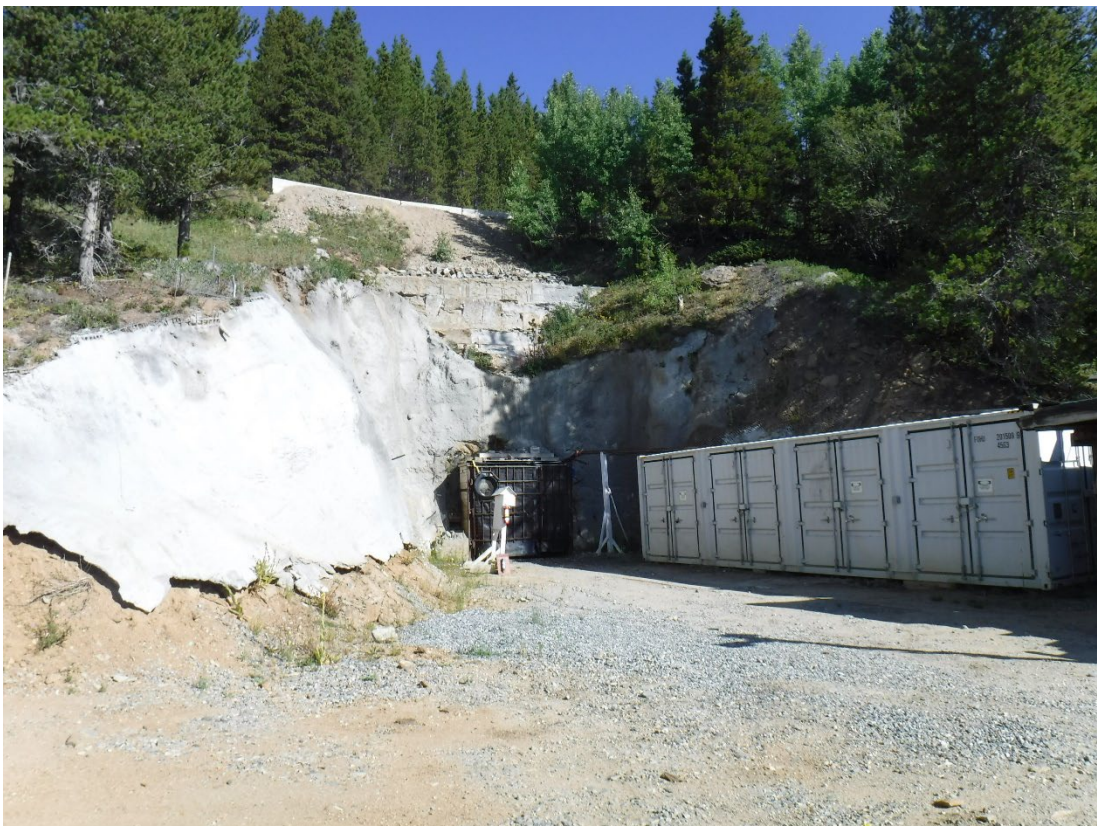
Photo 4: The Idaho Tunnel at the Caribou Mine

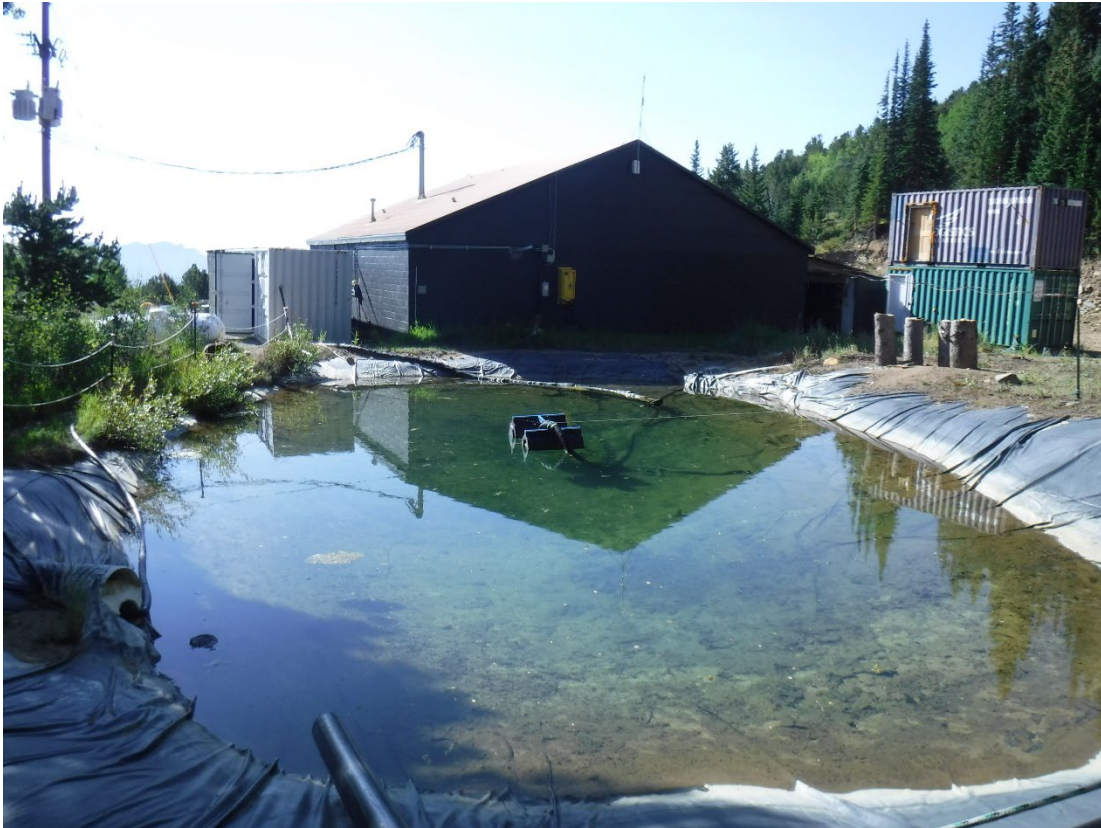
The other ponds, Pond 1 and Pond 2, were observed during the inspection. Pond 1 was clear and was operating as intended. Pond 2 was holding some water. The water in this pond is a combination of back-flush water and sediment from the water treatment plant, meteoric water, and runoff water. As stated in previous inspections, that when the Operator determines a proper disposable facility for the sediment, in the pond, that they provide the Division with the letter of acceptance from the facility along with the analytical results. It was also stated these similar documents were also needed for disposal of any water treatment sludge and associated filter bags as committed to in TR-10.

Photo 5: Pond 1

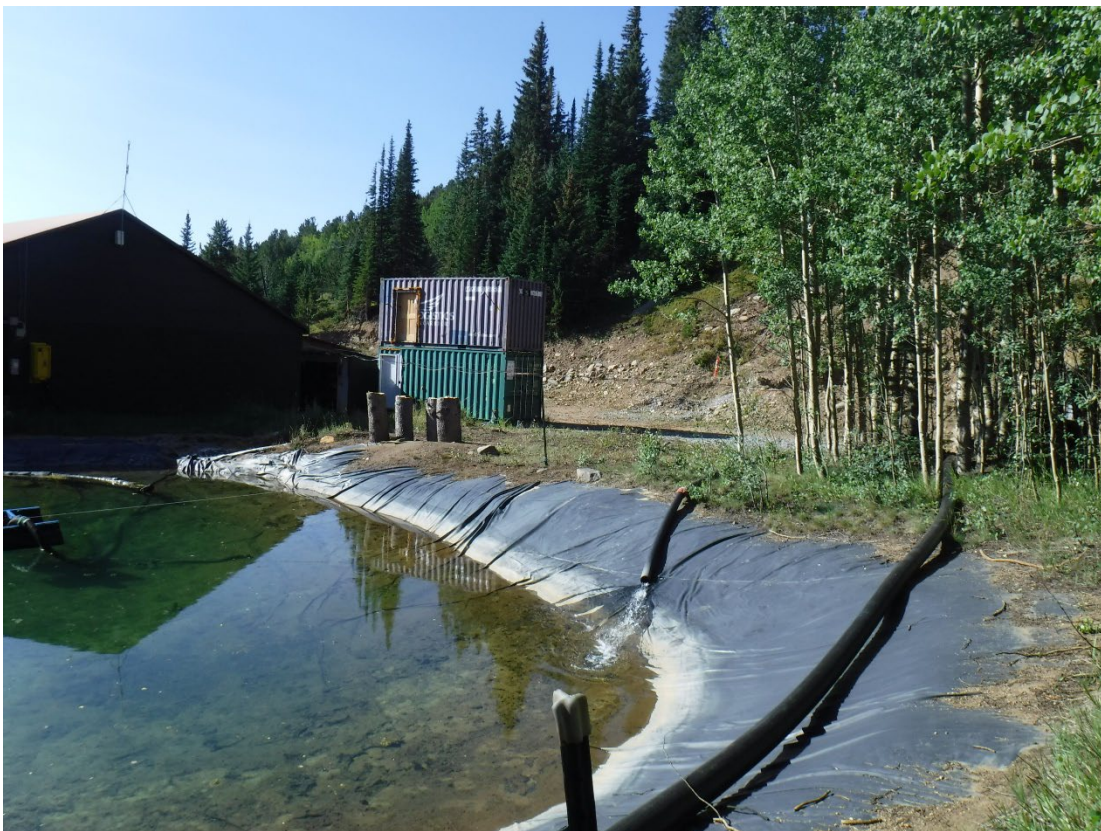
The site was not active during the inspection. The only activities reported to be taking place are related to normal operational activities associated with the water treatment plant and site maintenance. Since the last inspection four trees have been removed around the water treatment plant relocation approved in TR-12.

Photo 6: Trees removed from the new water treatment location

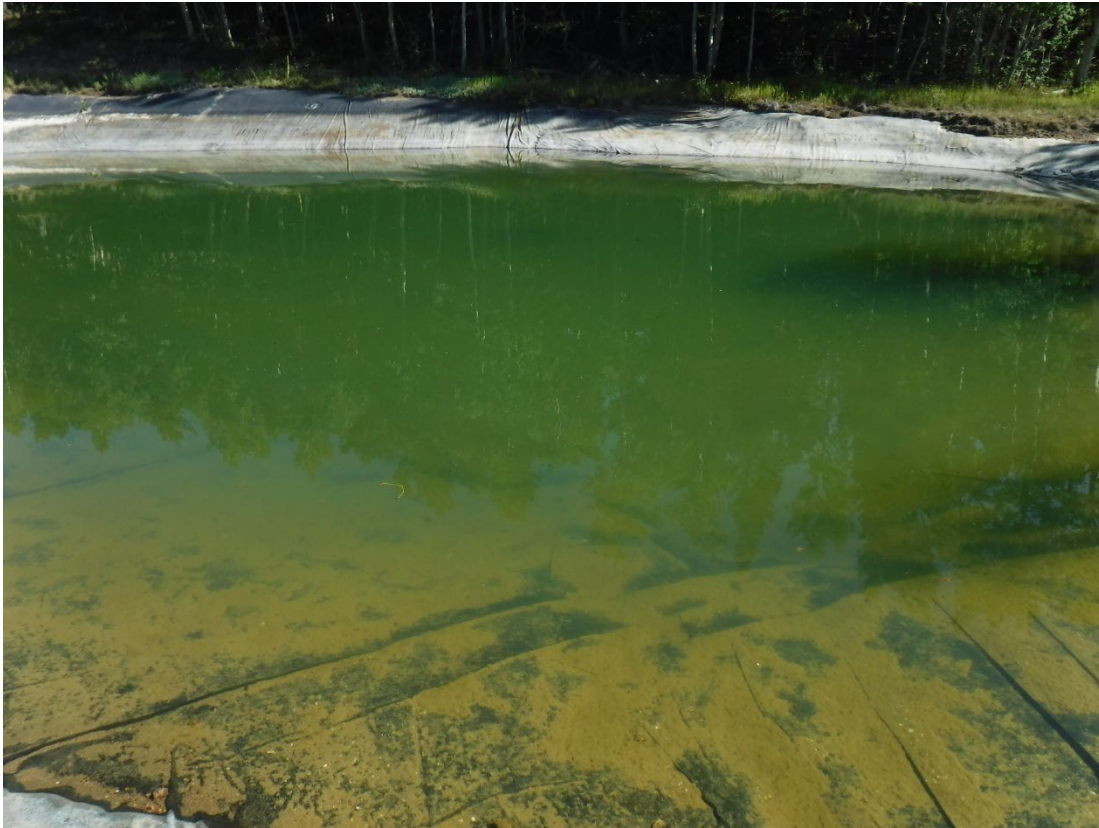
Photo 7: Pond 2

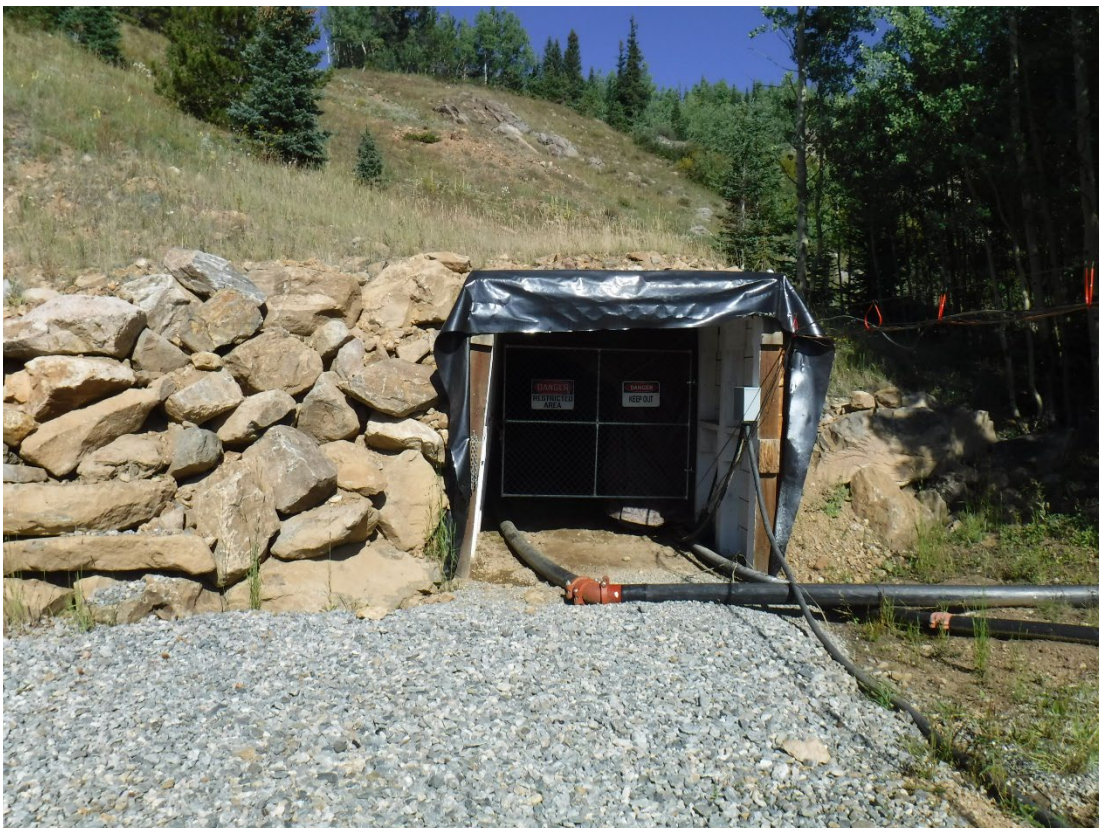
Photo 8: Cross Tunnel at the Cross Mine
