C1980007, West Elk Mine, August Inspection Report

PERMIT INFORMATION

INSPECTION INFORMATION

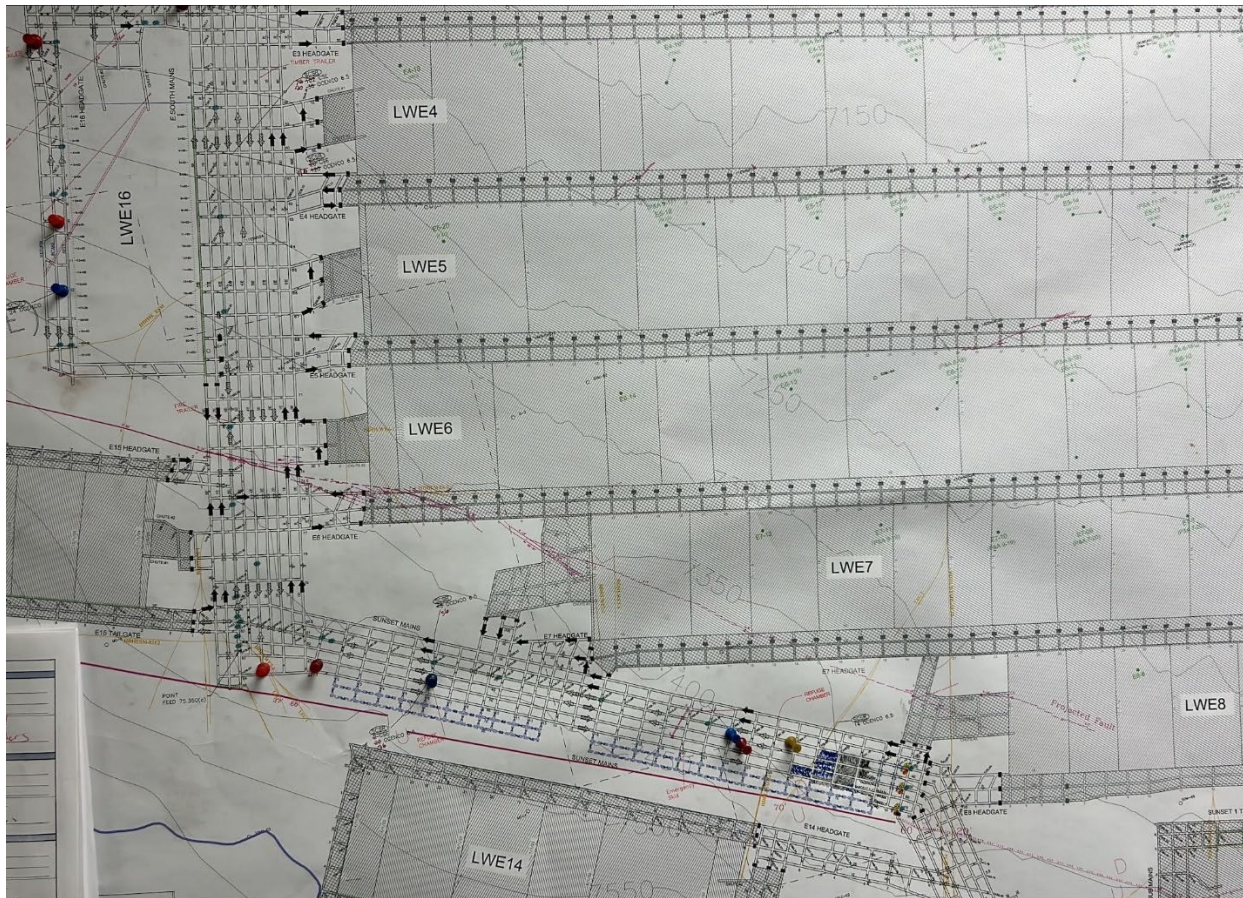
Pillaring of the Sunset Mains South was complete. Pillaring of the Sunset Mains was in progress at around crosscut 25.

Figure 1: Mine plan map showing progress of pillaring in Sunset Mains

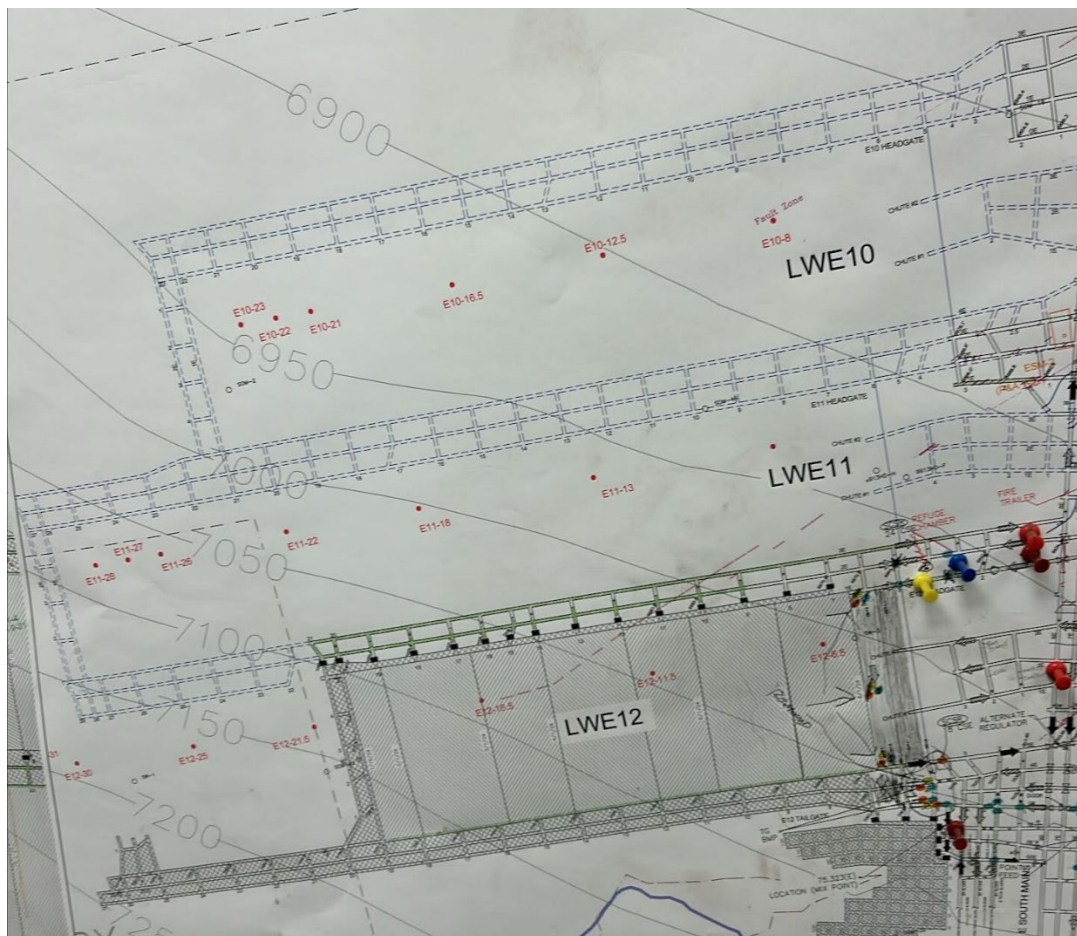
Longwall mining of the LWE12 panel was complete and a longwall move to the LWE16 panel was in progress.

Figure 2: Mine plan map showing completion of LWE12 panel

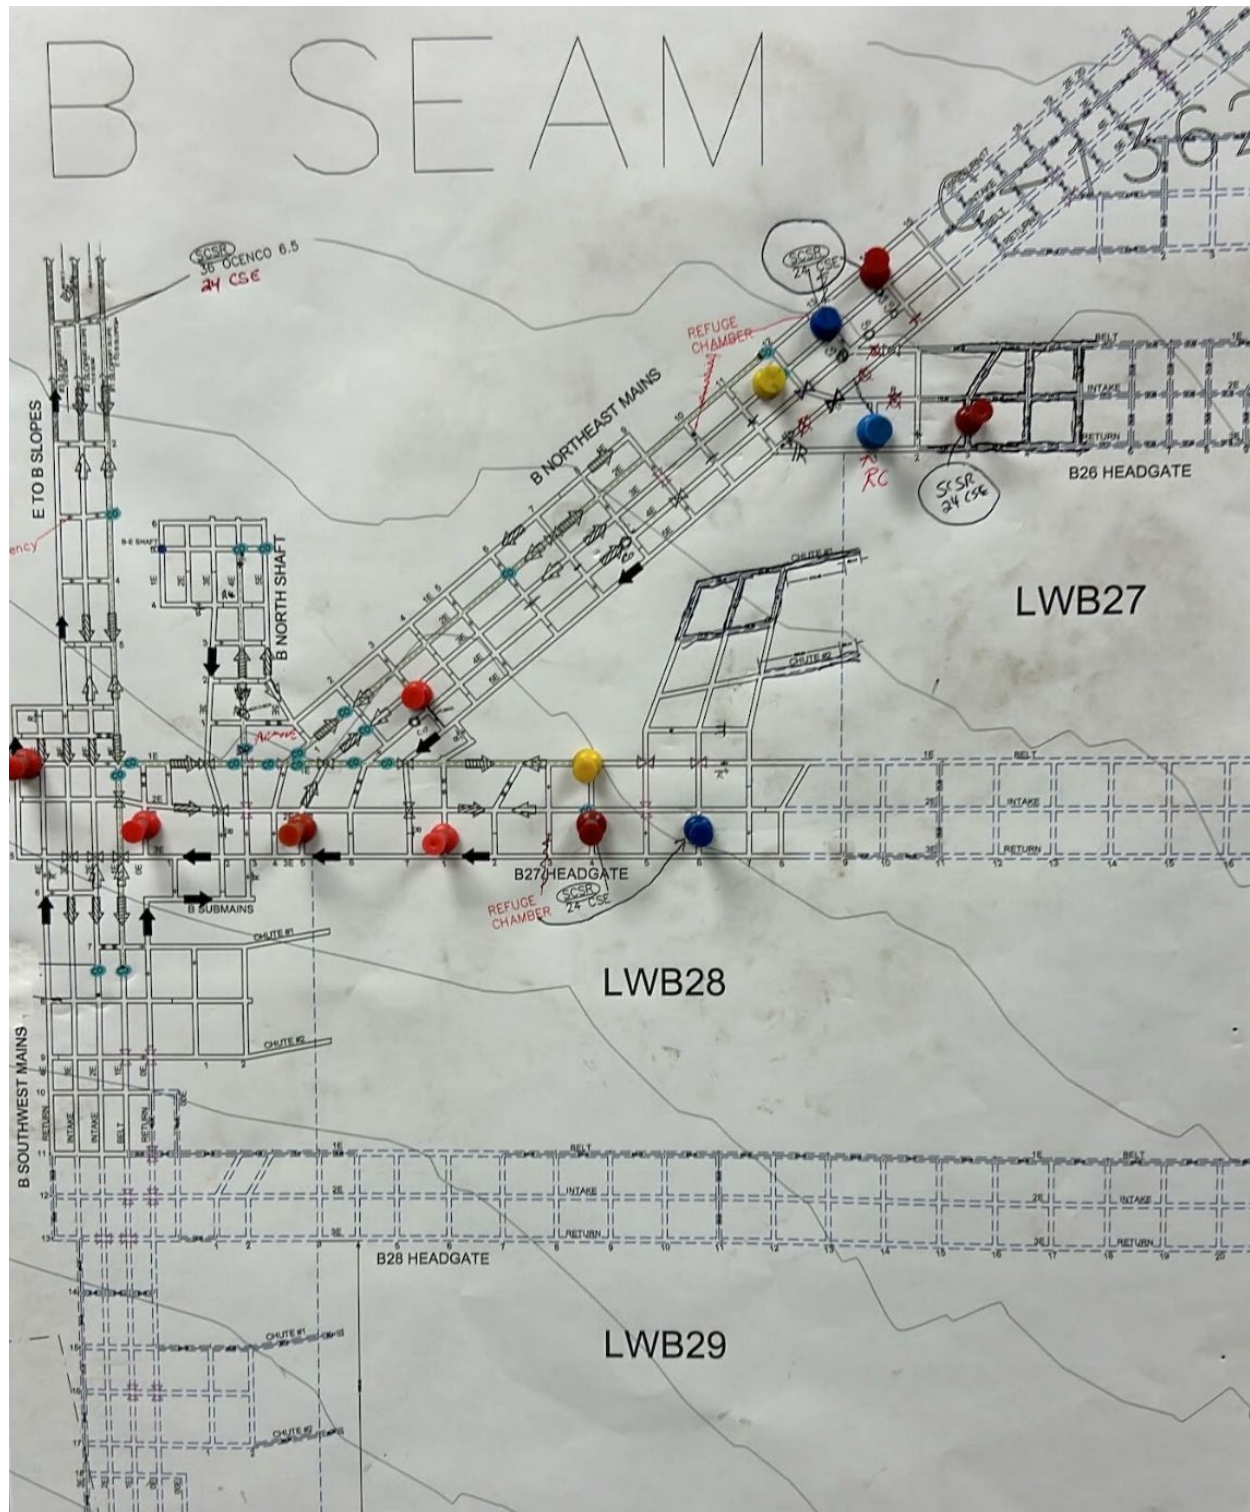
Development of the B Northeast Mains and the B26 and B27 headgates was in progress.

Figure 3: Mine plan map showing B-Seam development progress

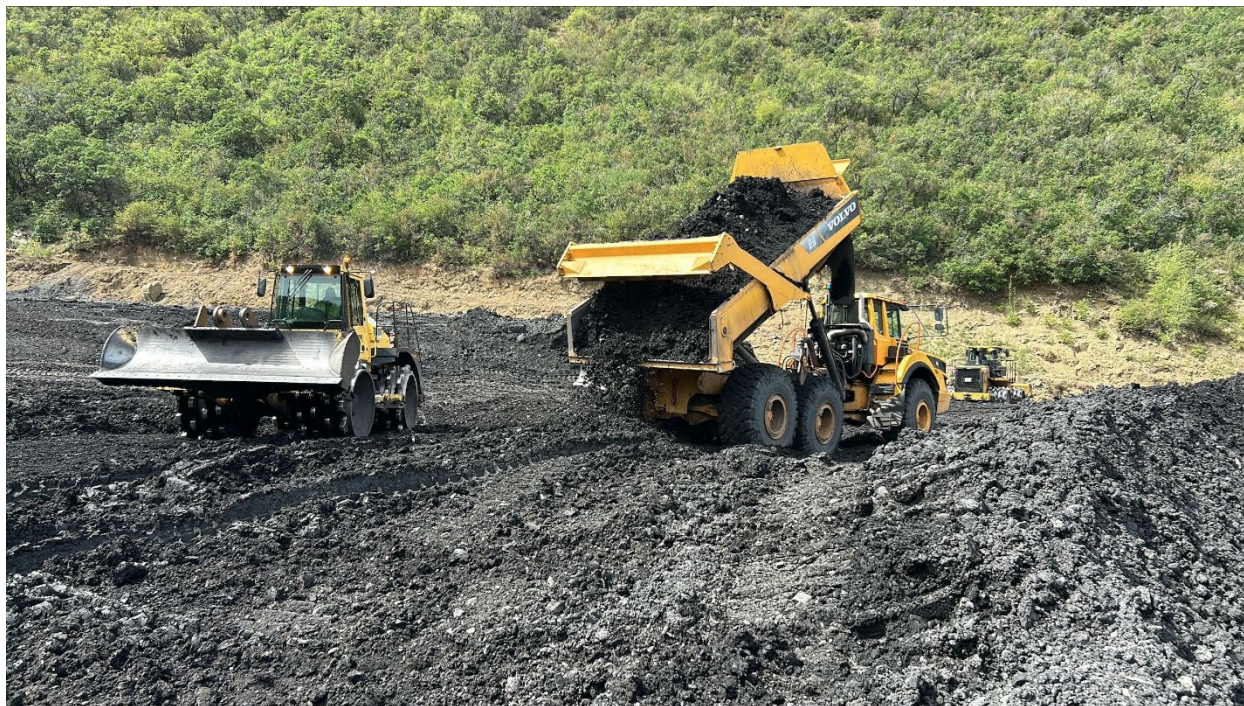
Refuse was being generated at the time of the inspection. New refuse continued to be temporarily stockpiled on the RPE but was being transported to the RPEE. The work to spread, dry and compact material that had been transported before the winter was almost complete.

Figure 4: Waste being transported to RPEE

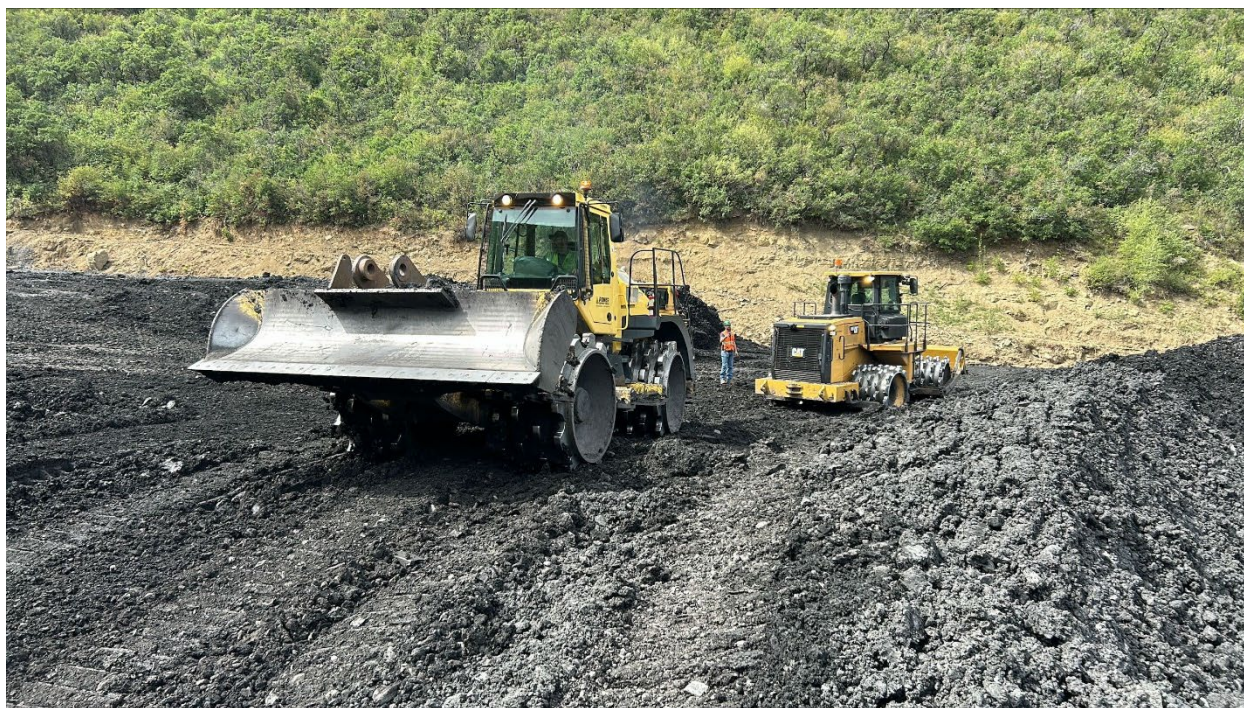
Figure 5: Compaction in progress on RPEE

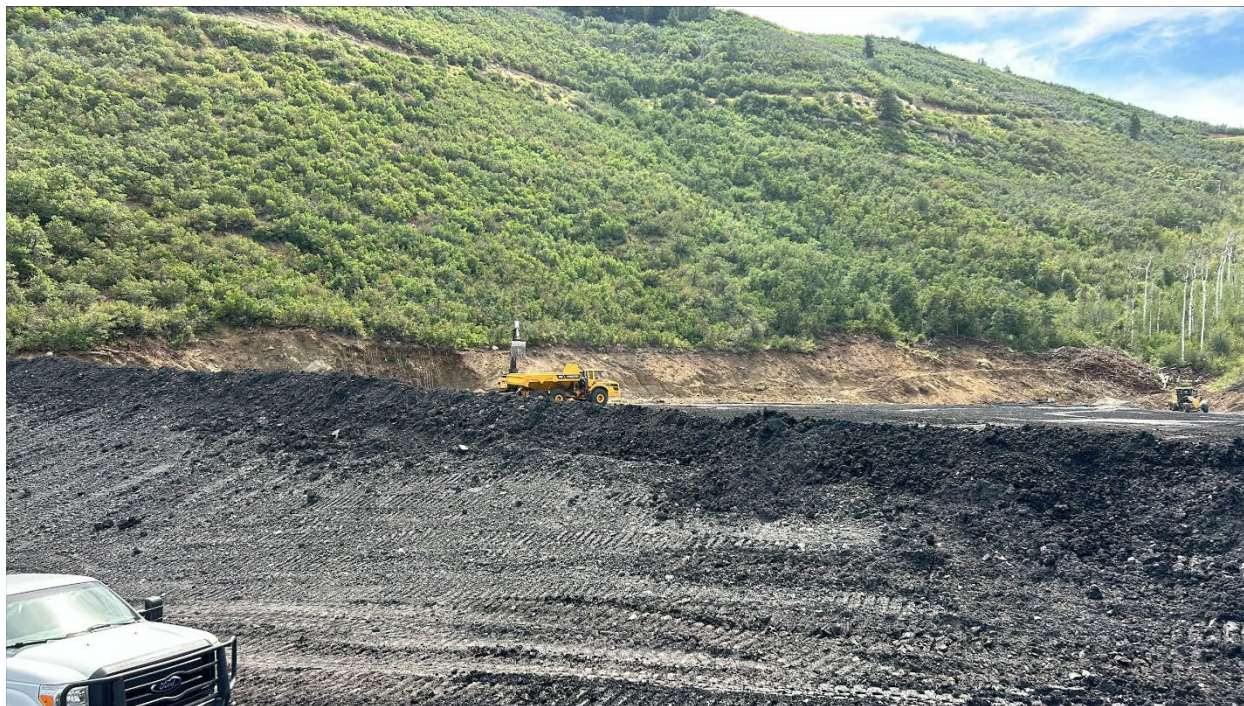
Topsoil stripped from the eastern edge of the pile was being transported to the front of the pile, ready to reclaim the graded outcrops.

Figure 6: Topsoil stripped from eastern edge of RPEE

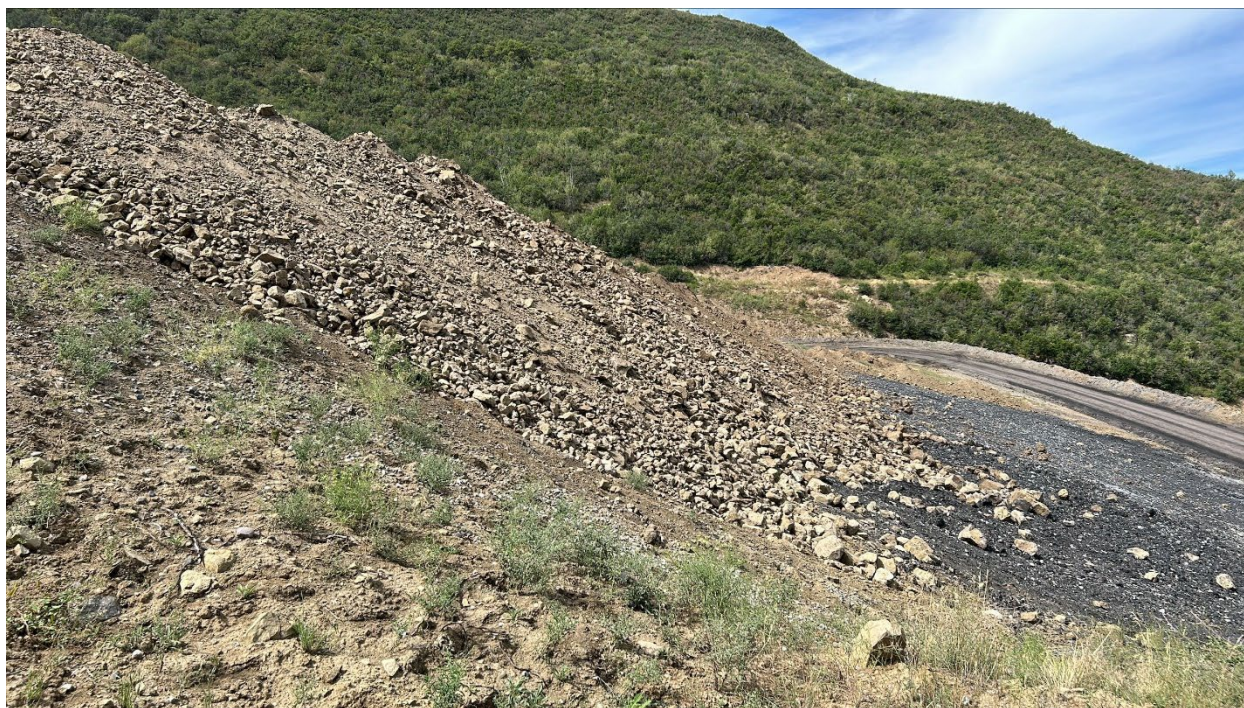
Figure 7: Topsoil transported to graded outslope, ready for reclamation

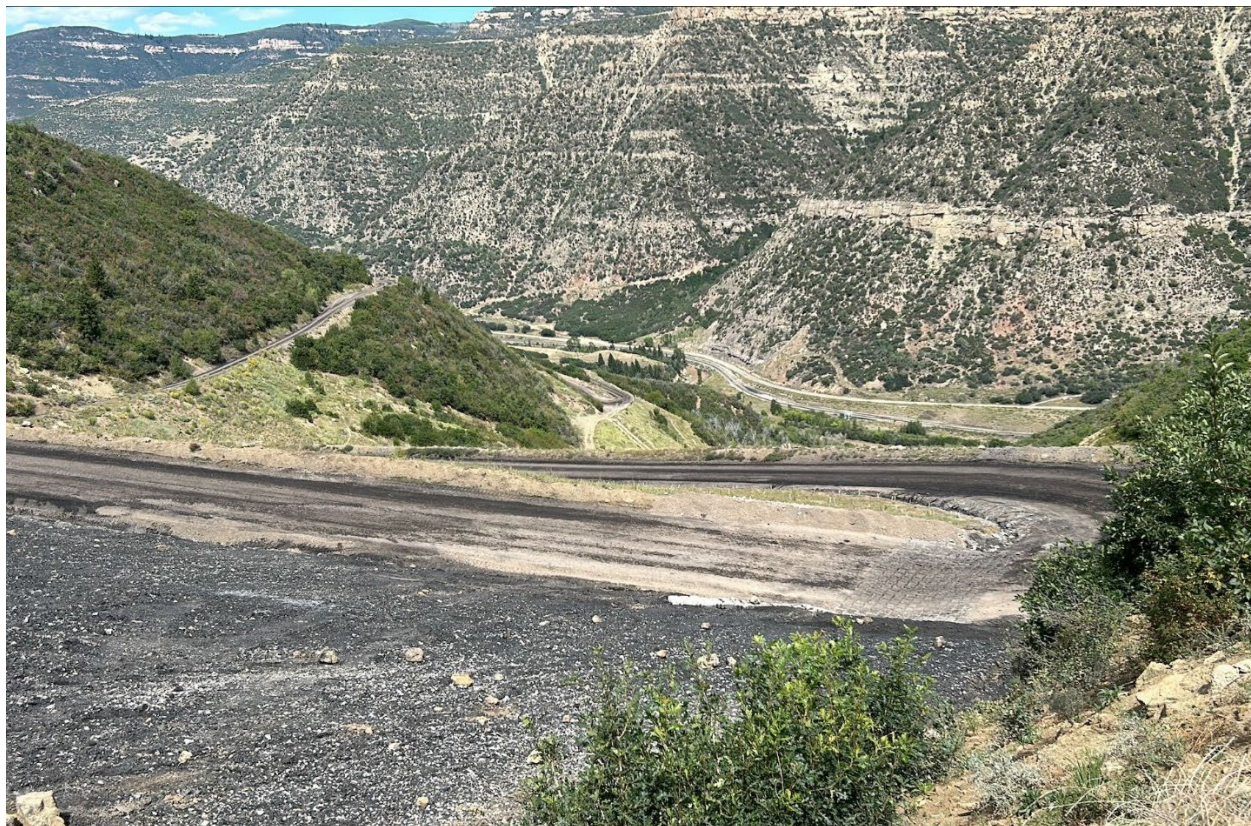
An armored crossing had been installed at the first hairpin on the RPEE haul road where it crosses the pile.

Figure 8: Armored crossing on RPEE haul road

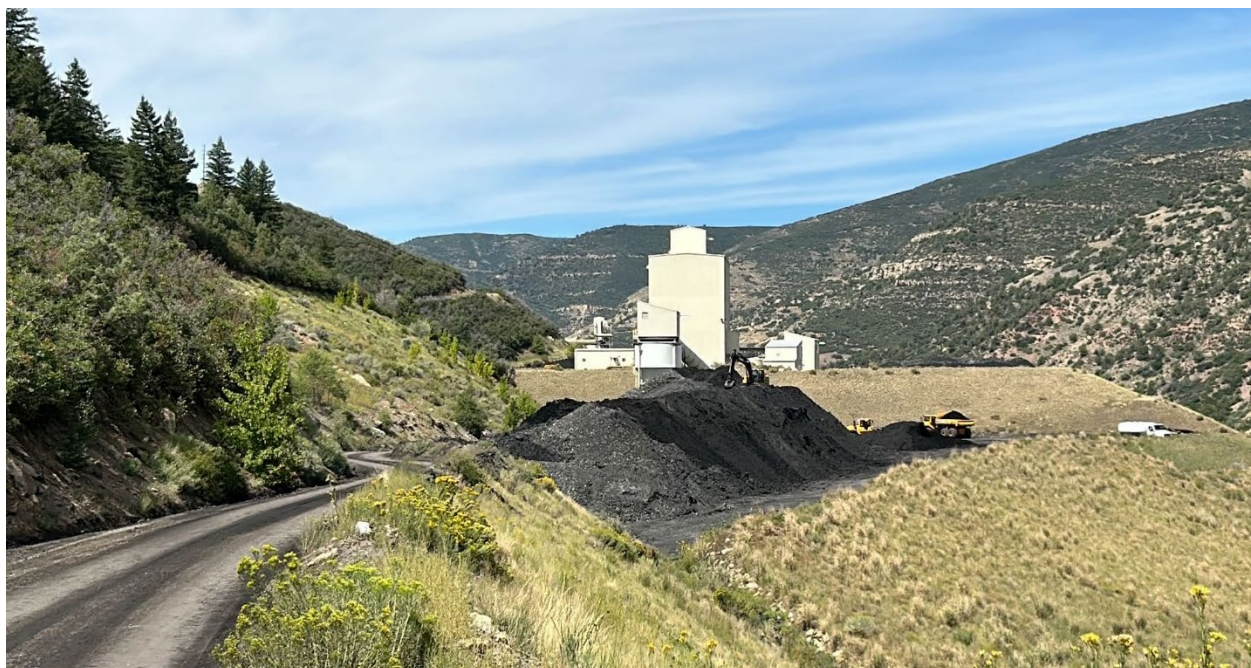
MCC plan to stop hauling refuse to the RPEE by the end of September. The goal is to clear the RPE of the temporary stockpile, so that there is space for more waste to be stored over the winter.

Figure 9: Temporary waste pile on RPE

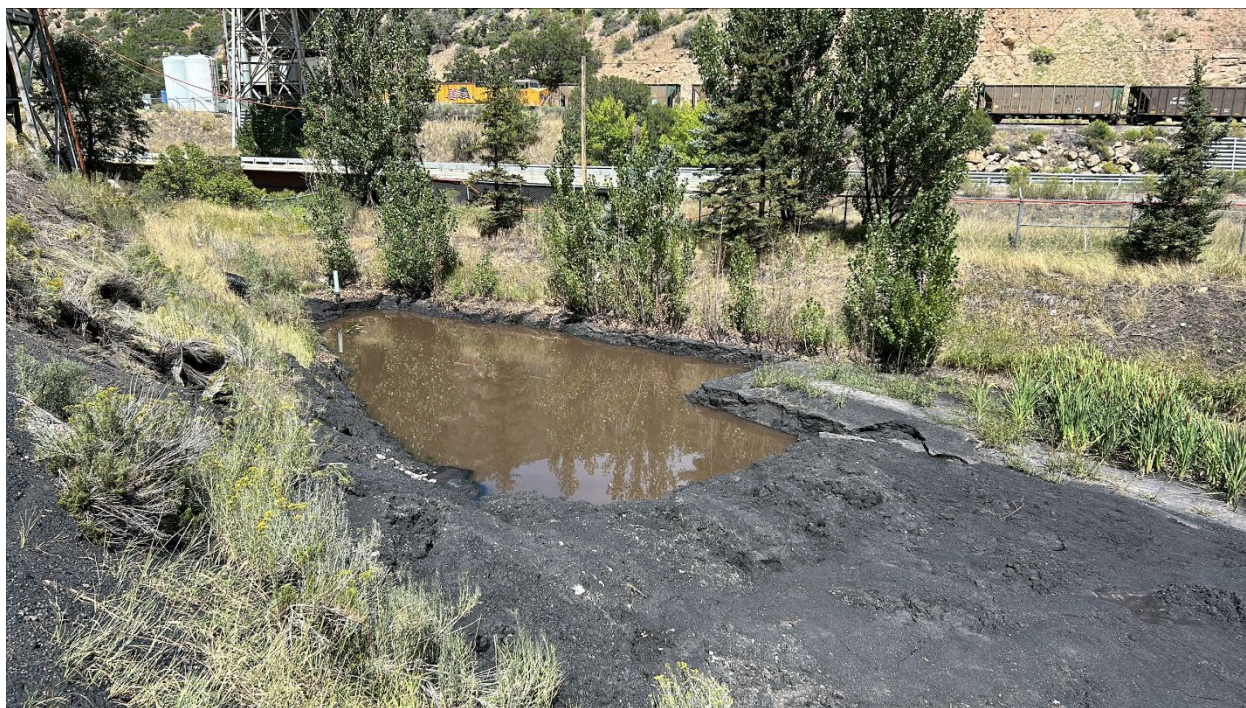
Work had begun to clean the MB3 pond, but had been suspended following recent heavy rain.

Figure 11: MB3 pond, partially cleaned
