C1983059, Terror Creek Loadout, August Inspection Report

PERMIT INFORMATION

Permit Number: C-1983-059 Mine Name: Terror Creek Loadout Operator: Oxbow Mining, LLC Operator Address: Mr Doug Smith PO Box 535 Paonia, CO 81434	County: Delta Operation Type: Loadout Permit Status: Active Ownership: Private
	Operator Representative Present: N/A
Operator Representative Signature: (Field Issuance Only)

Inspection Start Date: August 27, 2024 Inspection Start Time: 13:00 Inspection End Date: Inspection End Time:	Inspection Type: Coal Partial Inspection Inspection Reason: Normal I&E Program Weather: Clear
Joint Inspection Agency: None	Joint Inspection Contacts:
Post Inspection Agency: None	Post Inspection Contacts:
Inspector(s): Leigh Simmons	Inspector's Signature:

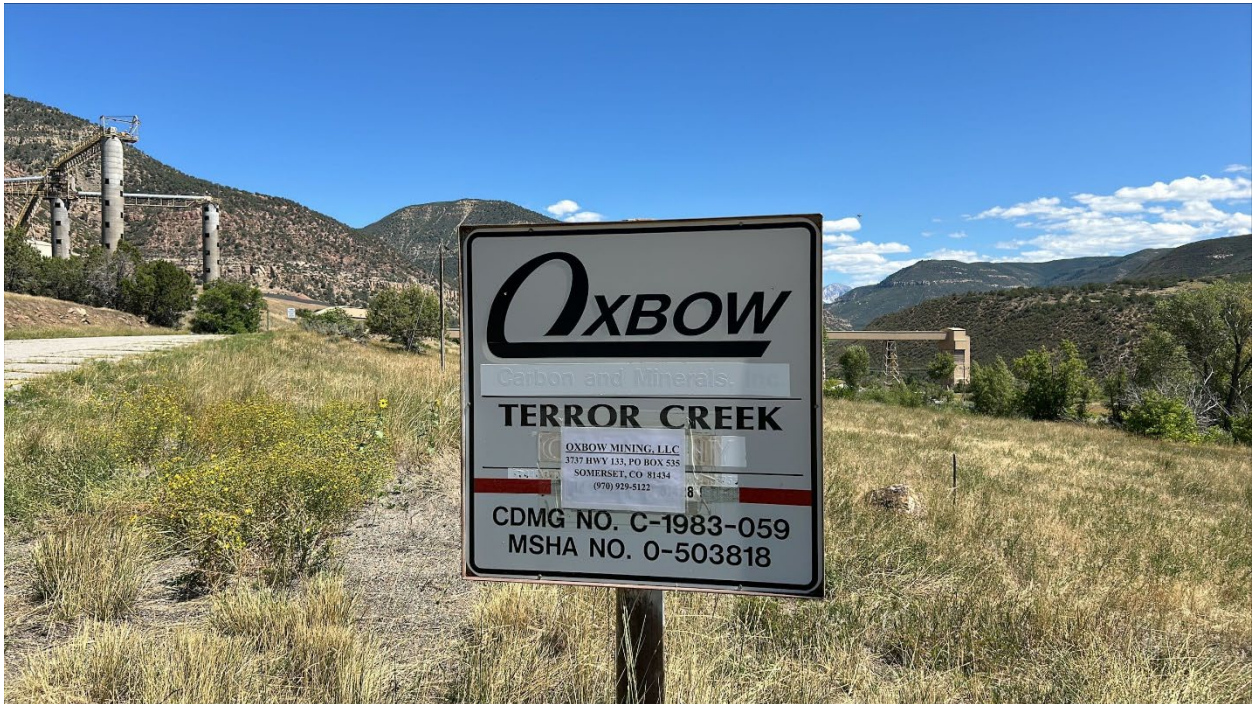
The mine ID sign was in place at the entrance to the site.

Figure 1: Mine ID sign

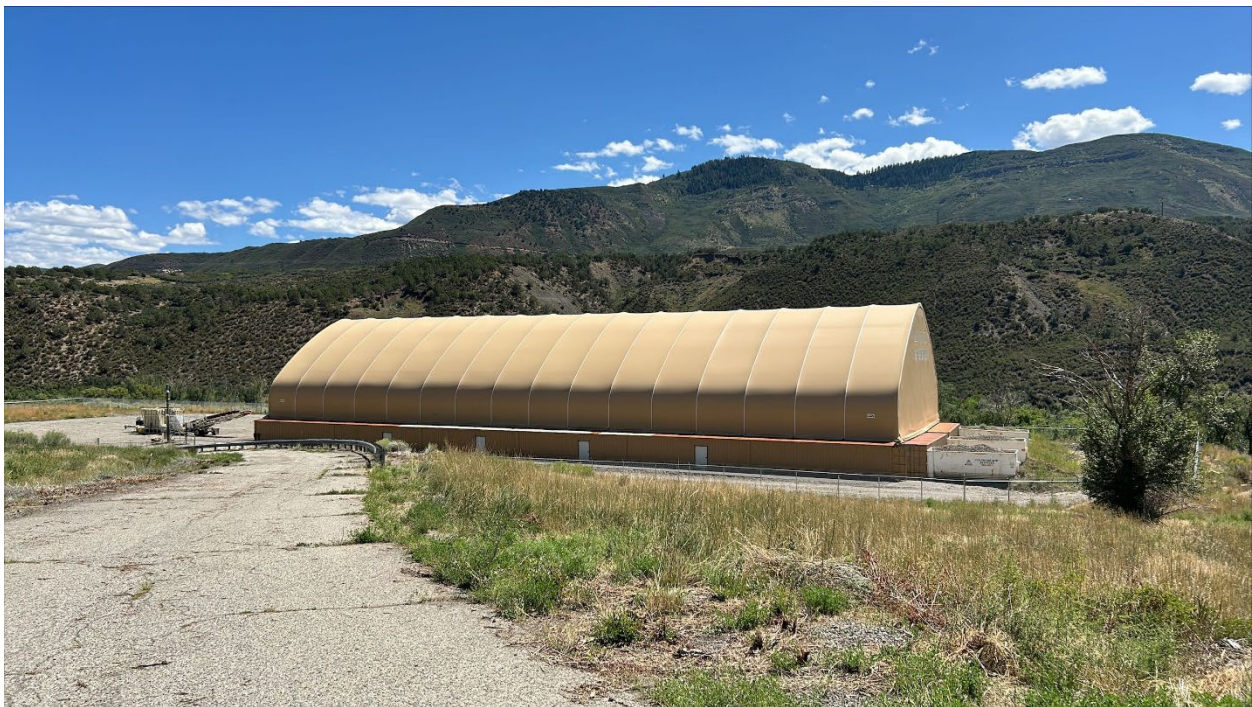
The site was being used by two entities other than Oxbow Mining for industrial/commercial purposes unrelated to mining, consistent with the approved post-mining land use: Gunnison Energy continued to store sand in the temporary building, and Eddie Bowden, a local general contractor, continued to store equipment and materials on the upper pad. A small lightweight building had been constructed on the pad by Mr. Bowden.

Figure 2: Overview of lower pad, in use by Gunnison Energy

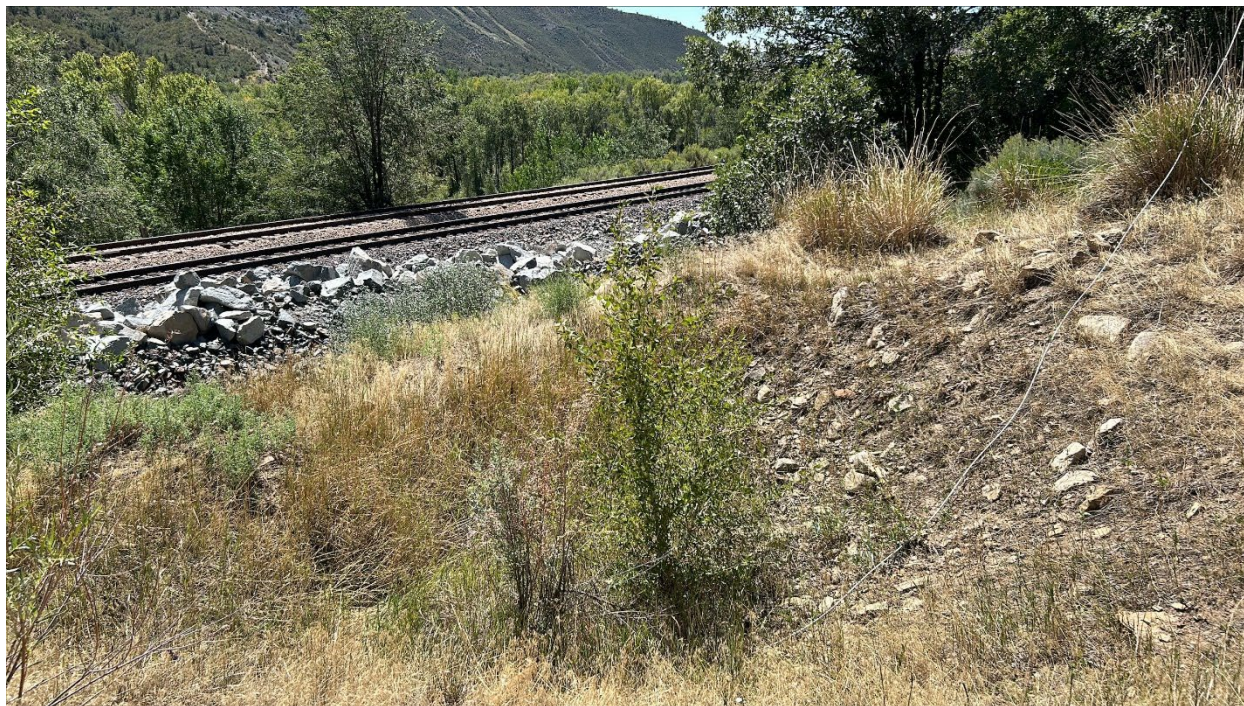
Following an unusually wet period in the region, a small puddle of water lay in the Sediment Pond. The Dug-out Pond was dry. Both ponds were stable and well vegetated.

Figure 3: Dug-out Pond

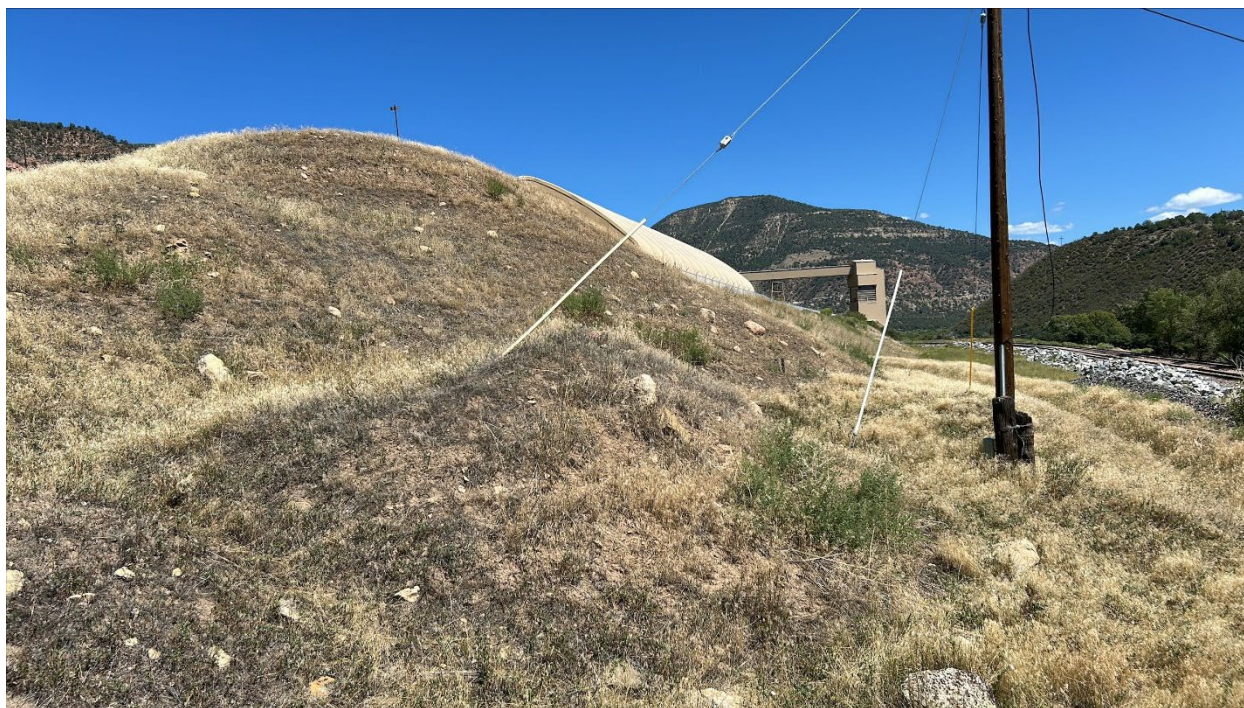
Unused topsoil was stockpiled and clearly marked. The surface of the pile was sufficiently well vegetated to prevent surface erosion.

Figure 4: Topsoil stockpile

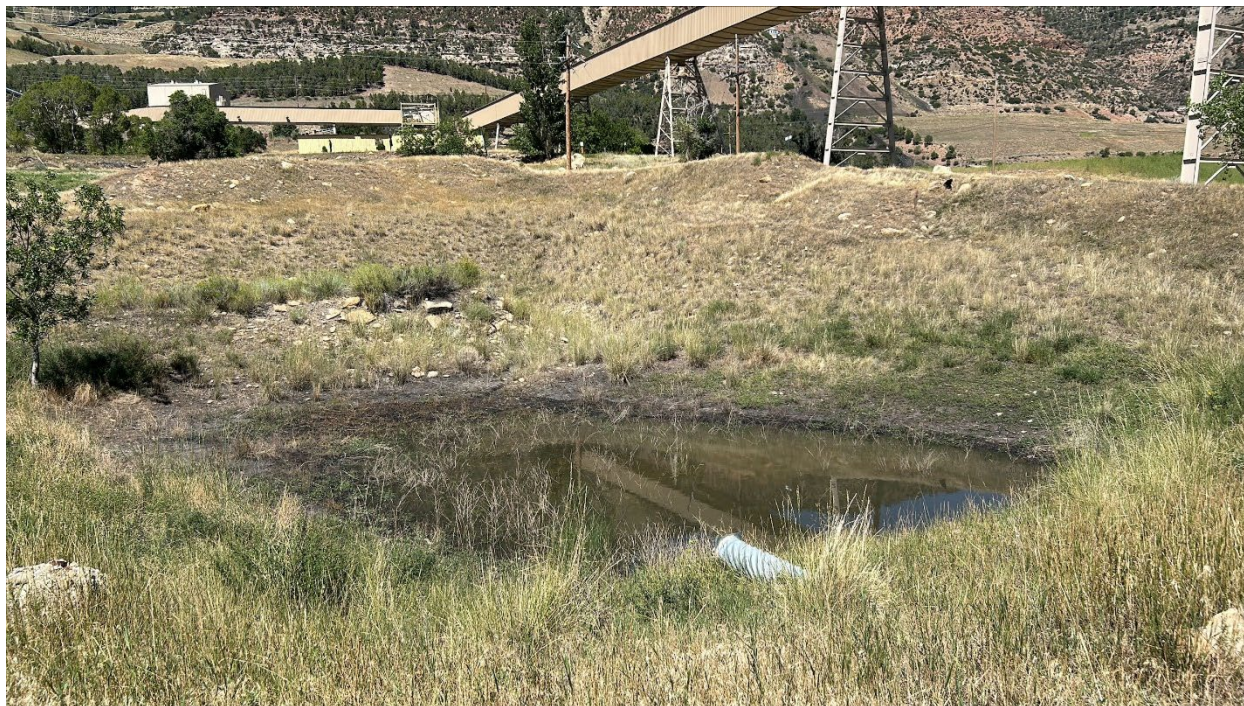
Figure 5: Sediment Pond

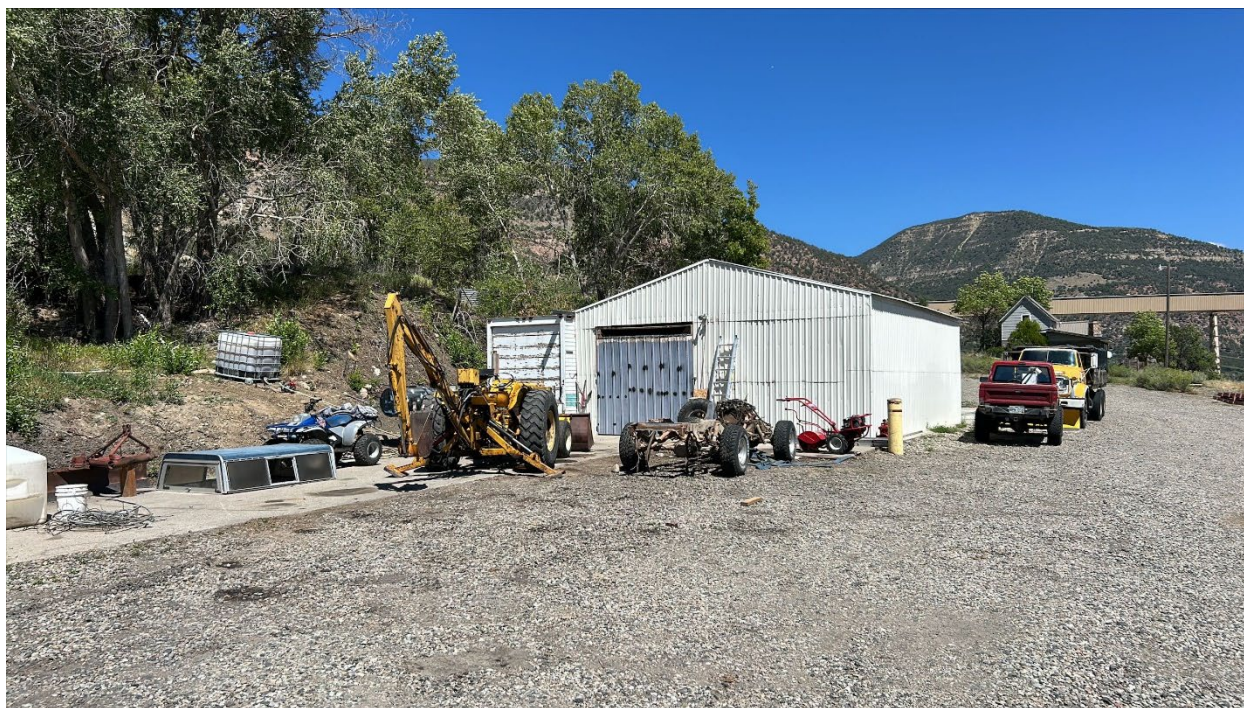
Figure 6: Upper pad, in use by Eddie Bowden
