PERMIT INFORMATION

Permit Number: C1981033 Mine Name: Bear Mine Operator: N/A Operator Address: N/A	County: Gunnison Operation Type: Underground Permit Status: Revoked Ownership: Private
	Operator Representative Present: N/A
Operator Representative Signature: (Field Issuance Only)

INSPECTION INFORMATION

Inspection Start Date: August 28, 2024 Inspection Start Time: 13:00 Inspection End Date: Inspection End Time:		Inspection Type: Coal Complete Inspection Inspection Reason: Normal I&E Program Weather: Clear	
Joint Inspection Agency: None		Joint Inspection Contacts: 	
Post Inspection Agency: None		Post Inspection Contacts: 	
Inspector(s): Leigh Simmons	Inspector's Signature:

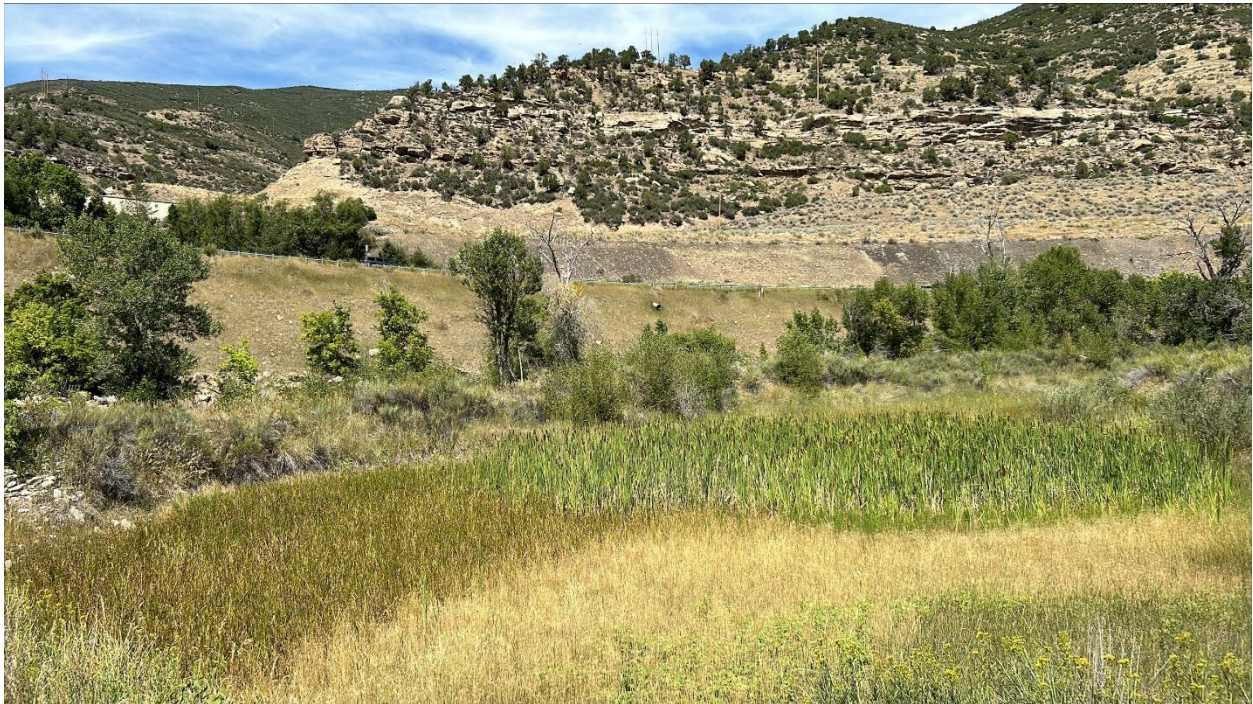
The site was accessed via the bridge from Somerset. Vegetation on the reclaimed area was much improved over previous years, with cheat grass making up a noticeably smaller proportion of the community.

Figure 1: Reclaimed sediment pond

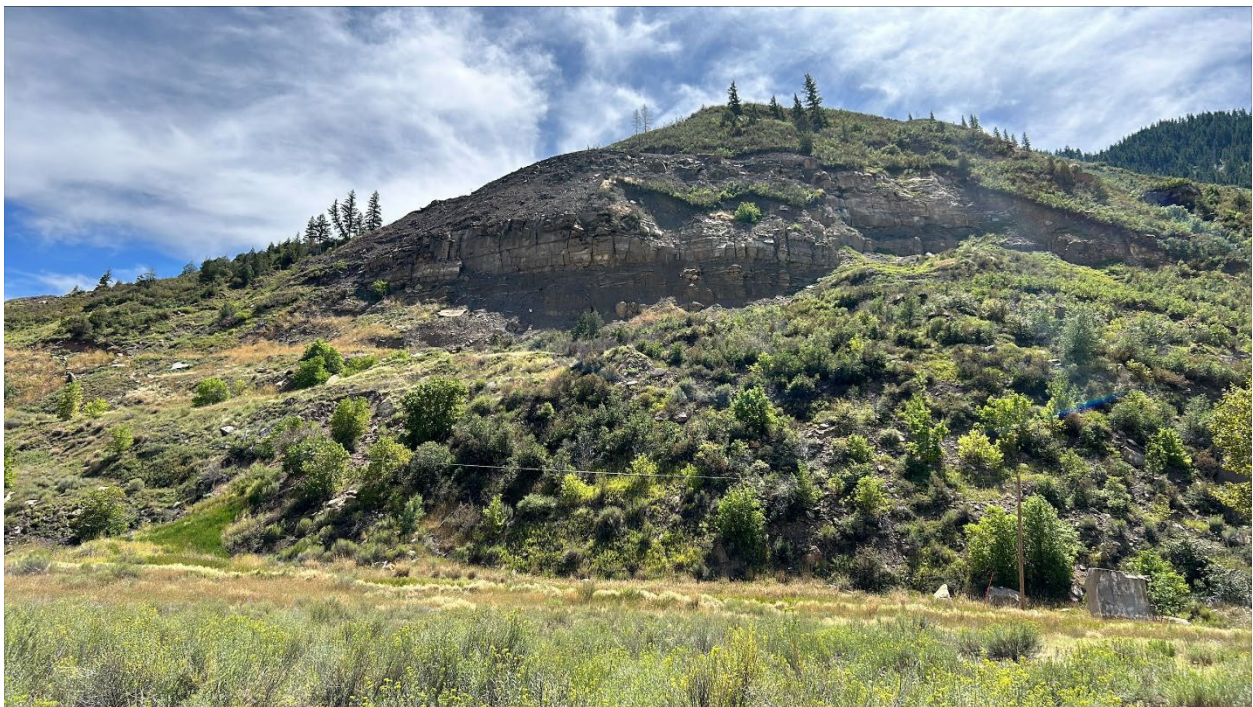
As was the case in April and May, signs of the underground fire were greatly reduced compared to 2023.

Figure 2: View of slide area and scarpe, with burn scar above

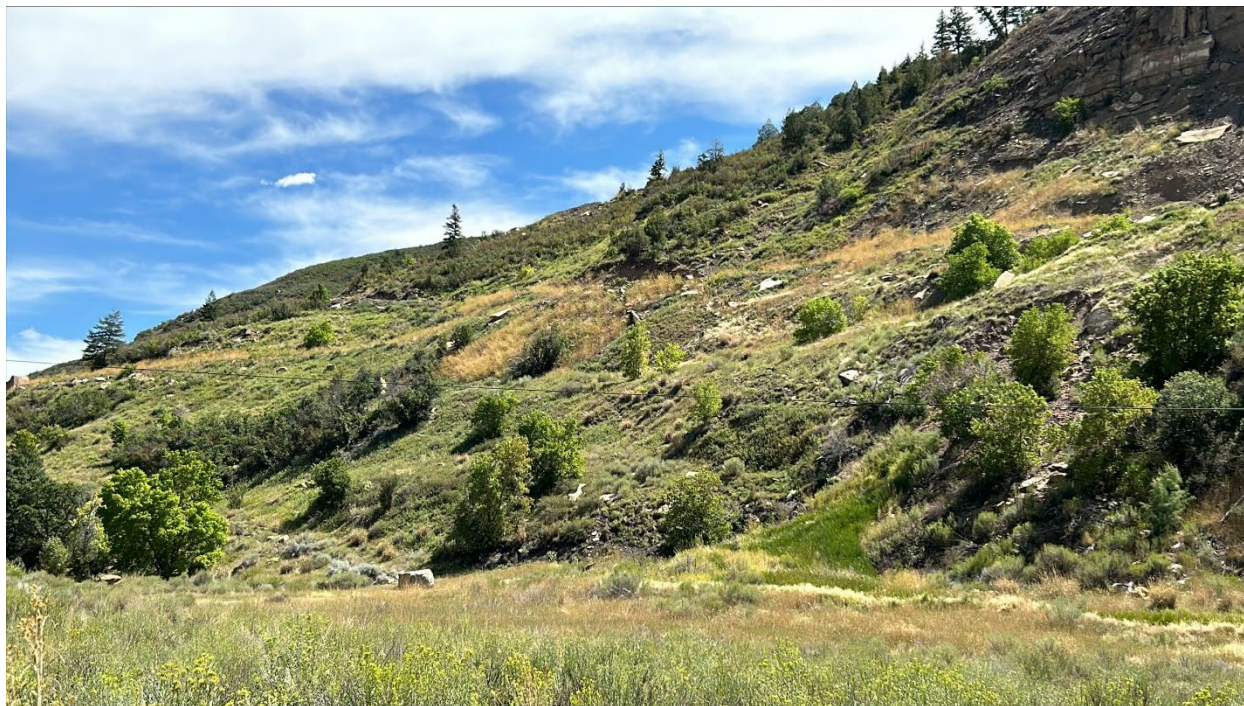
There did not appear to have been any further slumping of soil at the groundwater seep, but the previous slump continued to impede part of the flow into the channel.

Figure 3: Overview of groundwater seep area

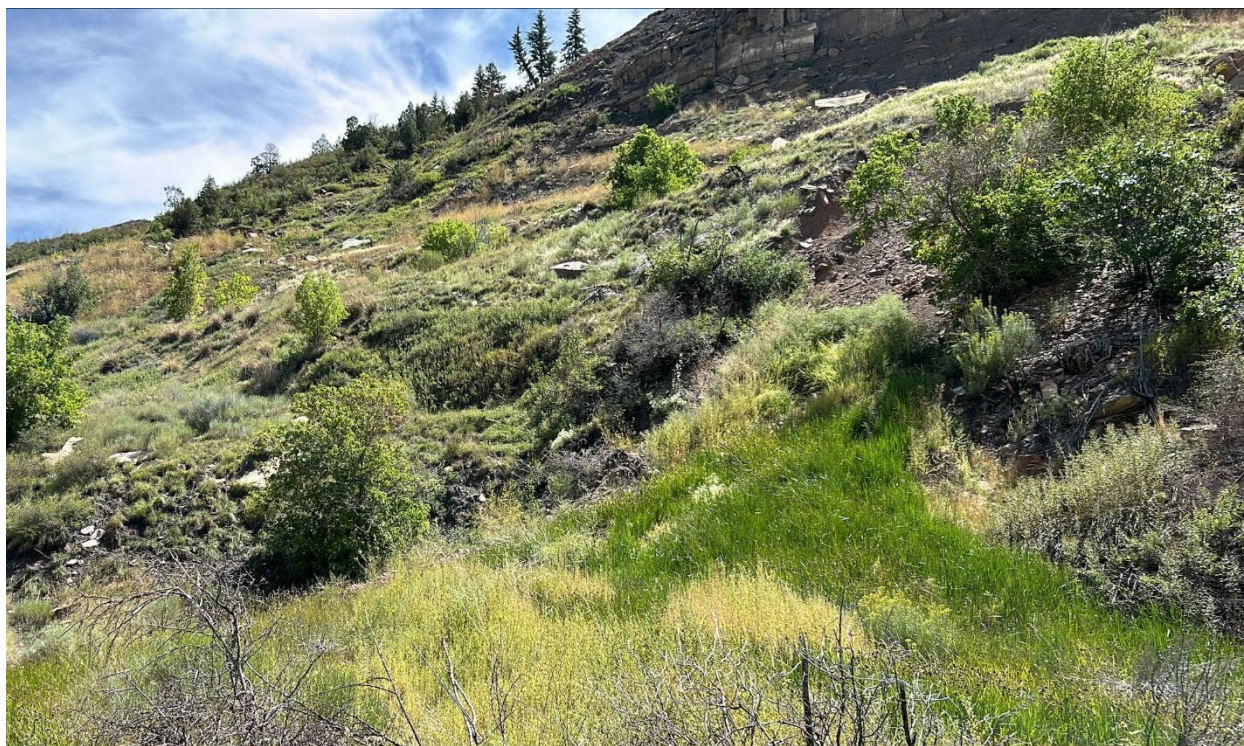
Figure 4: Groundwater seep

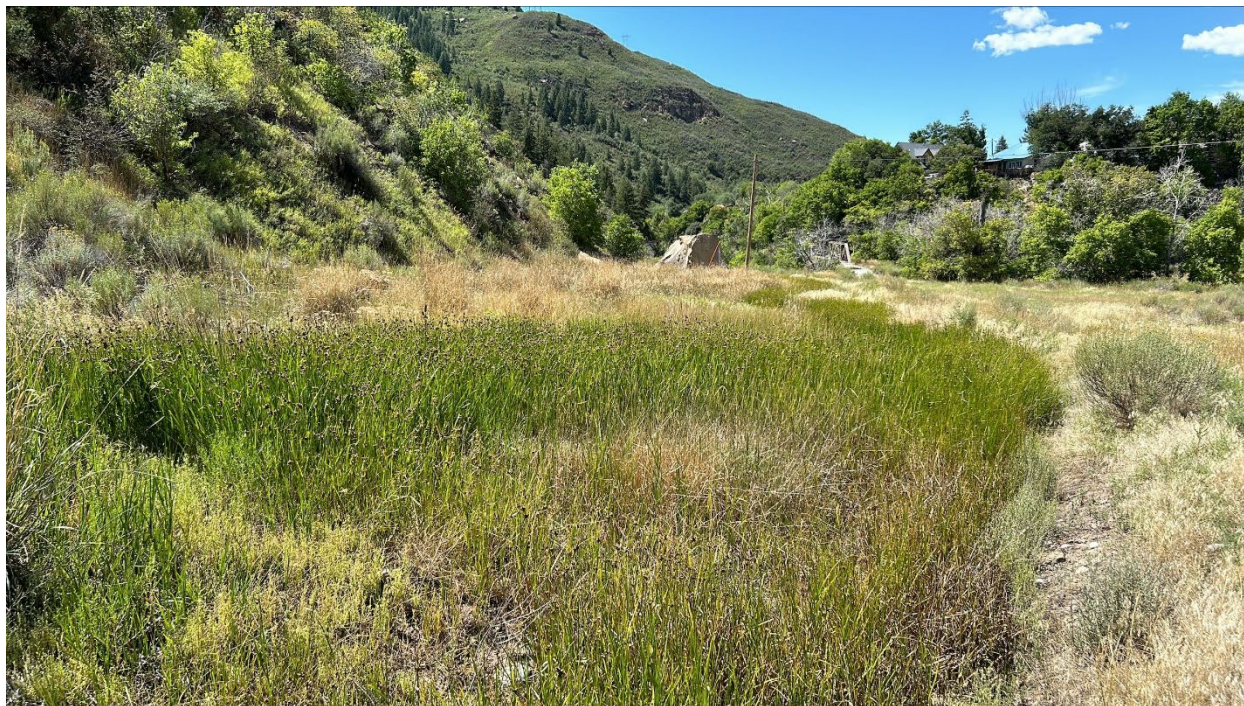
Figure 5: Sinuous channel, well vegetated with sedges

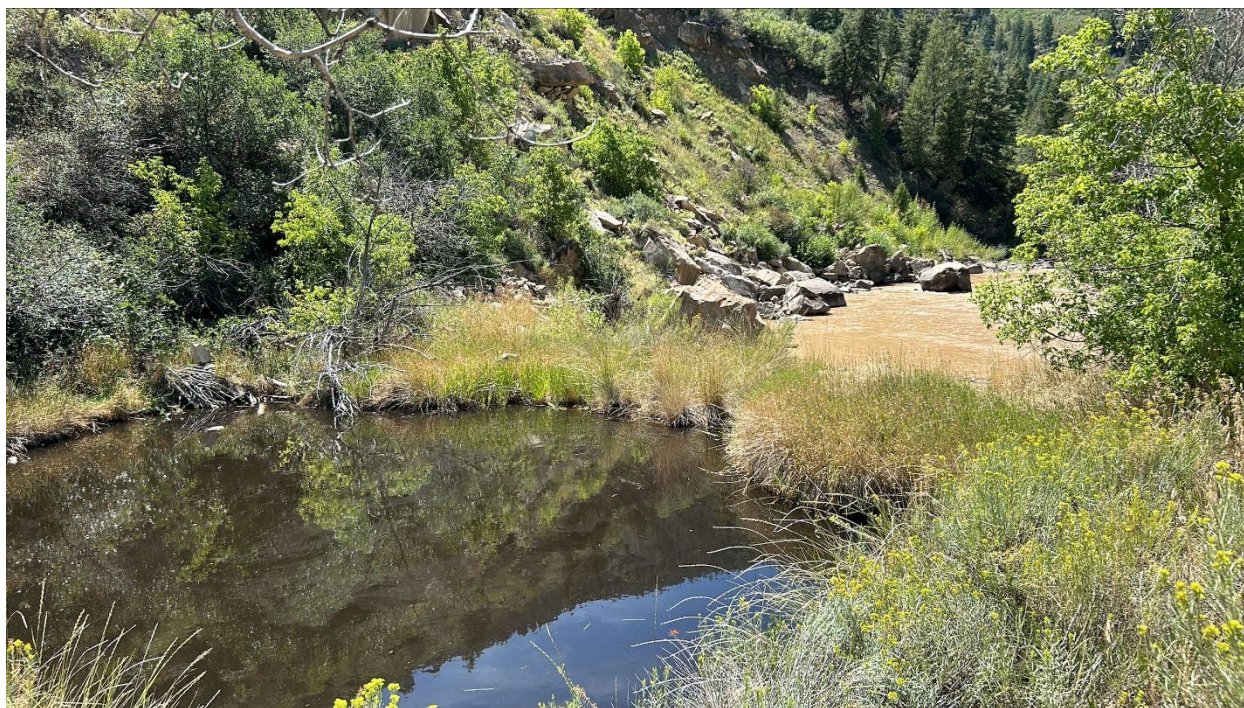
Figure 6: Ponded water at outlet of sinuous channel
